То	Antonio Todarello		
Copy to	File		
From	Kadir Oncu	Tel	0434 837 859
Subject	Slope Risk Assessment	Job no.	ANTT0396 - GEO AA Rev01
	Proposed Stormwater System		
	731 Great Western Highway, Faulconbridge NSW

## 1 Introduction

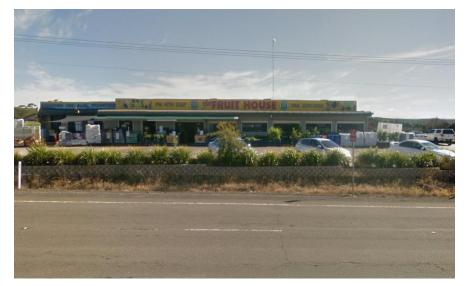
- The allotment is currently occupied by an existing single level commercial property/structure located in the centre of the lot (**Photo 1**). The structure appears in good condition with no visual signs of structural damage. It is envisaged that the foundations of this structure are likely supported on sandstone bedrock.

**Photo 1:** View looking west from the Great Western Highway showing the existing commercial building.

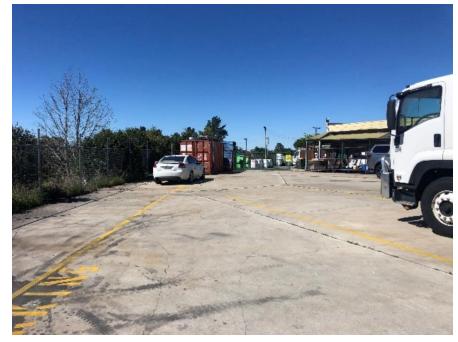
- The area surrounding the commercial building is covered with concrete pavement (hardstand). The hardstand covers the majority of the site area and provides access and parking facilities for vehicles. The hardstand appears fairly flat and consistent, and fenced along the northern and western boundary (**Photo2**).

**Photo 2:** Photo of the hardstand. Looking East towards the carpark exit.

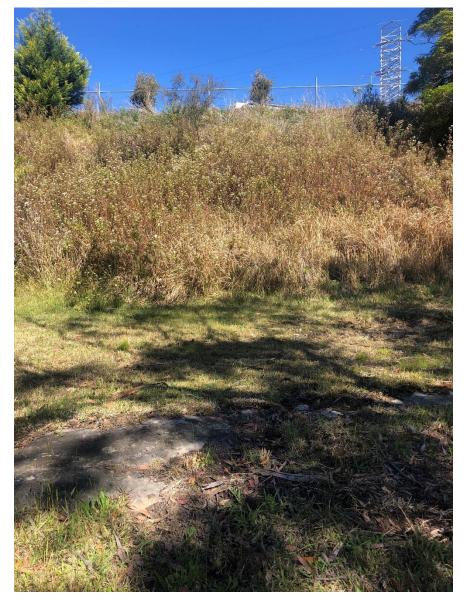
- Areas adjacent to northern extent of the embankment comprised moderately to steep side slopes with inclination between 15 degrees to 20 degrees and stepped/benched rocky outcrops (Photo 3 and Photo 4). The rear of the allotment is mostly open grassed area which is slightly vegetated including vegetable patches/gardens.

**Photo 3:** View looking east from the northern end of the site. Natural slope adjacent to the embankment with exposed sandstone outcrop at the bottom of the slope.

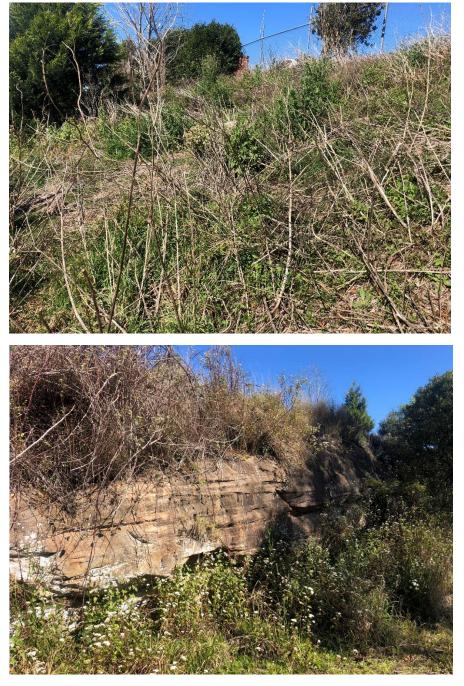
- The surface of the embankment is covered with vegetation and appears to be in stable condition. No evidence of previous slope movement was observed during our field assessment (**Photo 4**).

- Persistent surface bedrock outcrops were evident around the site (**Photo 5**). Where exposed, the bedrock comprised sandstone and was generally observed to brown-grey with surface staining, massive with minor to moderate bedding planes, moderately weathered to slightly weathered, medium to coarse grained, medium to high strength.

**Photo 4:** Surface of the embankment is covered with vegetation.

**Photo 5:** Persistent bedrock surface outcrop along the northern boundary line.

The proposed retaining wall must be constructed in accordance with the **good hillside practice** guidelines **(refer to Appendix C).** Additionally, vegetation cover on the slope surface must be maintained for erosion control and long term stability of the embankment.
