Ref: 24137 23rd October 2024

## RE: Canterbury Rd Overpass, Canterbury. NSW DA For Continued Signage Use, Structural Feasibility and Safety Report

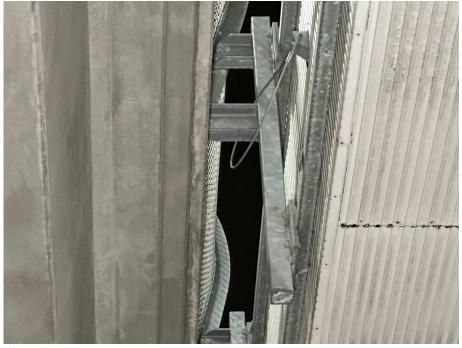
Photo 1

The existing signs are backlit landmark signs. The signs consist of steel boxes that are fixed to each side of a concrete girder footbridge located over Canterbury Rd. There are steel frames bolted to each side of the bridge's steel safety screen. Horizontal rails are fixed to the frames. Z brackets are fixed to the back of the sign boxes and the brackets fit over the rails connecting the boxes to the support frames. Each sign face is 22.5m horizontal x 1.8m vertical. Refer to photo 1 to 5 and 8 to 10.

Safety cables to stop the boxes falling onto the road during vehicle impact have been installed. Refer to photo 1 and 2.

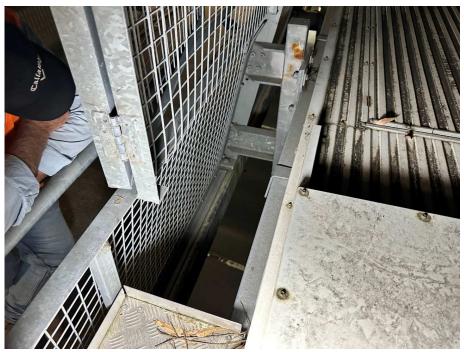
Photo 4

The sign boxes are located on the outside of the safety screen. Access to each sign box is from a hatch in the side of the safety screen. Refer to photo 4, 5 and 9. There are platforms between the safety screen and the sign boxes to step on when accessing each box. There is a hatch in the top of each sign box and a permanent ladder inside each sign box underneath the hatches.

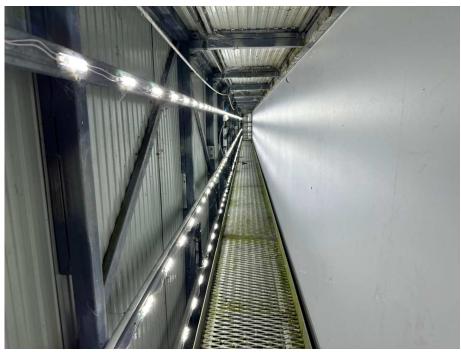
Photo 6

When the banners are replaced, it is done from a walkway inside each box without having to stop the traffic below the signs. There is a horizontal cable running the length of each box that workers replacing the banner can fix their harnesses to. Refer to photo 6,7 and 10.
