Proposed Demolition of Sonnblick Lodge

Our ref: OB/C14191v3

Proposed Demolition of Sonnblick Lodge **10 Bobuck Lane, Thredbo, NSW** *Geotechnical Investigation & Landslide Risk Assessment*

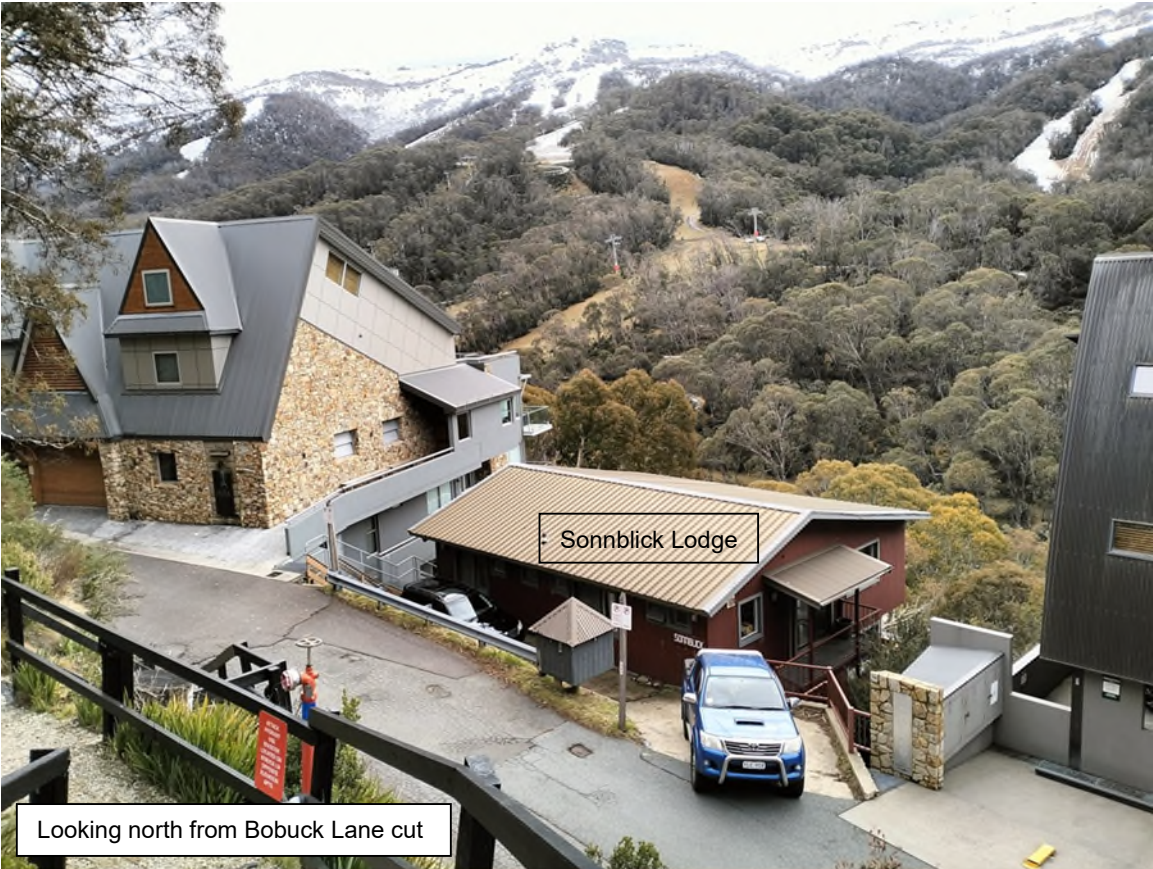
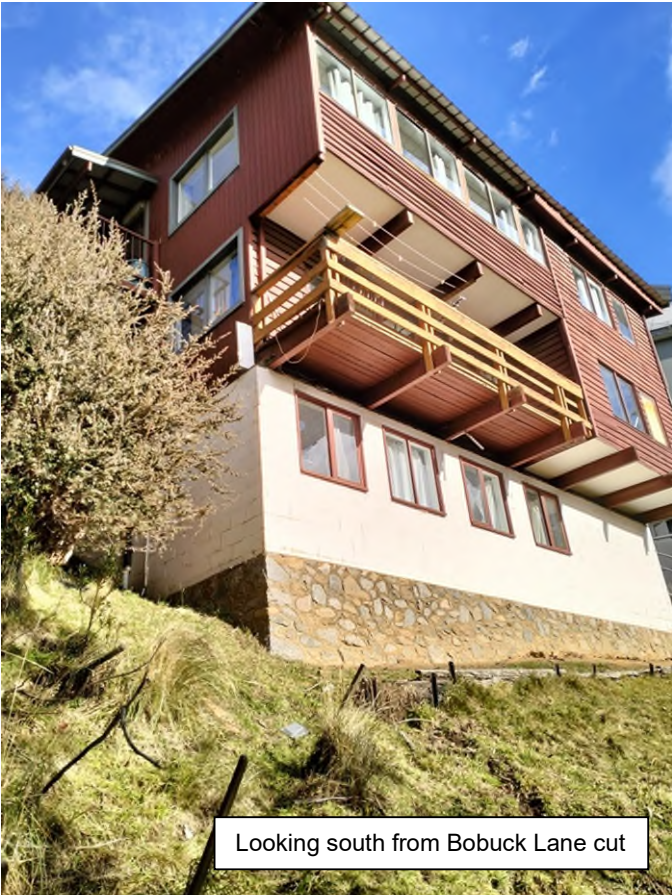
<p data-bbox="678 981 896 1029">Sonnblick Lodge</p> <p data-bbox="159 1278 589 1321">Looking north from Bobuck Lane cut</p>

<p data-bbox="1525 1294 1944 1337">Looking south from Bobuck Lane cut</p>

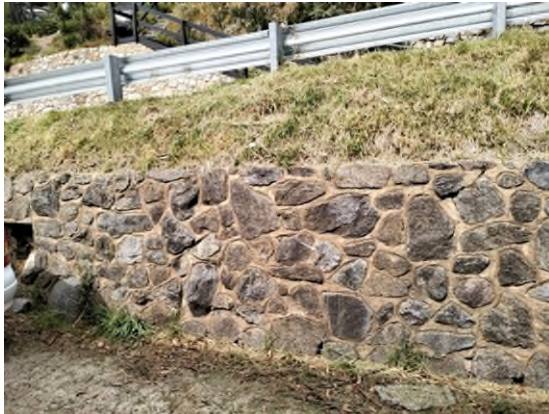
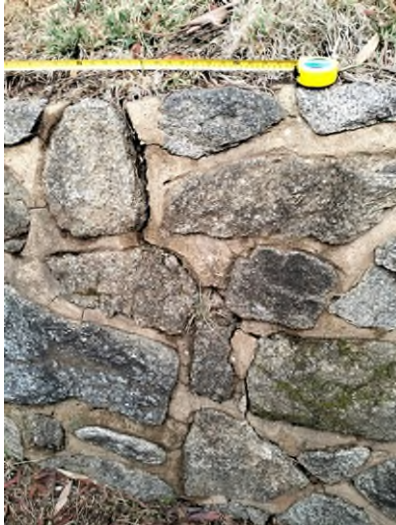
- RW4 supports Bobuck Lane on the downslope site. RW4 is up to 2m high and shows cracking through mortar and loose boulders.

Aspect & Location	Observations	
	2023	2024
Cracking in the Retaining Walls – RW 4 (Driveway Retaining Wall) Beneath Bobuck Lane	<p>Generally, good condition cracks through mortar to 20mm, some detached stones: no bulging or tilting.</p>

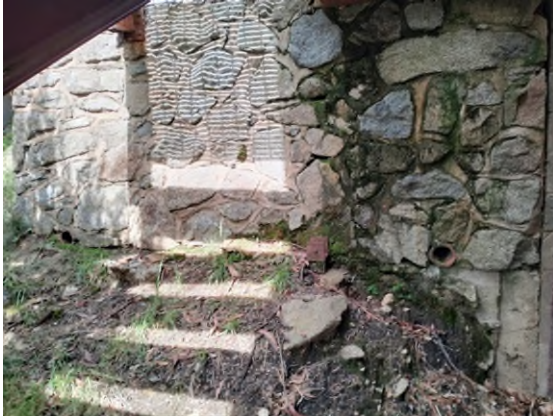
<p>The cracks run through mortar to 20mm, some detached stones: no bulging or tilting.</p>
<p>RW3 (Beneath/ supporting driveway) Most to wet soils, soil erosion/</p>	<p>The weep holes existed at the base of the retaining wall. However, the soils (fill) below RW3 were moist to wet, in loose density.</p>

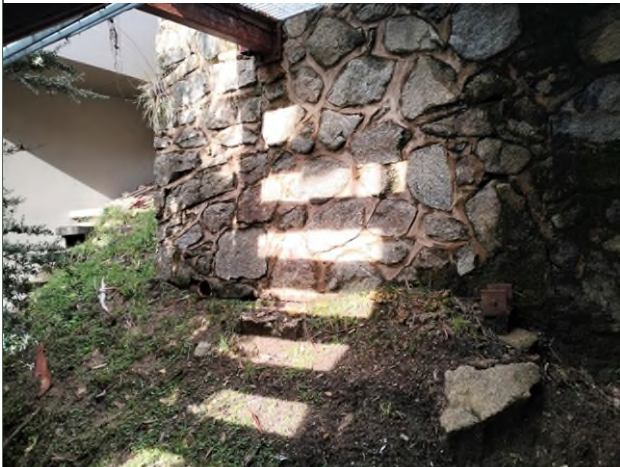
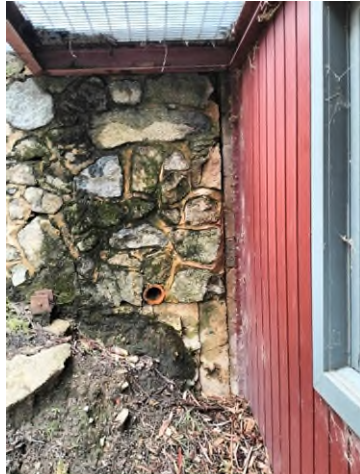
<p>The weep holes were wet soils below RW3 that were moist to wet. Some water was dripping from the roof. There is no surface drainage catching water from the roof.</p> <p>DCP 2 & 3 were done at the toe of the RW3 retaining wall.</p>

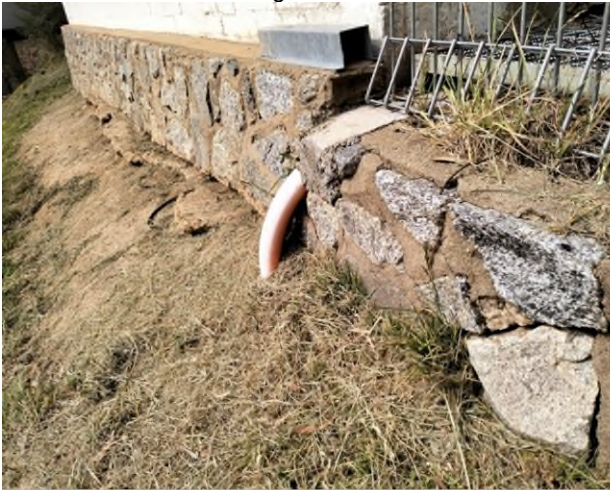
- RW1 is located at the rear of the property, supporting the ground level of Sonnblick Lodge. Previous investigation (Reference 2) found that the footings of that wall were found on colluvial soils. RW1 has cracks through the mortar, and is partially undermined due to soil erosion.

Aspect & Location	Observations	
	2023	2024
RW 1 supporting the Rear side of the lodge	<p>Undermined to 5-10mm. Some soil erosion. Cracking through mortar.</p>

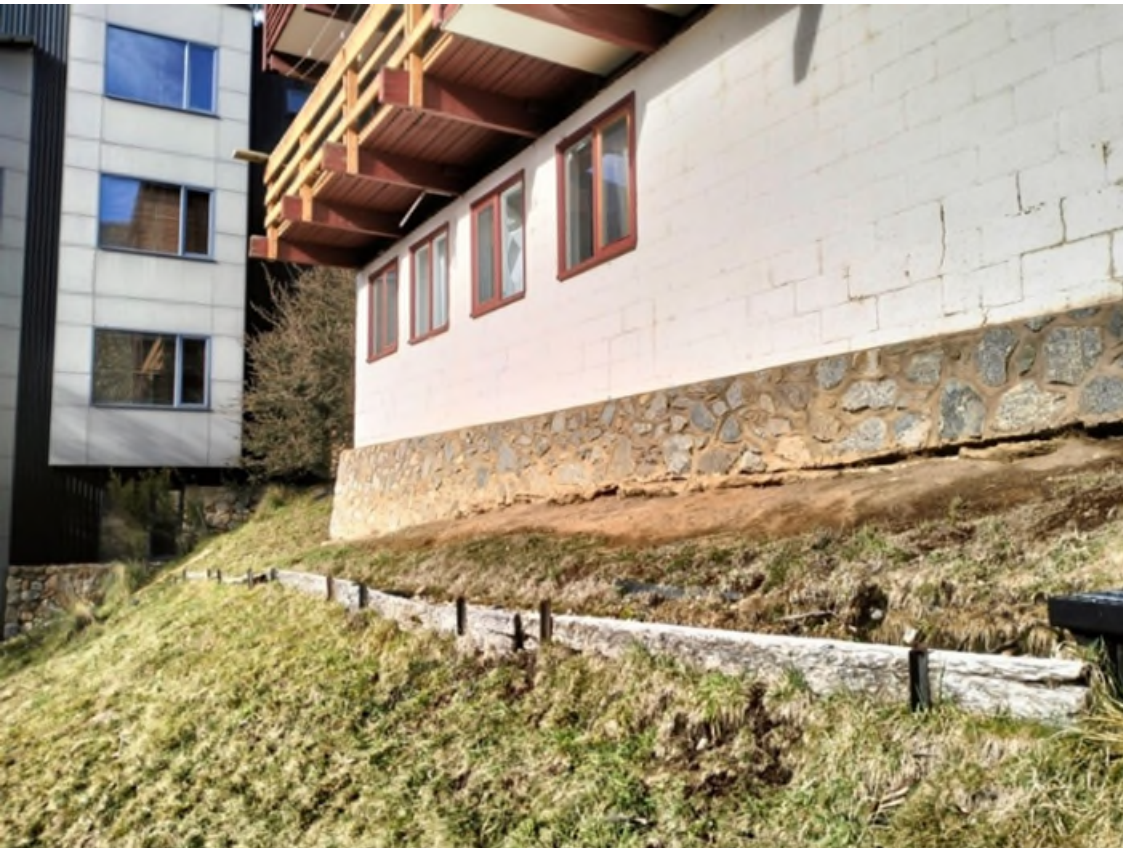
<p>Undermined to 5-10mm. Some soil erosion. No major changes noted</p>

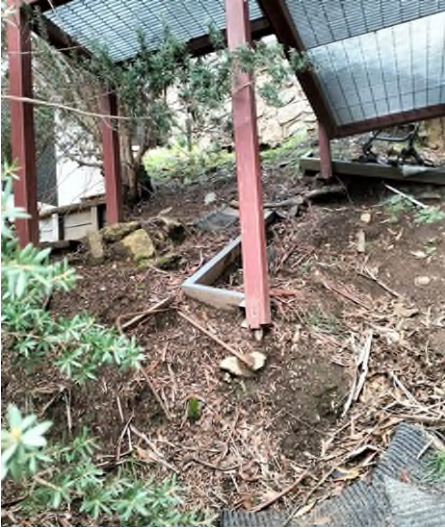
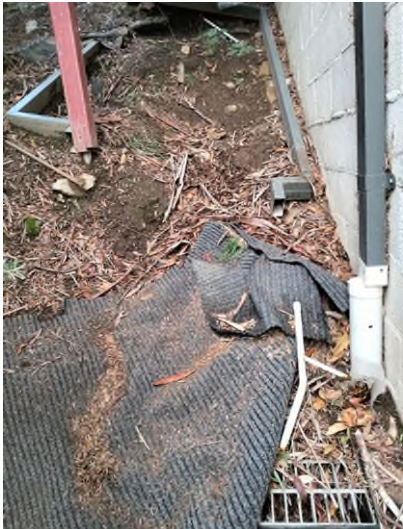
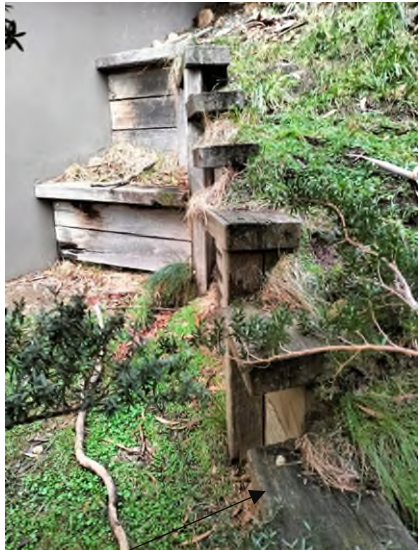
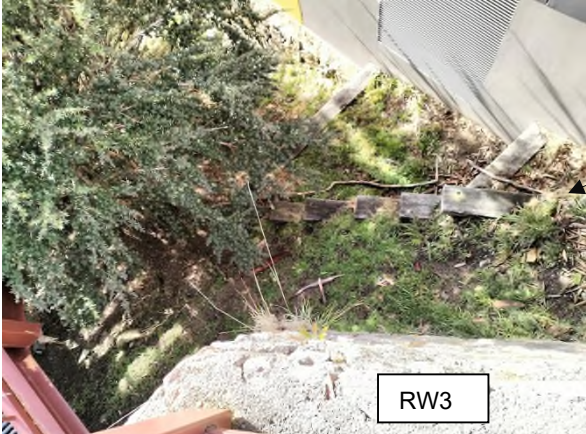
Aspect & Location	Observations	
	2023	2024
Batters on the western side of the block (boundary with Lot 801)	No photographs are available.	<p>The access stairs to level 1 are located on the western side of the block. Loose, moist, and wet soils (fill) were observed on the batters beneath the stairs. The subsurface drain inlet adjacent to the lodge was partially blocked with leaves and debris. Timber retaining walls on the block boundary were in good condition with only minor tilting.</p> <div>

<div>View on timber retaining walls from above</div></div>

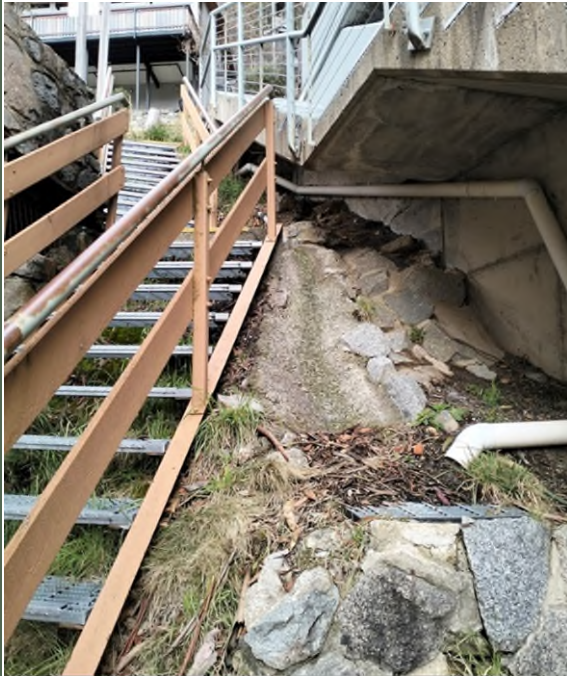
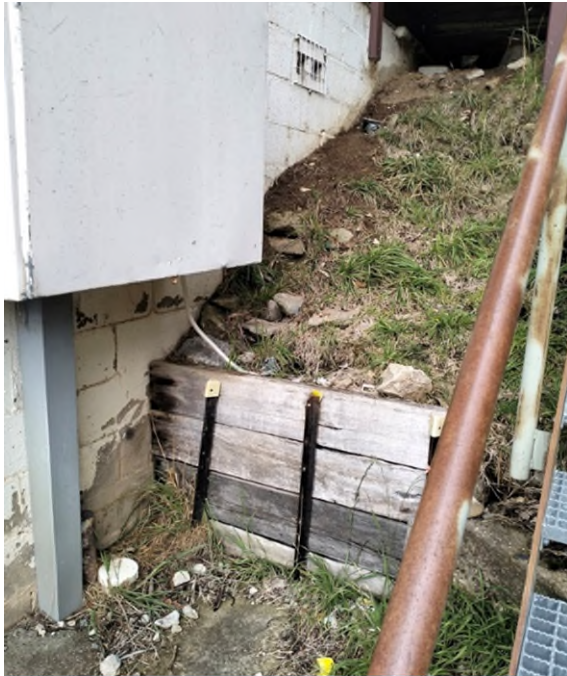
Aspect & Location	Observations	
	2023	2024
Batters on the eastern side of the block (boundary with Lot 803)	No photographs are available.	<p>The access stairs to the Sonnblick are located on the eastern side of the block. The batters are partially buttressed with boulders. Shallow swale drains and underground drainage dispose of stormwater from a neighbouring lodge. Some loose, moist, and wet soils (fill) were observed on the batters beneath the stairs and adjacent to the Sonnblick Lodge. The timber retaining wall was in good condition with only minor tilting.</p> <div data-bbox="848 477 1413 1155">

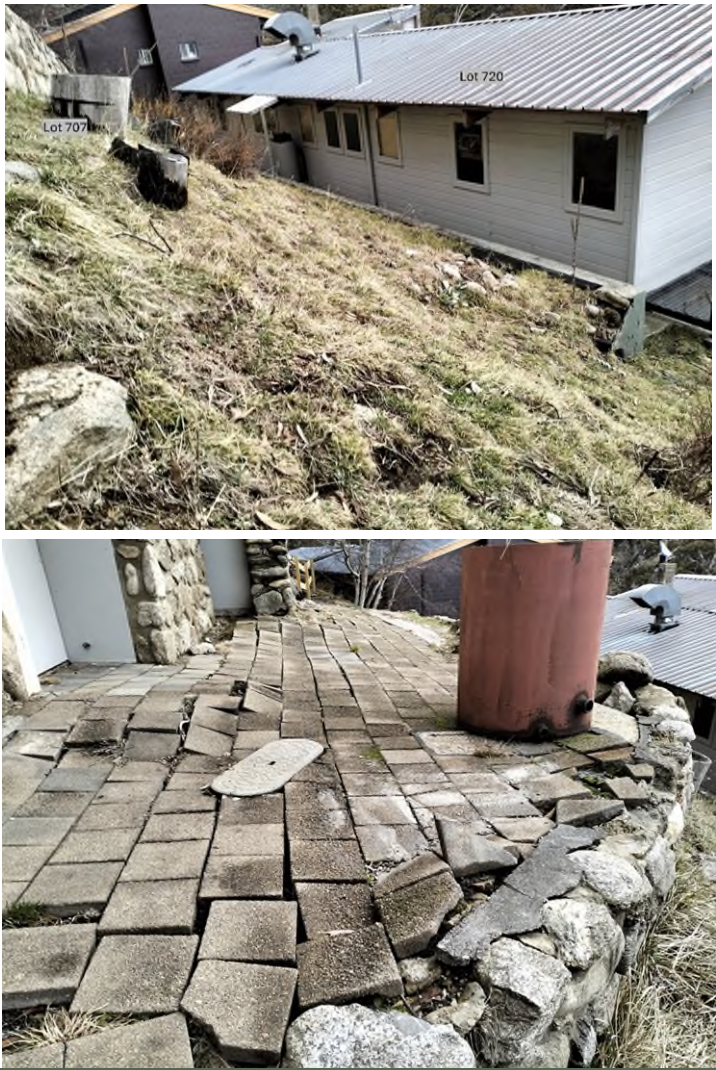
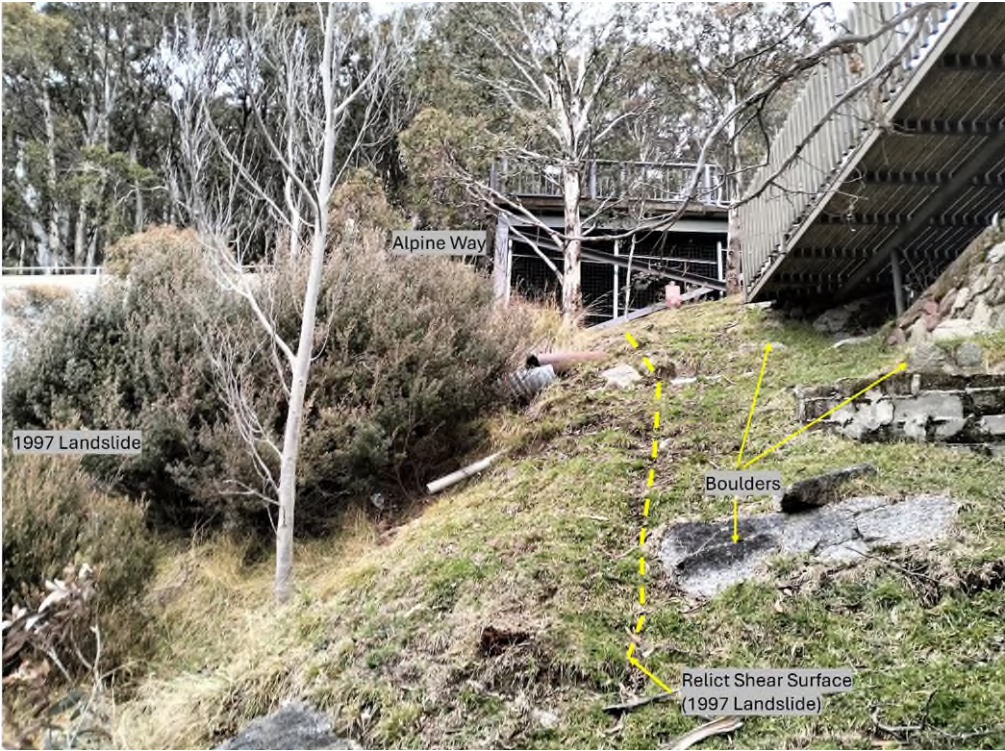
<p>The lodges above Bobuck Lane are located on a relatively steep slope of 25 to 35°. Some boulders 0.2m/1m were noted, soil creep and cracking were present, and tile backfill pavement and retaining walls were damaged.</p>

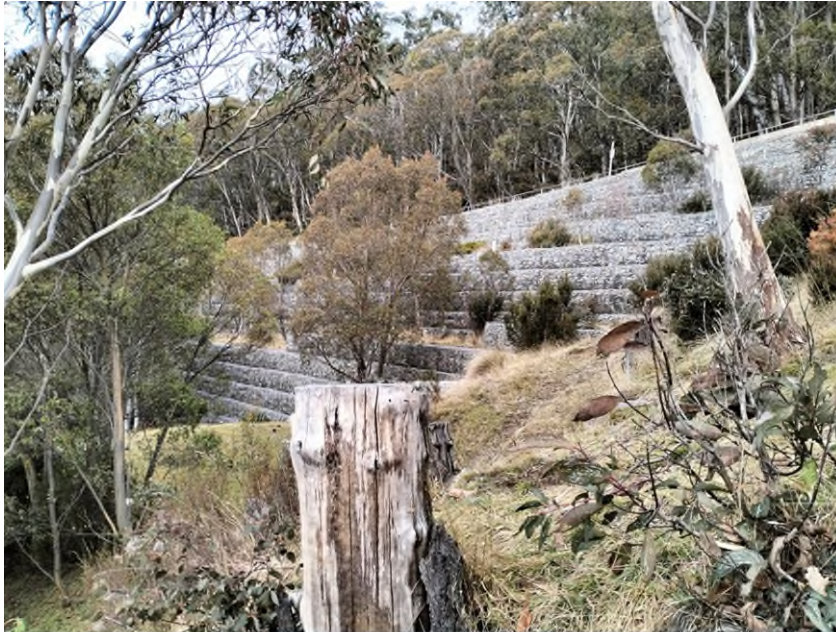
<p>Reconstructed Alpine Way embankment at location of 1997 Landslide</p>

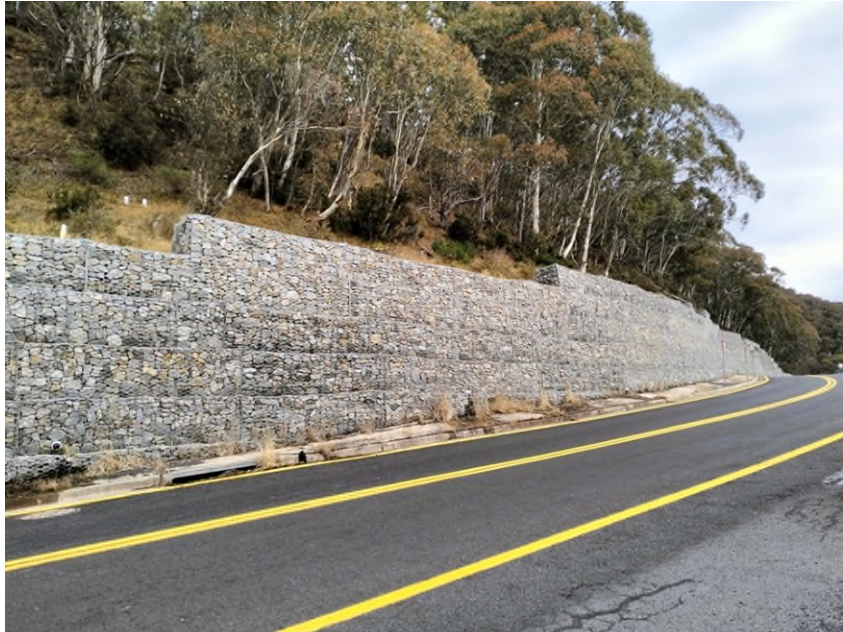
<p>Reconstructed Alpine Way cut (~70m upslope Lot 802)</p>

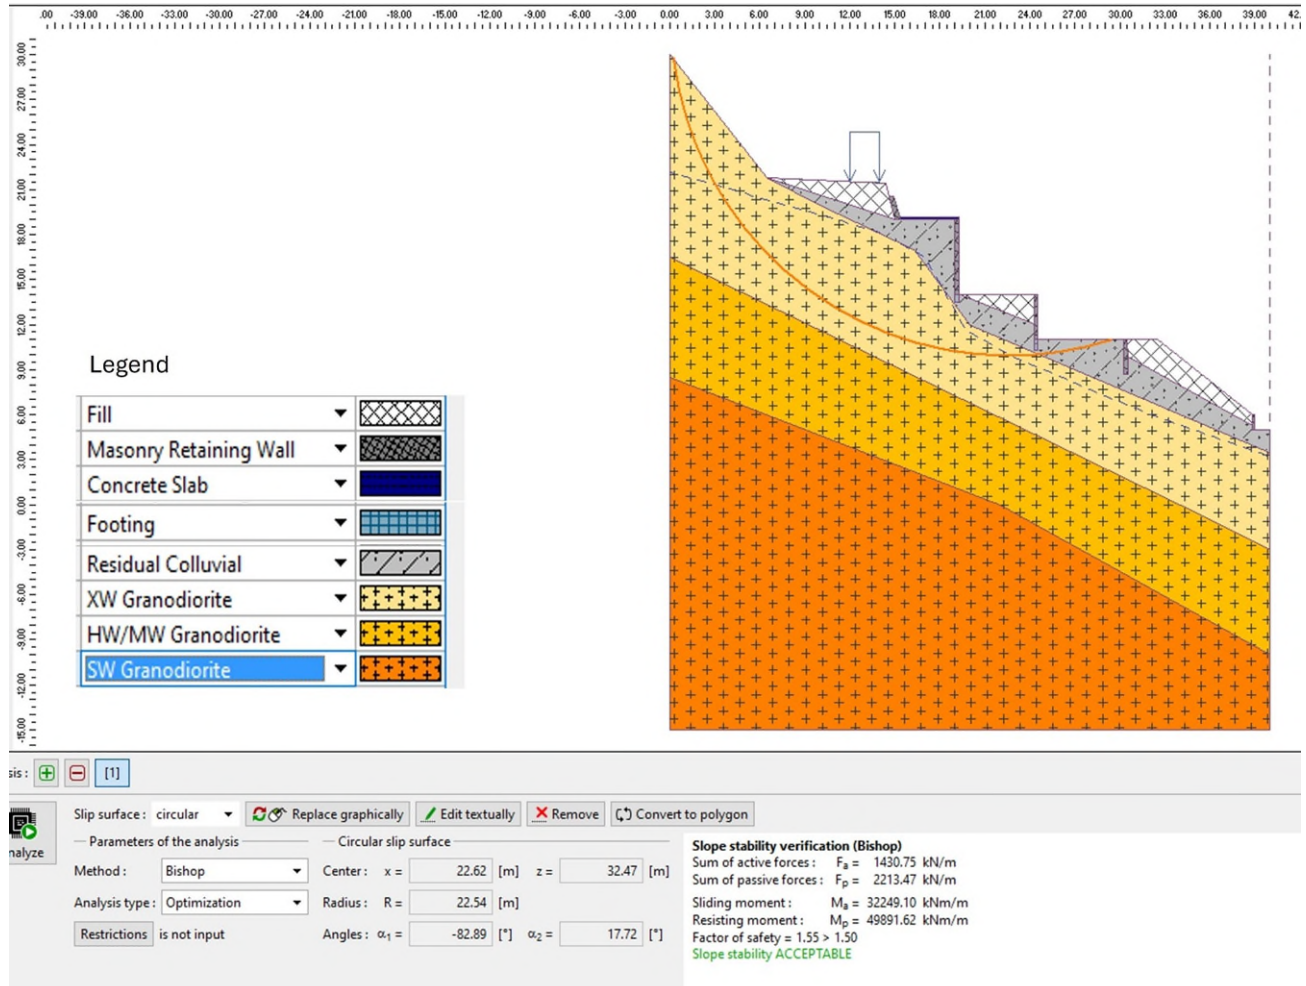
Plate 1: Results of Geo5 modelling for large deep-seated circular rupture surface.

Plates 1 to 3 show the simulation results for the existing conditions. The factor of safety (FOS) of the existing slope is 1.55 for the circular rupture surface beneath Bobuck Lane and 0.59 (unacceptable) for the smaller failure through the fill batter at the rear of the site. The slope instability was identified in the unsupported upper batter of Bobuck Lane embankment. The location of the failure on the slope analysis results correlates with the existing tension cracks on the outer line Bobuck Lane. The FOS for this shallow failure is $0.34 < 1.50$, and is unacceptable.

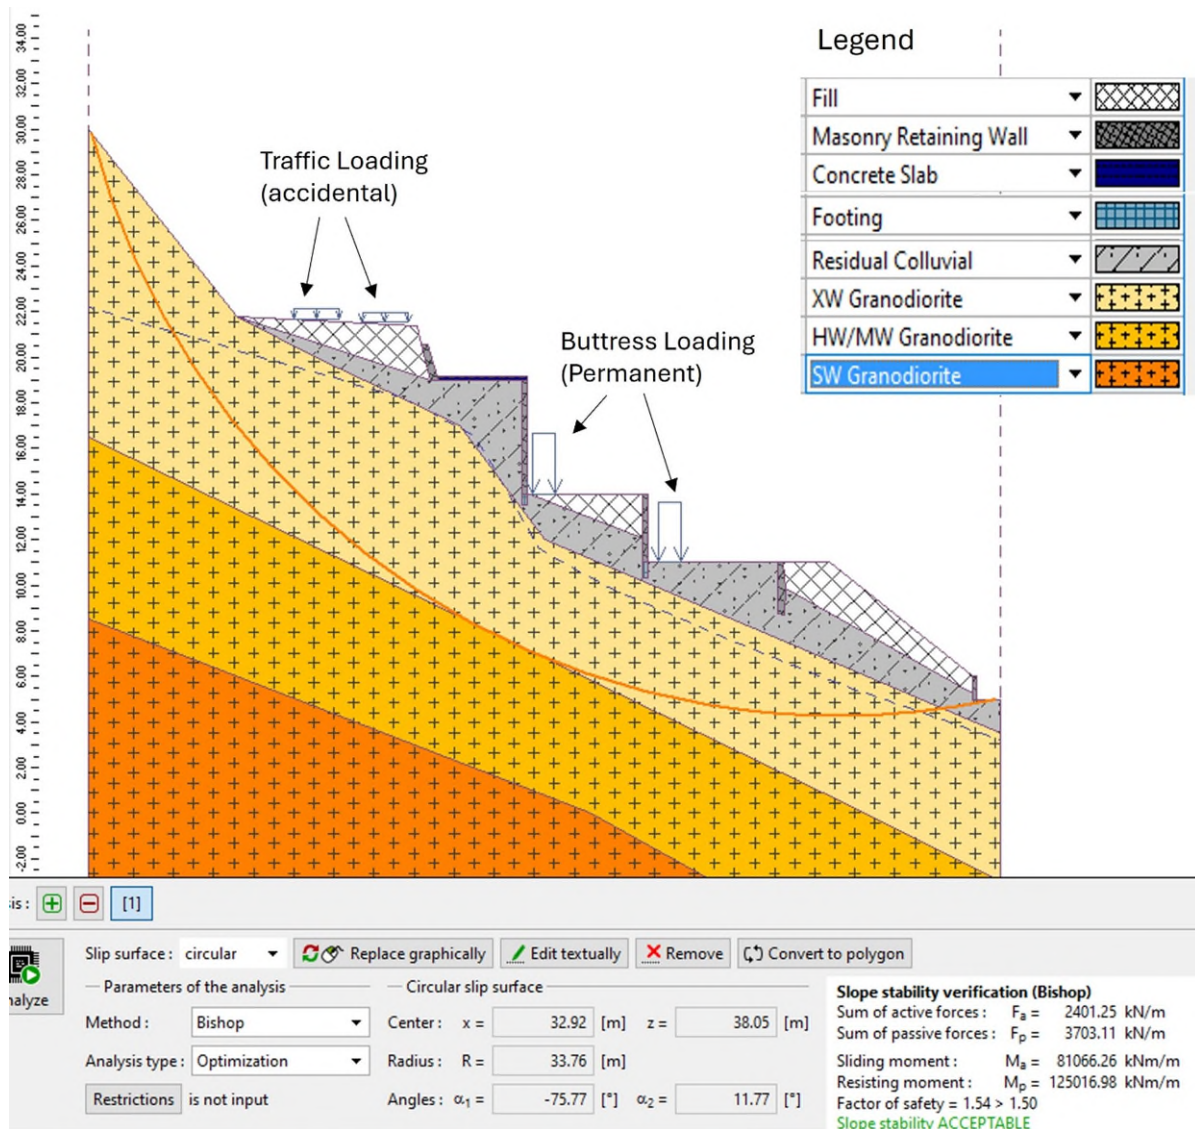
Plate 4: Results of Geo5 modelling for large deep-seated circular rupture surface including traffic and buttress loading.

Plate 4 shows the results of analysis that include additional permanent surcharge of 75kN/m^2 for the proposed buttressing of the retaining walls (Section 6.3). The gabion wall buttress was assumed for the surcharge calculation. The slope stability analysis results indicate a FOS of 1.54, which is acceptable.

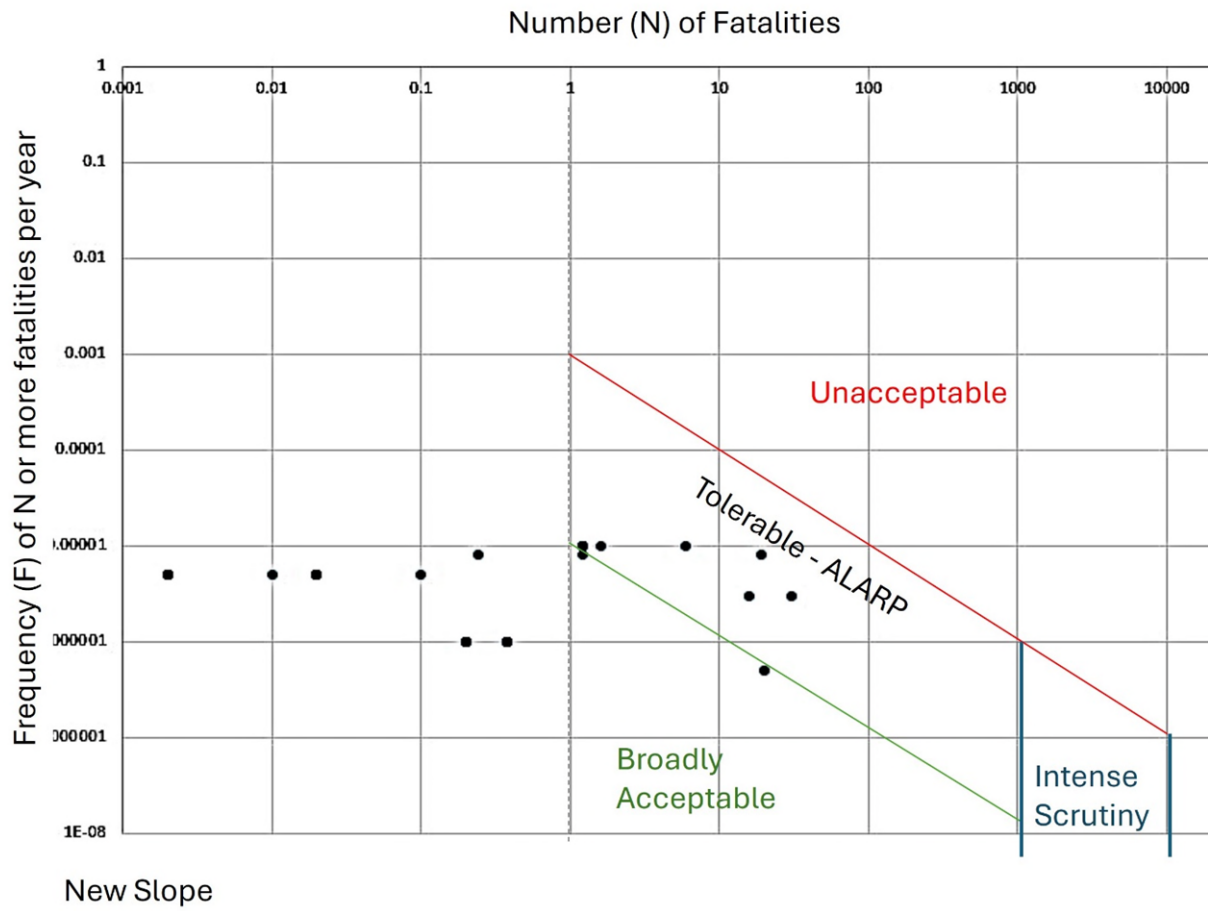
Plate 6: Societal Risk Assessment Plot (N-F) for Lot 802 and the vicinity – New Slope

As shown on Plate 6, the proposed new slope (in case if properly engineered) will decrease the societal risks to 'Tolerable' (ALARP) and 'Broadly Acceptable' areas.
