Our ref: 7471-R1 Rev3 13 February 2025

Proposed Playground Upgrade, Thredbo Village NSW Geotechnical Assessment

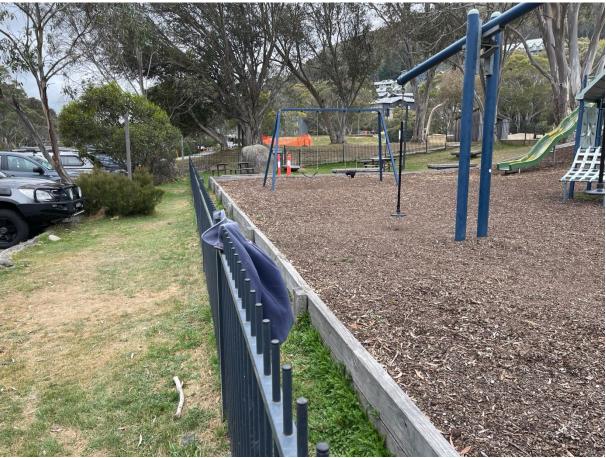
Photo 1: View of northern side of existing playground, looking northeast.

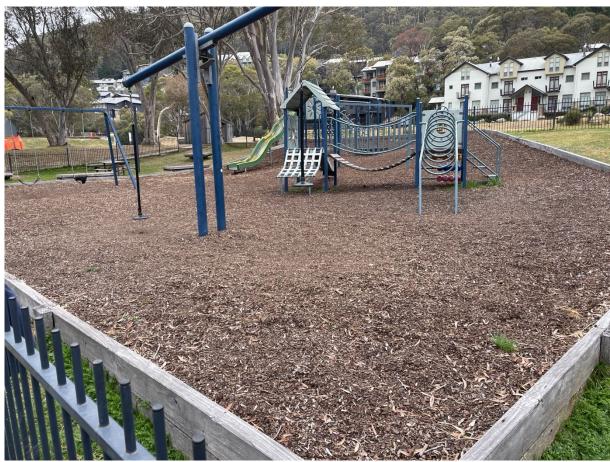
Photo 2: View of existing playground, looking southeast.

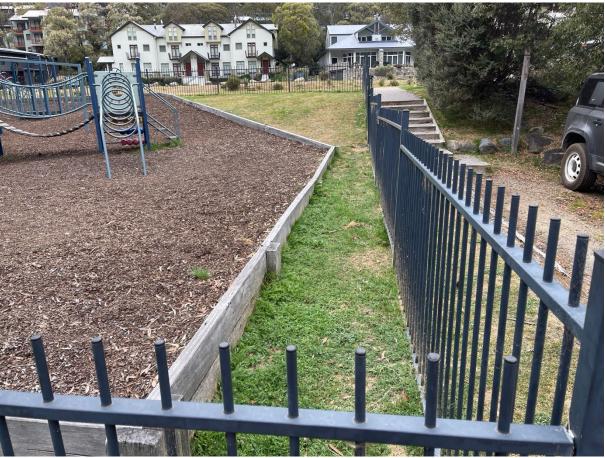
Photo 3: View of existing playground, looking south.

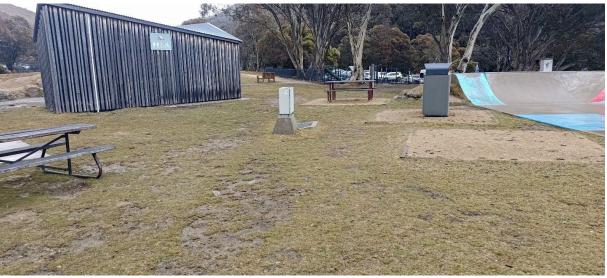
Photo 4: Existing Plaza Area, looking south. Source: Kosciuszko Thredbo Pty Ltd.

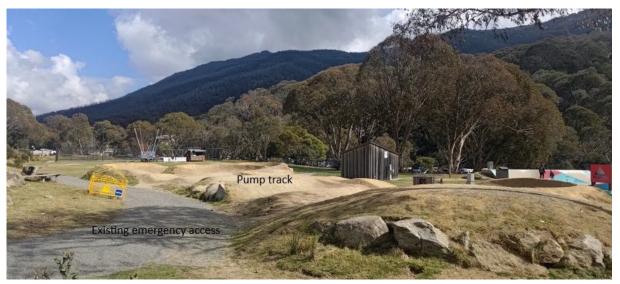
Photo 5: Existing Pump track Area, looking west. Source: Kosciuszko Thredbo Pty Ltd.

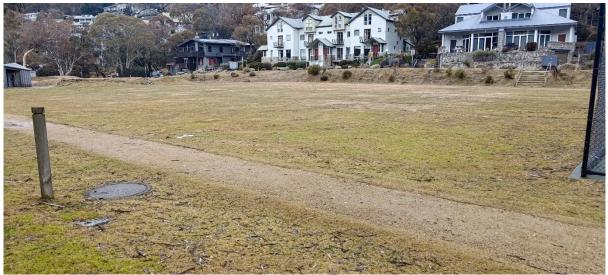
Photo 6: Existing Water Main and Emergency access area, looking east. Source: Kosciuszko Thredbo Pty Ltd.

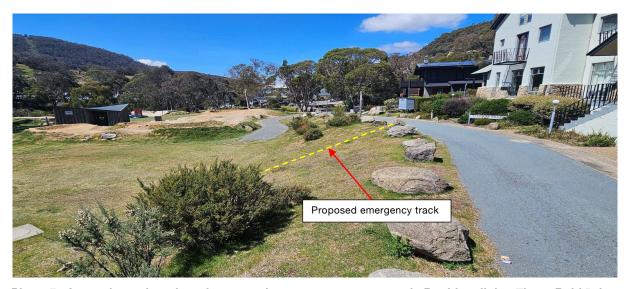
Pump track: The existing pump track (approximately 850 m²) will be demolished and rebuilt in the same location with a slightly larger footprint (approximately 1,000 m²). Bermed features reach up to 1.3 meters in height, and the entire surface will be asphalted. The current emergency access near Thyne Reid Drive will be removed, with a new emergency access lined with boulders for delineation as illustrated in Photo 7. It is noted that these boulders do not retain any soil.

Photo 7: Approximate location of proposed emergency access track. Boulders lining Thyne Reid Drive are proposed for lining new emergency access track. Source: Kosciuszko Thredbo Pty Ltd.

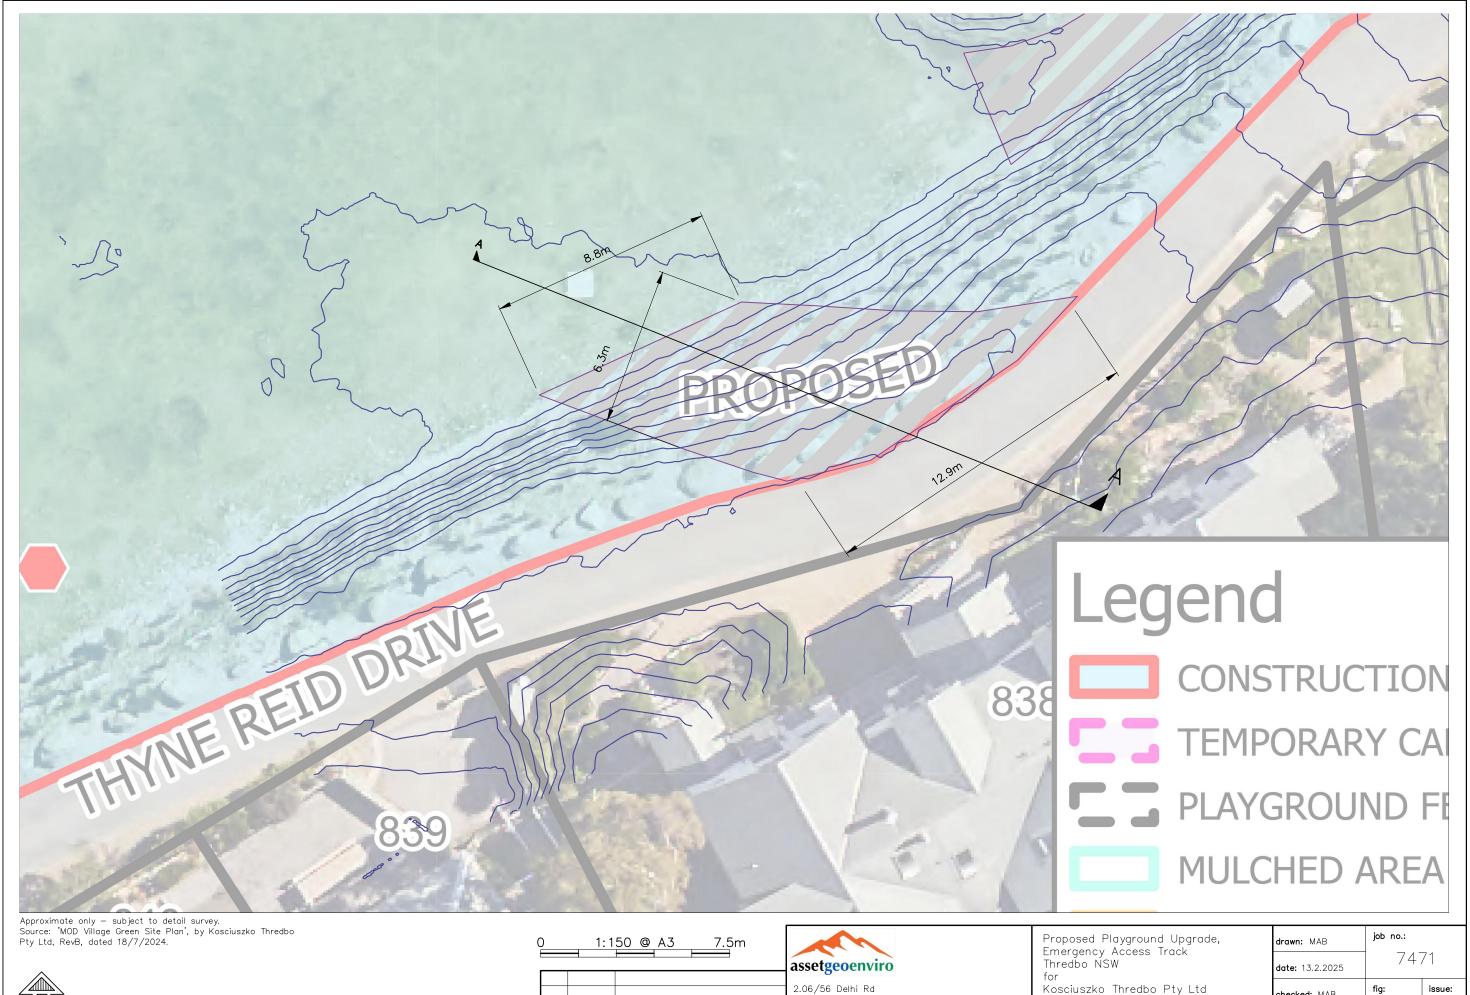
Site Plan with Surface Contours

The emergency access track will run off Thyne Reid Drive at the location indicated in Figure 1, at a maximum slope of 15° as shown in the long section in Figure 2. Based on a nominal 150mm thick gravel access track, minor cutting and filling are proposed to level out the track, with cutting expected to be less than 300mm deep and filling less than about 150mm. Widths of the track are shown on Figure 1. The entrance off Thyne Reid Drive is to be fitted with a suitable gate to prevent unauthorised vehicle access. Given the modest slopes and short lengths involved, no specific drainage measures are considered necessary.
