REMEDY
ENVIRO SERVICES

Asbestos Clearance Report

205 Dowling Street, Dungog NSW

Report No. A1388_CLR Report_160824

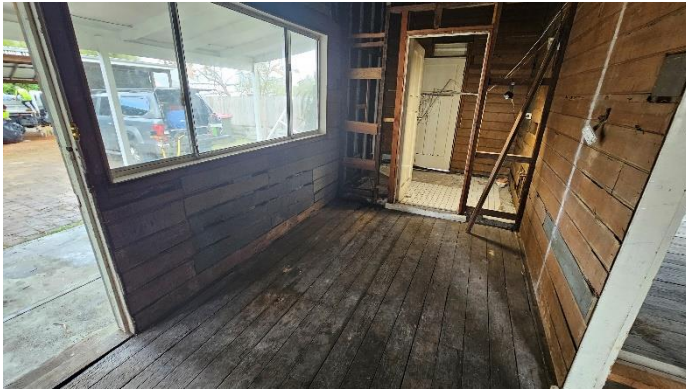
Photo 1

Removal of asbestos cement sheet internal wall linings to the Rear Entry Foyer as inspected on the 16th August 2024.

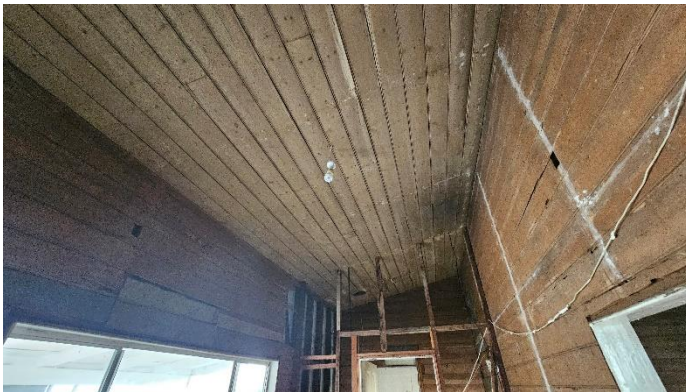
Photo 2

Removal of asbestos cement sheet internal ceiling linings to the Rear Entry Foyer as inspected on the 16th August 2024.

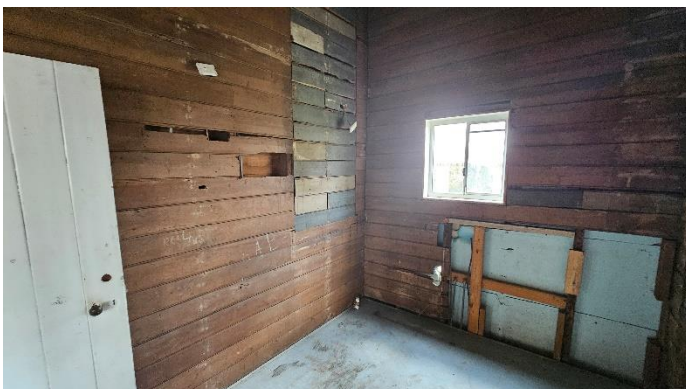
Photo 3

Removal of asbestos cement sheet internal wall linings to the rear north eastern room as inspected on the 16th August 2024.

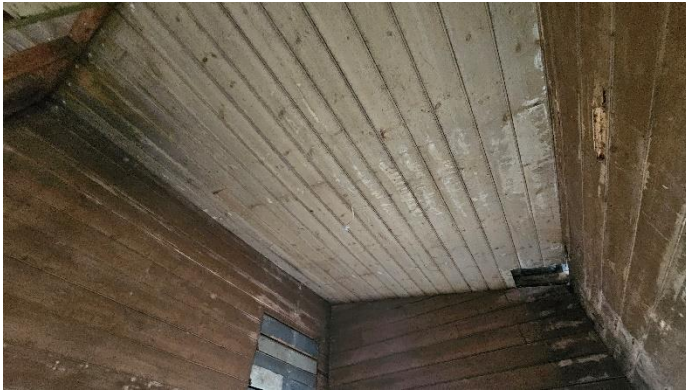
Photo 4

Removal of asbestos cement sheet internal ceiling linings to the rear north eastern room as inspected on the 16th August 2024.

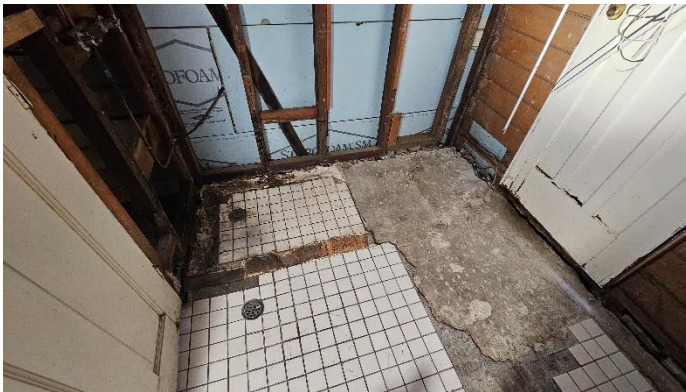
Photo 5

Removal of asbestos cement sheet internal wall linings to the Bathroom as inspected on the 16th August 2024.

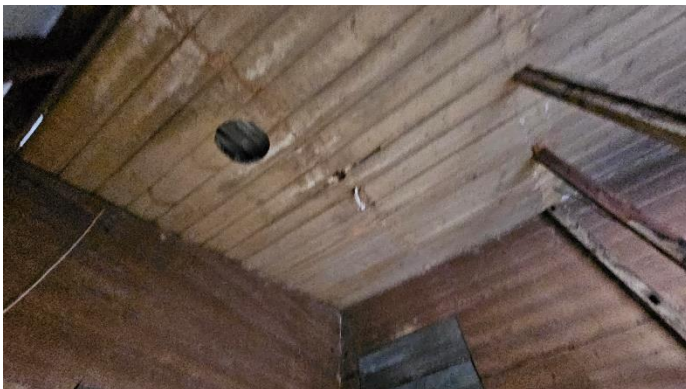
Photo 6

Removal of asbestos cement sheet internal ceiling linings to the Bathroom as inspected on the 16th August 2024.

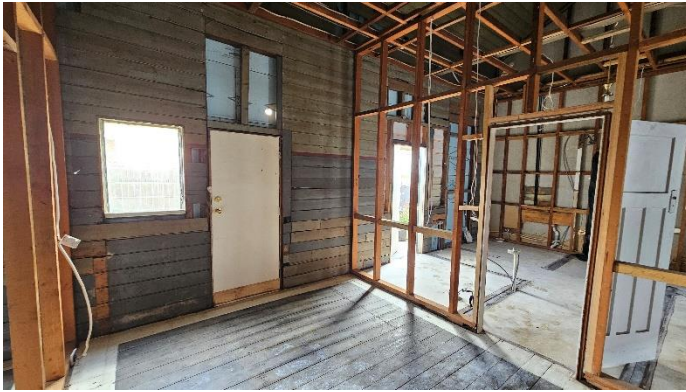
Photo 7

Removal of asbestos cement sheet internal wall linings to the central rooms as inspected on the 16th August 2024.

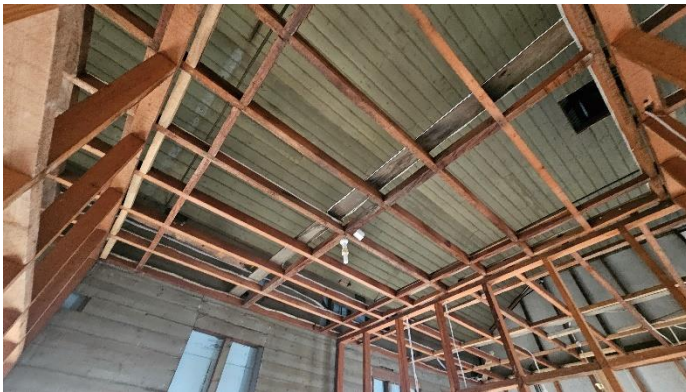
Photo 8

Removal of asbestos cement sheet internal ceiling linings to the central rooms as inspected on the 16th August 2024.

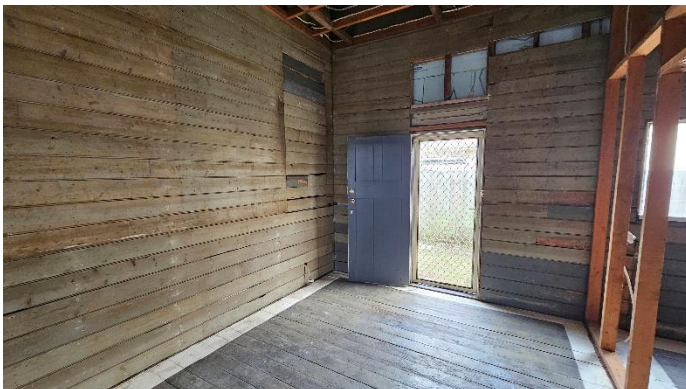
Photo 9

Removal of asbestos cement sheet internal wall linings to the central rooms as inspected on the 16th August 2024.

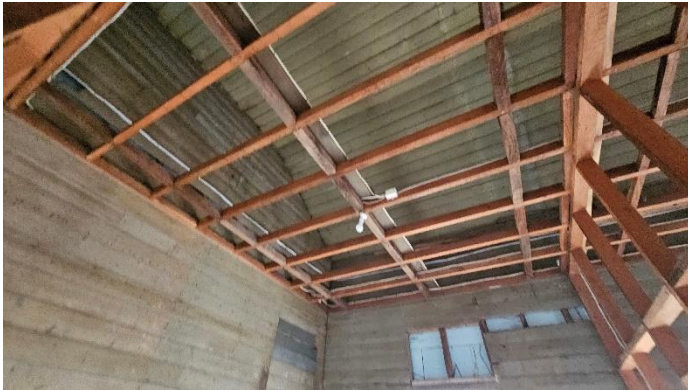
Photo 10

Removal of asbestos cement sheet internal ceiling linings to the central rooms as inspected on the 16th August 2024.

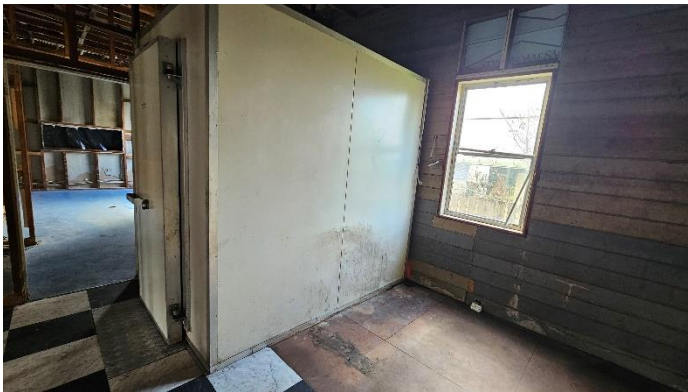
Photo 11

Removal of asbestos cement sheet internal wall linings to the Storeroom as inspected on the 16th August 2024.

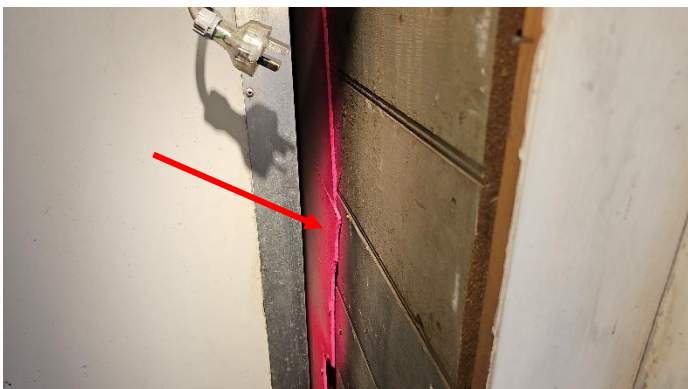
Photo 12

Asbestos cement sheet internal wall linings remain in-situ to the western dividing wall of the shopfront and central rooms, and a portion of asbestos cement sheet internal lining behind the cold-room on the northern aspect of the building.

A portion of asbestos cement sheet internal lining remains in-situ behind the cold-room on the northern aspect of the building as inspected on the 16th August 2024.

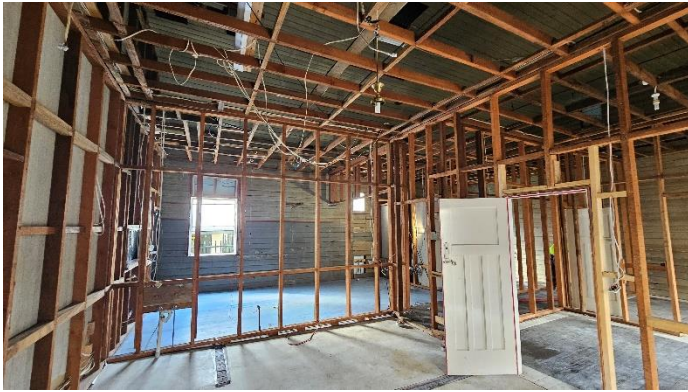
Photo 13

Removal of asbestos cement sheet internal wall linings to the central rooms as inspected on the 16th August 2024.

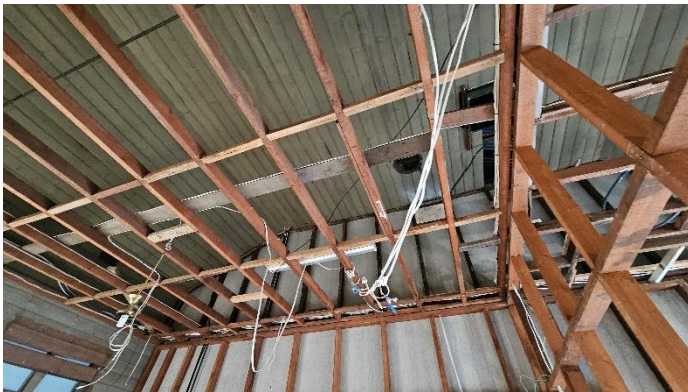
Photo 14

Removal of asbestos cement sheet internal ceiling linings to the central rooms as inspected on the 16th August 2024.

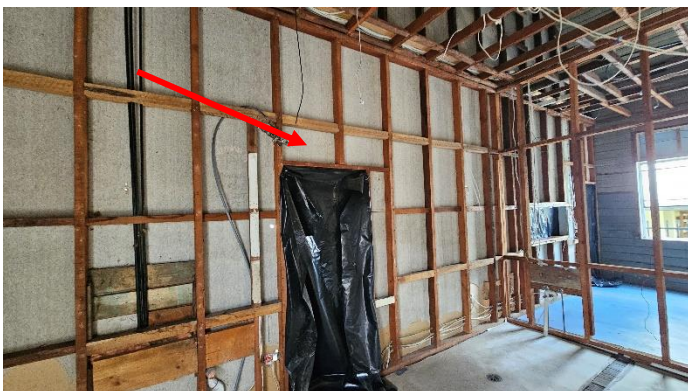
Photo 15

Asbestos cement sheet internal wall linings remain in-situ to the western dividing wall of the shopfront and central rooms as inspected on the 16th August 2024.

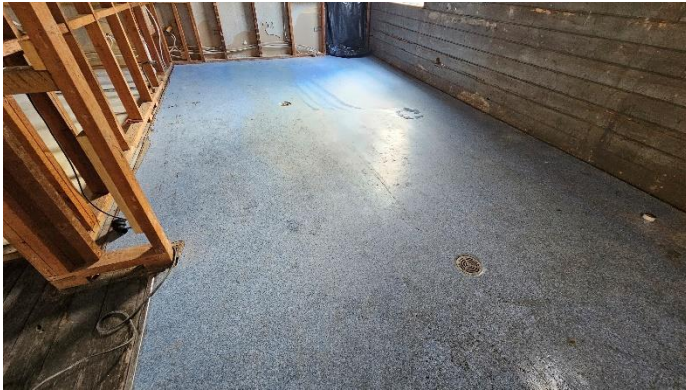
Photo 16

Asbestos containing materials may be present beneath vinyl floor sheeting in the northwestern room. This material should be treated with caution and tested for the presence of asbestos before it is disturbed in future works.

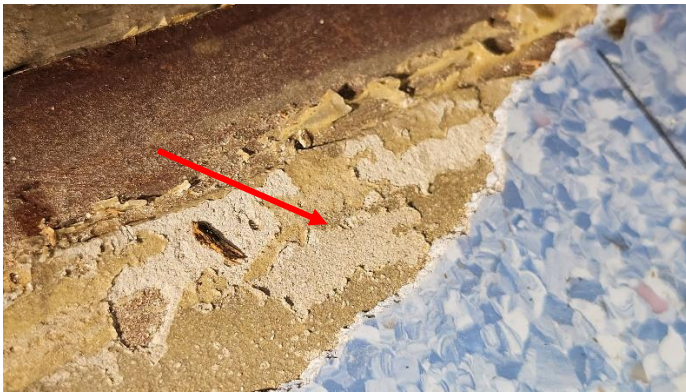
Photo 17

Asbestos containing materials may be present beneath vinyl floor sheeting in the northwestern room. This material should be treated with caution and tested for the presence of asbestos before it is disturbed in future works.
