29 September 2022

**RE: RESPONSE TO SHOALHAVEN CITY COUNCIL REQUEST FOR FURTHER INFORMATION – EIS RELATED TO EXPANSION OF SAND EXTRACTION OPERATIONS AT TERARA SHOALHAVEN SAND, TERARA, NSW**

### 3.3 MA Bank Inspection and Observations

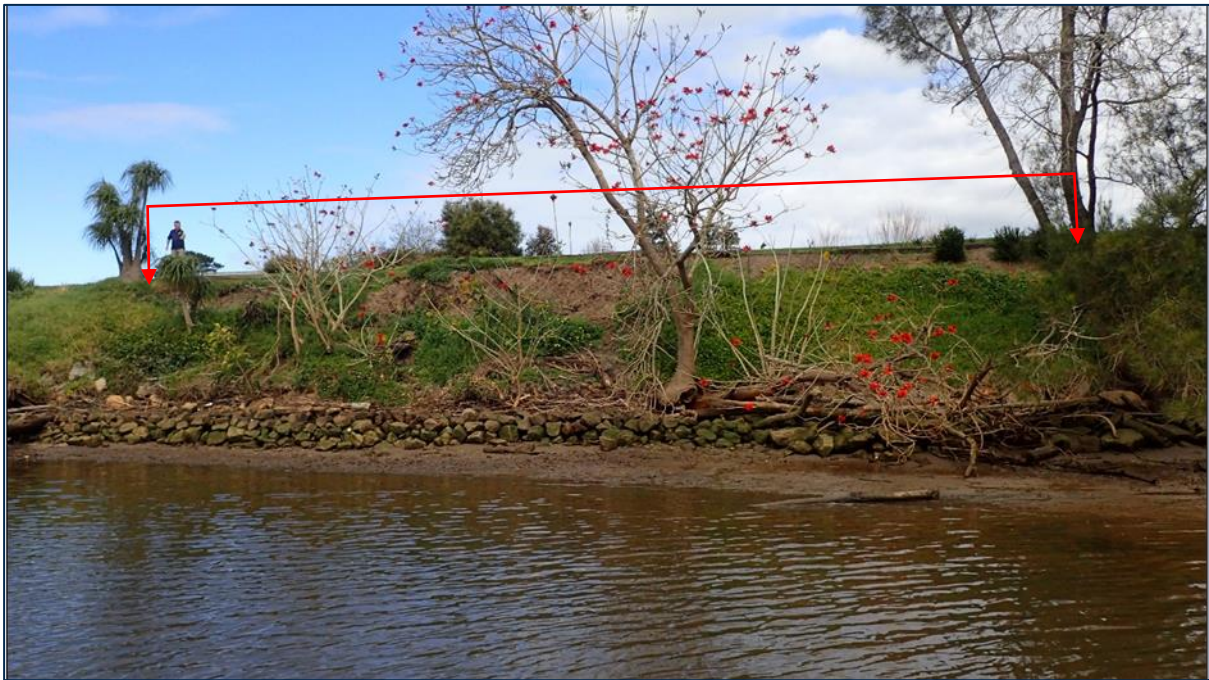
- Bank failure appeared to involve shallow rotational slump failure of the bank. A noticeable failure scarp was evident at the top of bank, which extended approximately 25 m along the length of the observable failure (see Figure 1).

- The accumulation zone of the slump appeared to have been retained behind the stone toe protection at the base of the bank slope. The failure mechanism at this location may relate to rapid drawdown / tidal oscillation combined with a steep bank. Bank material strength may also have been a factor in the bank failure.

Evidence of prior bank instability was also observed to the east of the bank failure, where a noticeable bulge projecting from the bank was present. Inspection established that the feature was related to a previous tree fall event, with the evident bulge constituting the lower trunk and root ball/soil mass of the fallen tree. This bulge is observable in the far left of the Figure 1 image.

**Figure 1:** Photograph of slumped bank and levee section documented in Council's RFI, located approximately 50 m downstream of the Terara Sand depot site.

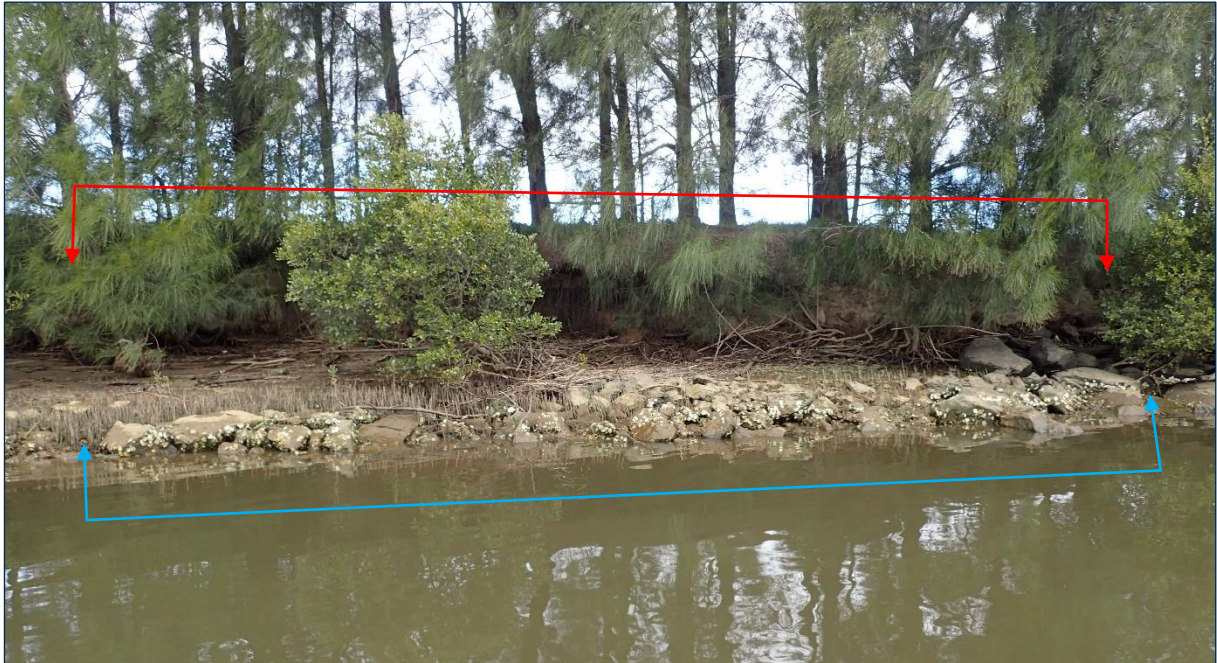
**Figure 2:** Representative photograph of bank scour along a bank section (identified by red arrows). Blue arrows identify a length of disarticulated bank protection stonework. Note the tidal bench accretion on the lee (downstream) side of the stonework. Flow is right to left. Bank height is about 1.5 m. Location is 1,060 m downstream of Terara Sands depot site.

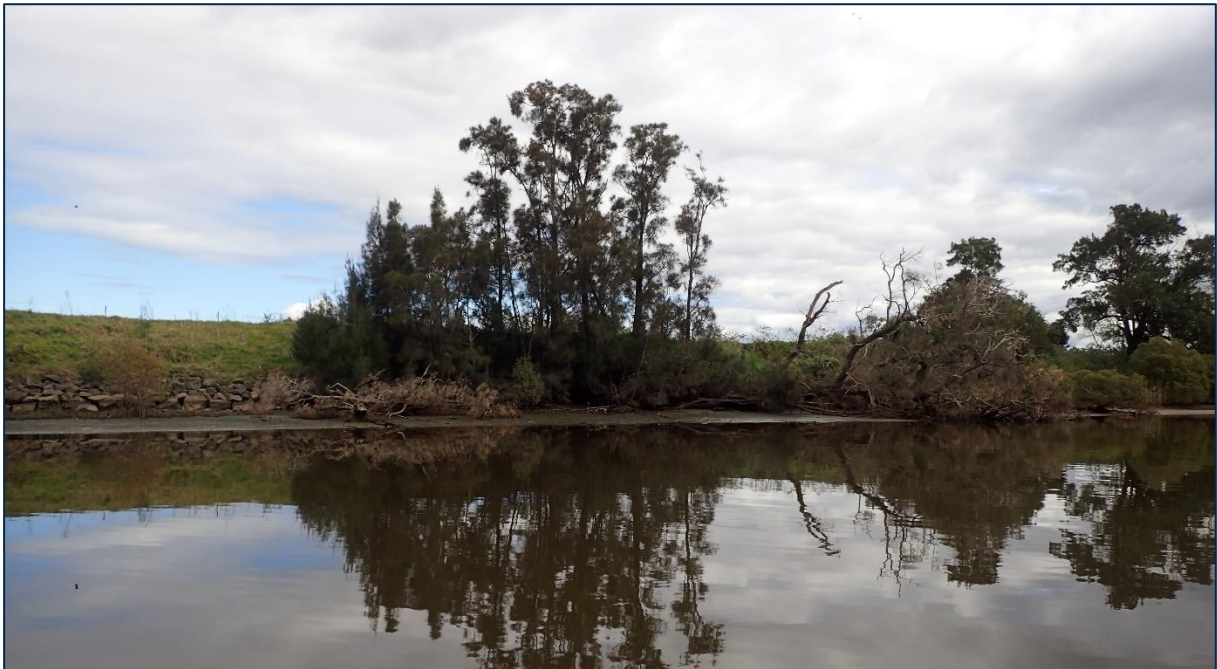
**Figure 3:** Representative photograph of episodic tree fall, likely associated with wind-generated wave action impacting the bank during the tidal cycle. Note the toe protection stone present along the bank in the left of the image and recruitment of mangroves upon the tidal bench. Location is 75 m upstream of Terara Sands depot site. Flow is right to left.

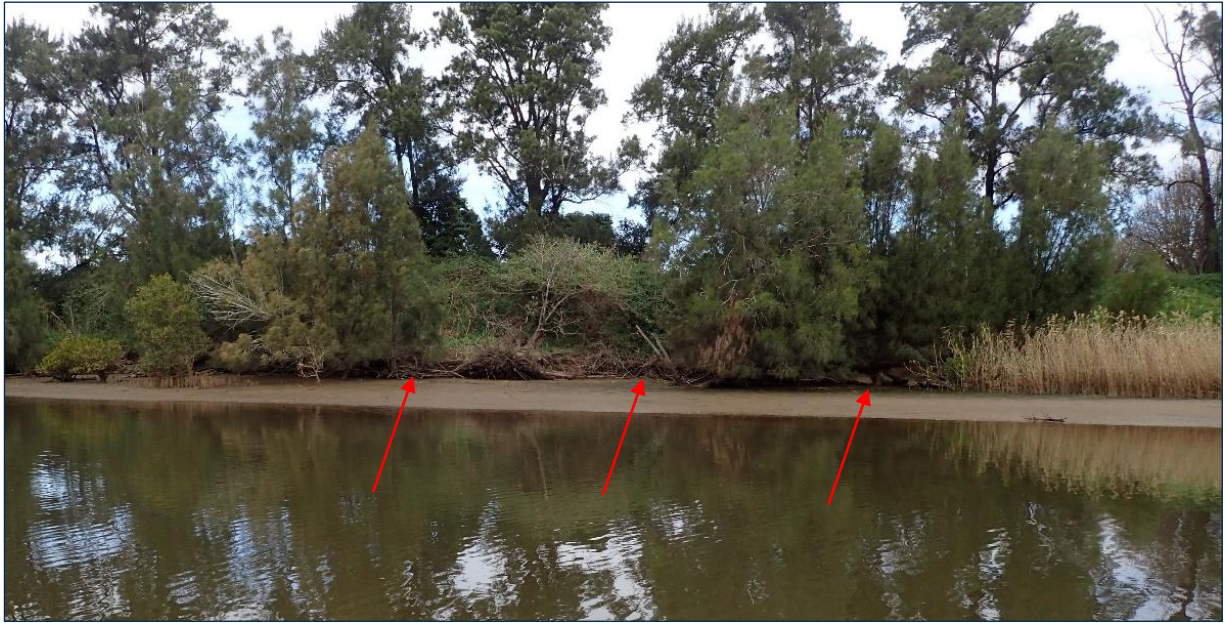
**Figure 4:** Representative photograph of bank scour along a bank section with an existing tidal bench. Note the partially detach root mat of the tree centre of picture and adjacent bank scour (identified by red arrows). Location is 550 m upstream of Terara Sands depot site. Flow is right to left.

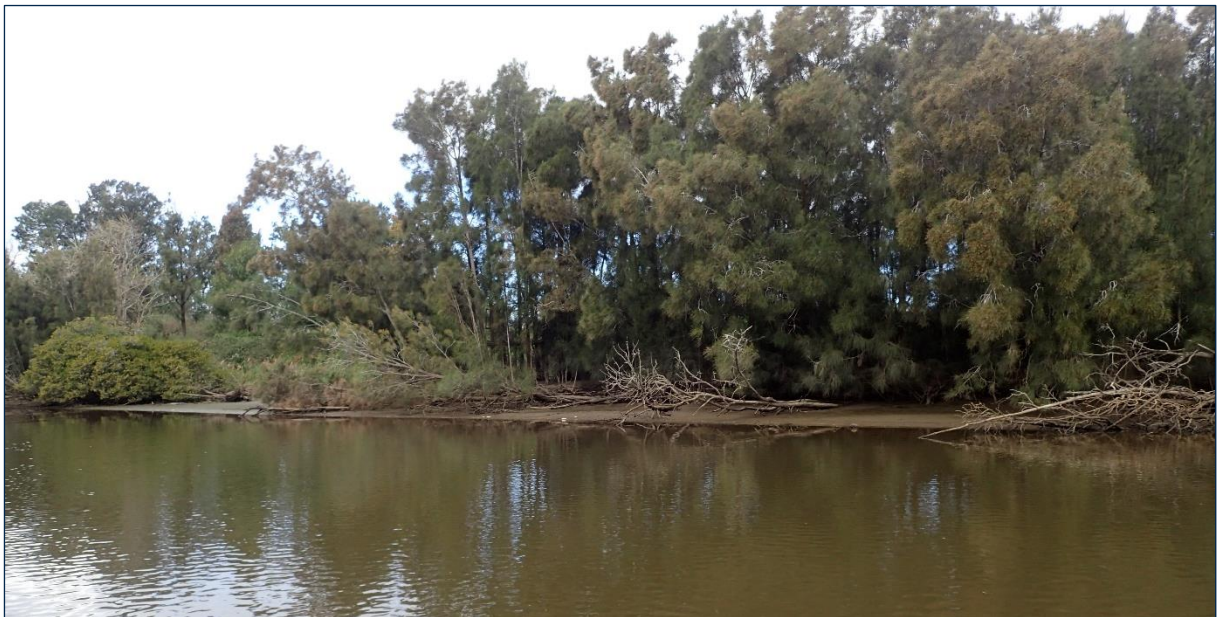
**Figure 5:** Representative photograph of episodic bank instability induced tree fall, as denoted by both older and more recent tree fall events. Location is 670 m upstream of Terara Sands depot site. Flow is right to left.

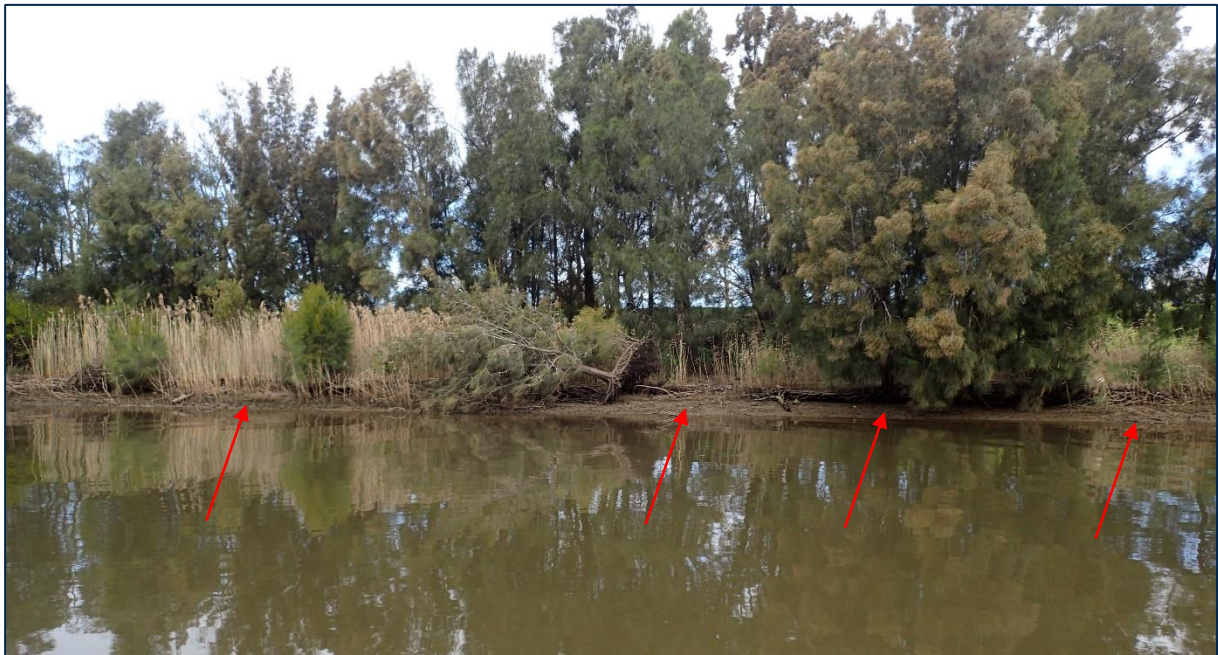
**Figure 6:** Representative photograph of bank scour along a bank section with an existing tidal bench. Note the partially detached tree and root mat in centre of picture and adjacent bank scour (identified by red arrows). Location is 990 m upstream of the Terara Sands depot site. Flow is right to left.
