Project 218669.00
27 October 2022
R.002.Rev0
ECB:gl

Preliminary Geotechnical Assessment
Proposed Billboard Structure
Corner of Saunders Street and Miller Street,
Western Distributor North, Pyrmont

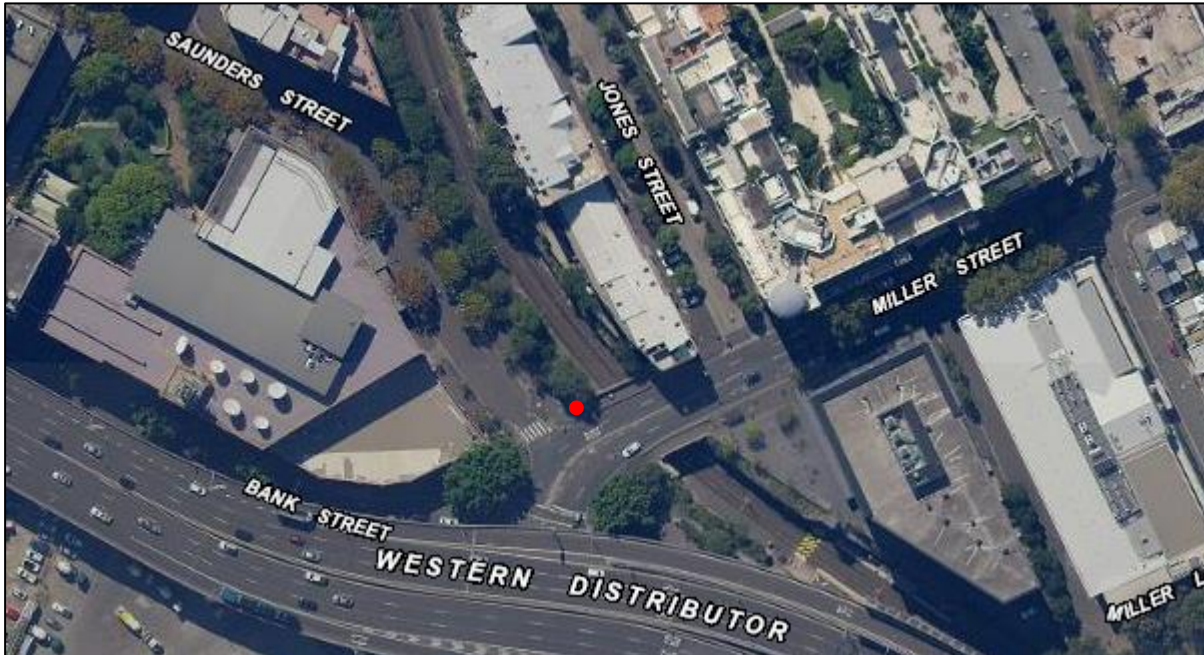
Figure 1: Aerial photograph of the site area (red mark).

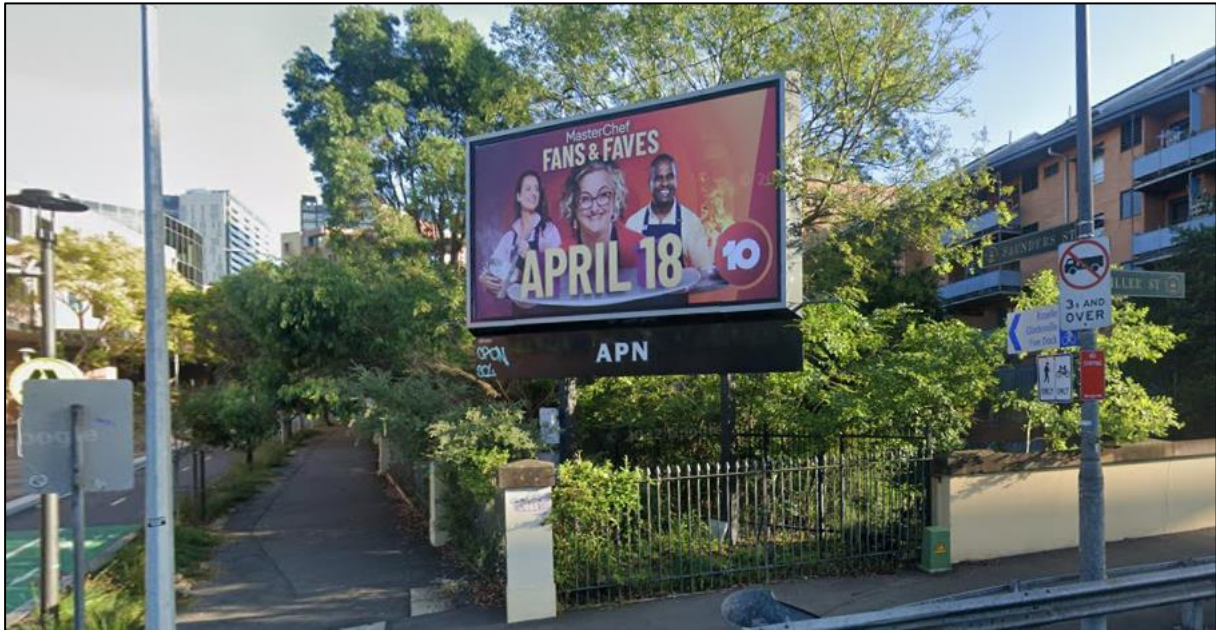
Street level view from the corner of Saunders Street and Miller Street of the location with the pre-existing structure is shown in Figure 2.

Figure 2: Streetview of the site location.

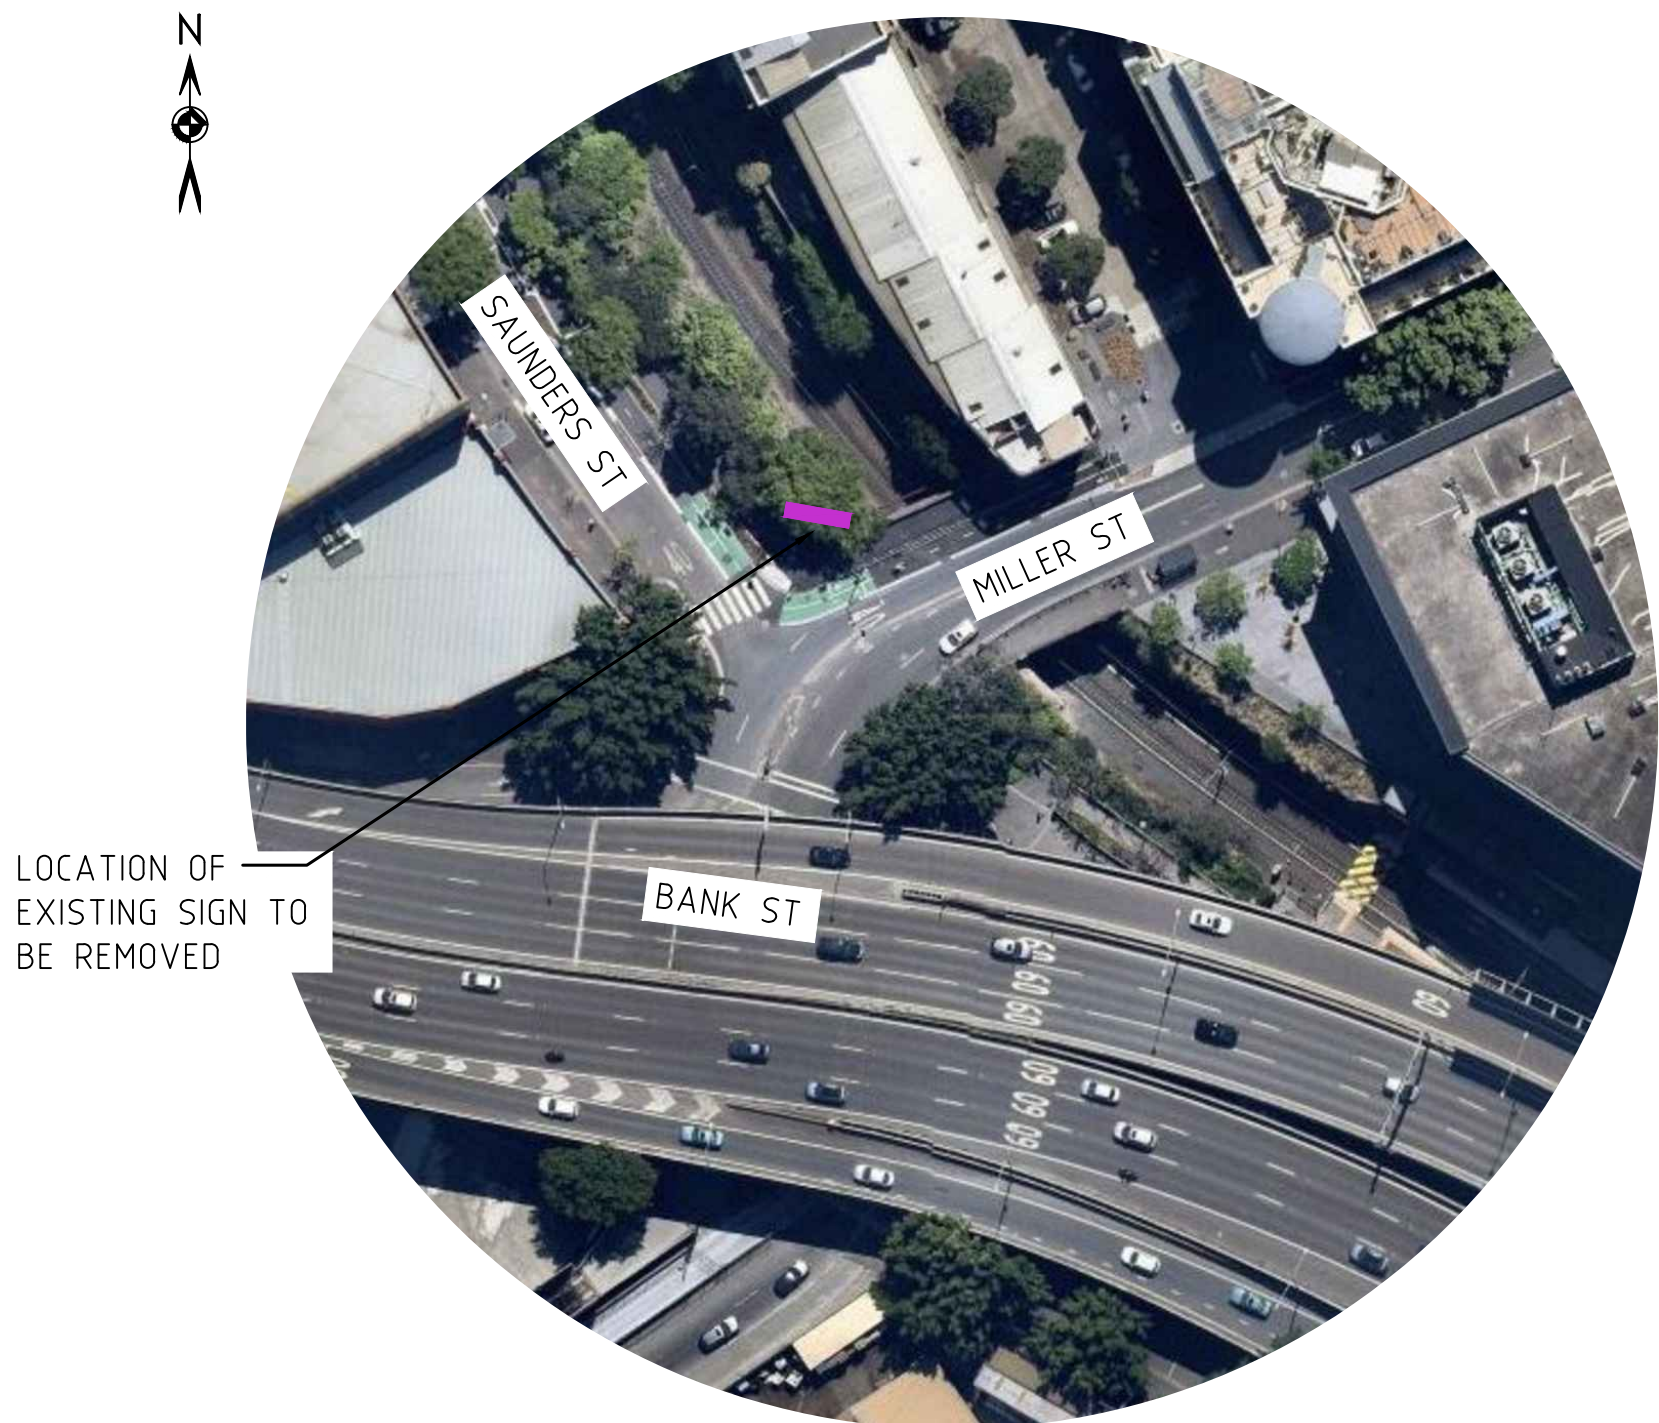
AERIAL PHOTO
NTS

LOCATION OF
EXISTING SIGN TO
BE REMOVED

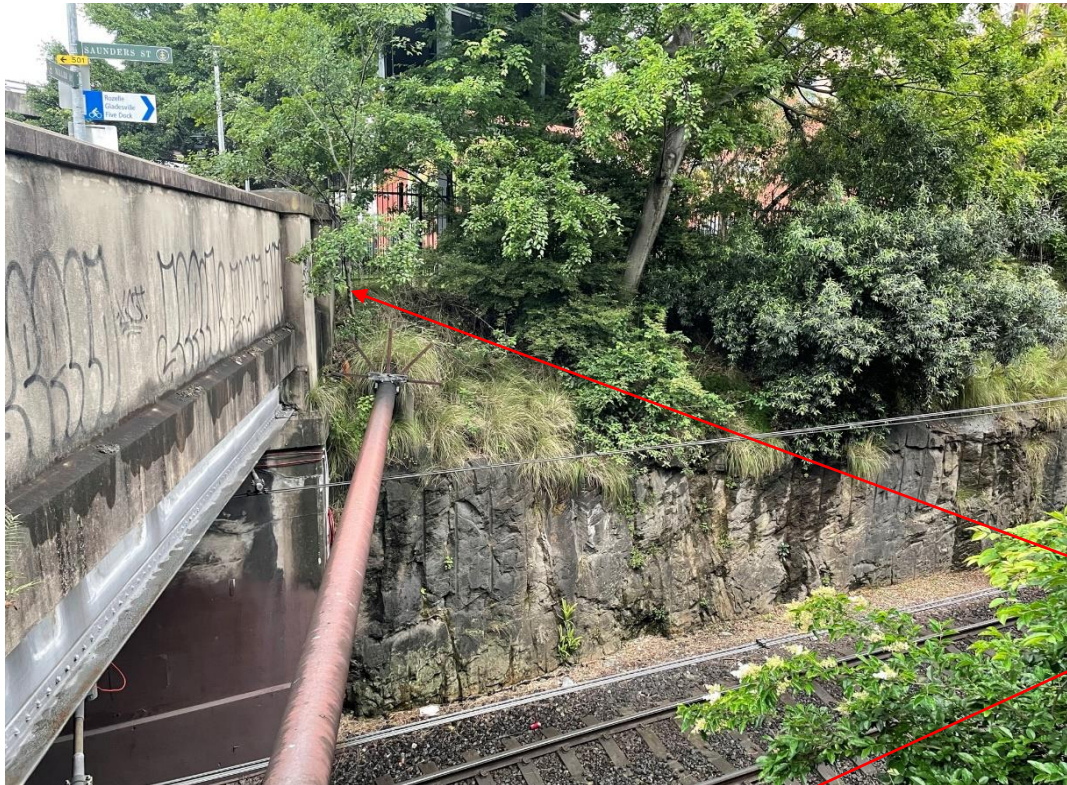
Proposed
Location

The rail cutting at the proposed location is approximately 3 m to 6 m high (see attached Photoplate). The lower approximate 3 m is sub-vertical with exposed massive sandstone bedrock which appears to be medium to high strength (closely spaced pre-split blast holes are visible on the face). Above this face, it appears as if the upper part of the profile is a stepped rock bench that has been covered with colluvium and vegetation. Rock face may be located next to inner black fence but obstructed by vegetation. The area above the cutting crest is covered by soil and semi-dense to dense vegetation consisting of scrub and several trees. The footpath is set back from the cut face by two fences and up to approximately 2 m of soil coverage.

- Drilling a cored borehole at the structure location to determine the strata depths. The borehole should extend at least 4 m into rock;
- Mapping of the existing rock cutting to identify any areas of potential instability. Any such mapping would have to be carried out during a track possession; and
- Stability assessment of the rail cutting.
