Proposed Alpine Coaster, Thredbo NSW – Geotechnical Investigation, Ref 5920-G1 Rev 4

Our ref: 5920-G1 Rev 3  
23 December 2022

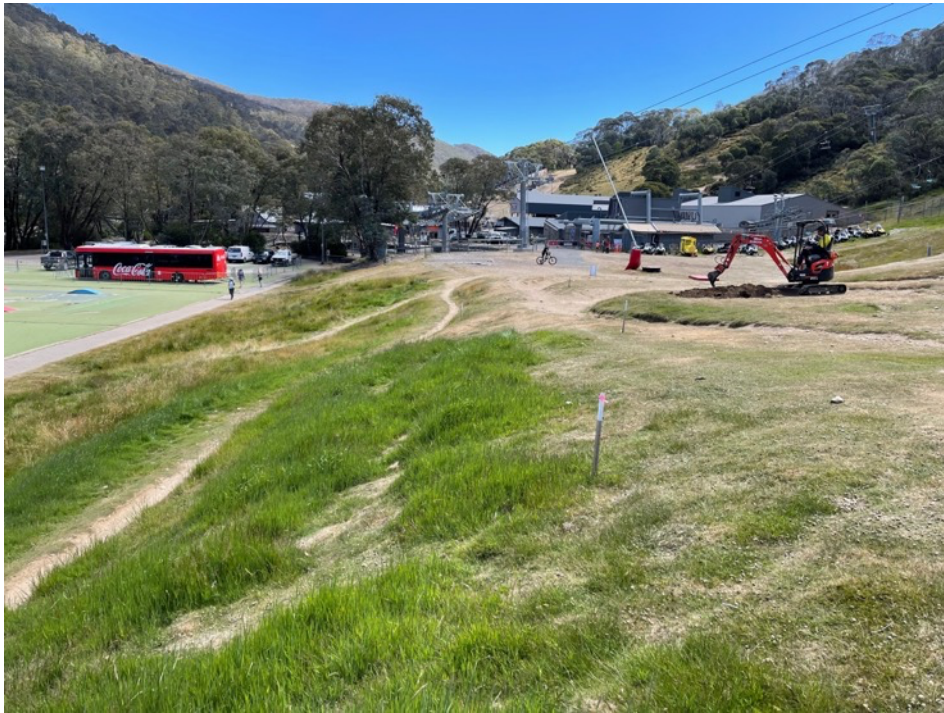
**Photo 1**  
North east of exit  
area, looking  
southwest towards  
circle construction

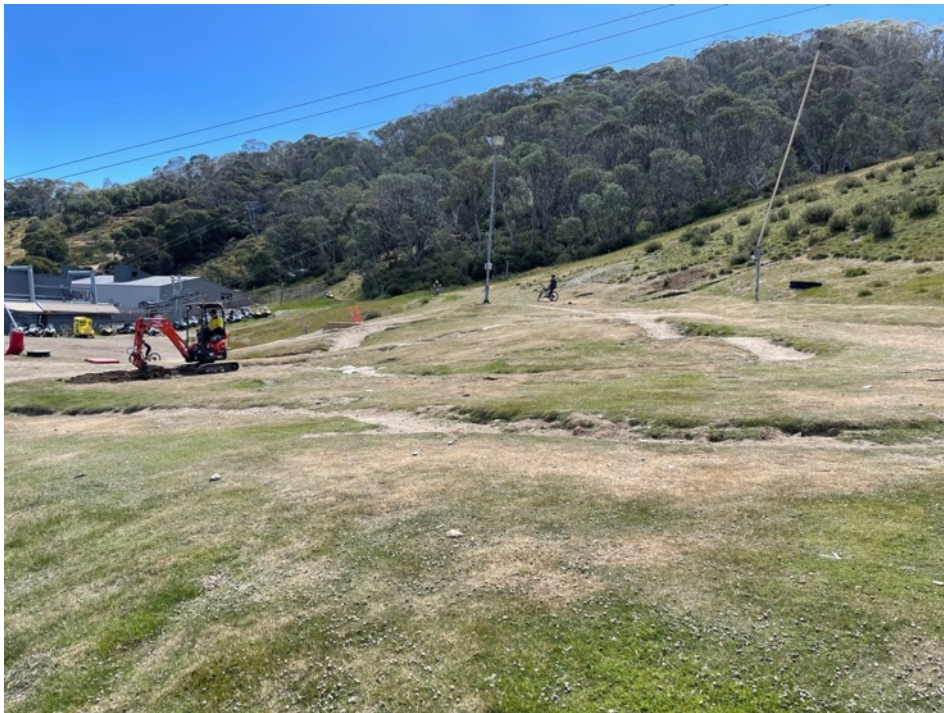
**Photo 2**  
From Photo 1  
location looking west

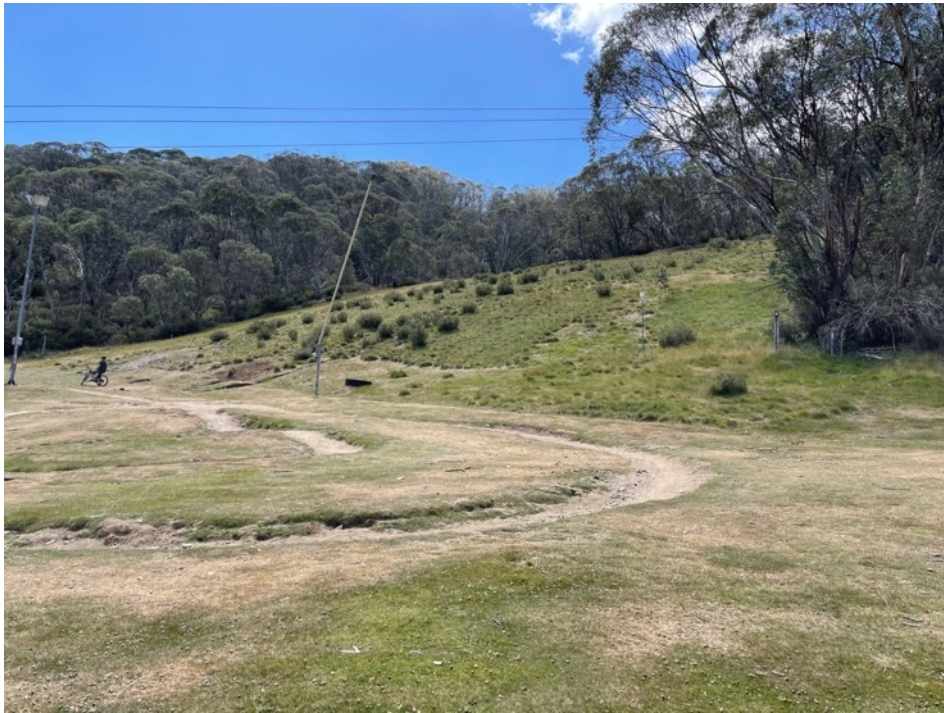
**Photo 3**  
From Photo 1  
location looking  
northwest

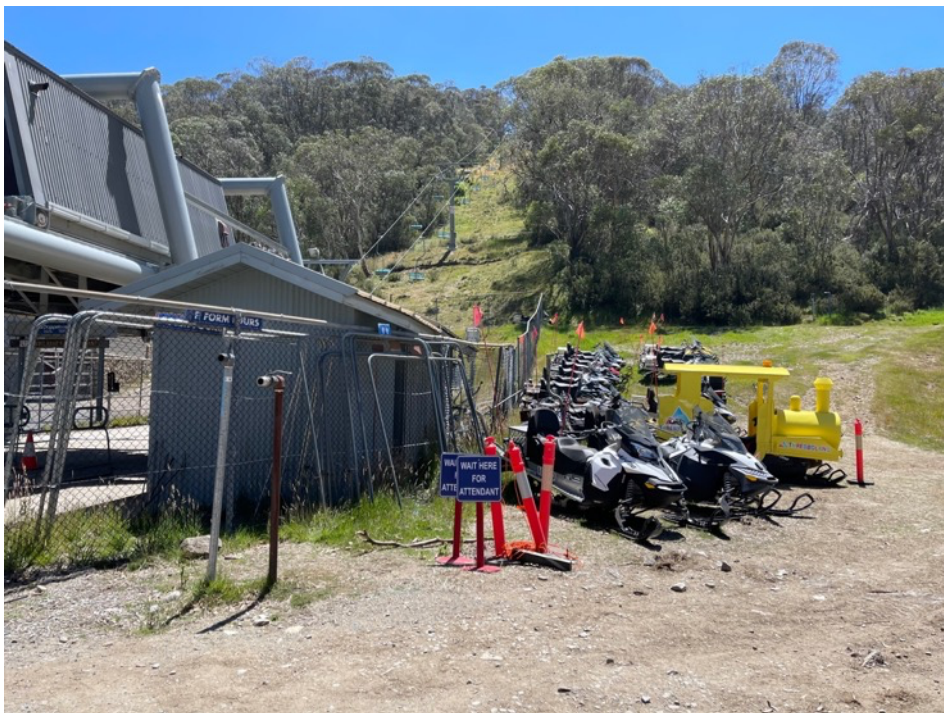
**Photo 4**  
View from tunnel  
location looking  
upslope to northwest

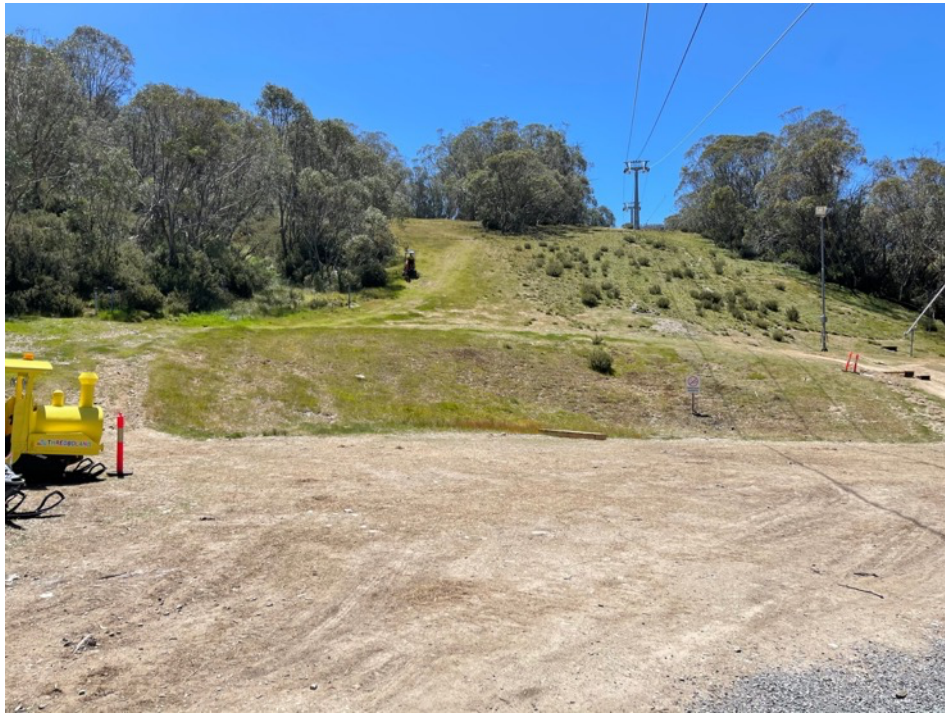
**Photo 5**  
View from Photo 4  
location looking north

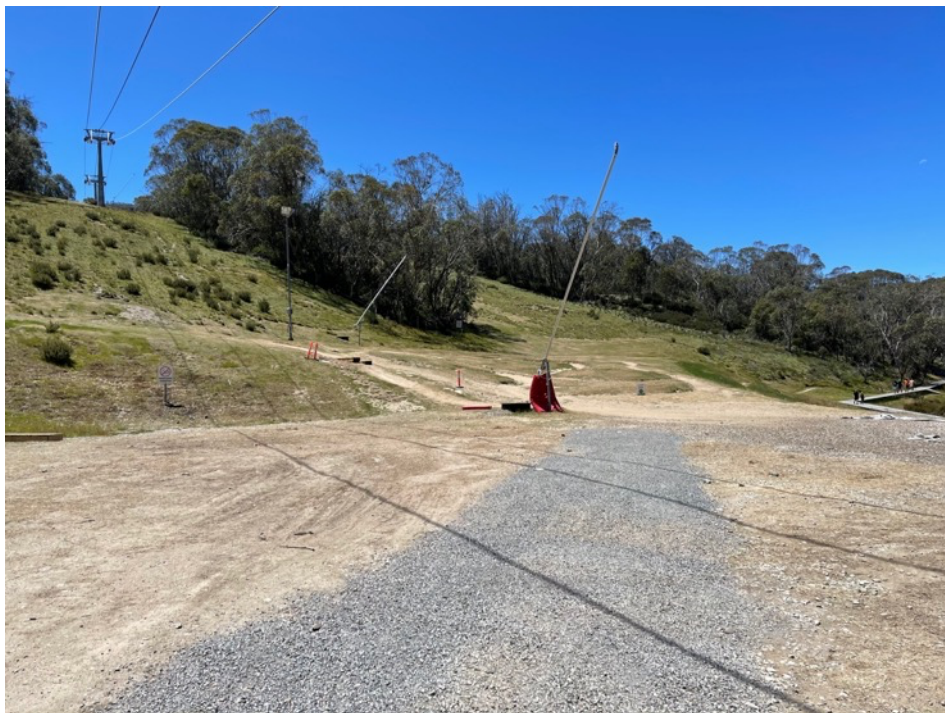
**Photo 6**  
View from Photo 4  
location looking  
northeast

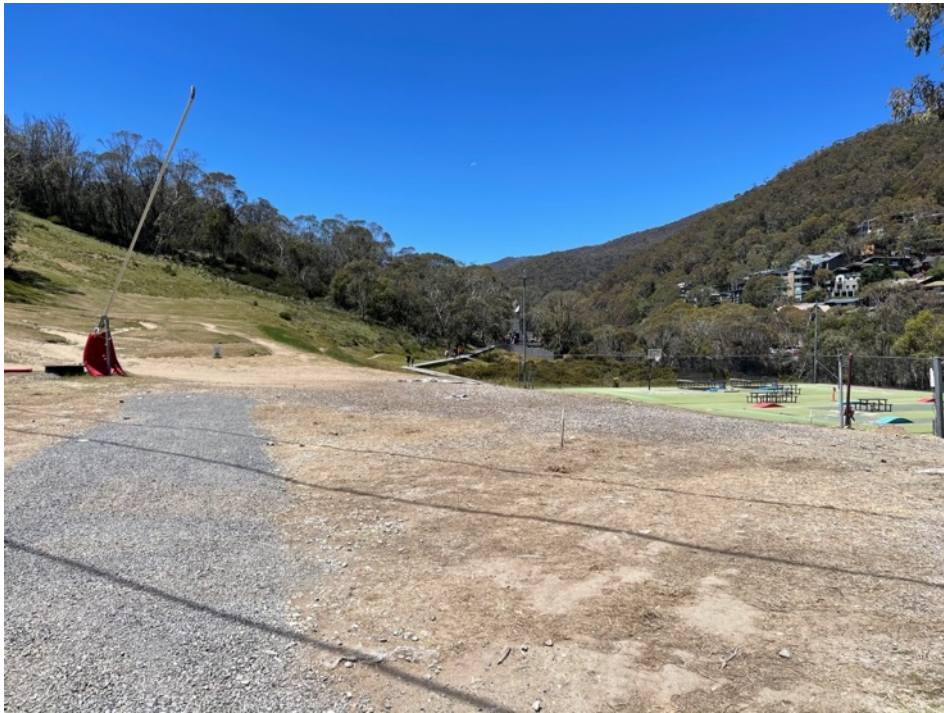
**Photo 7**  
View from Photo 4  
location looking east

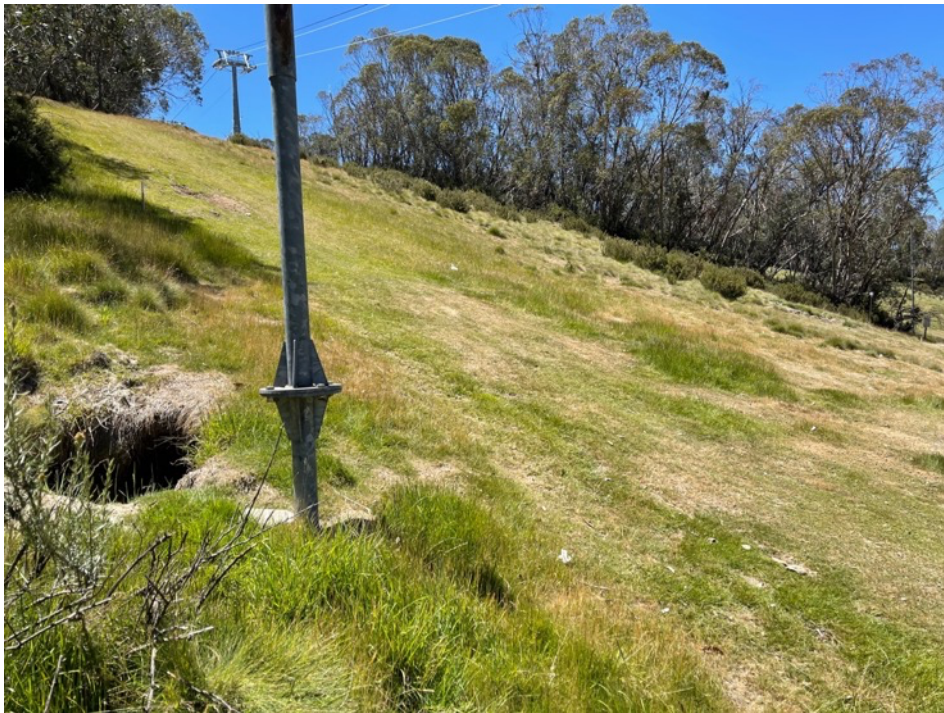
**Photo 8**  
View near TP13  
location looking north

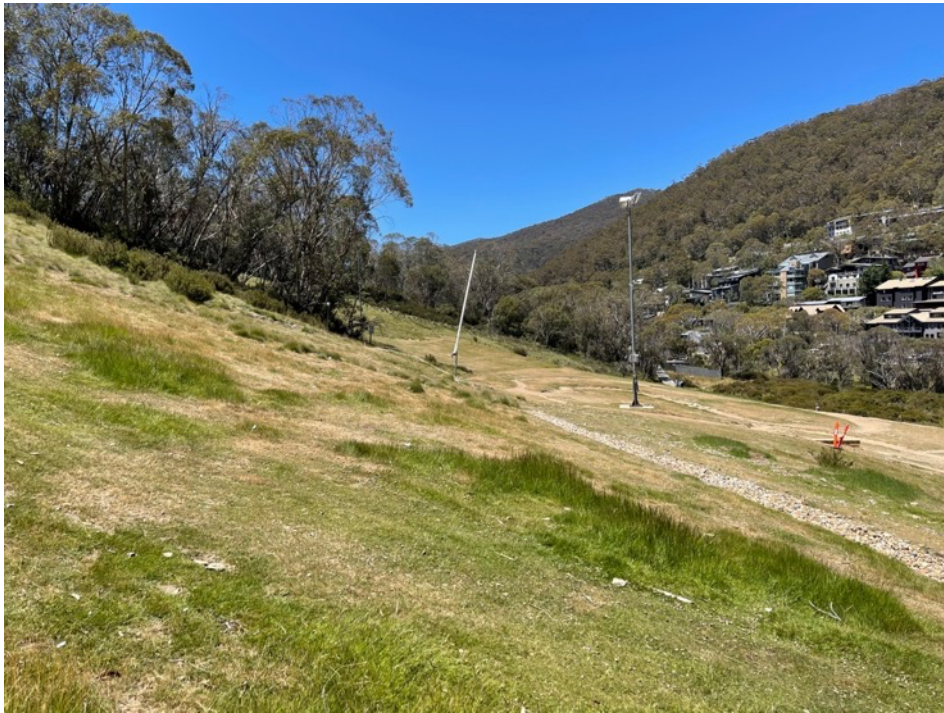
**Photo 9**  
View near TP13  
location looking east

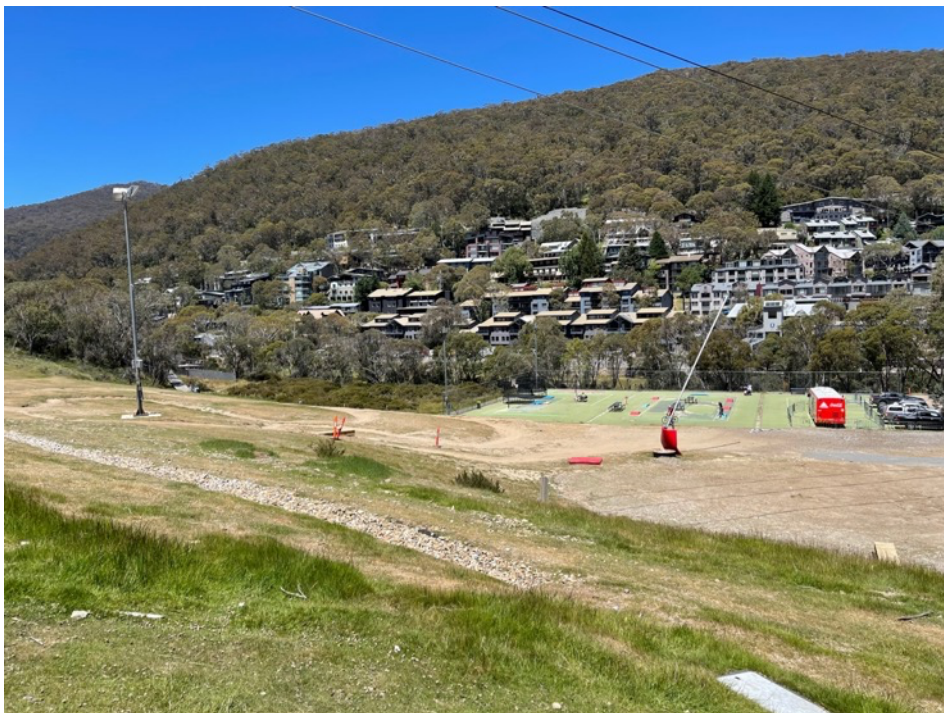
**Photo 10**  
View near TP13  
location looking  
southeast

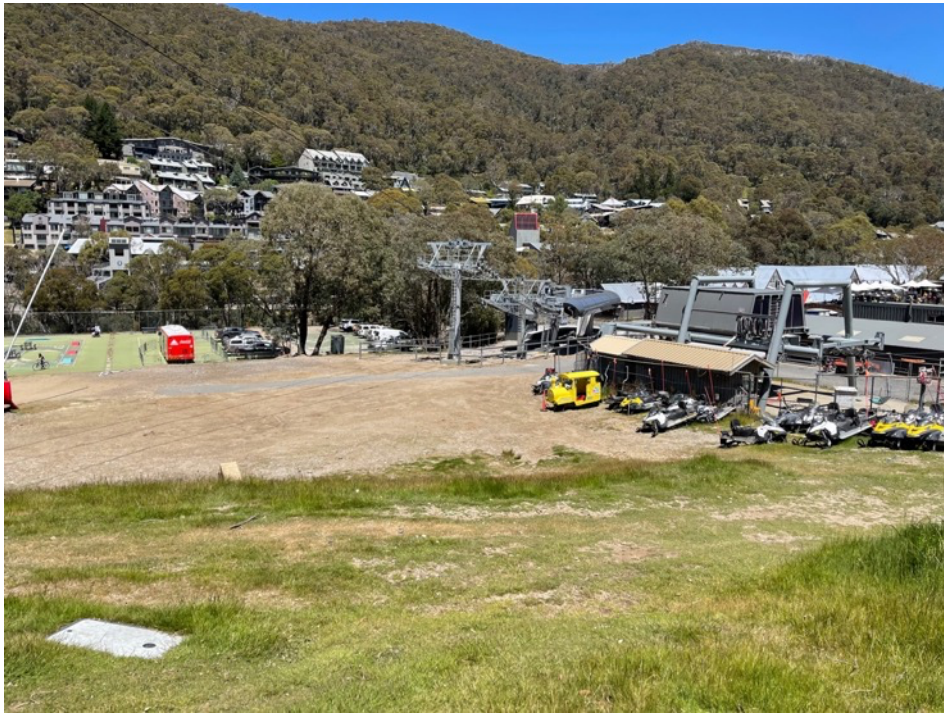
**Photo 11**  
View near TP13  
location looking  
south

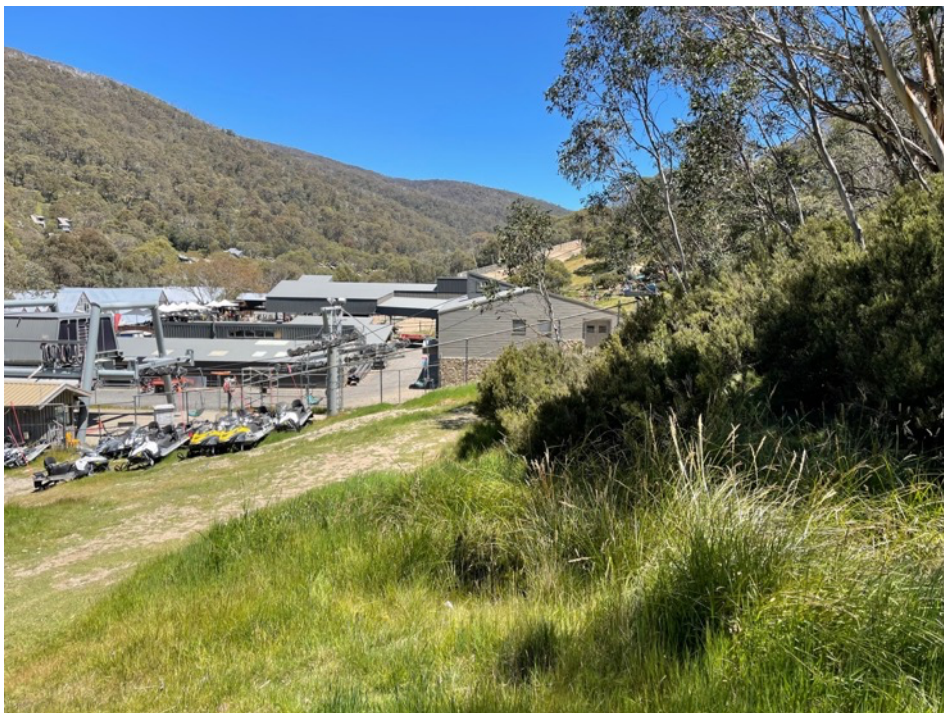
**Photo 12**  
View near TP13  
location looking  
southwest

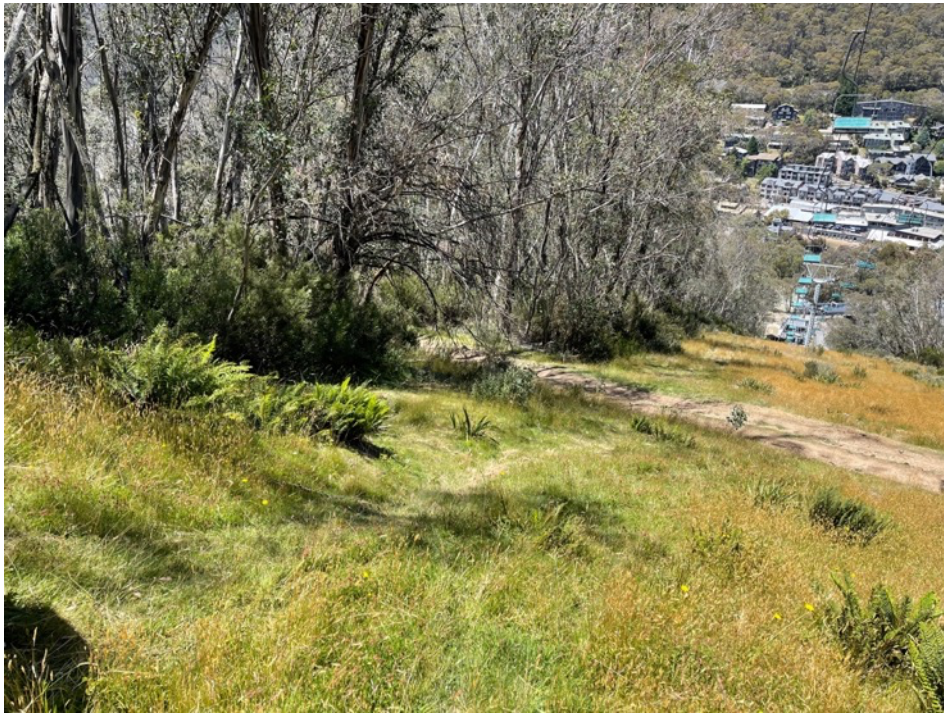
**Photo 13**  
View near TP22  
looking downslope  
(south east)

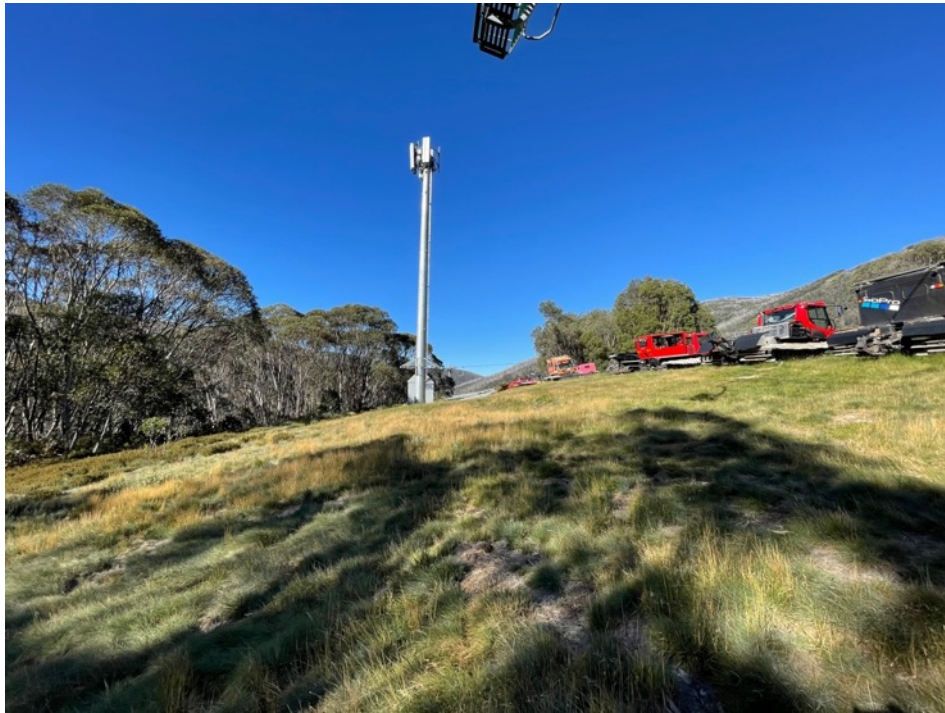
**Photo 19**

View north east of TP01 looking south west towards top of incline.
