Project 220606.01
13 February 2023
R.001.Rev0
AK

Preliminary Geotechnical Assessment
Proposed Digital Sign
939A Pacific Highway, Pymble

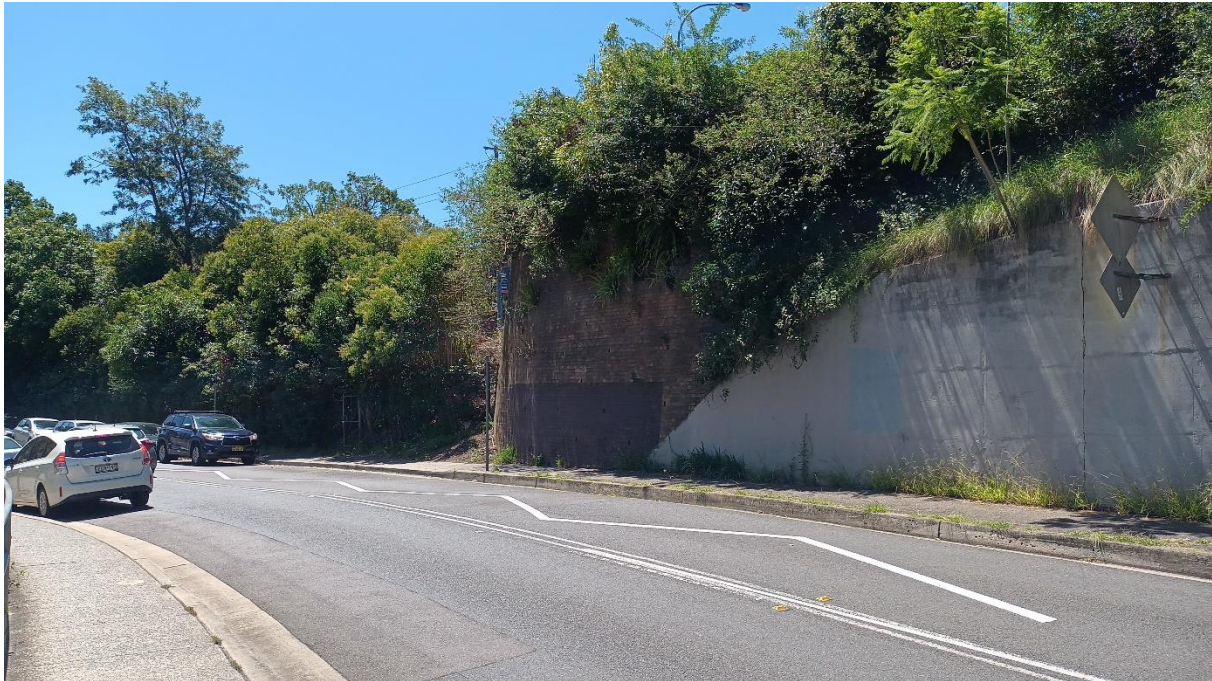
Figure 2: Streetview image of the site location from Avon Road

The site is located approximately 3.5 m behind the crest of an existing retaining wall. The retaining wall is curved in plan, being approximately 6.0 m in height with a facing slope angle of about 80° to the horizontal. It has a brick facing with numerous 'weep holes' at regular spacing, both vertically and

horizontally. Some cracking of the retaining wall facing was noted along mortar joints near the top of the wall at its southern end, where it joins a second retaining wall supporting the approach embankment of the underbridge. A photograph of the existing retaining wall at the site taken from Avon Road is shown in Figure 2.

- Investigation of the existing retaining wall to determine its type, wall thickness and variations thereof over its height, backfill, wall drainage, footing type, founding level and foundations;

Further to the intrusive geotechnical investigations, investigation of the structural elements and capacity of the existing retaining wall by a structural engineer will be required to determine if the retaining wall can support the additional surcharge loading due to the construction equipment and the sign footing. The geotechnical engineer could assist the structural engineer in their structural assessment by providing additional advice on the lateral surcharge pressure behind the retaining wall and its distribution due to the design loadings from the proposed sign footing.

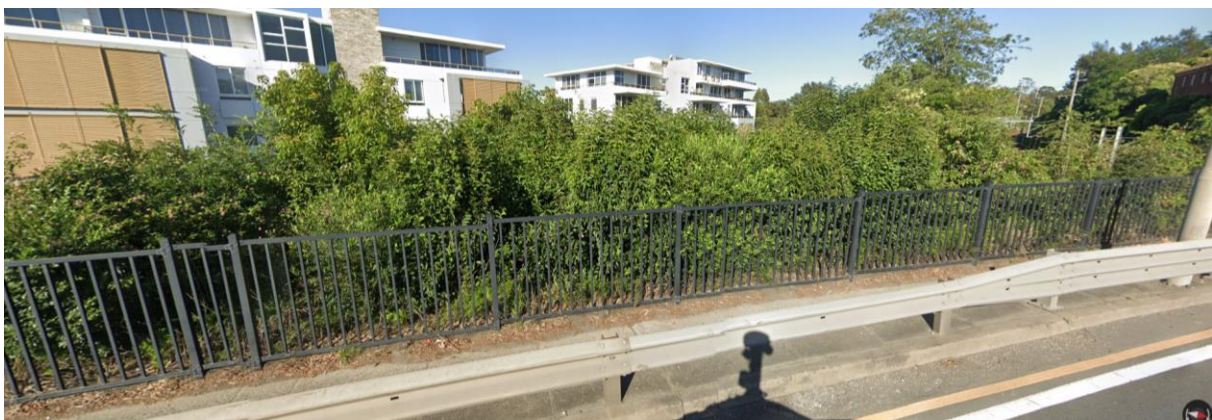
Figure 3: View of site from the Pacific Highway

The ground surface behind the crest of the retaining wall appears to be well vegetated with bushes, as shown on the Streetview image of the site taken from the northbound lanes of the Pacific Highway in Figure 3.
