Hadley Park

Conservation Management Plan 2020

Prepared for
NSW Department of Planning, Industry & Environment

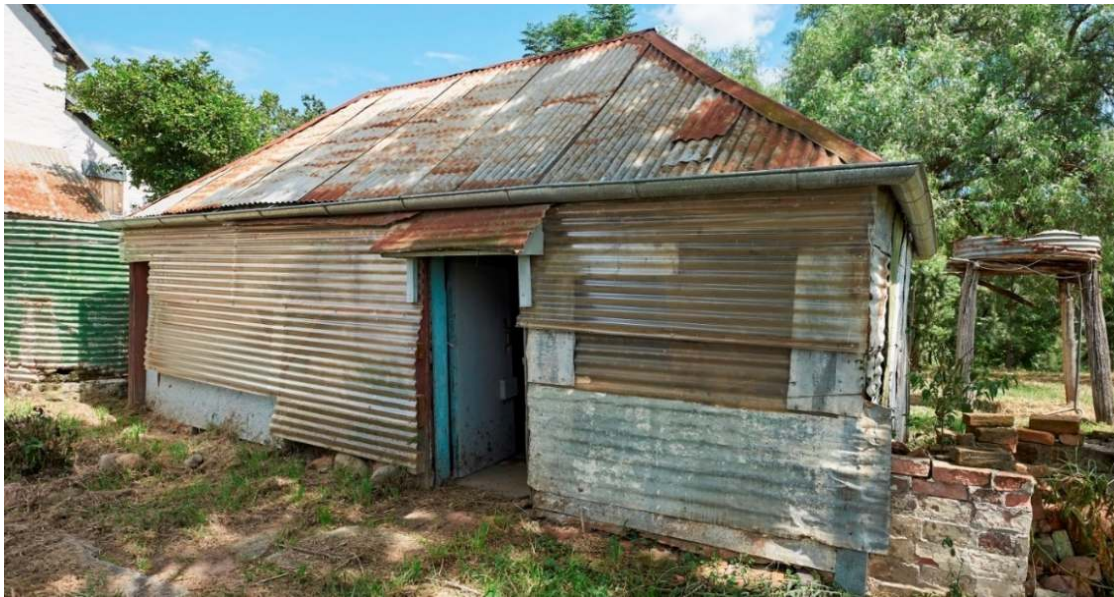
Figure 41. East elevation of the weatherboard cottage. Note the remains of the brick hearth and chimney at the right. Source: Ross Thornton, 2019.

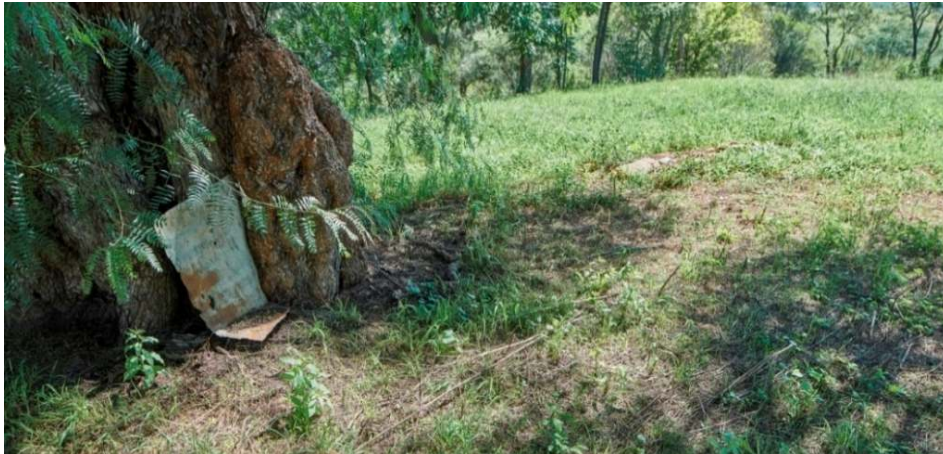
The former wash house was built behind the line of the rear of the houses to accommodate the bathroom and laundry. The original structure in this location was a timber slab building, which was replaced in the 1950s–1960s with a post and beam construction with a skillion roof. The site contains a number of sandstock bricks that may be the ruins of the structure. The structure is no longer in existence. It was removed between 2013 and 2018.

Figure 47. The wash house was believed to have been located to the right (north) of this tree. Source: Ross Thornton, 2019

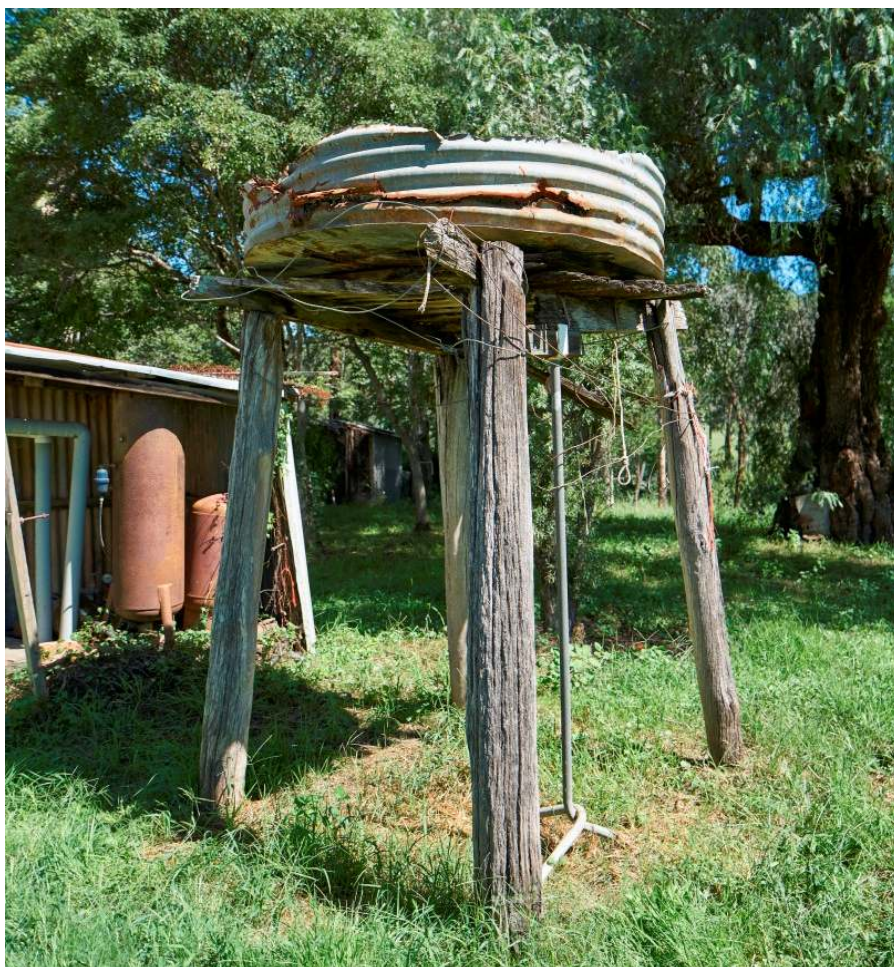
The water tank is the remains of a circular corrugated-iron tank on a stand supported by four circular bush poles, with sawn timber beams and a platform consisting of sawn planks. Much of the tank has rusted away, and only the base of the iron tank now remains upon the platform.

Figure 56. Water tank and stand. Source: Ross Thornton, 2019.

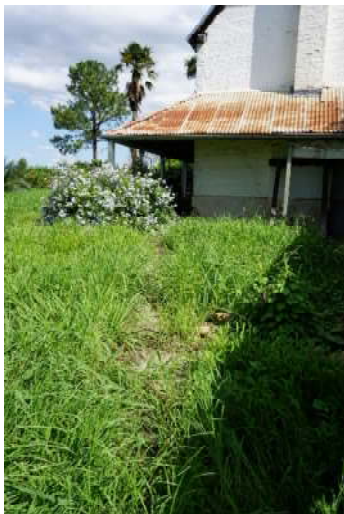
An early brick paved pathway between the Hadley Park House and the Weatherboard Cottage was noted in Britton's 2007 report but it appears that this has since been concreted over. (Refer Figure 71.)

Figure 71. Remnant of early brick paved pathway noted in the Britton 2007 report. Source: Ross Thornton, 2020.

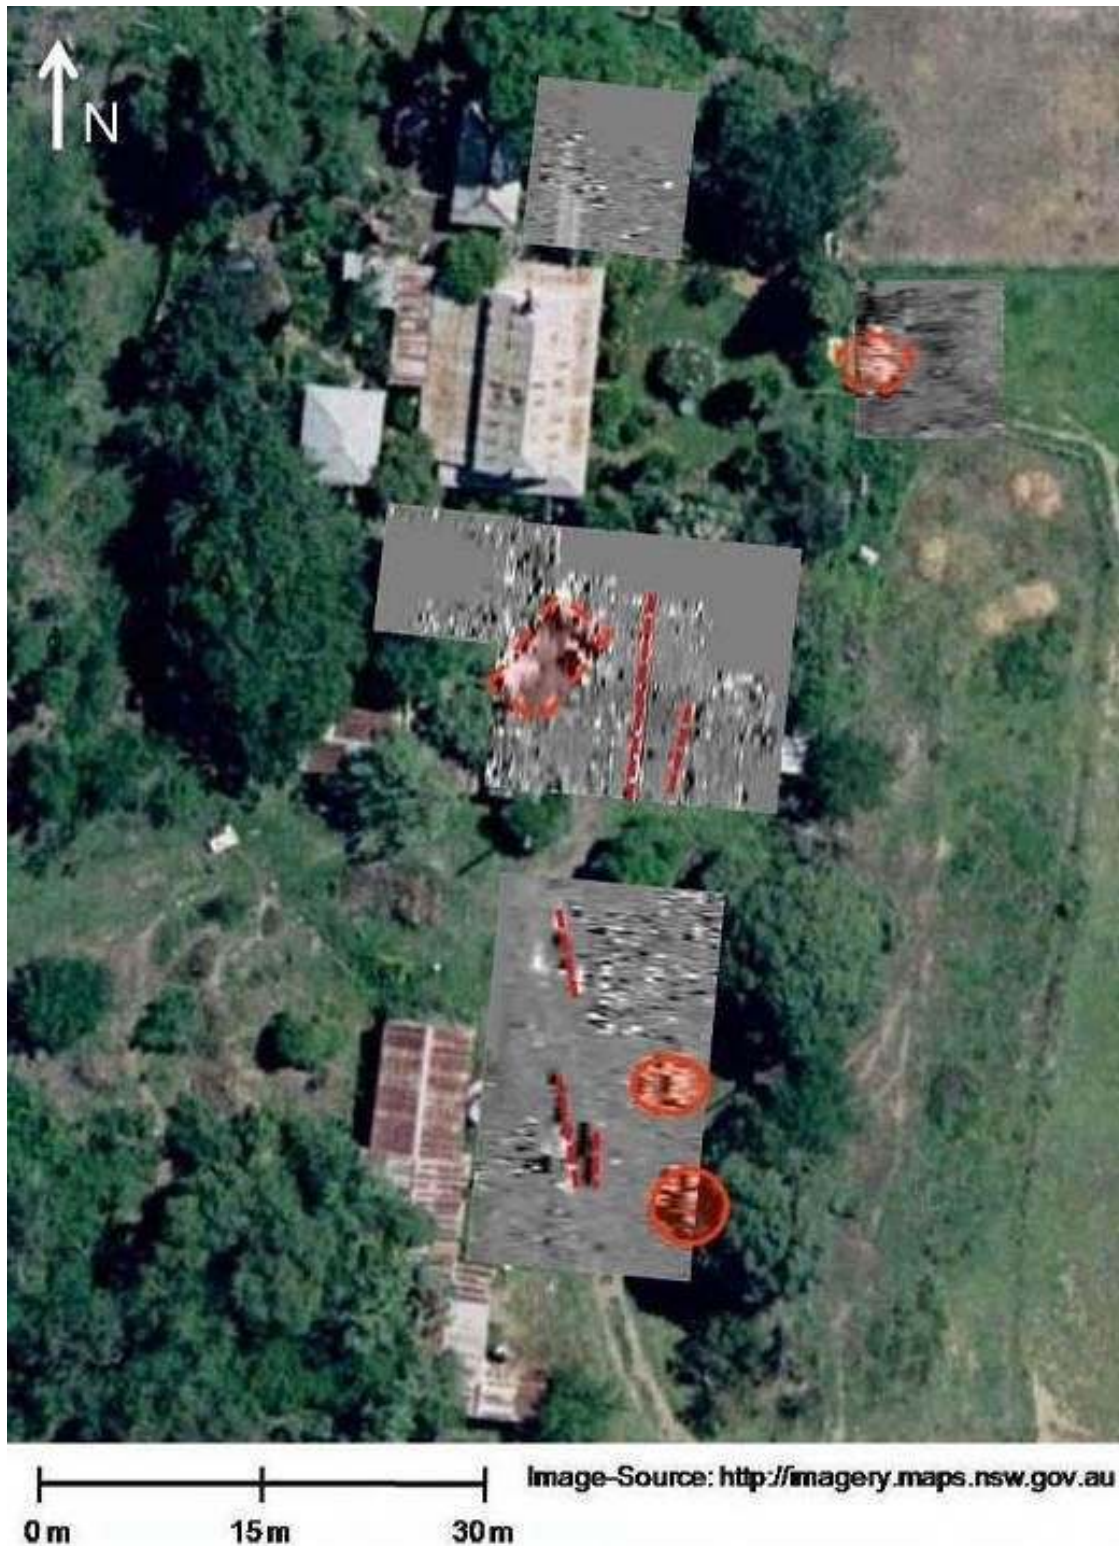
Figure 80. Ground penetrating radar image showing the location of a former structure (dashed rectangle), possibly the remains of the former cream shed (previously located closer to the road), underground silos (circles) and services (dashed lines). Source: GML CMP 2013, Archaeological Computing Laboratory, University of Sydney, 2008.
