Supplementary Appendix P – Evidence of Works Required (DA23/907)

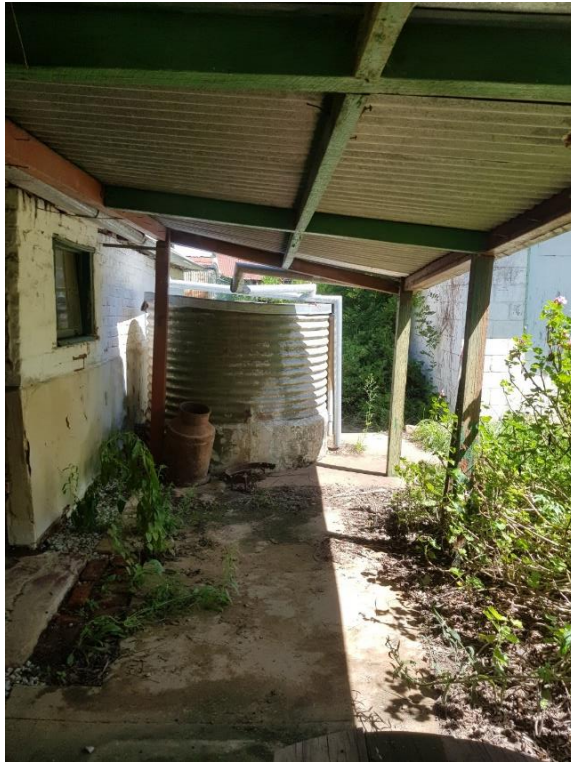
Figure 1. Evidence of brick paved veranda; Brick paving below concrete topping rear veranda (Source: JPA& D 2023)

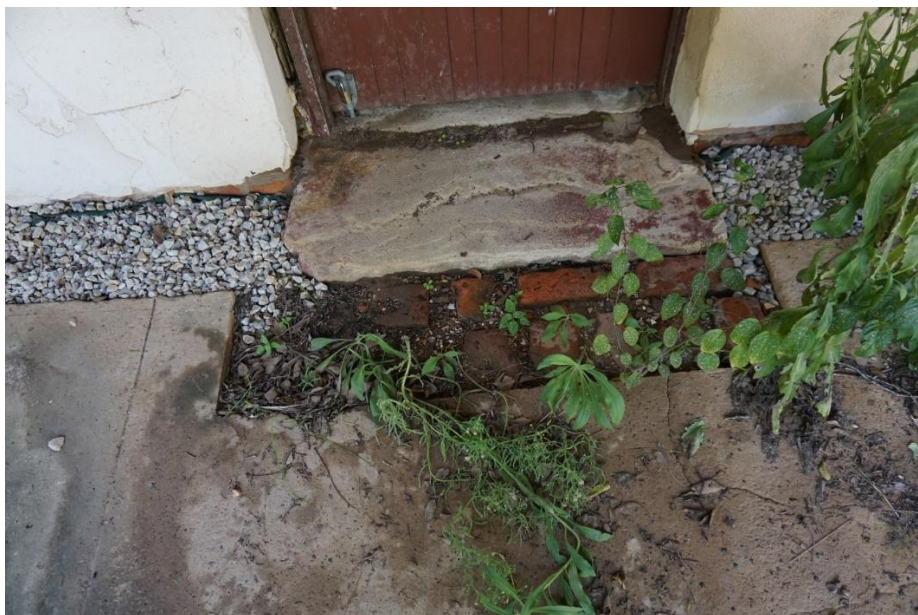
Figure 2. Evidence of brick paved veranda; Brick paving below concrete topping to rear veranda (Source: JPA& D 2023)

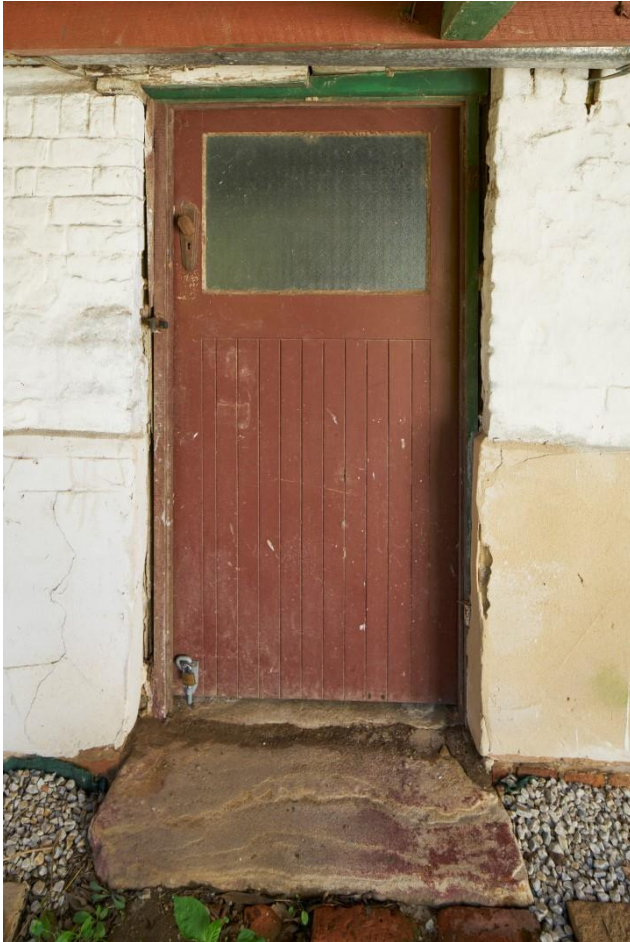
Figure 3. Evidence of brick paved veranda; Brick to rear veranda (Source: JPA& D 2023)

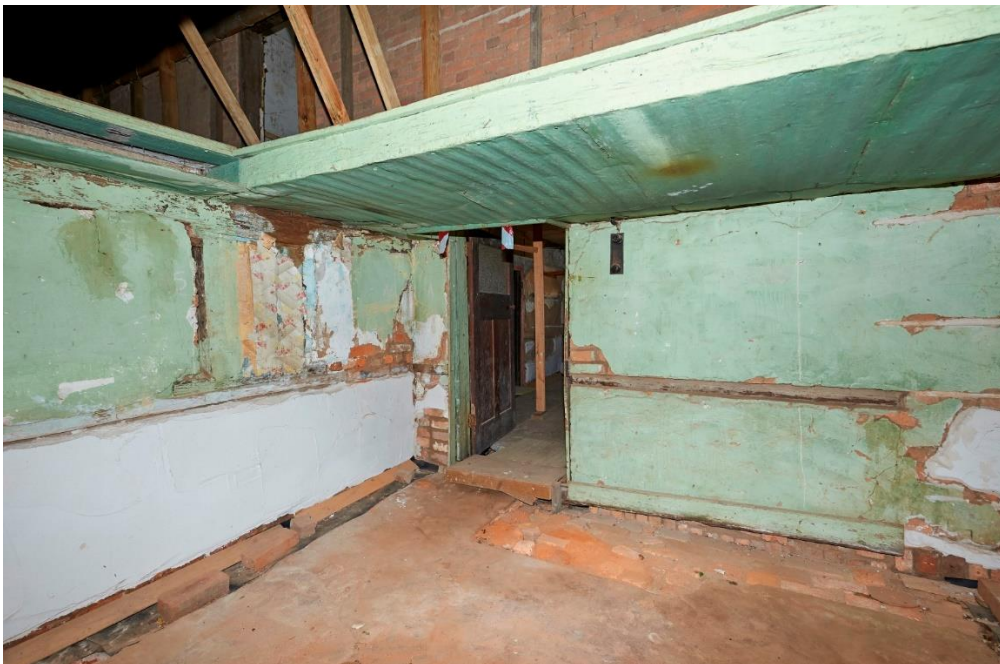
Figure 4. Ground Floor storeroom of the main house; Brick below concrete topping to store of main house (Source: JPA&D 2023)

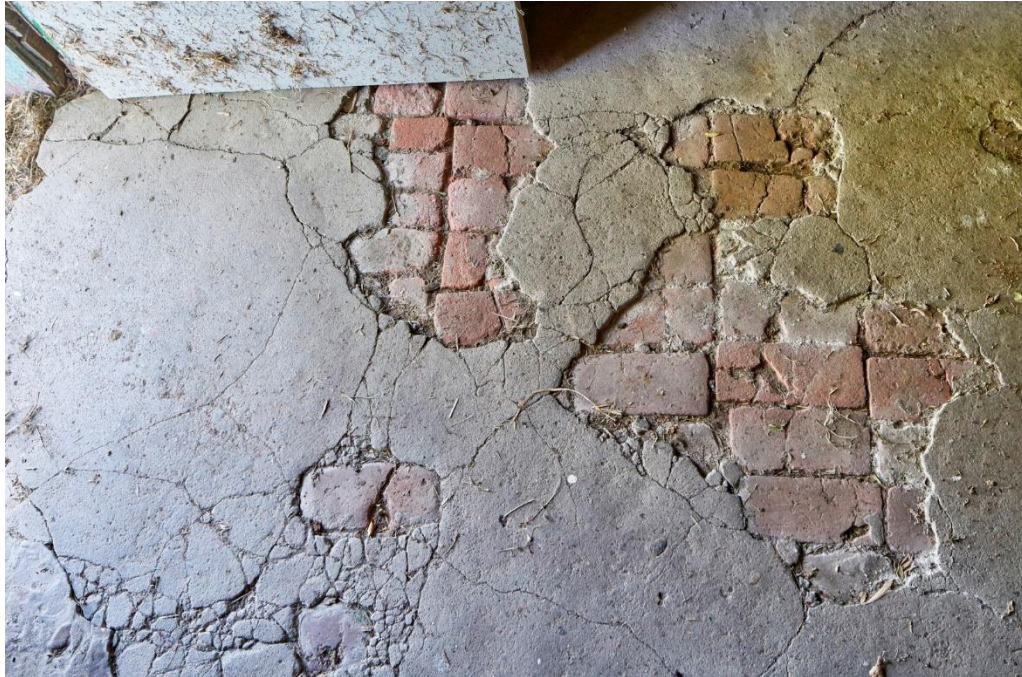
Figure 5. Ground Floor storeroom of the main house; Brick Floor below concrete store of main house (Source: JPA&D 2023)

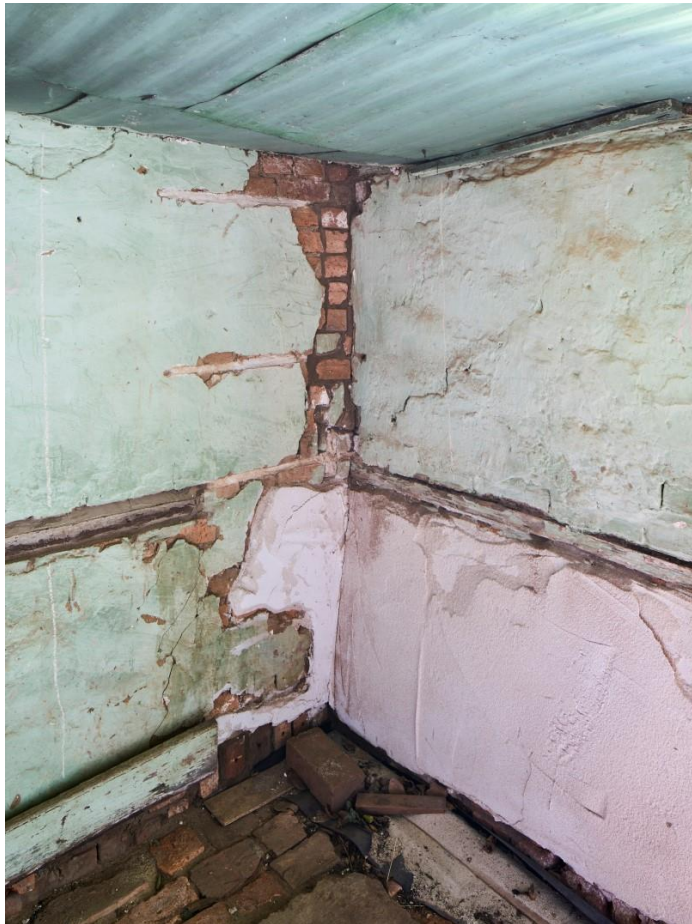
Figure 6. Ground Floor storeroom of the main house; Brick floor surface in store of main house (Source: JPA&D 2023)

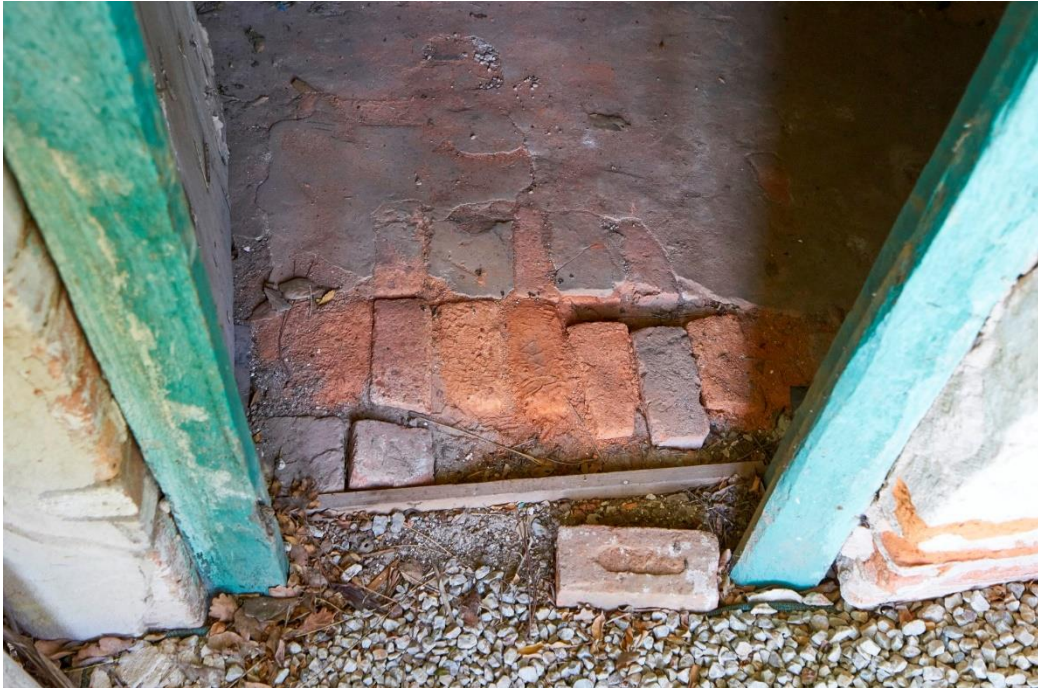
Figure 7. Ground Floor storeroom of the main house; Brick floor of storeroom in the main house (Source: JPA&D 2023)

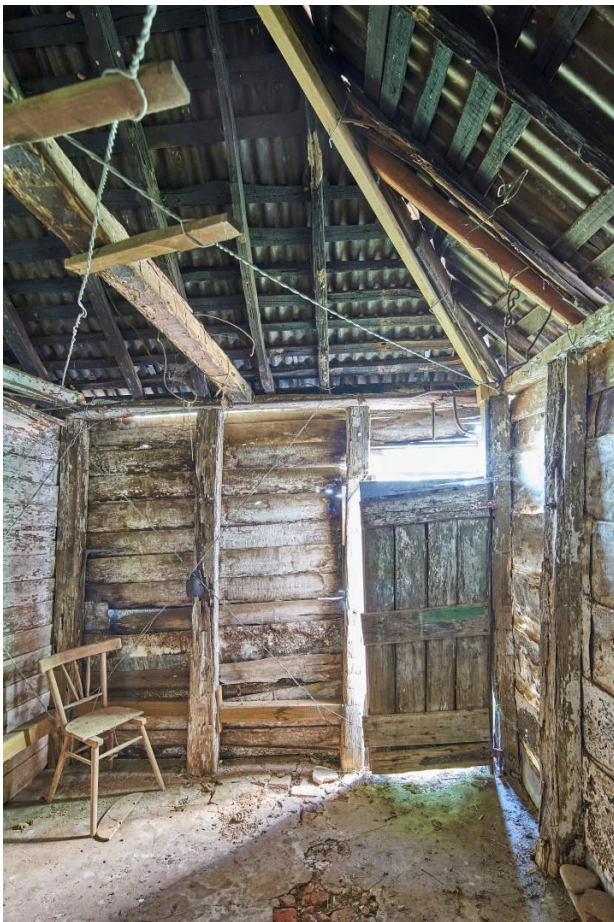
Figure 8. Floor of the weatherboard cottage is brick paved below concrete topping (Source: JPA&D 2023)

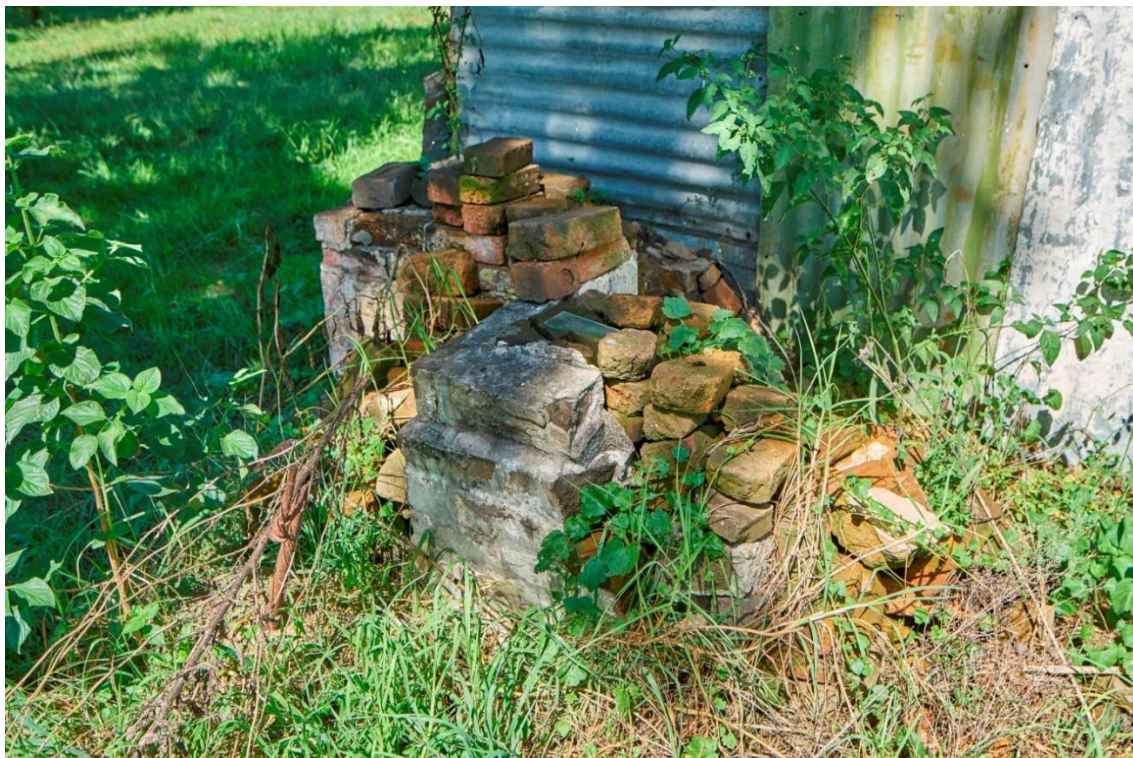
Figure 9. Some bricks to be used for reconstruction of the weatherboard cottage chimney which are loose but insitu (Source: JPA&D 2023)

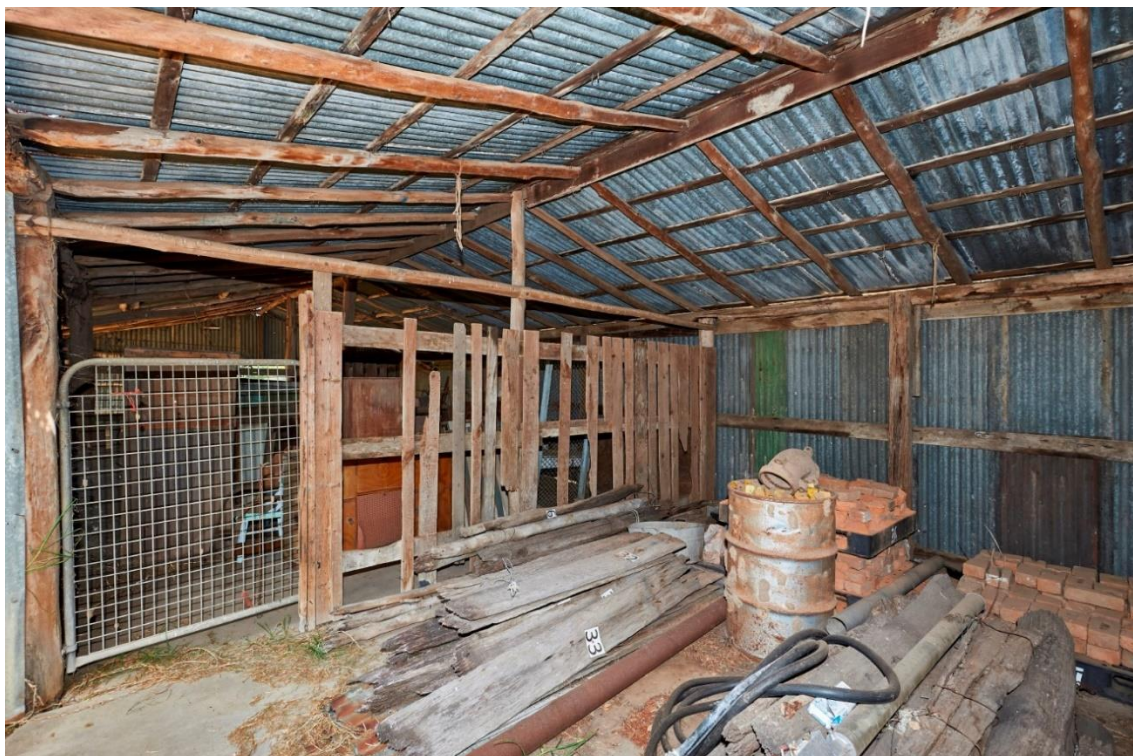
Figure 10. Other bricks stored on pallets in a shed on site (Source: JPA&D 2023)
