# REPORT

## FALL ARREST SYSTEM FOR SIGN STRUCTURE

Prepared for **MULPHA NORWEST**

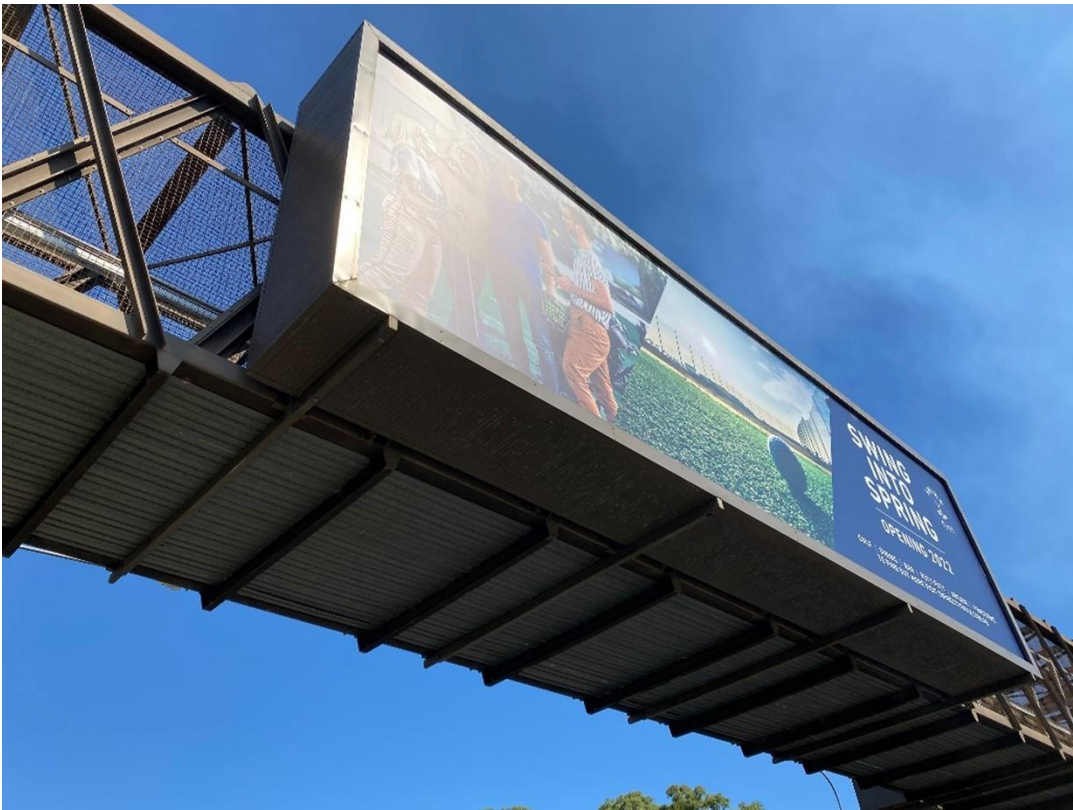
**FIGURE 3: SIGN BOARD ATTACHED AT THE EASTERN SIDE OF THE BRIDGE**

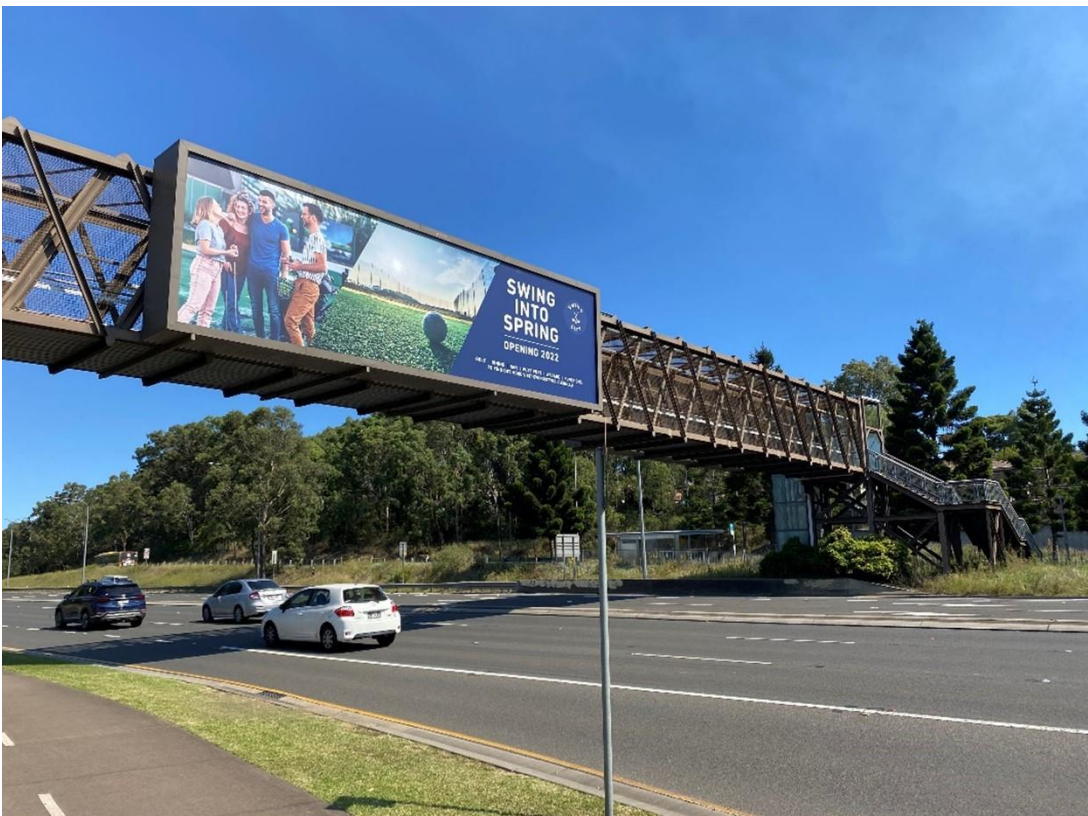
**FIGURE 4: SIGN BOARD ATTACHED AT THE EASTERN SIDE OF THE BRIDGE**

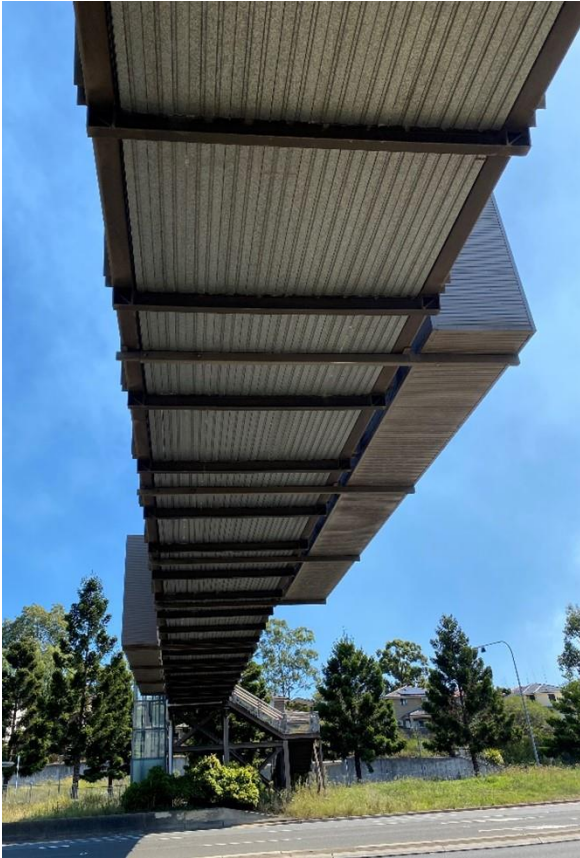
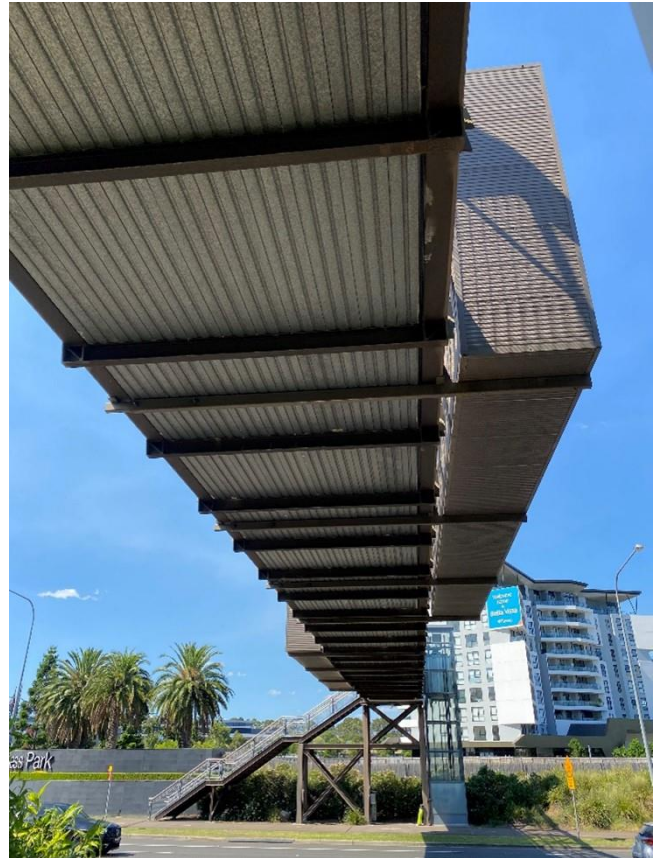
**FIGURE 5: OUTRIGGERS SUPPORTING THE BOTTOM OF THE EASTERN AND WESTERN SIGNBOARDS**

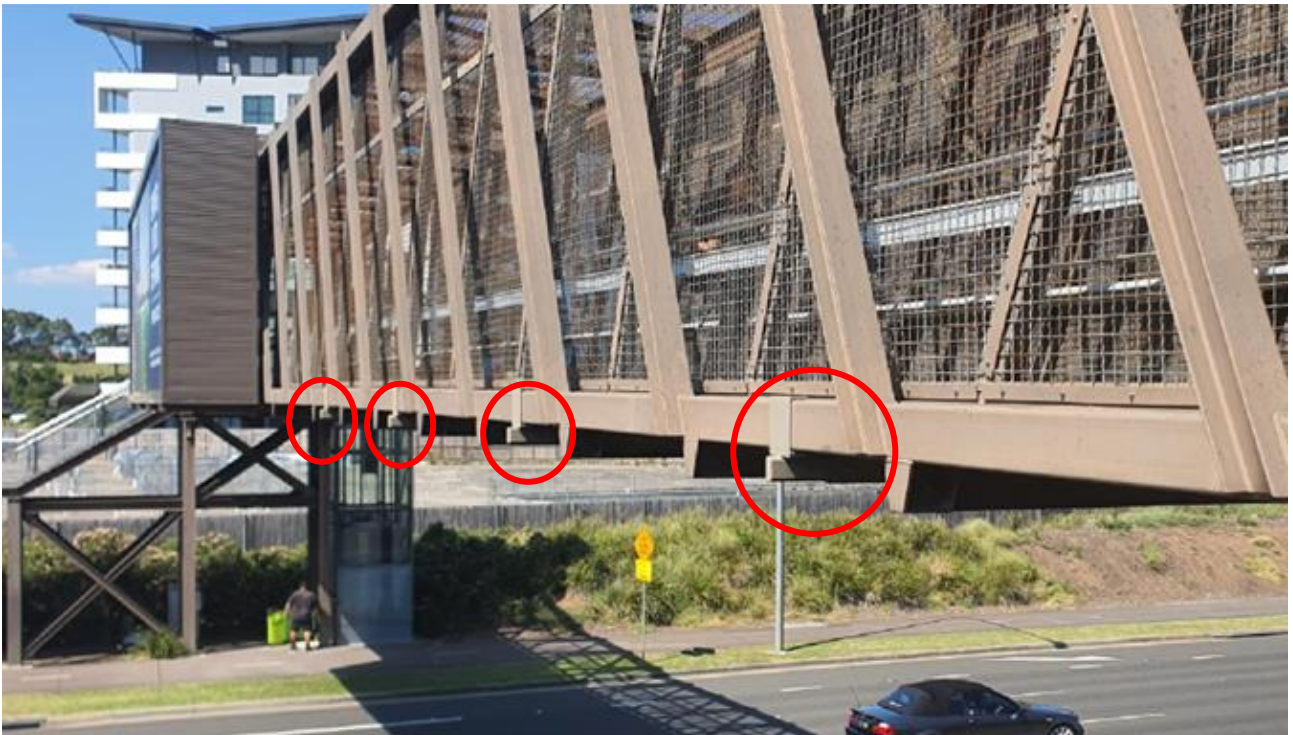
**FIGURE 6: OUTRIGGERS SUPPORTING THE BOTTOM OF THE EASTERN AND WESTERN SIGNBOARDS**

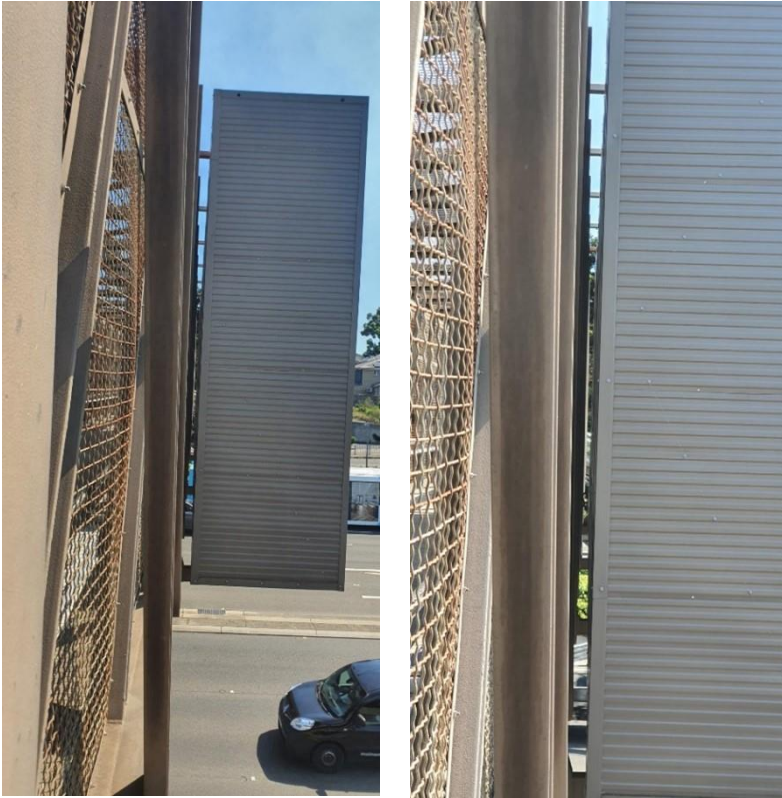
**FIGURE 7: CONNECTION BETWEEN BRIDGE AND SIGNBOARD**

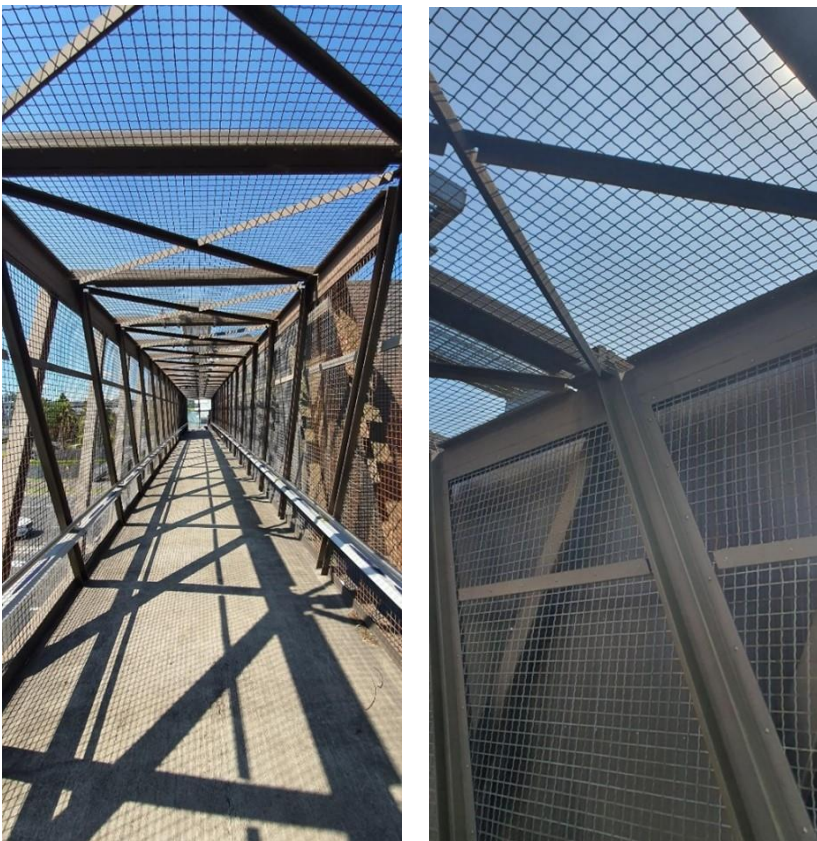
**FIGURE 8: DECK OF BRIDGE AND BRIDGE FRAMING AT THE BACK OF THE SIGNBOARD**

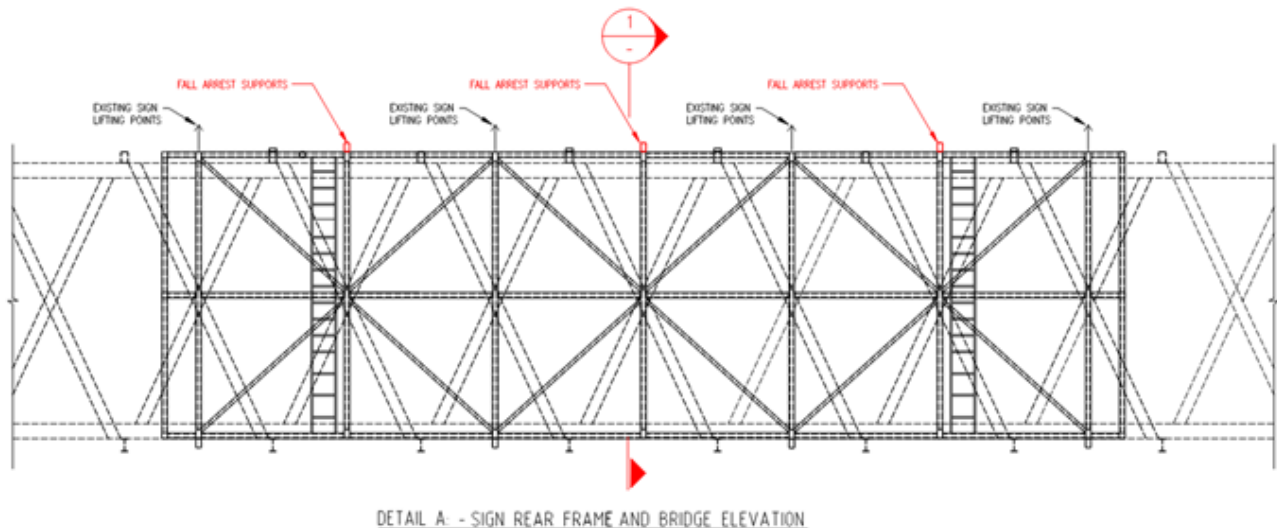
The sign structure will be supported at 3 points by the fall arrest system, these locations are as shown in Figure 9 below. The supports are located as to avoid clashing with the existing sign lifting points.

**FIGURE 9: SIGNAGE ELEVATION SHOWING THE FALL ARREST SUPPORT LOCATIONS**

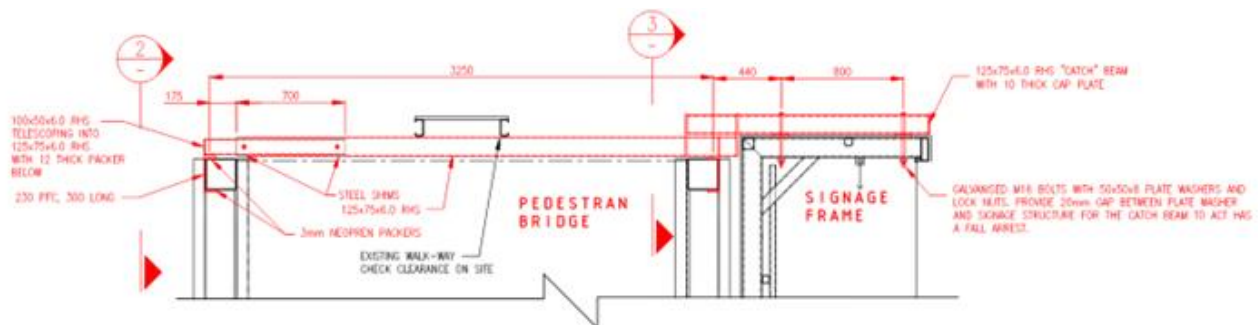
The support arrangement for the fall arrest system is of a similar design to the current support for the signage. This consists of 3 x 125x75x6.0 RHS frames spanning across the bridge top chords as shown in Figure 10. The frames are telescoping and have 230 PFC segments which are designed to clamp around the bridge top chords.

**FIGURE 10: SIGNAGE FALL ARREST SUPPORT FRAME**
