Asbestos Survey Report

**Corner Winbourne Street and Mulgoa
Way, Mudgee, NSW**

Housing Plus

22 December 2021

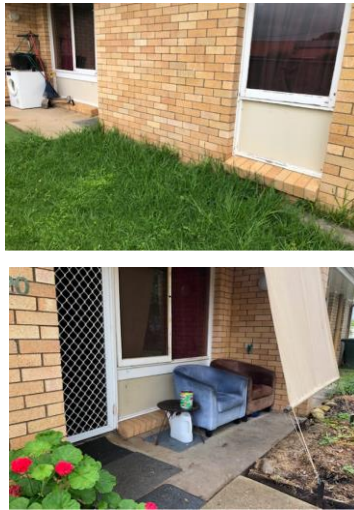
Asbestos material detected																				
Unit 19 - 22 (whole building)	Ground	External	Flat cement product	Infill panels beneath windows	Single at the front and two panels at the rear	Sealed

MW03 (sampled from Unit 20)	Chrysotile Detected	Yes	Bonded	Good	High	Very high	Removal	Not required	5	m2	As building is proposed for demolition, all positive and presumed asbestos materials are considered very high risk. All identified ACM must be removed prior to demolition in accordance with the Code of Practice: How to Safely Remove Asbestos, 2019. SafeWork NSW	
Unit 19 - 22 (whole building)	Ground	External	Flat cement product	Eave linings	Eaves on all sides of building	Sealed on one side

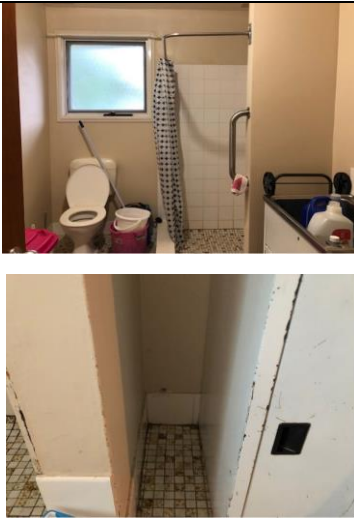
MW04 (sampled from Unit 20)	Chrysotile Detected	Yes	Bonded	Good	High	Very high	Removal	Not required	20	m2		
Unit 20	Ground	Internal	Flat cement product	Internal wall linings - bathroom, toilet and laundry	Wall linings	Sealed

MW01	Chrysotile Detected	Yes	Bonded	Very good	High	Very high	Removal	Not required	35	m2
