Arboricultural Impact Assessment Report

Seniors Housing Development, NSW Land & Housing Corporation

17, 19 and 21 Wardell Road, Alstonville NSW

Date: 25 August 2023

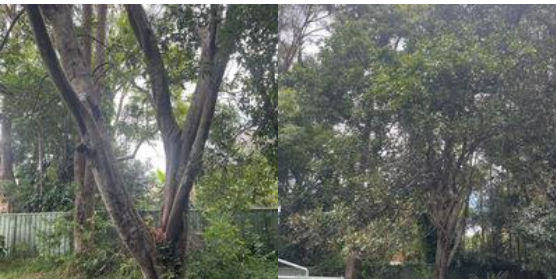
T28 Tuckeroo <i>Cupaniopsis anacardioides</i> Likely planted; Native rainforest tree species TCV Very Low	65 72 10 7	Over- Mature Poor Poor	7.8 2.9	REMOVE tree for construction and due to Poor health and condition, Very Low TRV and since it is hazardous Tree base is entirely within the construction footprint for dwelling construction Upright; Highly defective and poor form, Codominant stems with narrow V-shaped union, NE leader severely leaning, Low foliage density, Tip dieback, clothes line present as failure target, High volume deadwood to ~10cmØ, hazardous

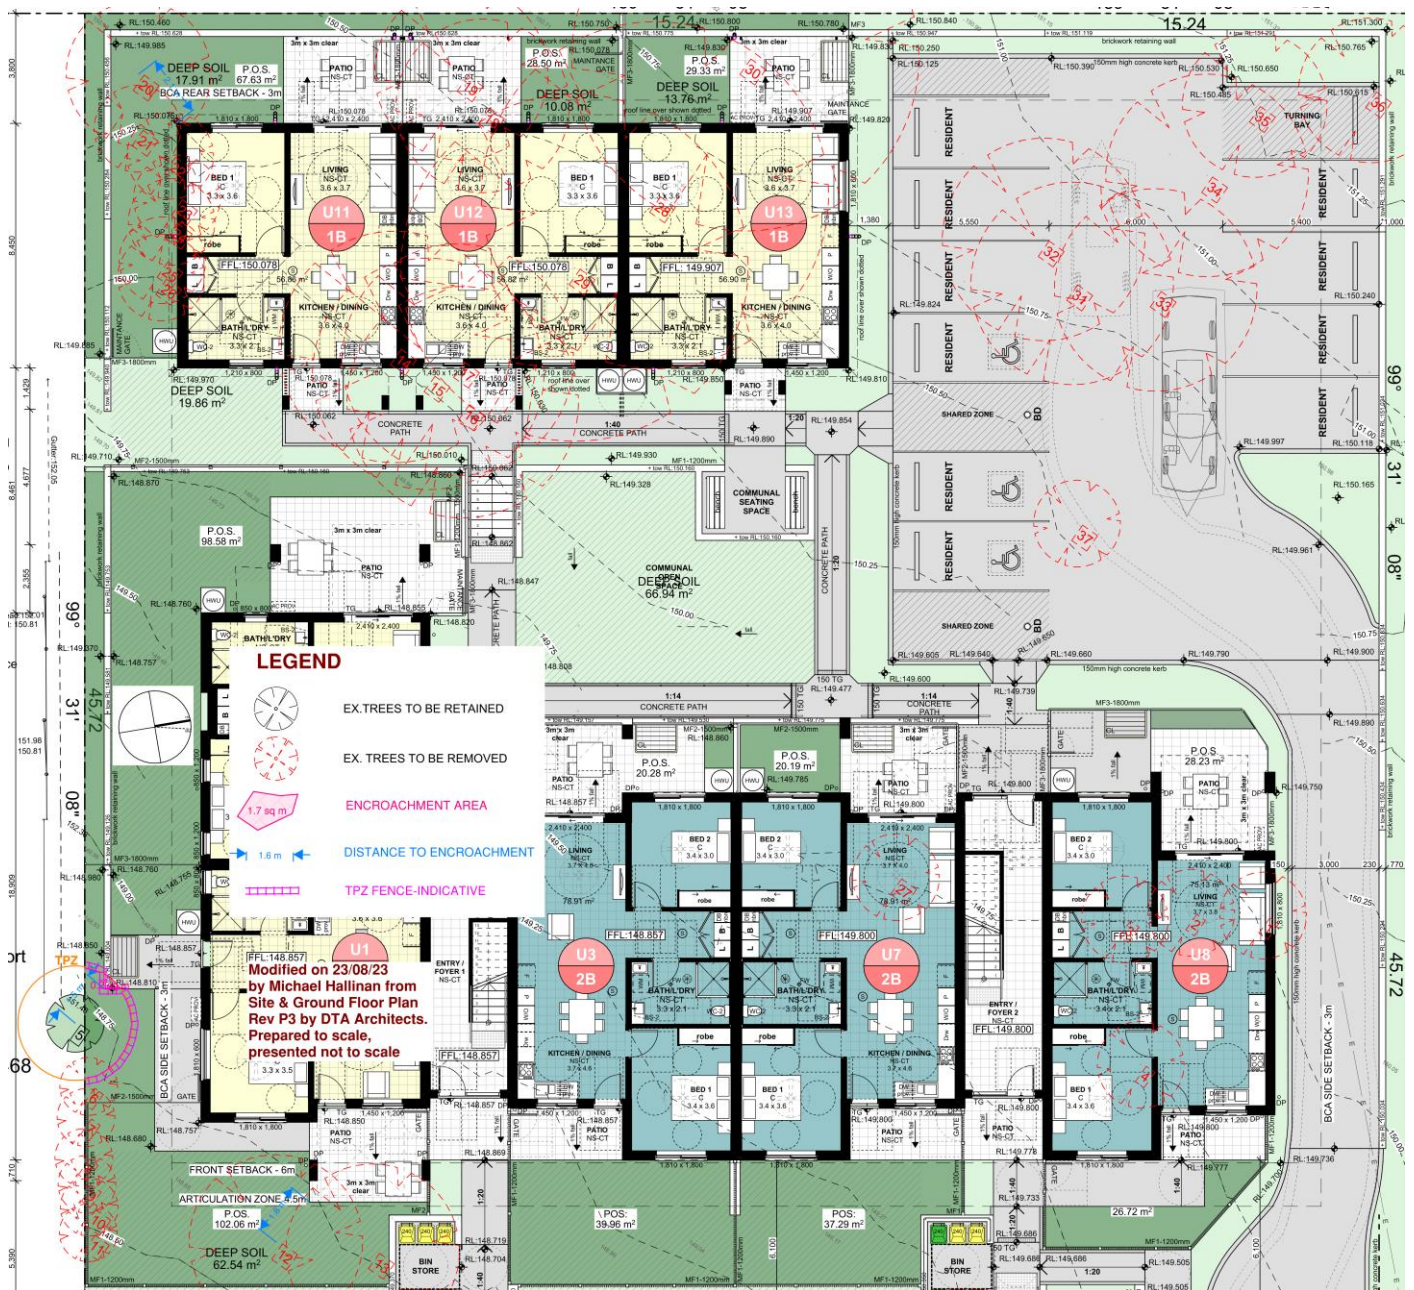
Figure 1. Tree retention, tree removal and tree protection plan drawing

- A total of 37 trees, shrubs and clumps were assessed within the area of the site.
- One shrub (T5) only is recommended to be retained. It has a Minor¹⁵ TPZ encroachments of less than 10%. Standards Australia (2009) note that TPZ locations may be varied for trees with Minor TPZ encroachments where the area lost to the encroachment is compensated for elsewhere and is contiguous with the TPZ, as is the case in this instance.

The project Tree Protection Zones (TPZs) are the areas dedicated to tree protection. **Figure 1** shows the recommended project TPZ fence locations in relation to retained T5 and the construction footprint.
