**Fireproofing Extent  
Investigation  
Block F, Level 2 & 3  
Westmead Hospital,  
Westmead NSW 2145**

**Renascent  
May 2023**

**Client No: R0051  
Job No: 114424S**

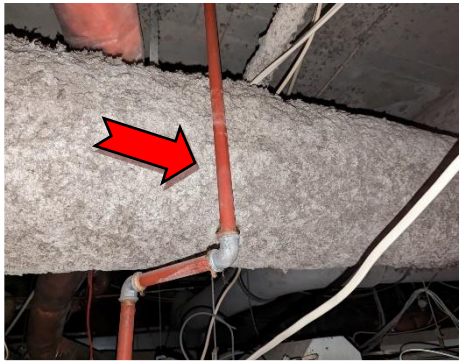
1. Heavy loading of fireproofing to pipework - poor condition assumed asbestos-containing fireproofing.

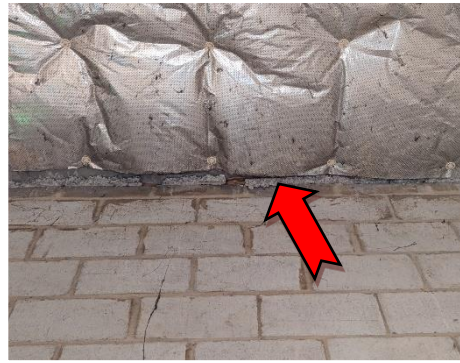
2. Representative photograph of high risk, poor condition, structurally unstable assumed asbestos-containing fire proofing.

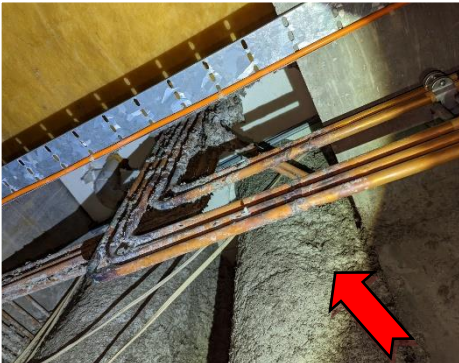
3. Representative photograph of high risk, poor condition, structurally unstable assumed asbestos-containing fire proofing.

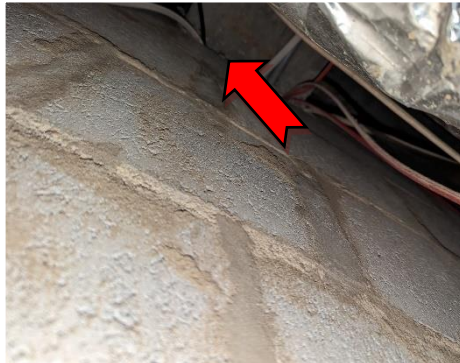
4. Representative photograph of low risk, good condition assumed asbestos-containing fire proofing.

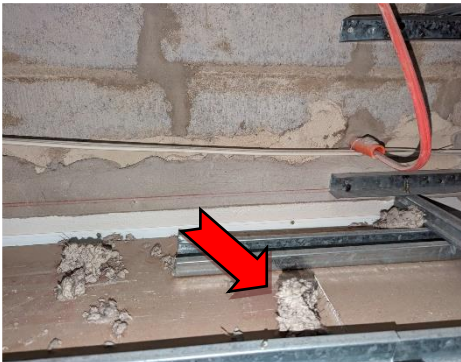
5. Representative photograph of high risk, poor condition, assumed asbestos-containing fire proofing debris.

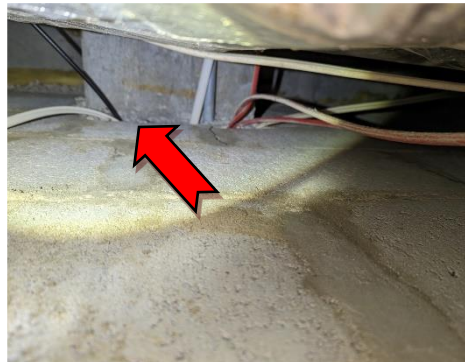
6. Representative photograph of low risk, good condition assumed asbestos-containing fire proofing.
