Asbestos and Hazardous Materials Pre-Demolition Assessment

Block C

Wyong Public Hospital

754-SYDEN329755 - Wyong Public Hospital, Block C - HMDR - 02082023

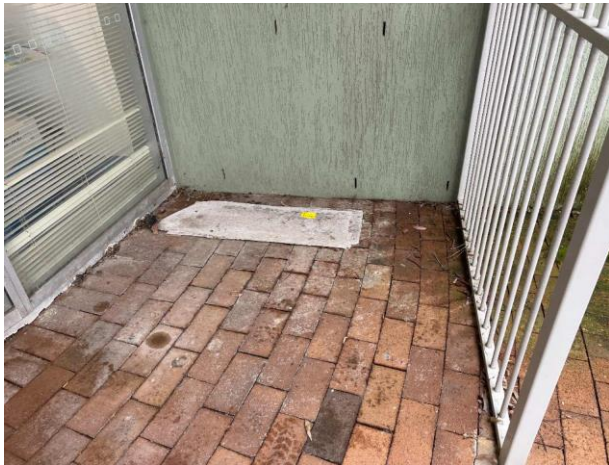
Line ID 1: External, Geriatric Unit Ground Level, South Eastern Side, on Floor, Adjacent Stairs to Roof, Fibre Cement Sheet Debris - No Asbestos Detected

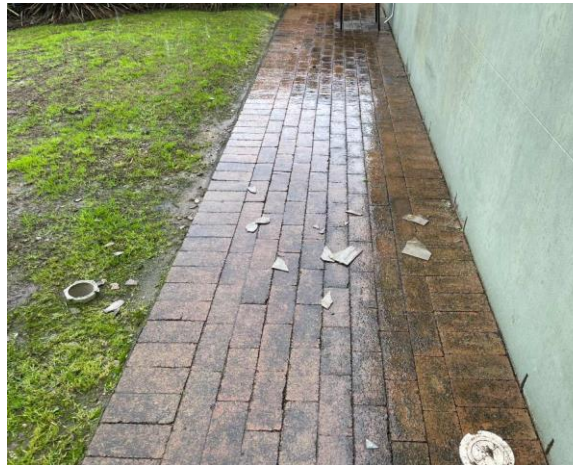
Line ID 2: External, Geriatric Unit Ground Level, South Western Side, Floor, Fibre Cement Sheet Debris - No Asbestos Detected

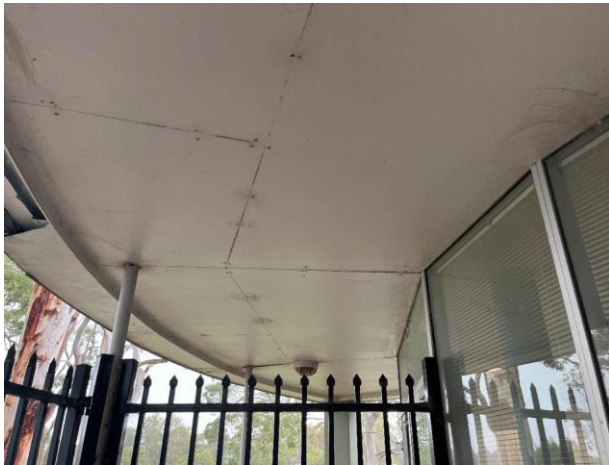
Line ID 3: External, Geriatric Unit Ground Level, Throughout, Awning, Fibre Cement Sheet - No Asbestos Detected

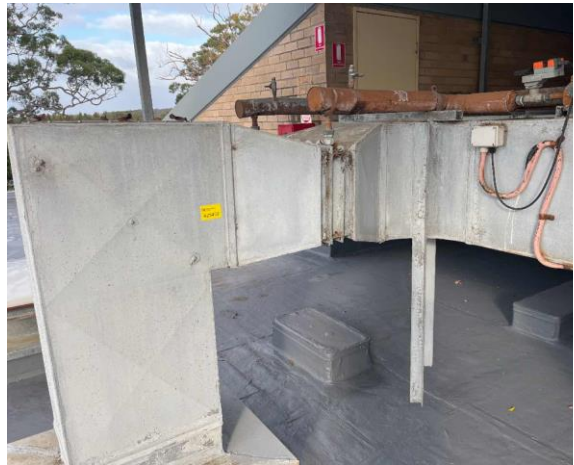
Line ID 4: External, Geriatric Unit Roof, Rooftop Plantroom, Ductwork Throughout, Mastic Sealant - No Asbestos Detected

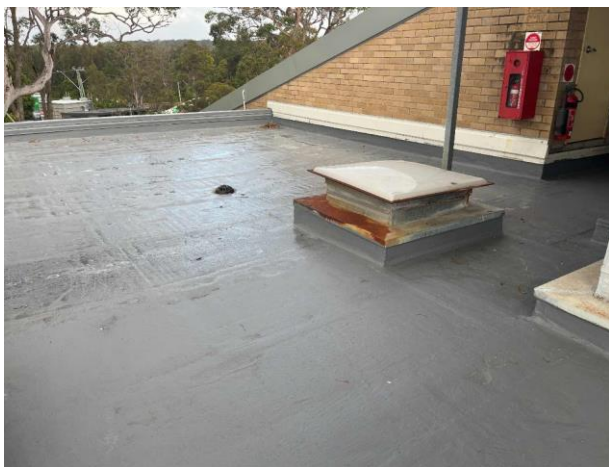
Line ID 5: External, Geriatric Unit Roof, Rooftop Plantroom, Floor, Bituminous Membrane - No Asbestos Detected

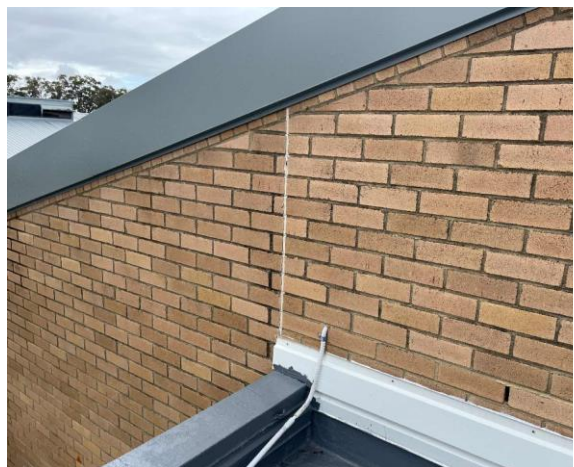
Line ID 6: External, Geriatric Unit Roof, Rooftop Plantroom, to Walls, Construction Joint Mastic - No Asbestos Detected

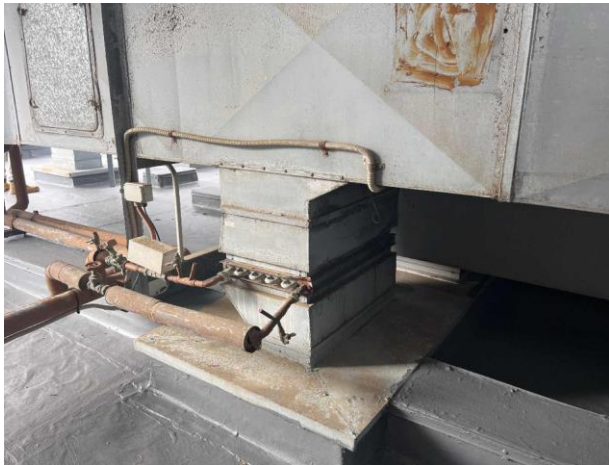
Line ID 7: External, Geriatric Unit Roof, Rooftop Plantroom, Within Eastern Ductwork, Millboard Insulation to Heating Coils - Suspected Asbestos

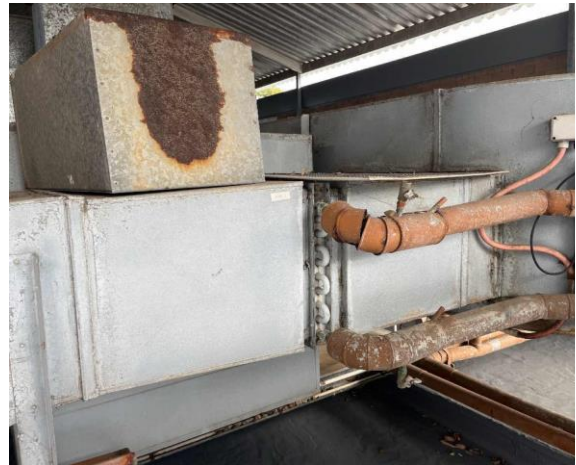
Line ID 7.1: External, Geriatric Unit Roof, Rooftop Plantroom, Within Eastern Ductwork, Millboard Insulation to Heating Coils - Suspected Asbestos

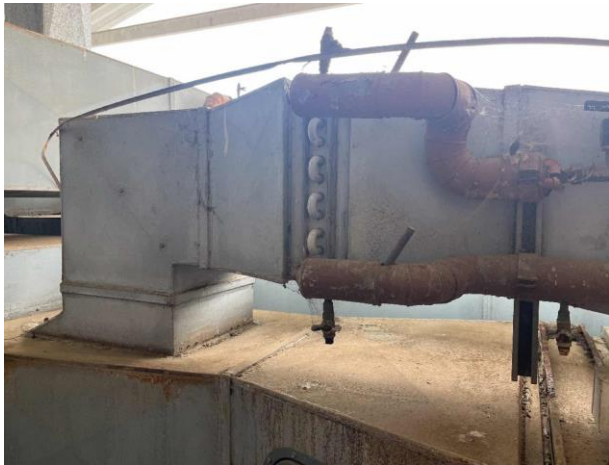
Line ID 8: External, Geriatric Unit Roof, Rooftop Plantroom, Within Western Ductwork, Millboard Insulation to Heating Coils - Suspected Asbestos

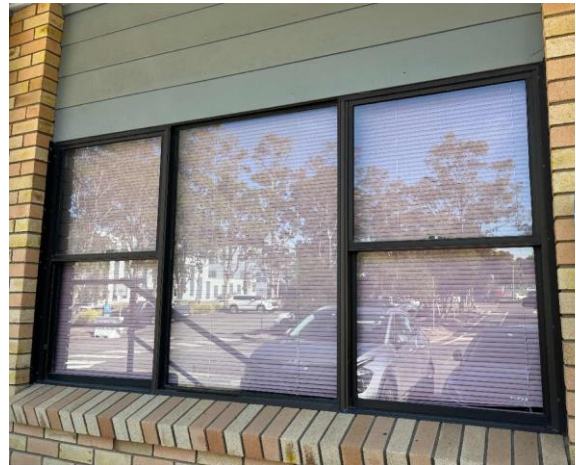
External	Paediatric Unit / Throughout / Window Frames	Mastic Sealant	Asbestos	A12291	Chrysotile Asbestos Detected	Non-Friable	10 m	Fair	Low	5 Yearly Reinspection	Sampled on the eastern side. Remove windows whole without direct disturbance to caulking under controlled non-friable asbestos removal conditions prior to refurbishment or demolition works by a Class B (non-friable) licensed asbestos removal contractor. If scraping out of caulking is undertaken as the removal method (i.e. material is being crumbled, pulverized, rendered to a powder), this should be done under friable asbestos removal conditions by a Class A (friable) licensed asbestos removal contractor.	9
External	Paediatric Unit / Northern Side / Wall	Mastic to Expansion Joint (lighter)	Asbestos	A25429	No Asbestos Detected	-	5 m	-	-	-	-	10

Line ID 9: External, Paediatric Unit, Throughout, Window Frames, Mastic Sealant - Chrysotile Asbestos Detected

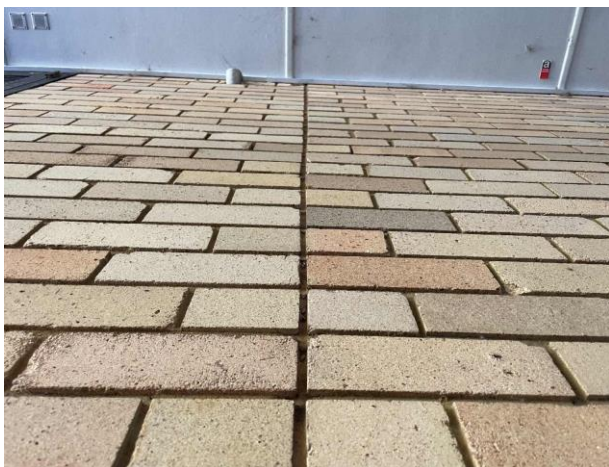
Line ID 10: External, Paediatric Unit, Northern Side, Wall, Mastic to Expansion Joint (lighter) - No Asbestos Detected

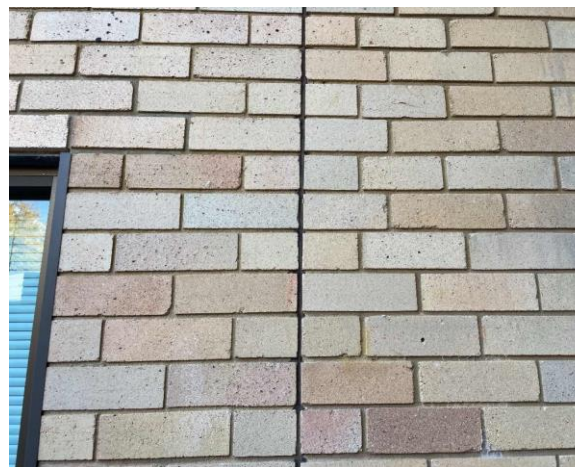
Line ID 11: External, Paediatric Unit, Northern Side, Wall, Mastic to Expansion Joint (darker) - No Asbestos Detected

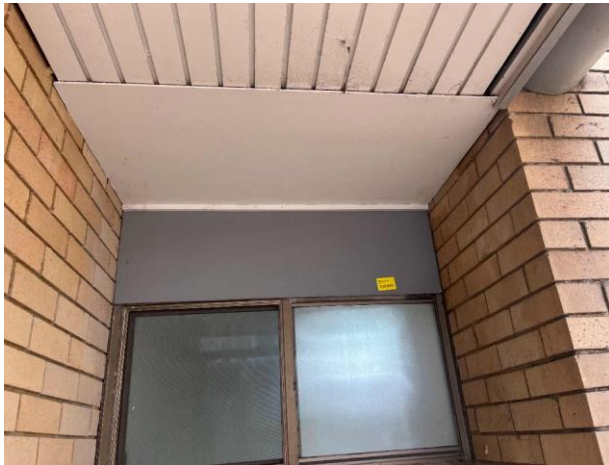
Line ID 12: External, Paediatric Unit, South Side, Infill Panel Above Window, Fibre Cement Sheet - No Asbestos Detected

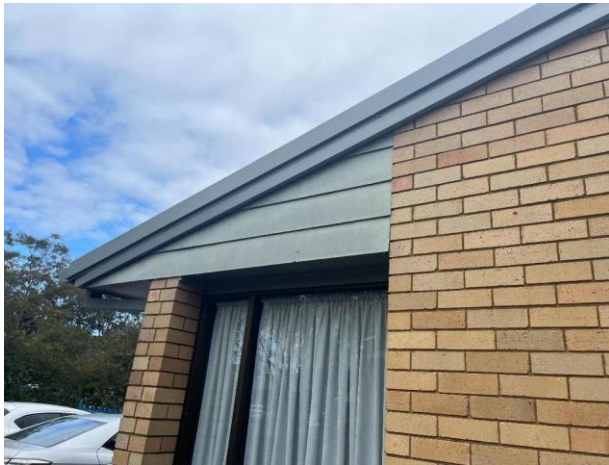
Line ID 14: External, Paediatric Unit, Throughout, Cladding around Windows and Awnings, Fibre Cement Sheet - No Asbestos Detected

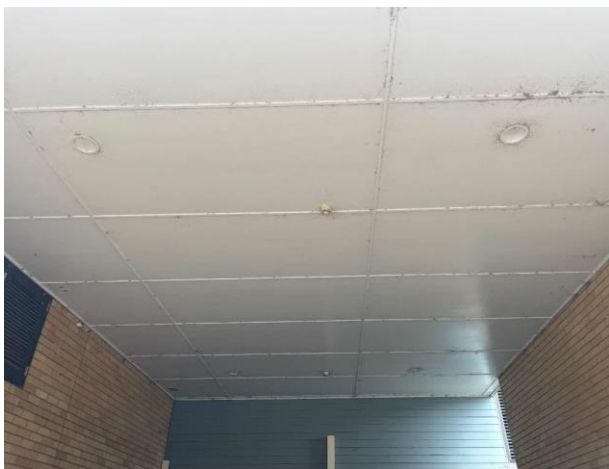
External	Paediatric Unit / Throughout / Old Ambulance Carport, Ceiling	Fibre Cement Sheet	Asbestos	Previously Sampled NAA 91935 - Stage 1-04	Chrysotile Asbestos Detected	Non-Friable	40 m²	Stable	Low	5 Yearly Reinspection	Maintain in current condition if to remain in-situ. Remove under controlled non-friable asbestos removal conditions prior to refurbishment or demolition works by a Class B (non-friable) licensed asbestos removal contractor in accordance with relevant State	16

Line ID 16: External, Paediatric Unit, Throughout, Old Ambulance Carport, Ceiling, Fibre Cement Sheet - Chrysotile Asbestos Detected

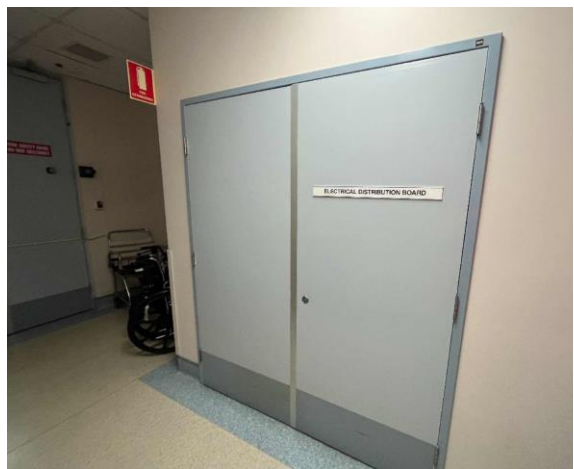
Line ID 19: Internal, Cancer Care Unit, Electrical Distribution Cupboard, Fire Doors, Fire Door Core - Suspected Asbestos

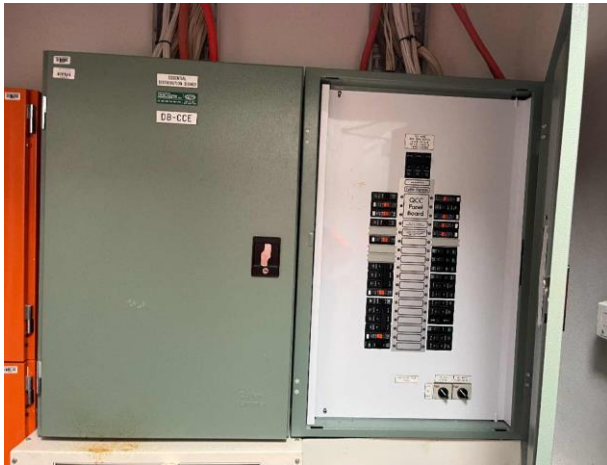
Internal	Cancer Care Unit / Electrical Distribution Cupboard / Switchboard	HRC Fuses	Asbestos	754-SYDEN329755 Block C168A8	Suspected Asbestos	Friable	10 Units	Unknown	Low	5 Yearly Reinspection	Confirm status and maintain in current condition if to remain in-situ in accordance with relevant State Regulations, Compliance Codes, Codes of Practice and Guidance Notes. Remove under controlled friable asbestos removal conditions prior to refurbishment or demolition works by a Class A (friable) licensed asbestos removal contractor in accordance with relevant State Regulations, Compliance Codes, Codes of Practice and Guidance Notes.	20

Line ID 20: Internal, Cancer Care Unit, Electrical Distribution Cupboard, Switchboard, HRC Fuses - Suspected Asbestos

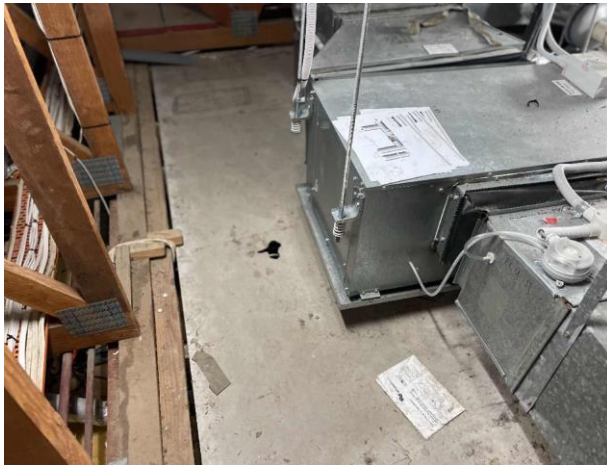
Line ID 22: Internal, Geriatric Unit, Rooftop Plant Rooms, Central Plant Areas on Southern Side, Compressed Cement Sheet - No Asbestos Detected

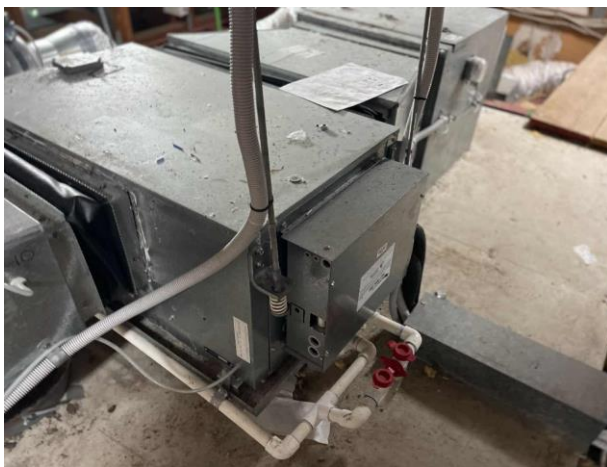
Line ID 24: Internal, Geriatric Unit, Rooftop Plant Rooms, Within Ductwork Throughout, Millboard Insulation to Heating Coils - Suspected Asbestos

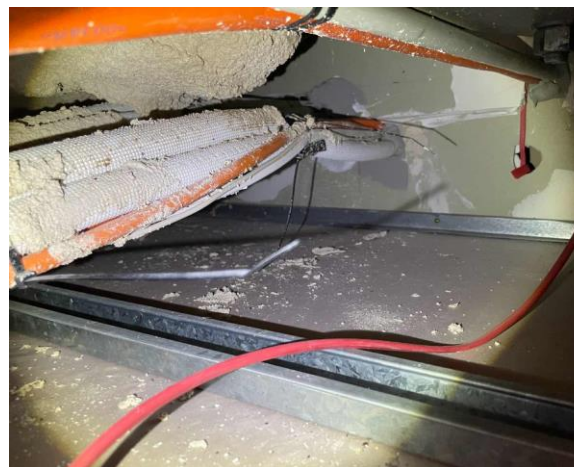
Line ID 25: Internal, Geriatric Unit Ground Level, Ceiling Space Above Doors to Cancer Unit, to Structural Beams, Vermiculite - No Asbestos Detected

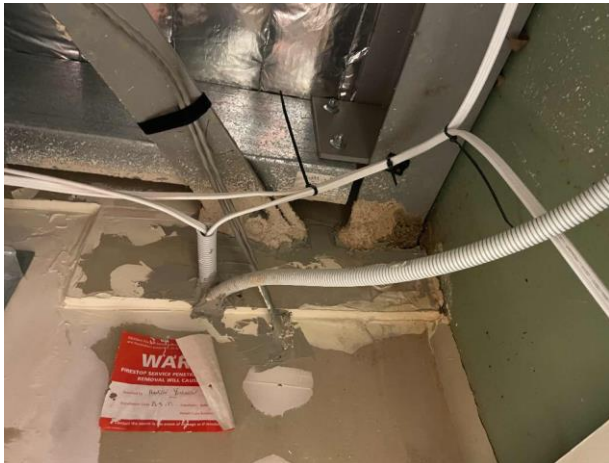
Line ID 26: Internal, Geriatric Unit Ground Level, Meeting Room, to Beams, Vermiculite - No Asbestos Detected

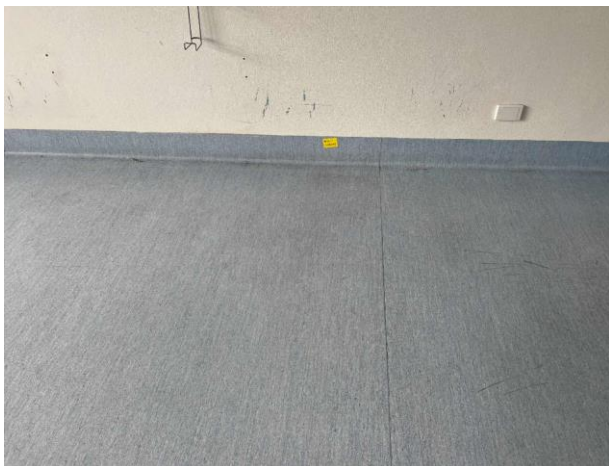
Line ID 28: Internal, Geriatric Unit Ground Level, Throughout, Floor Covering Throughout Rooms, Blue Vinyl Sheet - No Asbestos Detected

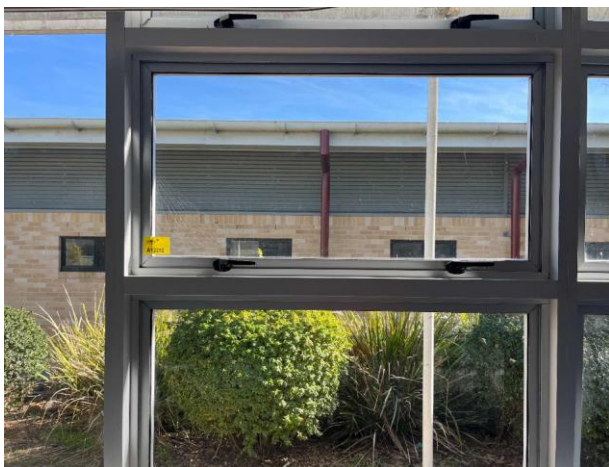
Line ID 30: Internal, Geriatric Unit Ground Level, Western Side, Window Frames, Mastic Sealant - No Asbestos Detected

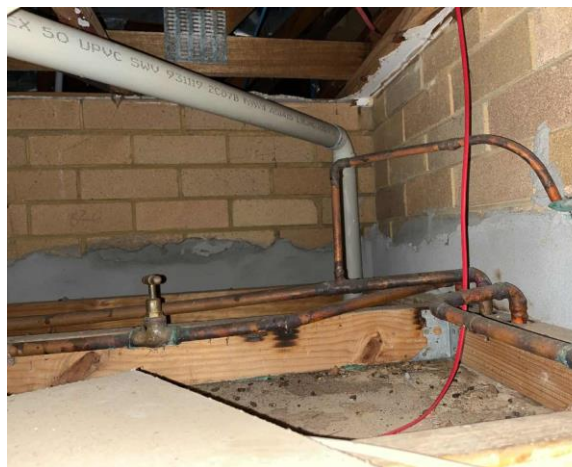
Line ID 31: Internal, Paediatric Unit, Adjacent NUM Room 30083, Ceiling Space, Dust - Chrysotile Asbestos Detected

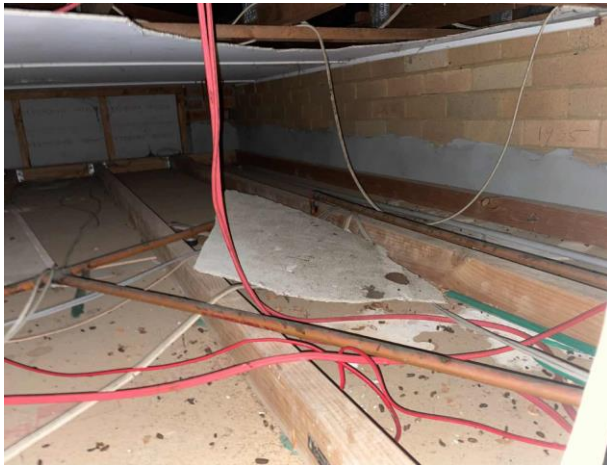
Line ID 32: Internal, Paediatric Unit, Adjacent NUM Room 30083, Ceiling Space, Fibre Cement Sheet Debris - Chrysotile Asbestos Detected

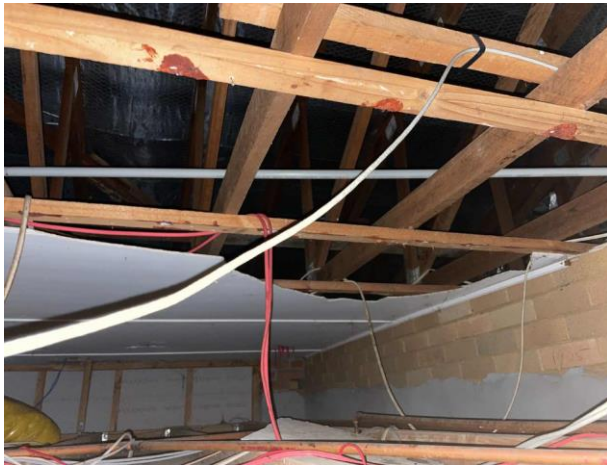
Line ID 33.1: Internal, Paediatric Unit, Adjacent NUM Room 30083, False Ceiling, Fibre Cement Sheet - Chrysotile Asbestos Detected

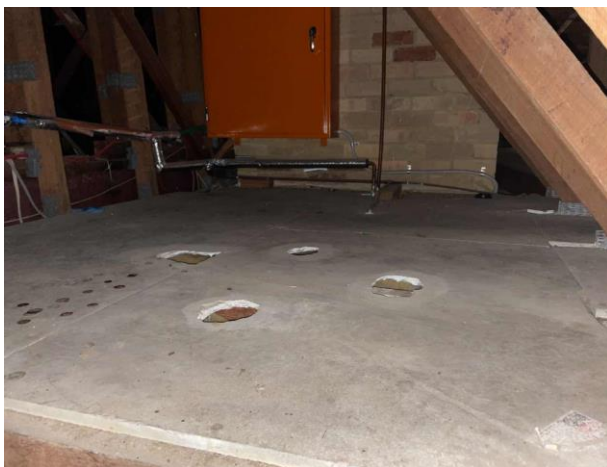
Line ID 36: Internal, Paediatric Unit, Ceiling Space, Central Area, Floor, Compressed Cement Sheet - Chrysotile Asbestos Detected

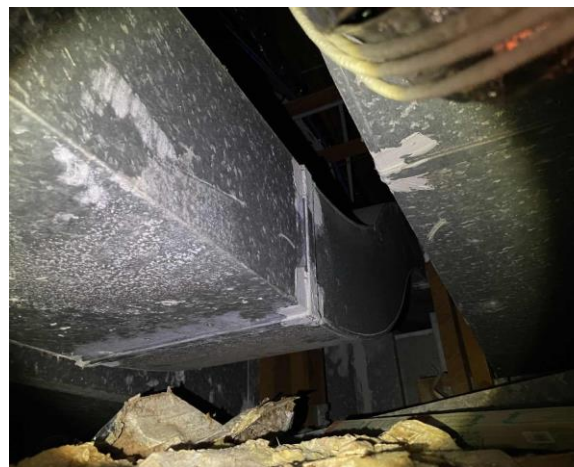
Line ID 37: Internal, Paediatric Unit, Ceiling Space, Ductwork Throughout, Mastic - No Asbestos Detected

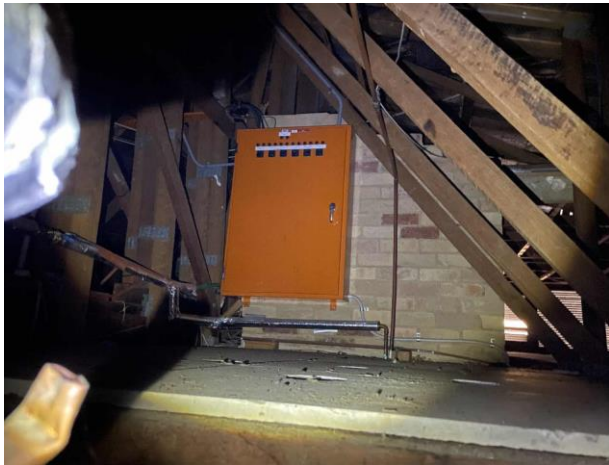
Line ID 38: Internal, Paediatric Unit, Ceiling Space, Switchboard, Bituminous Backing Board - Suspected Asbestos

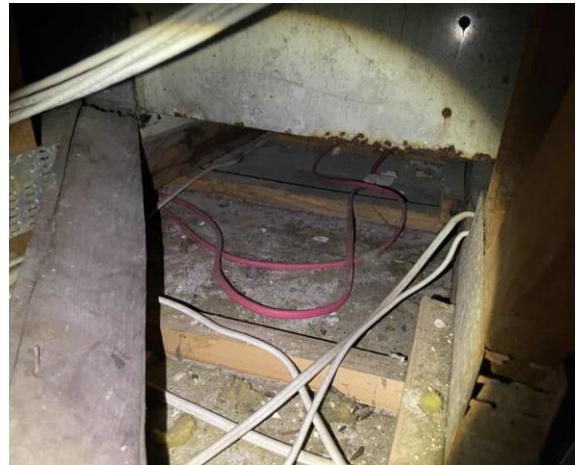
Line ID 40: Internal, Paediatric Unit, Central Corridor, Ceiling Space Above Plaster Ceiling, Below Compressed Panels, Fibre Cement Sheet - Chrysotile Asbestos Detected

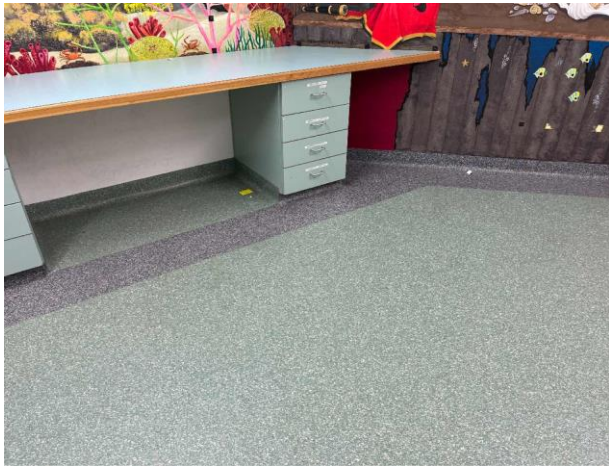
Line ID 41: Internal, Paediatric Unit, Procedure Room 30073, Below Green Vinyl Sheet, Paper Backing - Chrysotile Asbestos Detected

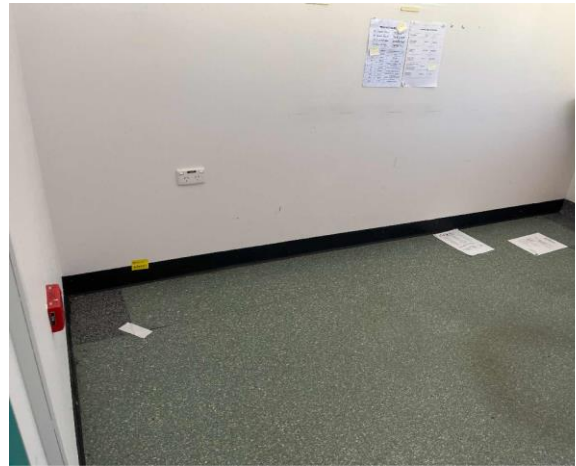
Line ID 42: Internal, Paediatric Unit, Room 8 30076, Below Green Vinyl, Paper Backing - Chrysotile Asbestos Detected

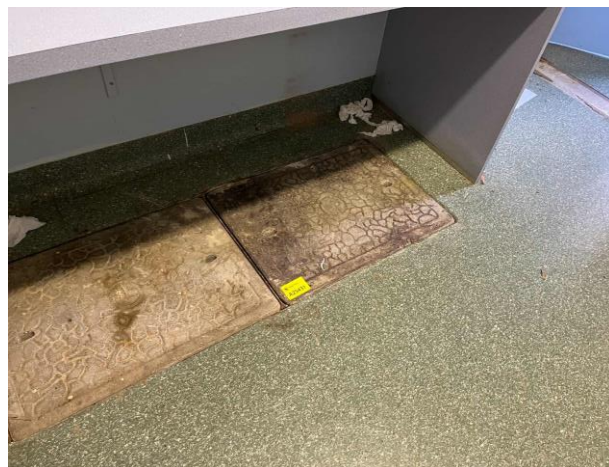
Line ID 43: Internal, Paediatric Unit, Room Adjacent Exit 30079, Walls to Telecom Pit, Compressed Cement Sheet - No Asbestos Detected

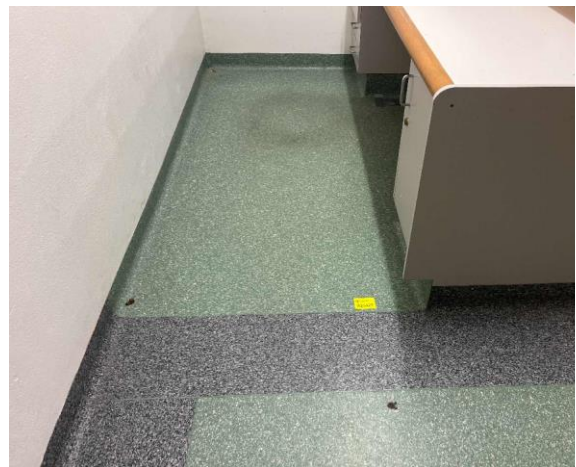
Line ID 44: Internal, Paediatric Unit, Short Stay Room 30069, Floor, Paper Backing under Green Vinyl - Chrysotile Asbestos Detected

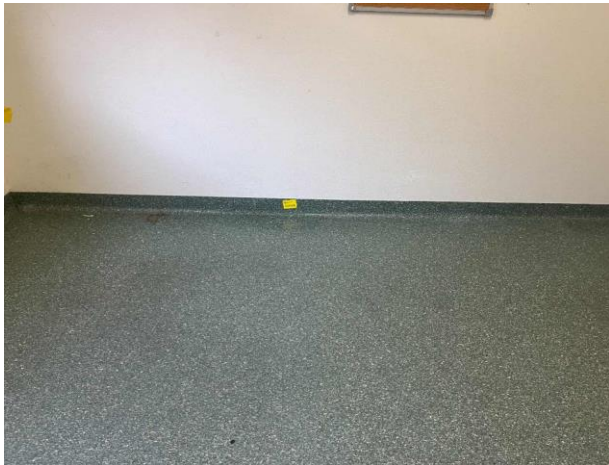
Line ID 45: Internal, Paediatric Unit, South Western Room 30094, Below Green Vinyl, Light Green Vinyl Sheet and Paper Backing - Chrysotile Asbestos Detected

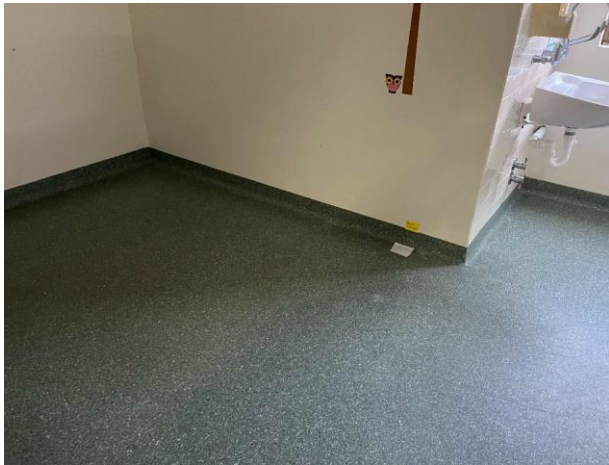
Line ID 47: Internal, Paediatric Unit, Throughout, Below Green Vinyl Sheet, Screed - Chrysotile Asbestos Detected

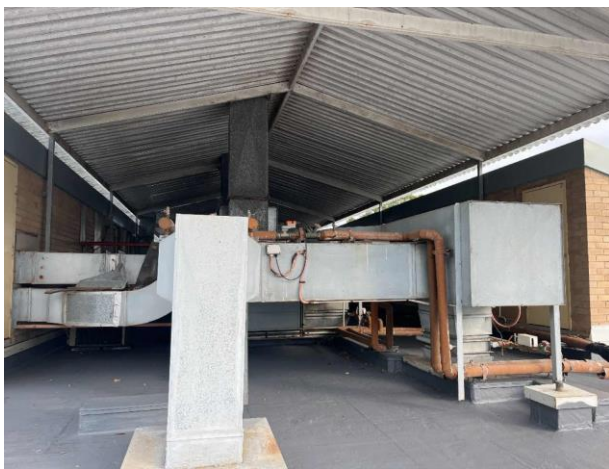
Line ID 51: External, Geriatric Unit Roof, Rooftop Plantroom, Air Conditioning Ductwork Throughout, Grey (Light) Paint - Lead Detected (0.02% w/w)

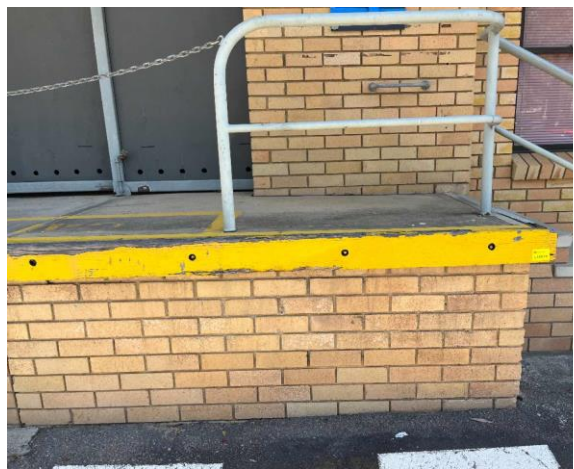
Line ID 52: External, Paediatric Unit, Eastern Side, to Timber, Yellow Paint - Lead Detected (1.8% w/w)

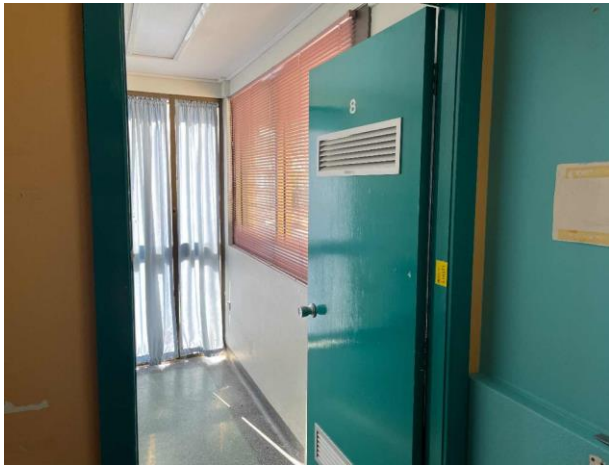
Line ID 53: Internal, Paediatric Unit, Throughout, Doors and Frames, Aqua Paint - Lead Detected (<0.005% w/w)

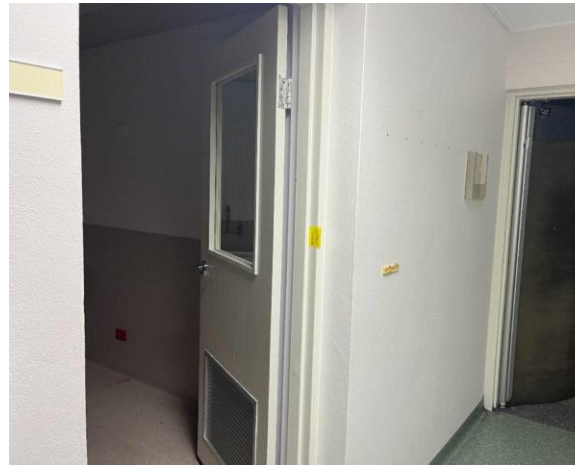
Line ID 54: Internal, Paediatric Unit, Throughout, Doors and Frames, White Paint - Lead Detected (0.005% w/w)

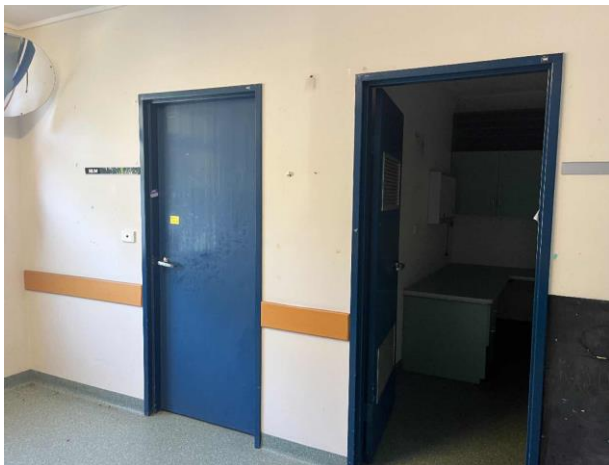
Line ID 55: Internal, Paediatric Unit, Throughout, Doors and Frames, Blue (Dark) Paint - Lead Detected (0.04% w/w)

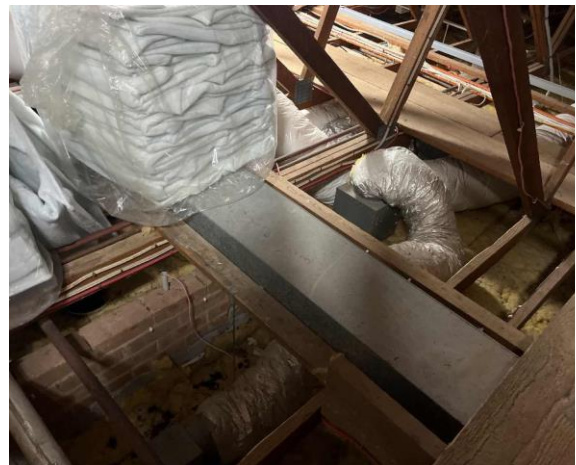
Line ID 56: Internal, Geriatric Unit, Rooftop Plant Rooms, Northern Side Throughout, Dust - Lead Detected (420 mg/kg)

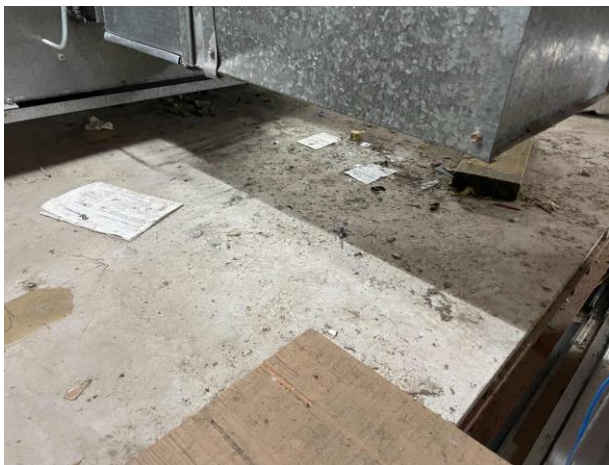
Line ID 57: Internal, Geriatric Unit, Rooftop Plant Rooms, South Side Throughout, Dust - Lead Detected (160 mg/kg)

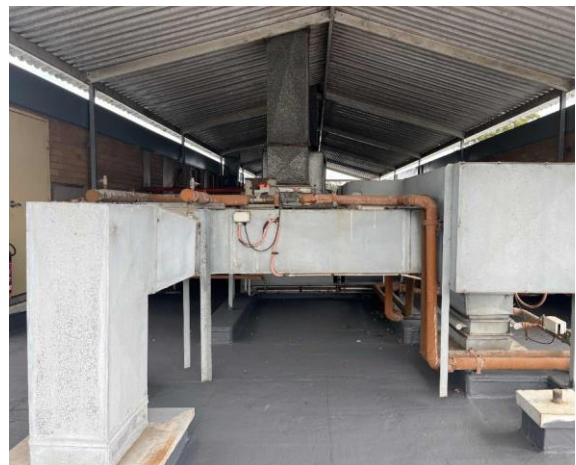
Line ID 60: External, Geriatric Unit Roof, Rooftop Plantroom, Ductwork Throughout, Internal Insulation - Suspected SMF

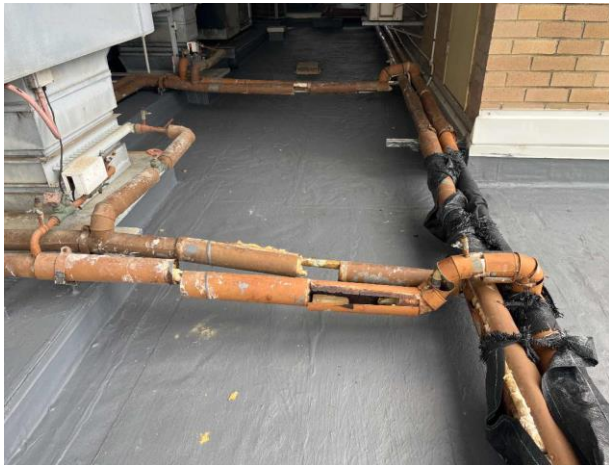
Line ID 61: External, Geriatric Unit Roof, Rooftop Plantroom, Pipework Throughout, Internal Insulation - Suspected SMF

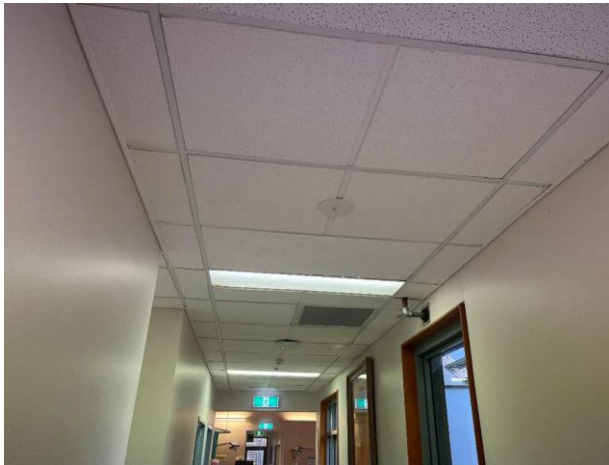
Line ID 63: Internal, Cancer Care Unit, East and West Sides, Ceiling, Compressed Ceiling Tiles - Suspected SMF

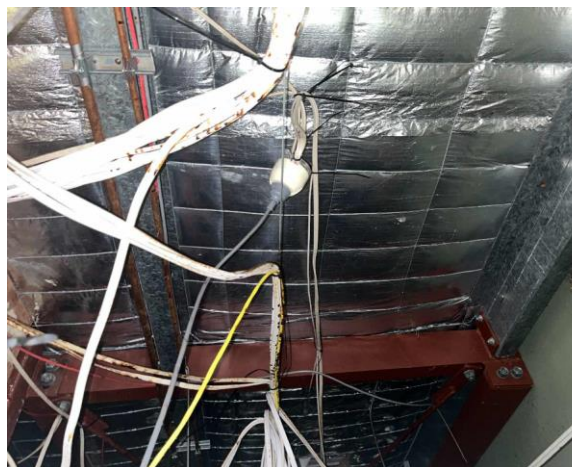
Line ID 67: Internal, Cancer Care Unit, East and West Sides, Throughout Ceiling Space, Sarking Insulation - Suspected SMF

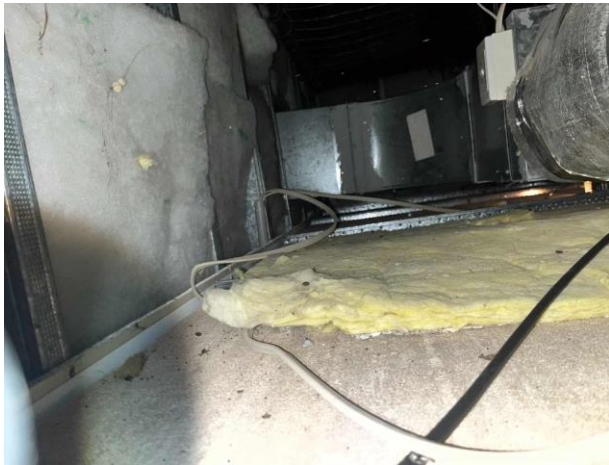
Line ID 68: Internal, Cancer Care Unit, East and West Sides, Throughout Ceiling Space, Insulation Batts - Suspected SMF

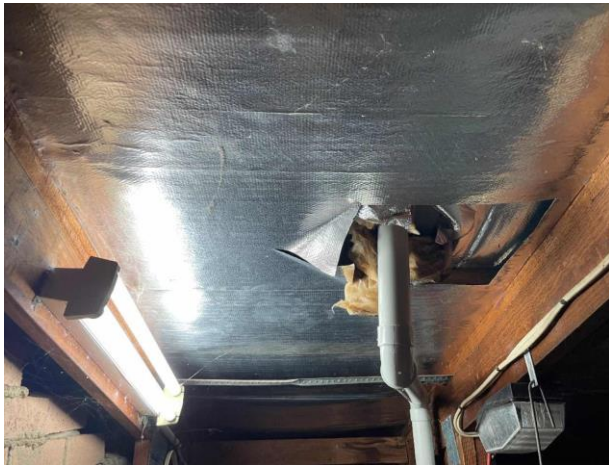
Line ID 70: Internal, Geriatric Unit, Rooftop Plant Rooms, Ceiling Throughout, Sarking Insulation - Suspected SMF

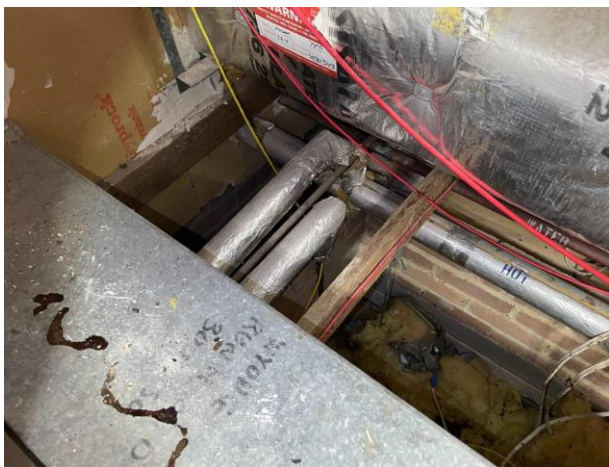
Line ID 72: Internal, Geriatric Unit, Rooftop Plant Rooms, Pipework Throughout, External Insulation - Suspected SMF

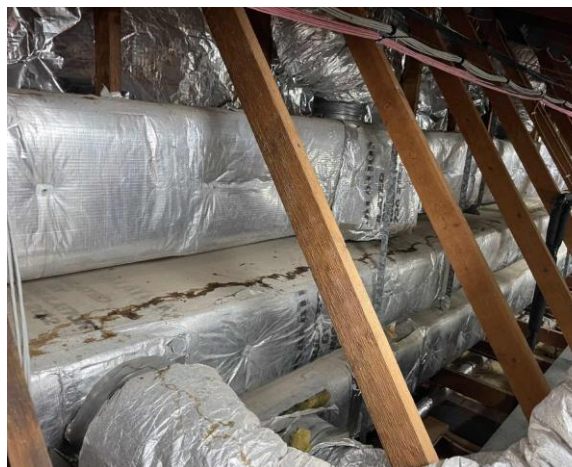
Line ID 73: Internal, Geriatric Unit, Rooftop Plant Rooms, Rigid Ductwork Throughout, External Insulation - Suspected SMF

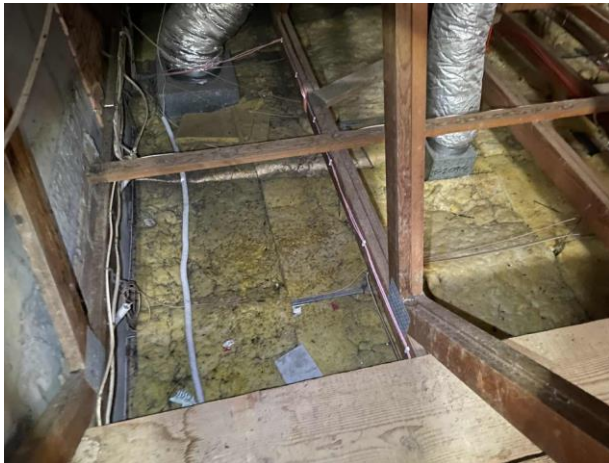
Line ID 74: Internal, Geriatric Unit, Rooftop Plant Rooms, Throughout Floor, Insulation Batts - Suspected SMF

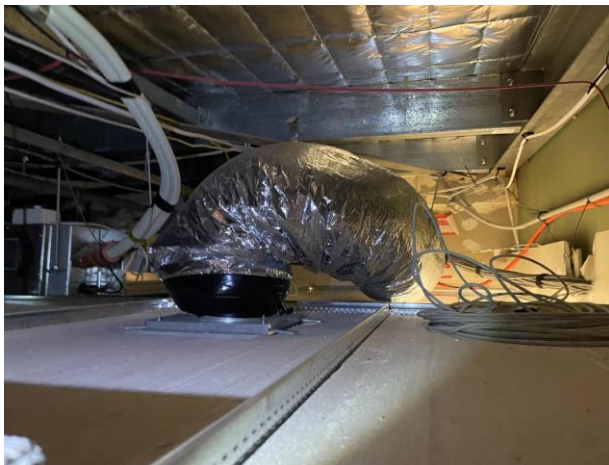
Line ID 76: Internal, Geriatric Unit Ground Level, Ceiling Space, Flexible Ductwork Throughout, Insulation Material - Suspected SMF

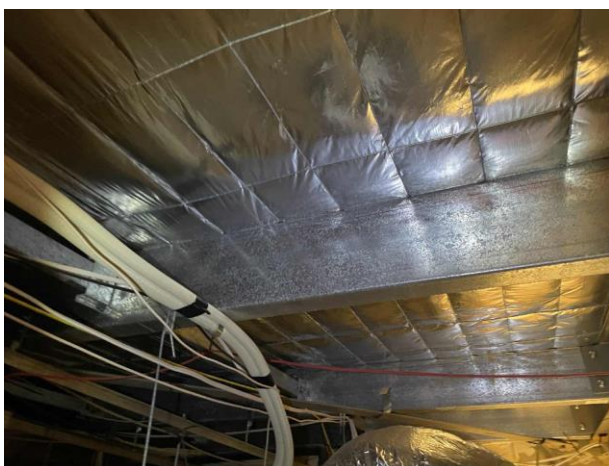
Line ID 78: Internal, Geriatric Unit Ground Level, Ceiling Space, Throughout, Sarking Insulation - Suspected SMF

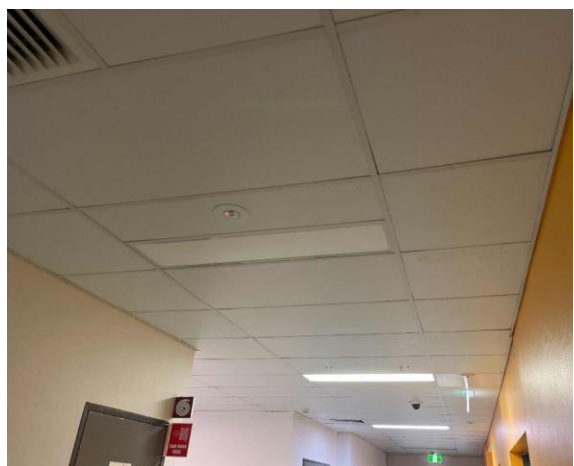
Line ID 79: Internal, Geriatric Unit Ground Level, Throughout, Hallways and Rooms, Compressed Ceiling Tiles - Suspected SMF

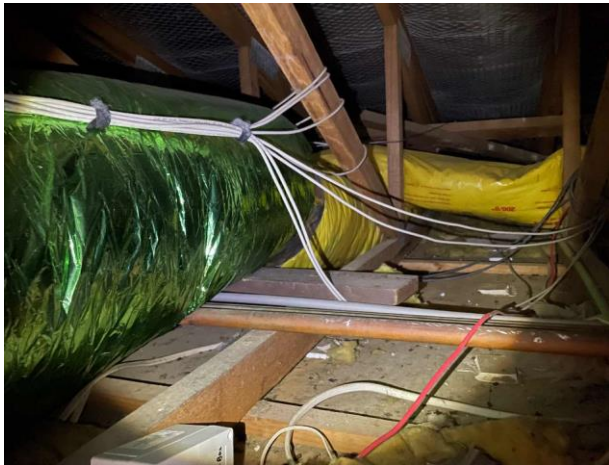
Line ID 80: Internal, Paediatric Unit, Ceiling Space, Flexible Ductwork Throughout, Insulation Material - Suspected SMF

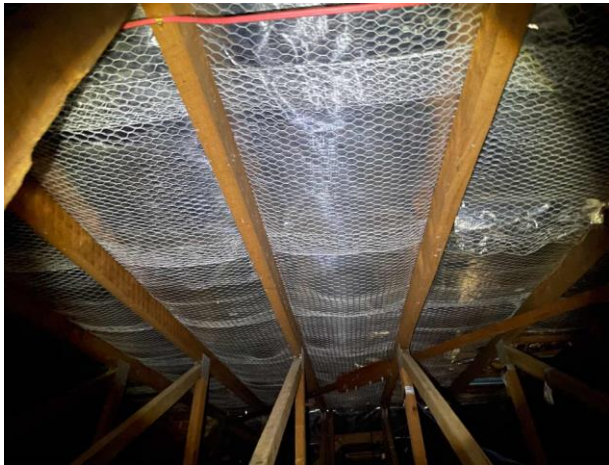
Line ID 82: Internal, Paediatric Unit, Ceiling Space, Throughout, Sarking Insulation - Suspected SMF

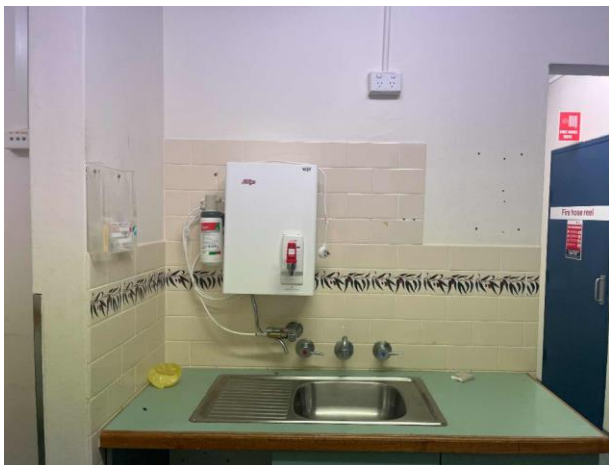
Line ID 84: Internal, Paediatric Unit, Central Corridor, Hot Water Heater, Above Sink, Internal Insulation - Suspected SMF

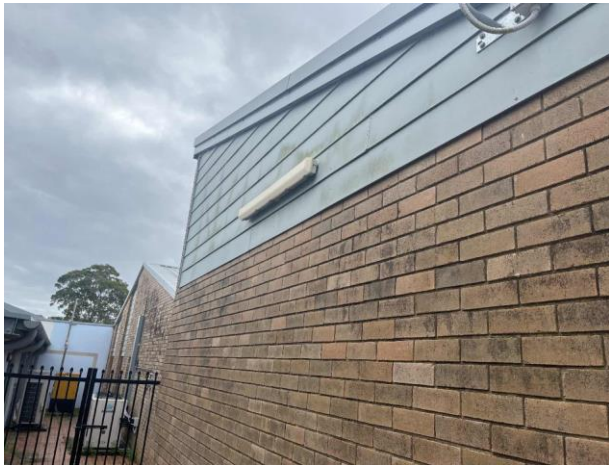
Line ID 86: External, Paediatric Unit, Throughout, Light Fittings, Ballast(s) and Capacitor(s) - Suspected PCB

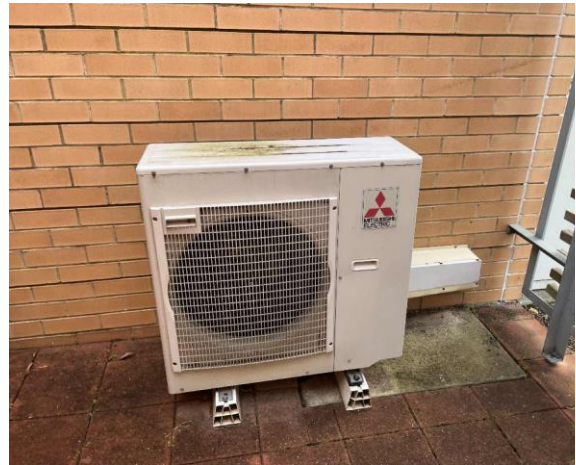
Line ID 87: External, Cancer Care Unit Ground Level, East Side, Mitsubishi AC Unit, R410A Hydrofluorocarbon (HFC) - Non ODS Refrigerant

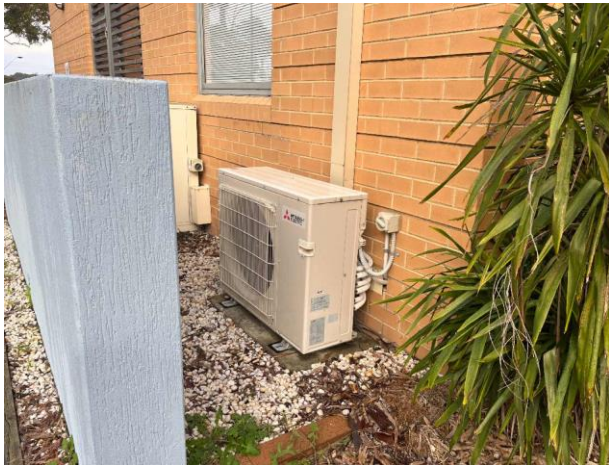
Line ID 87.1: External, Cancer Care Unit Ground Level, East Side, Mitsubishi AC Unit, R410A Hydrofluorocarbon (HFC) - Non ODS Refrigerant

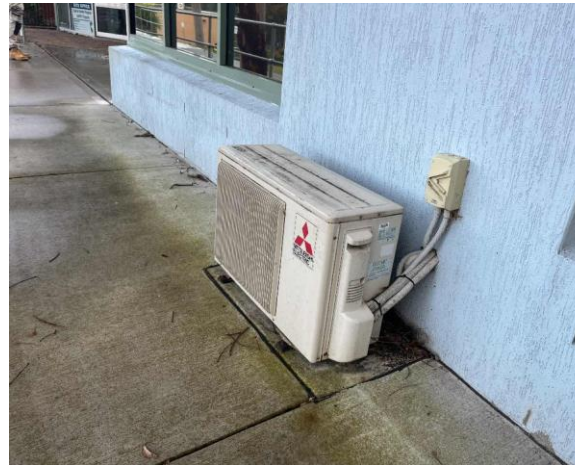
Line ID 88: External, Cancer Care Unit Ground Level, South Side, Mitsubishi AC Unit, R410A Hydrofluorocarbon (HFC) - Non ODS Refrigerant

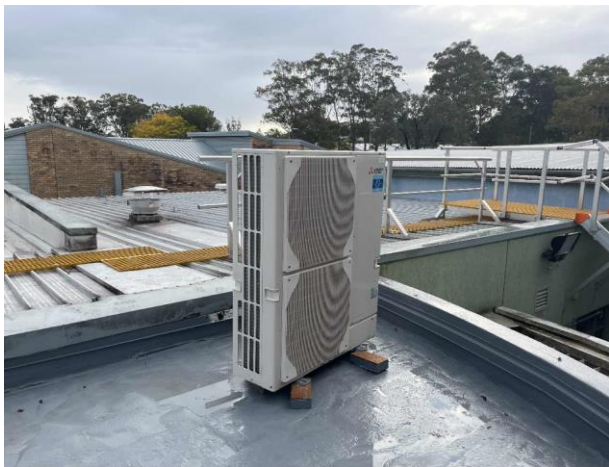
Line ID 89: External, Geriatric Unit Roof, Rooftop Plantroom, Mitsubishi AC units, R410A Hydrofluorocarbon (HFC) - Non ODS Refrigerant

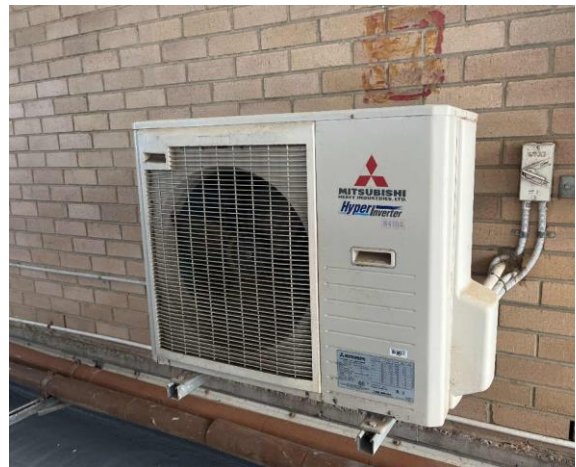
Line ID 89.1: External, Geriatric Unit Roof, Rooftop Plantroom, Mitsubishi AC units, R410A Hydrofluorocarbon (HFC) - Non ODS Refrigerant

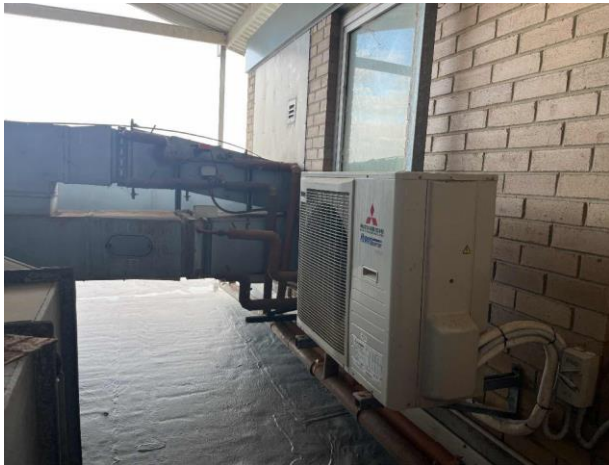
Line ID 89.2: External, Geriatric Unit Roof, Rooftop Plantroom, Mitsubishi AC units, R410A Hydrofluorocarbon (HFC) - Non ODS Refrigerant

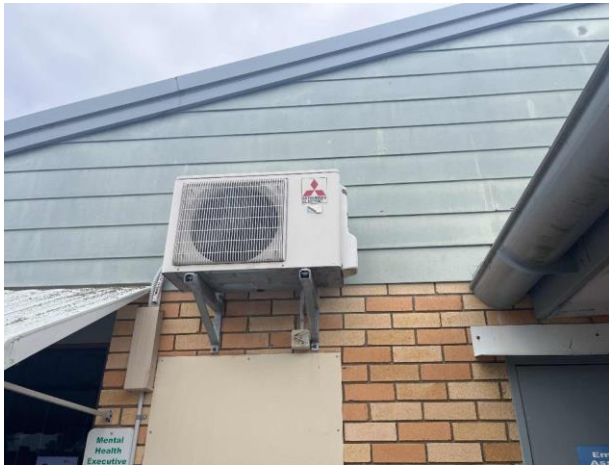
Line ID 91: External, Paediatric Unit, Northern Side, Mitsubishi AC Unit, Unknown Refrigerant - Non ODS Refrigerant

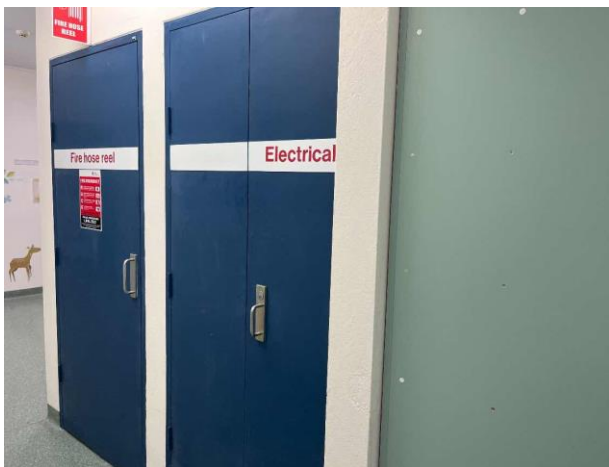
Line ID 93: Internal, Paediatric Unit, Electrical Cupboard, - No Access
