Health Infrastructure
Pre-Demolition Hazardous Building Materials Survey

Wentworth Health Services Facility
Wentworth, NSW

20 September 2022
63097/ 147,383 (Rev 0)
JBS&G

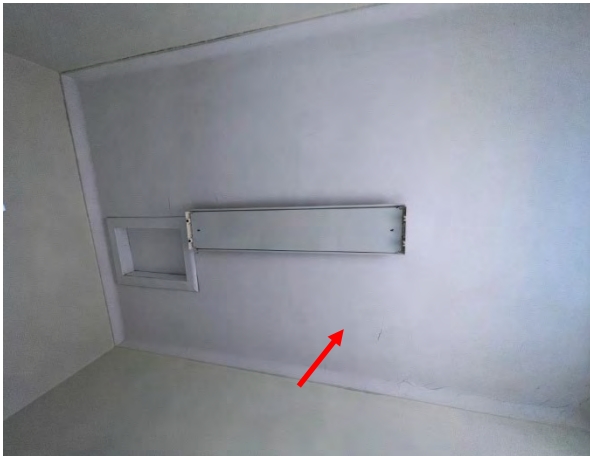
Photo 4: Wentworth Hospital Services - Former Surgical change room asbestos ceiling lining

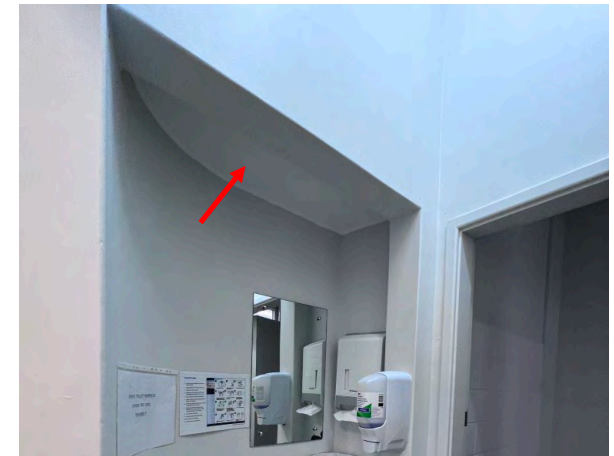
Photo 9: Wentworth Hospital Services - North-western corridor hand wash alcove asbestos ceiling lining

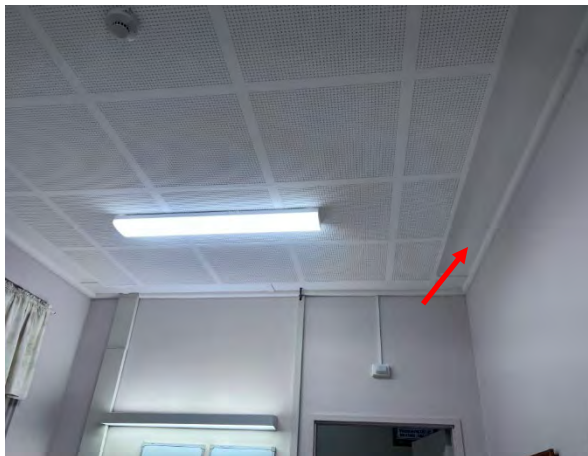
Photo 10: Wentworth Hospital Services - Northern Palliative Care asbestos ceiling lining

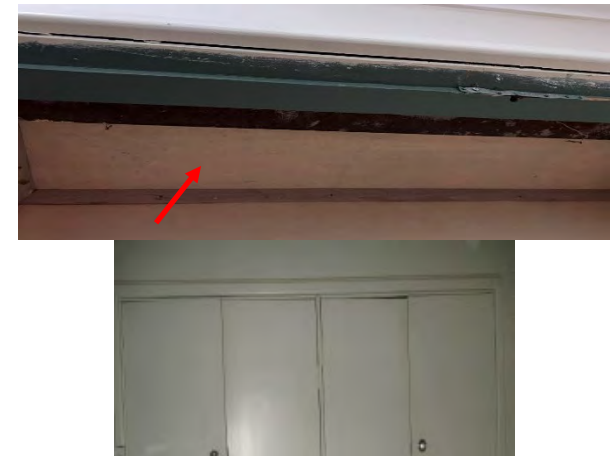
Photo 12: Wentworth Hospital Services - Internal, Former Maternity hallway asbestos cupboard ceiling lining

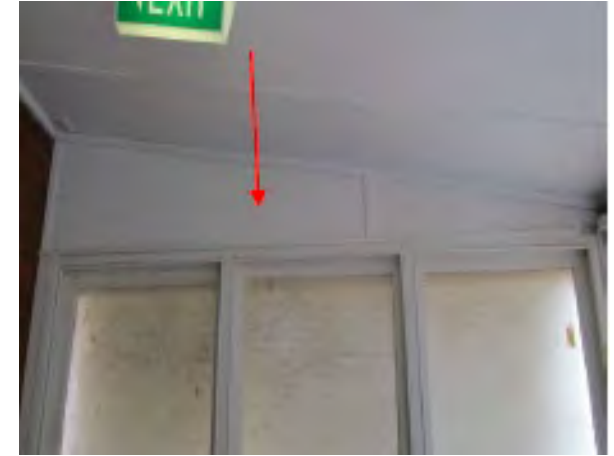
Photo 15: Wentworth Hospital Services - Internal former maternity veranda lining – south-west asbestos wall lining

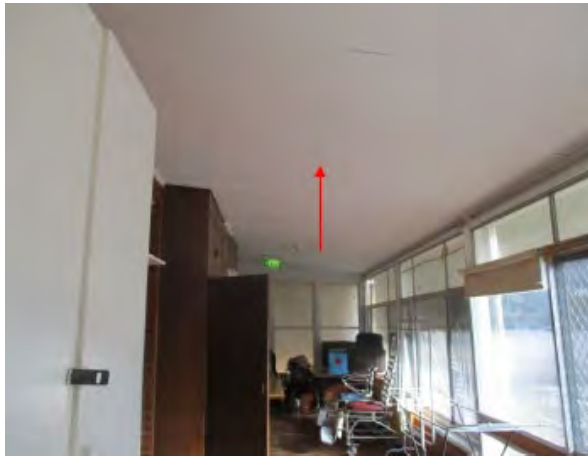
Photo 16: Wentworth Hospital Services - Internal Former Maternity west & north-west veranda asbestos ceiling lining

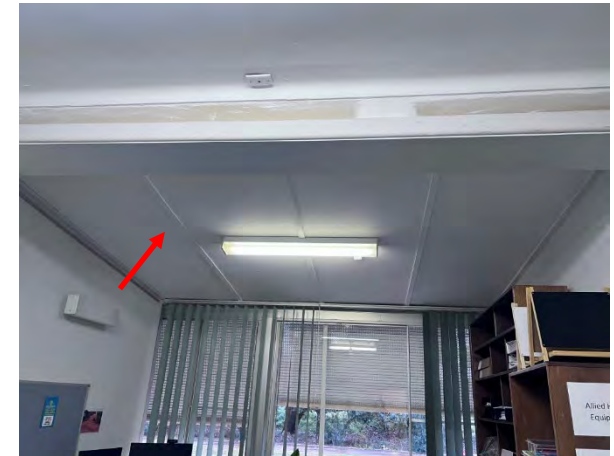
Photo 18: Wentworth Hospital Services - Internal northern 'NUM's office' asbestos ceiling lining

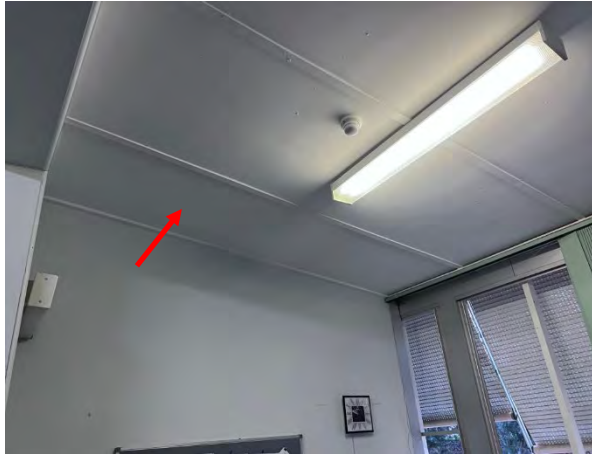
Photo 19: Wentworth Hospital Services - Internal northern 'Nurse Manager' asbestos ceiling lining

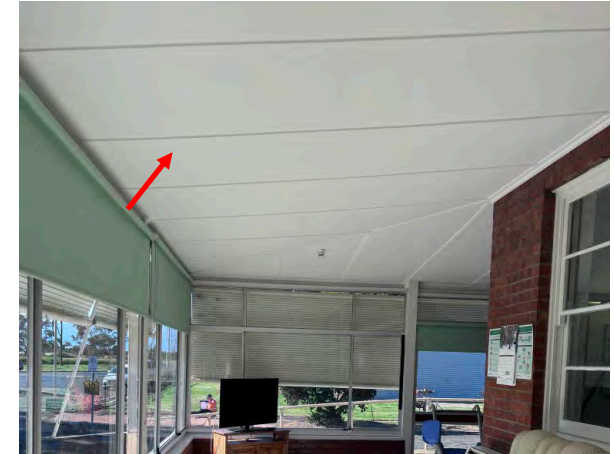
Photo 21: Wentworth Hospital Services - Internal north eastern veranda asbestos ceiling lining

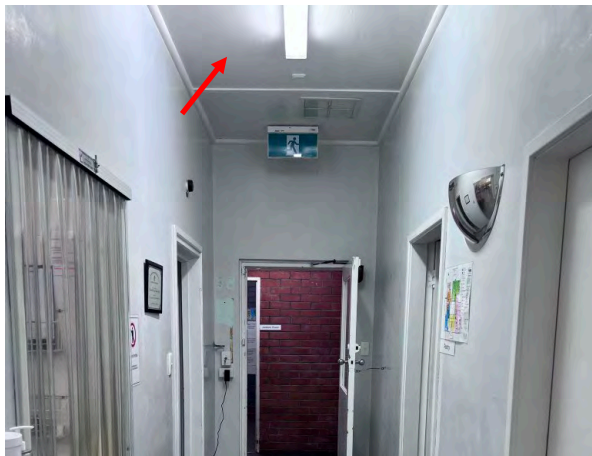
- Assumed asbestos containing fibre cement sheeting was previously identified to the ceiling of the Hotel Services in FWLHD 2017. A representative sample was collected from the Hotel Services hallway (WHS_01_MAT13) and confirmed to contain asbestos. Ceiling linings of consistent appearance were observed in the following locations in the south-eastern portion of the building and should also be assumed to contain asbestos:

Photo 22: Wentworth Hospital Services - Internal Hotel Services hallway – asbestos ceiling lining

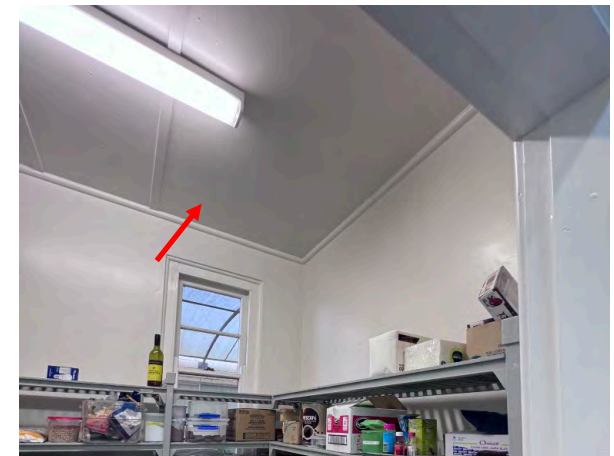
Photo 24: Wentworth Hospital Services - Internal Hotel Services western pantry – asbestos ceiling lining

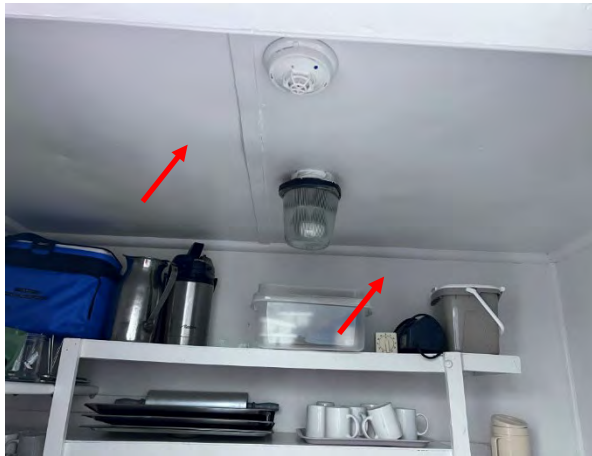
Photo 25: Wentworth Hospital Services - Internal Hotel Services eastern pantry – asbestos ceiling and wall lining

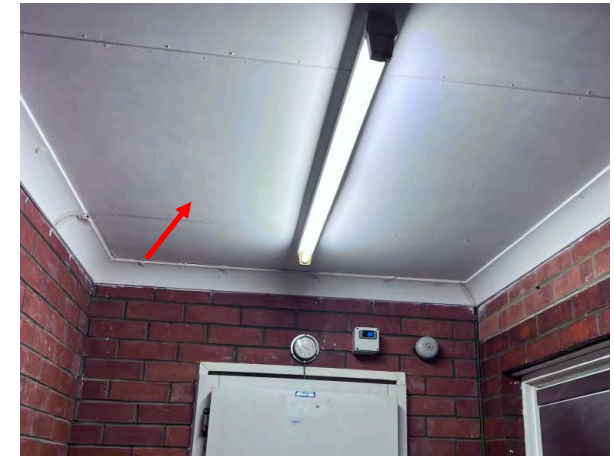
Photo 27: Wentworth Hospital Services - Hotel Services Hallway adjacent Janitors Room asbestos ceiling lining

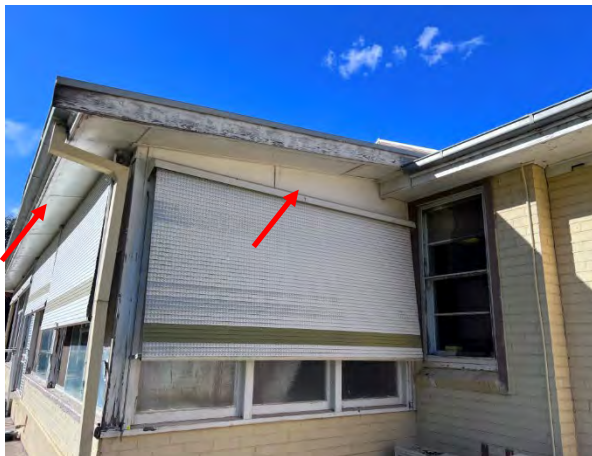
Photo 28: Wentworth Hospital Services - External asbestos flat sheet eaves

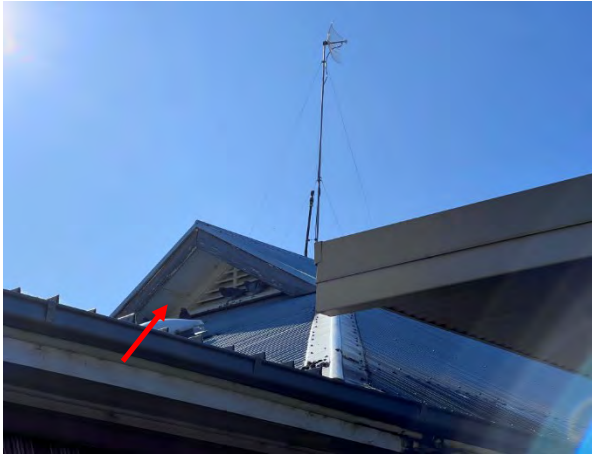
Photo 31: Wentworth Hospital Services - External flat sheet asbestos eaves & gables

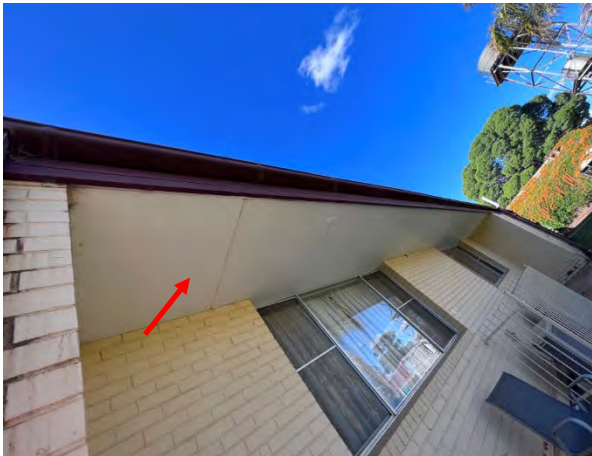
Photo 34: Wentworth Hospital Services - External flat sheet asbestos eaves - southern awning linings

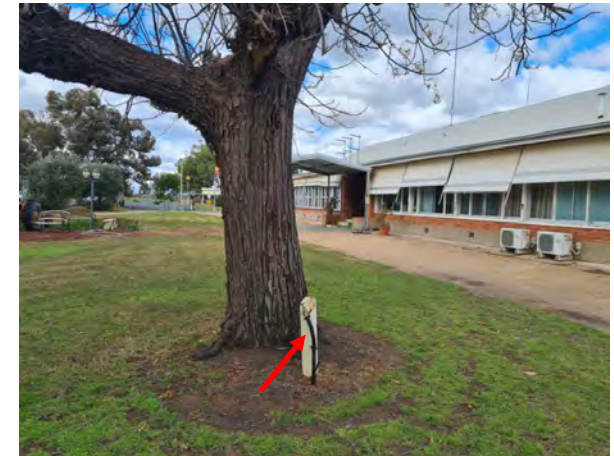
Photo 36: Wentworth Hospital Services - External assumed asbestos containing tap pipe stand

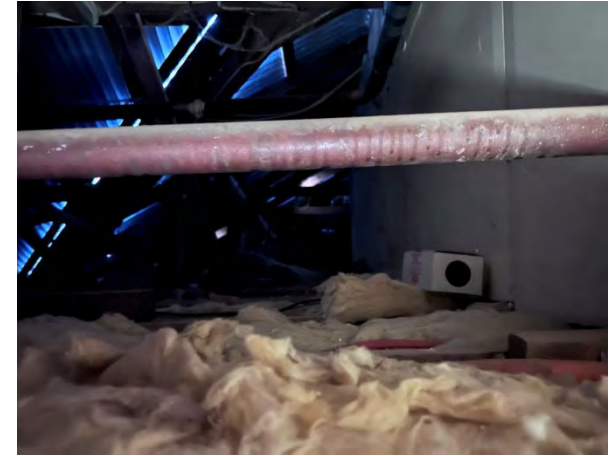
- Lead concentrations within settled dust above the adopted site criteria (WHS_01_LD01, 540 mg/kg) was identified within the former maternity pan room ceiling cavity. This dust was found not to contain asbestos (WHS_01_AD01).

Photo 39: Wentworth Hospital Services - Former Maternity Pan Room Ceiling Cavity

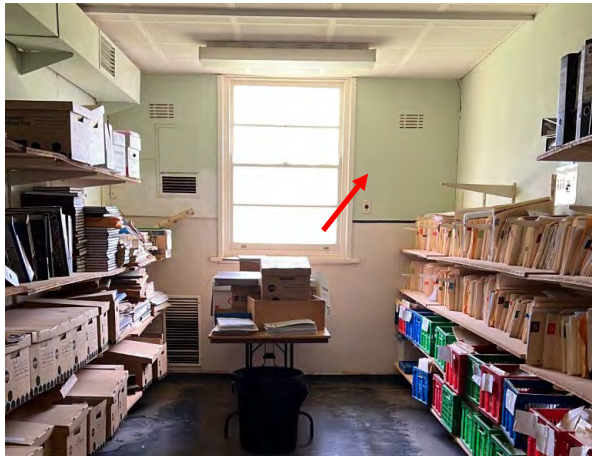
Photo 40: Wentworth Hospital Services - Former Maternity Labour Room – Green Lead Paint

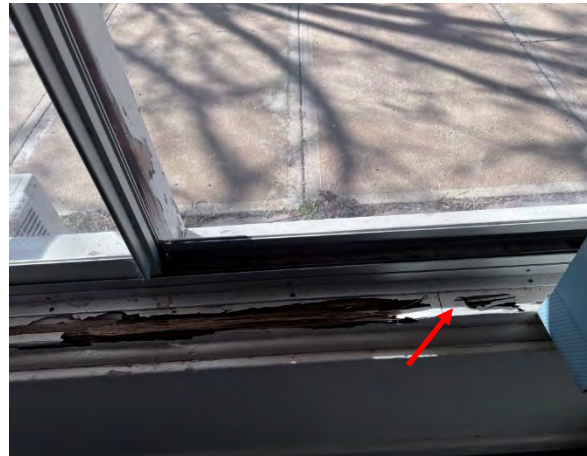
Photo 41: Wentworth Hospital Services - Internal – timber skirting boards, architraves, door jambs and windows White lead paint

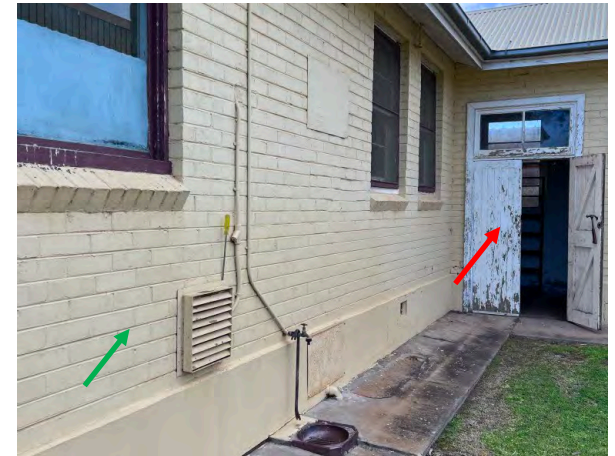
Photo 42: Wentworth Hospital Services - External, Old Records Room timber door white lead paint, Yellow non-lead paint

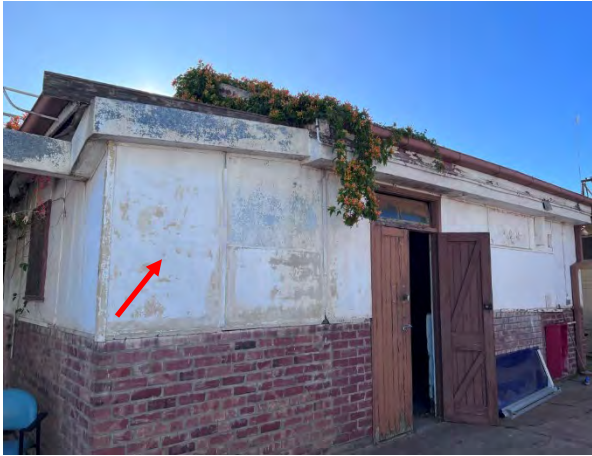
Photo 43: Old Boiler House – Old Boiler House Overview & External asbestos cladding with brick lower

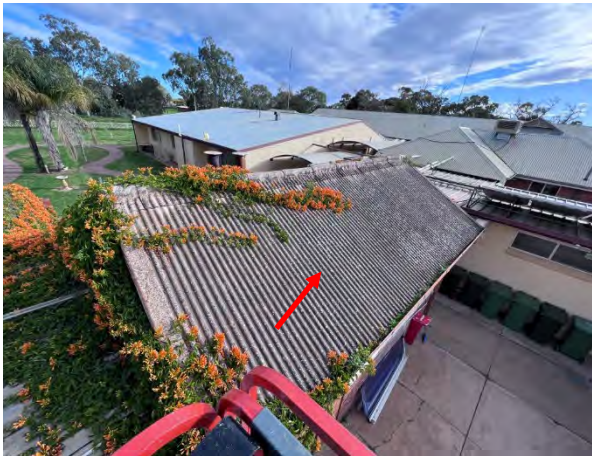
Photo 46: Old Boiler House – Asbestos super 6 Roofing

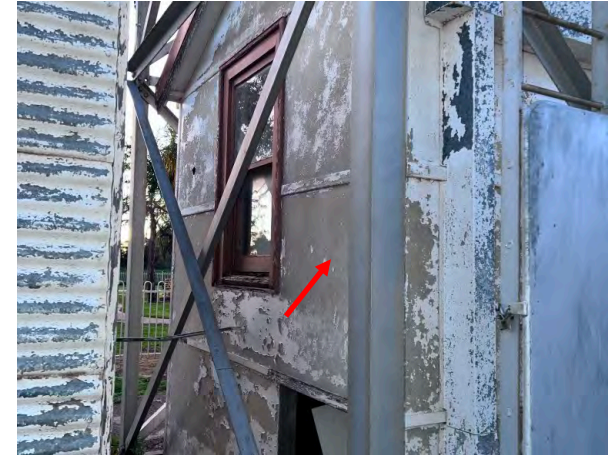
Photo 51: Pump Shed - External asbestos walls fibre cement sheet cladding

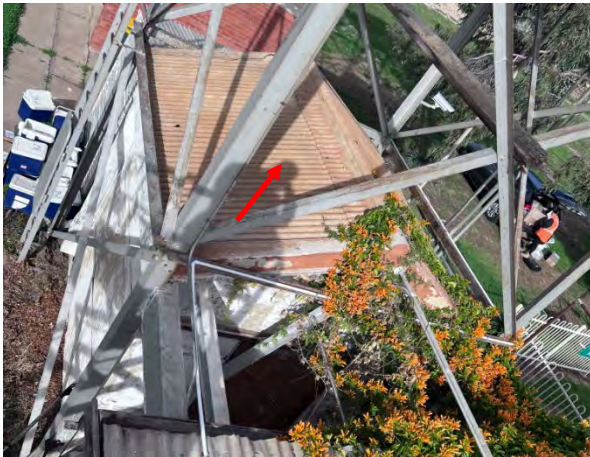
Photo 52: Pump Shed – Asbestos super 6 roofing

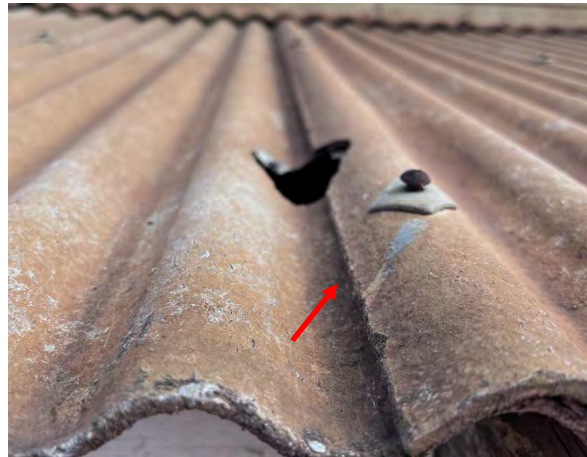
Photo 53: Pump Shed – Asbestos super 6 roofing

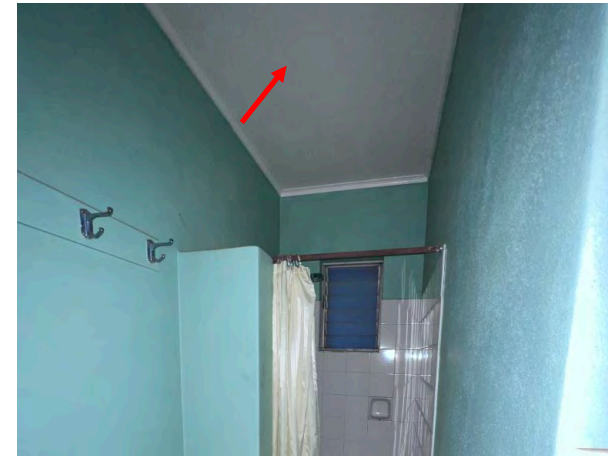
Photo 63: Staff Amenities – Assumed asbestos ceiling linings

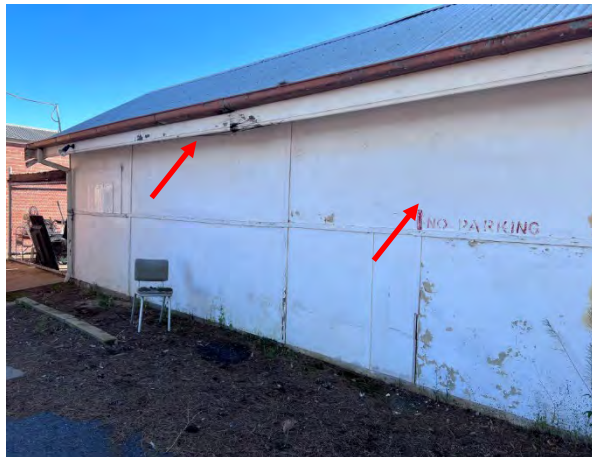
Photo 64: Maintenance Storage Shed - Asbestos fibre cement sheeting eaves & external wall cladding

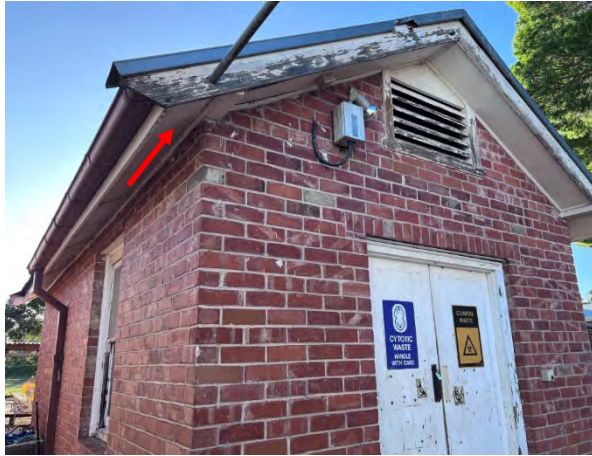
Photo 67: Old Morgue – Asbestos fibre cement eaves

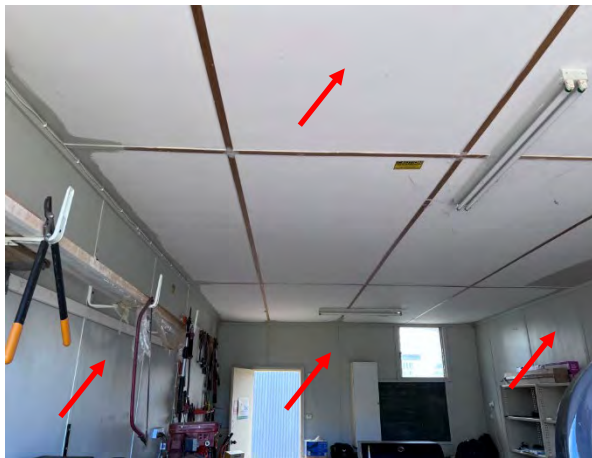
Photo 70: Maintenance Workshop – Internal asbestos fibre cement sheet ceiling and wall lining

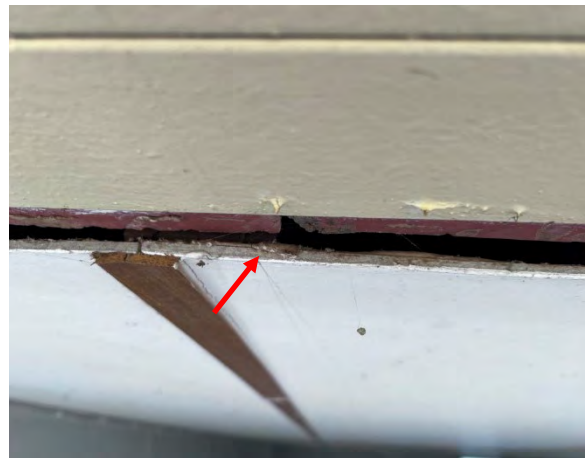
Photo 71: Maintenance Workshop – Internal asbestos fibre cement sheet ceiling lining

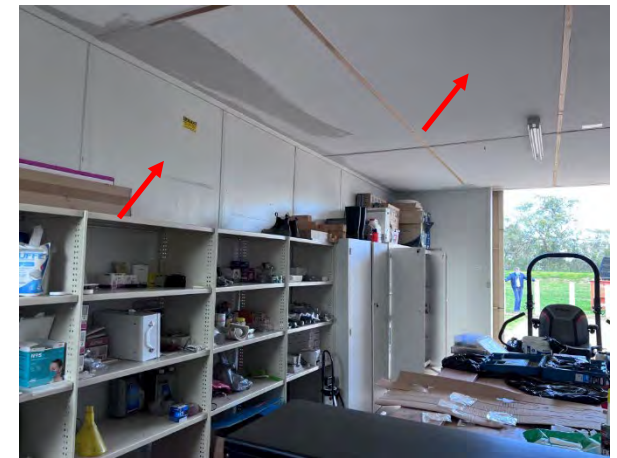
Photo 72: Maintenance Workshop – Internal asbestos fibre cement sheet ceiling and wall lining

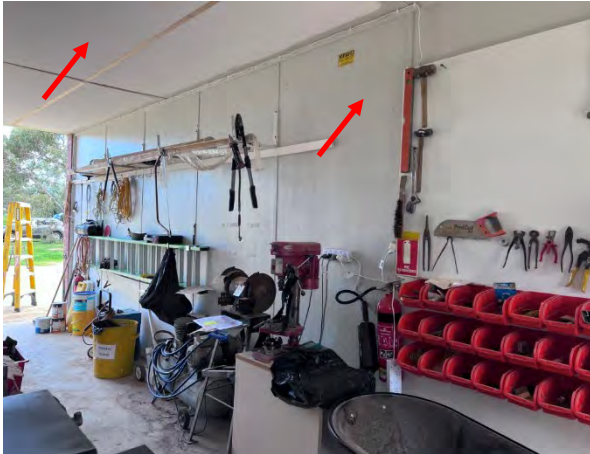
Photo 73: Maintenance Workshop – Internal asbestos fibre cement sheet ceiling and wall lining

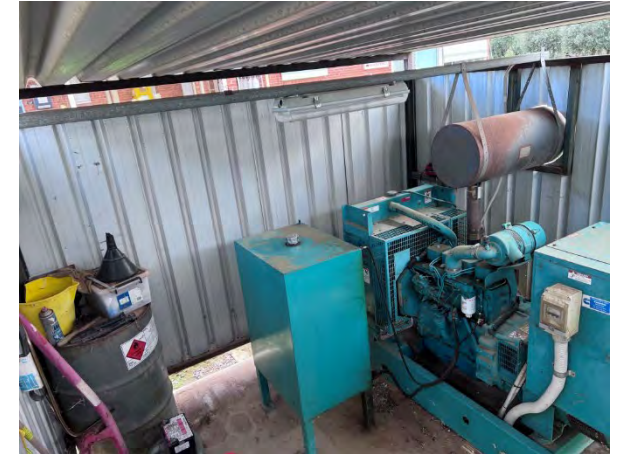
Photo 75: Emergency Generator Shed – Generator Machinery, assumed asbestos gaskets

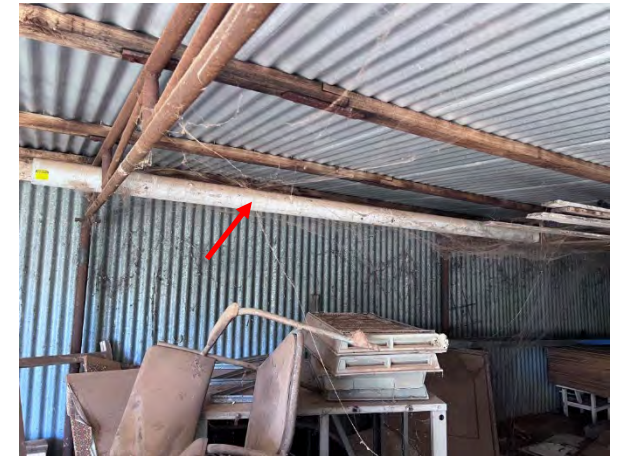
Photo 78: Carports/Storage Sheds – Assumed asbestos fibre cement pipe in rafters of shed

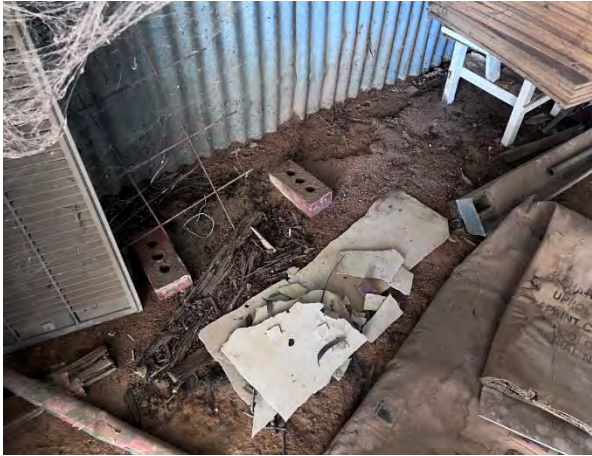
Photo 79: Carports/Storage Sheds – Stockpile of fragments of fibrous material

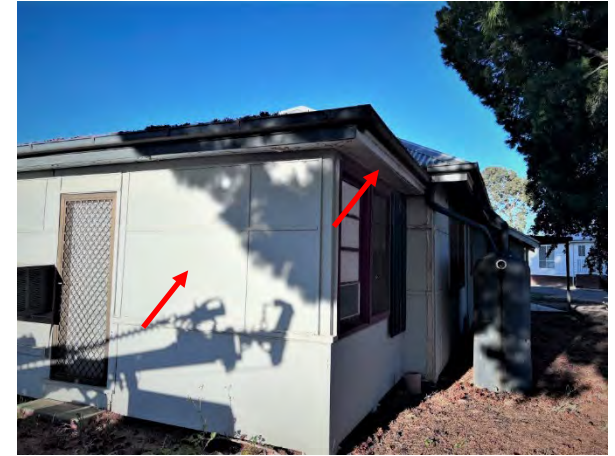
Photo 81: Old Nurses Home – Asbestos fibre cement eaves and external cladding

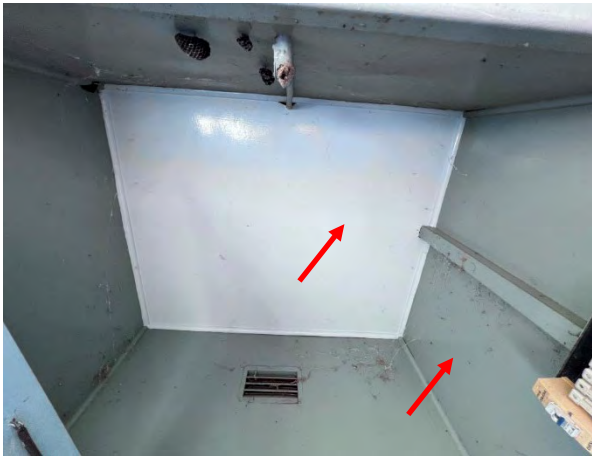
Photo 82: Old Nurses Home – Asbestos fibre cement external cladding & assumed porch lining

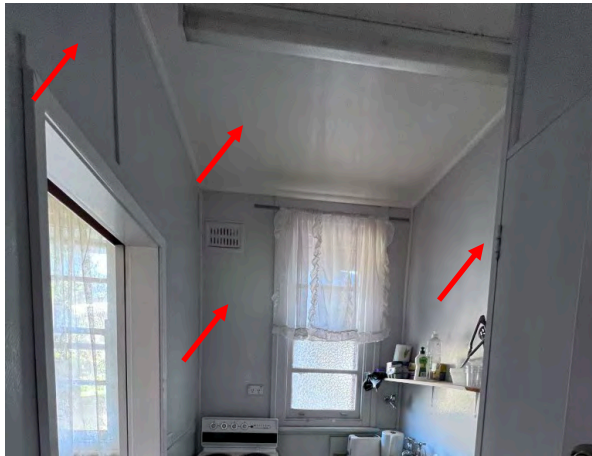
Photo 85: Old Nurses Home – Asbestos fibre cement internal kitchen wall & ceiling lining

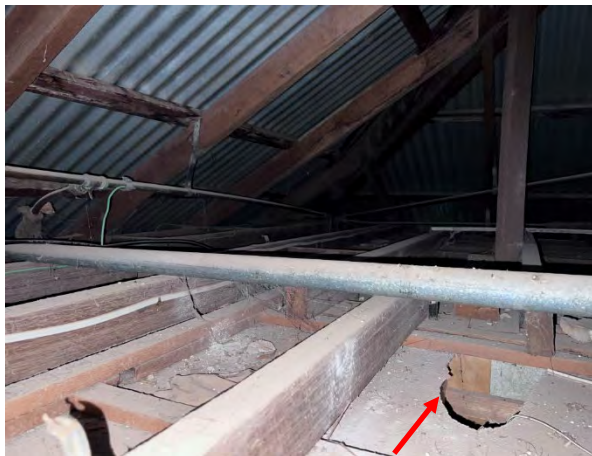
Photo 88: Old Nurses Home – Ceiling cavity, Accessed through kitchen – broken asbestos fibre cement sheeting

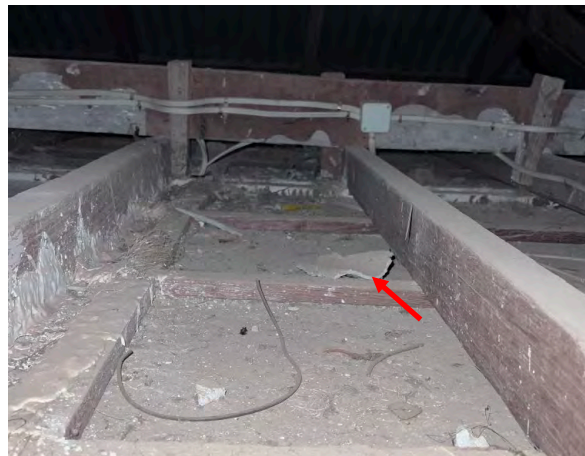
Photo 89: Old Nurses Home – Ceiling cavity, Accessed through kitchen – broken asbestos super six sheeting

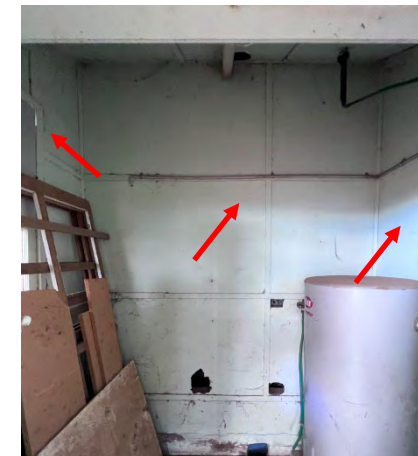
Photo 90: Old Nurses Home – Internal of southern plant room – asbestos fibre cement sheet wall lining

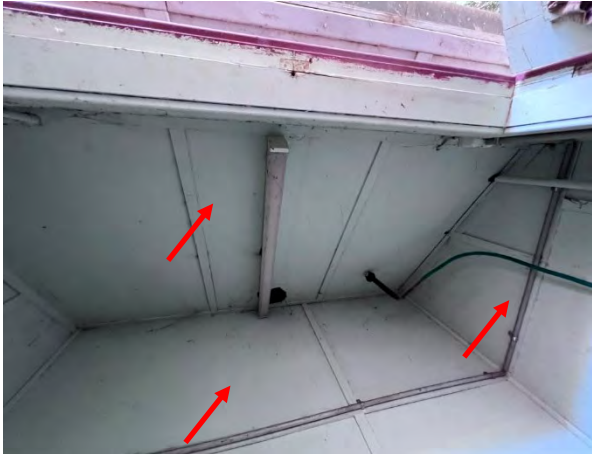
Photo 91: Old Nurses Home – Internal of southern plant room – asbestos fibre cement sheet ceiling lining

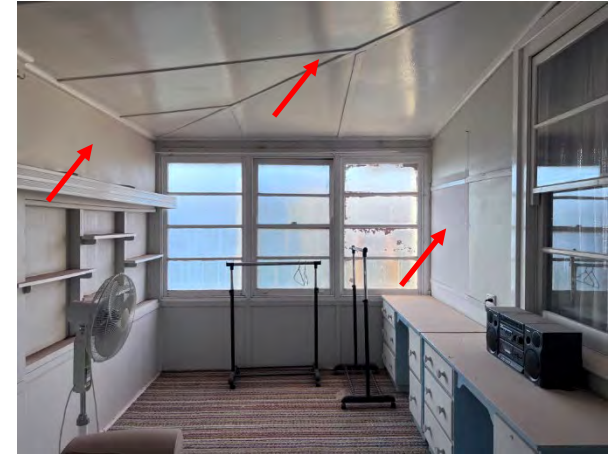
Photo 93: Old Nurses Home – Internal western room asbestos wall and ceiling lining

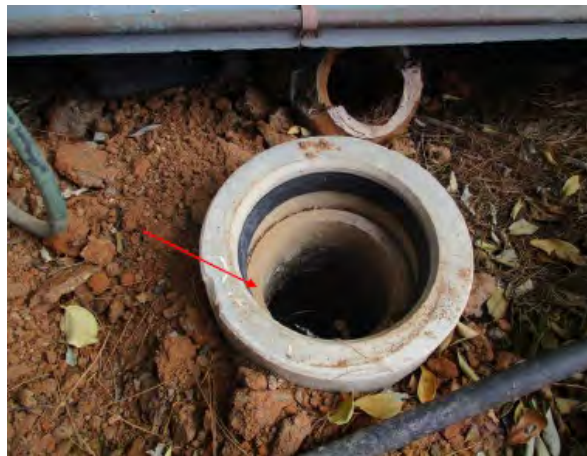
Photo 95: Old Nurses Home – External east – assumed asbestos containing gully drain pipe

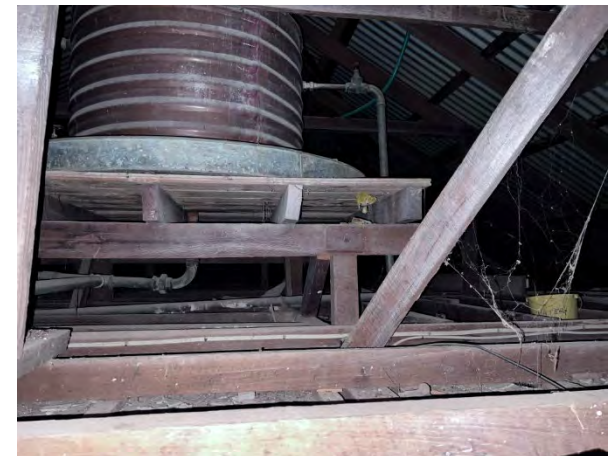
Photo 96: Old Nurses Home – Ceiling Cavity – Assumed asbestos containing former hot water system

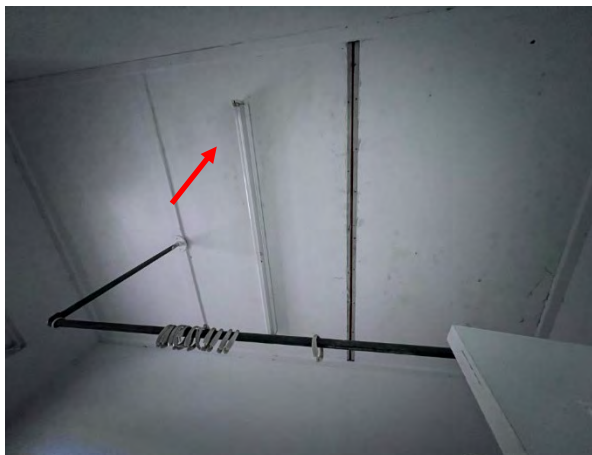
Photo 106: Senior Centre – western bathroom asbestos ceiling lining
