Health Infrastructure NSW
Pre-Demolition Hazardous Building Materials Survey

Broken Hill Hospital Redevelopment
Mental Health Unit and Emergency Department
Upgrade
Broken Hill Hospital,
Broken Hill NSW

22 February 2023
63879/150,077 (Rev A)
JBS&G Australia Pty Ltd

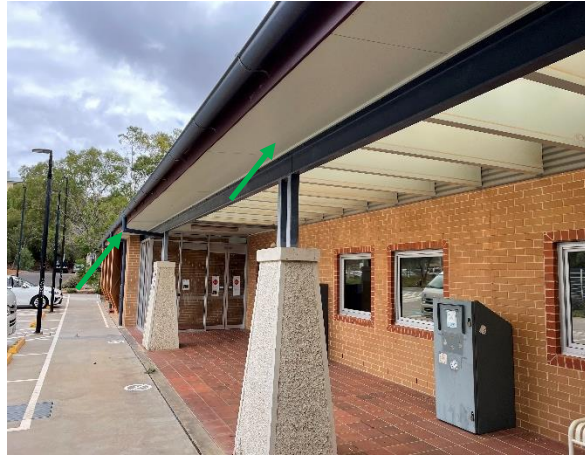
Photo 2: Oncology Ward, external eaves – Non-asbestos containing fibre cement sheeting

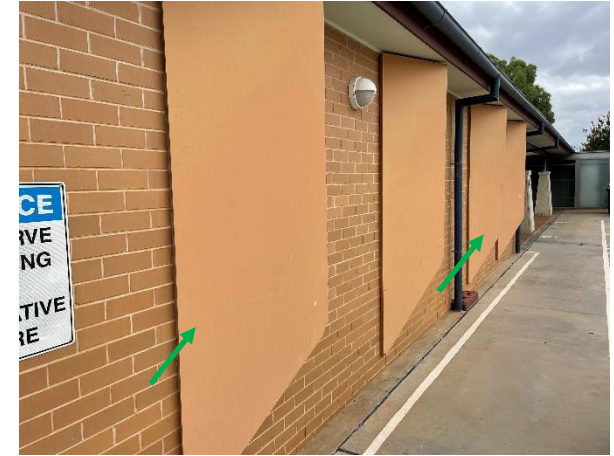
Photo 3: Oncology Ward, external window covers – Non-asbestos containing compressed fibre cement sheeting

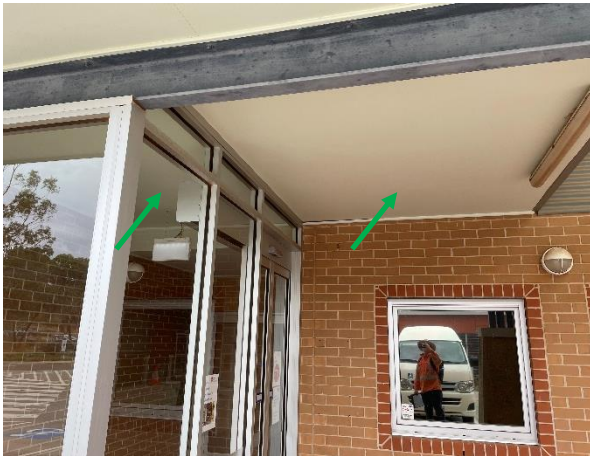
Photo 4: Oncology ward, western entrance way external and internal ceiling lining – Non-asbestos containing fibre cement sheeting

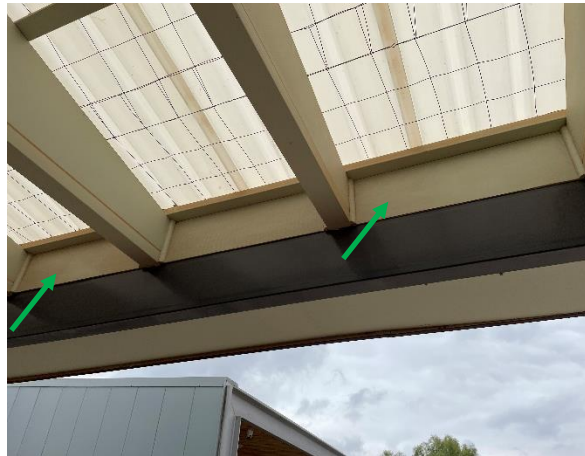
Photo 5: West of mental health services office, external awning infill panel between awning roof and eaves – Non-asbestos containing fibre cement sheeting

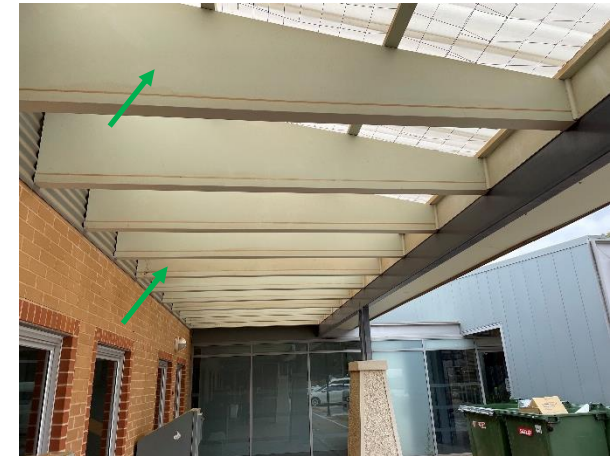
Photo 6: West of mental health service office, box cover to rafters of awning – Non-asbestos containing fibre cement sheeting

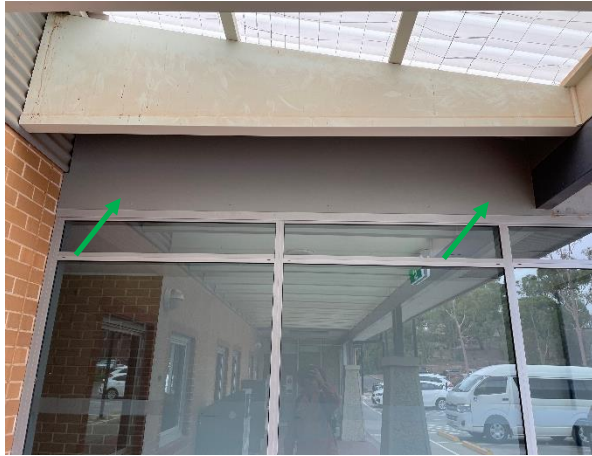
Photo 7: Southern external gill wall of corridor to sub-acute rehabilitation unit and roof, infill panel – Non-asbestos containing fibre cement sheeting

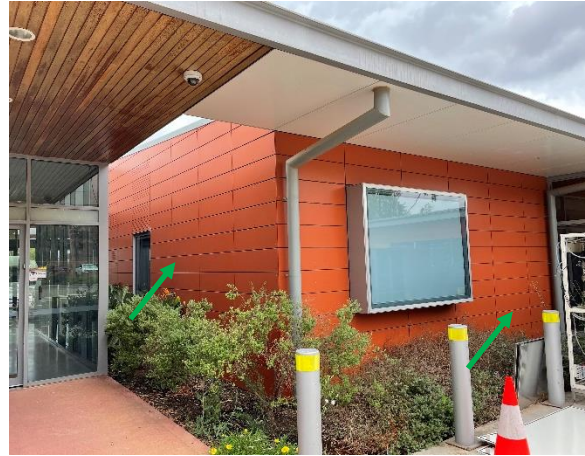
Photo 8: Sub-acute rehabilitation unit, external wall cladding – Non-asbestos containing compressed fibre cement

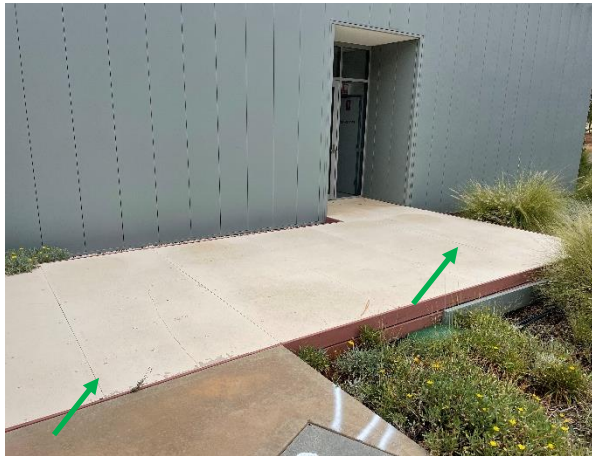
Photo 10: Sub-acute rehabilitation unit northern entrance way, floor – Non-asbestos containing compressed fibre cement

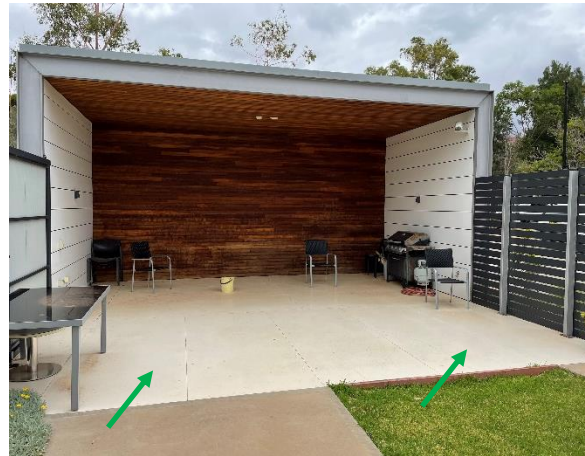
Photo 11: BBQ area, floor – Non-asbestos containing compressed fibre cement

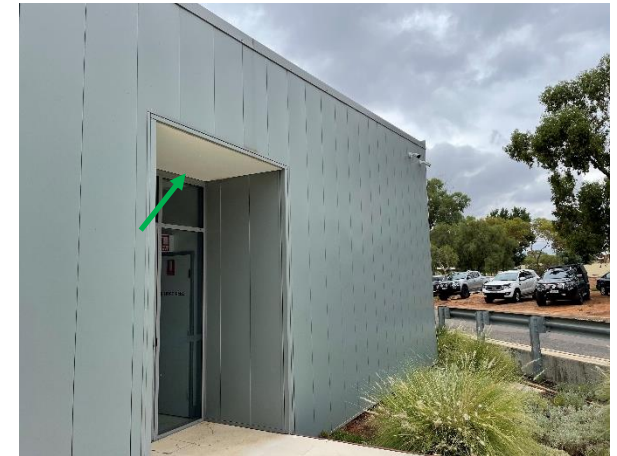
Photo 12: Sub-acute rehabilitation unit northern entrance way, soffit lining – Non-asbestos containing compressed fibre cement

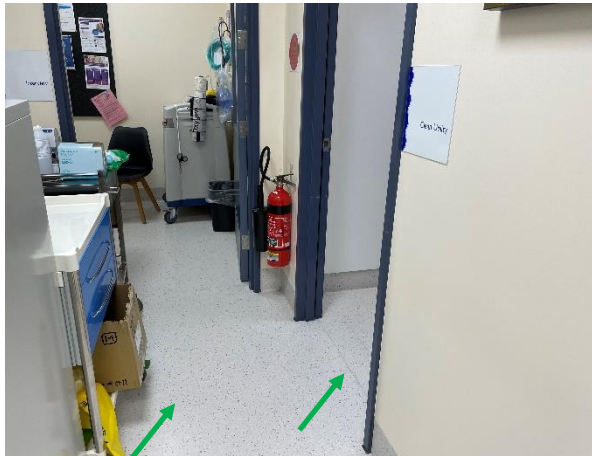
Photo 13: Oncology unit and mental health service office, floor – Non-asbestos containing grey speckled vinyl floor sheeting

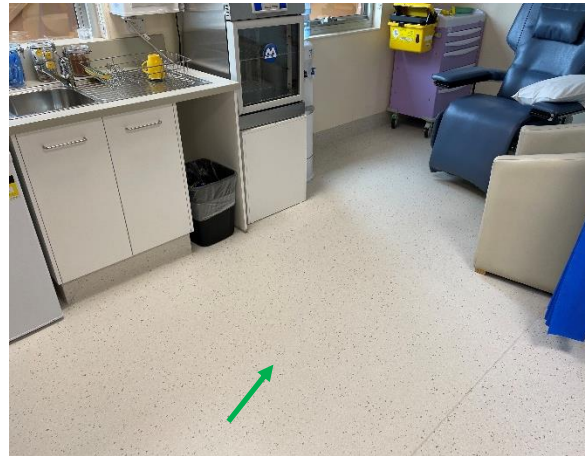
Photo 14: Oncology unit ward, floor – Non-asbestos containing white speckled vinyl sheeting

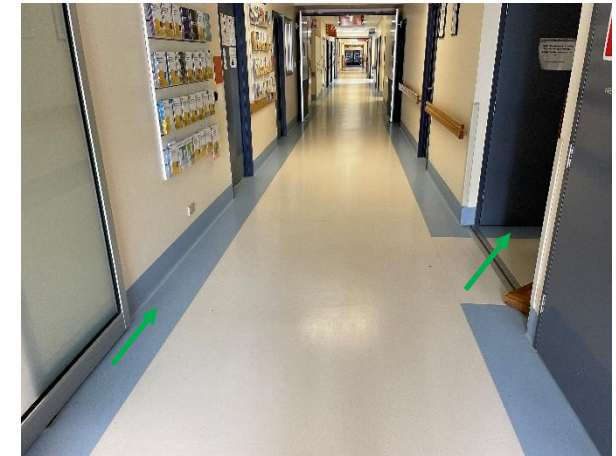
Photo 15: Oncology unit and mental health service office corridor, floor – blue speckled vinyl sheeting

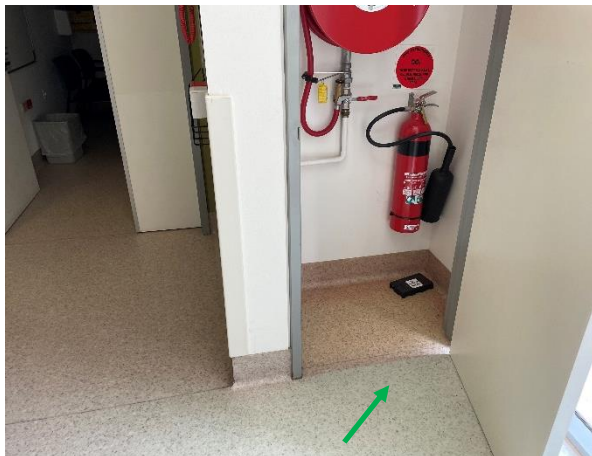
Photo 16: Oncology unit, mental health service office and sub-acute rehabilitation unit, floor throughout – Non-asbestos containing beige speckled vinyl sheeting

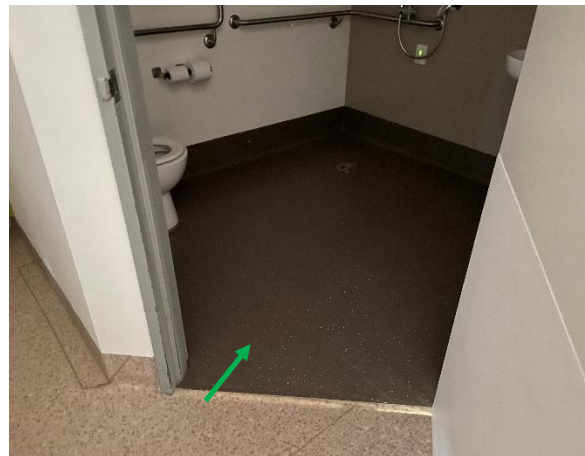
Photo 17: Sub-acute rehabilitation unit, patient bathroom floor – Non-asbestos containing maroon speckled vinyl sheeting

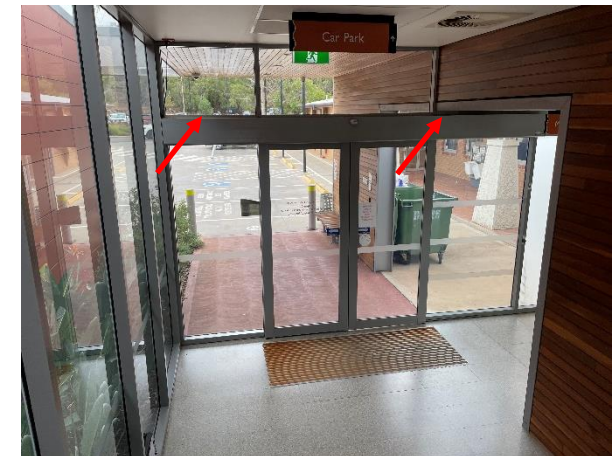
- Lead concentrations within settled dust above the adopted site criteria (LD01, 430mg/kg) was identified atop the sliding door motor housing to the corridor between Mental Health Services office and Sub-acute Rehabilitation ward. This dust was also found not to contain asbestos (AD01).

Photo 18: Corridor between mental health services office and sub-acute rehabilitation ward, atop sliding door motor housing – elevated levels of lead within settled dust, it is noted this dust does not contain asbestos

Slightly elevated lead levels were identified within both upgrade areas, due to the minor level of elevated lead detected, it is recommended that all ground workers wear P2 respiratory protection during demolition activities of this structure. Plant operators must also keep cabin doors closed and air conditioning set to recycle during the completion of demolition of these structures. Care should also be taken to minimise dust generation during demolition activities.

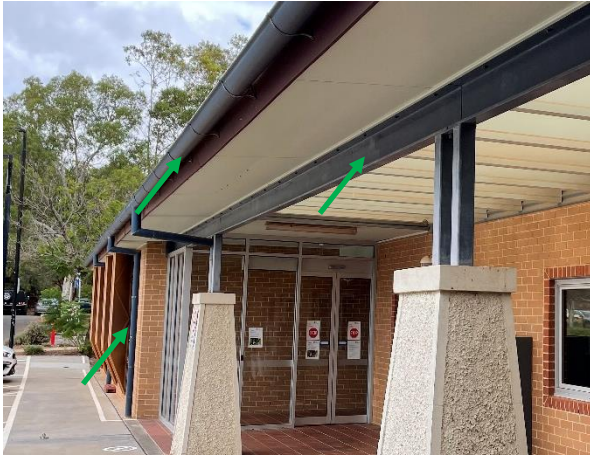
Photo 19: Oncology ward and mental health services offices, external downpipes, steel framework and I beams – Non-lead based blue paint

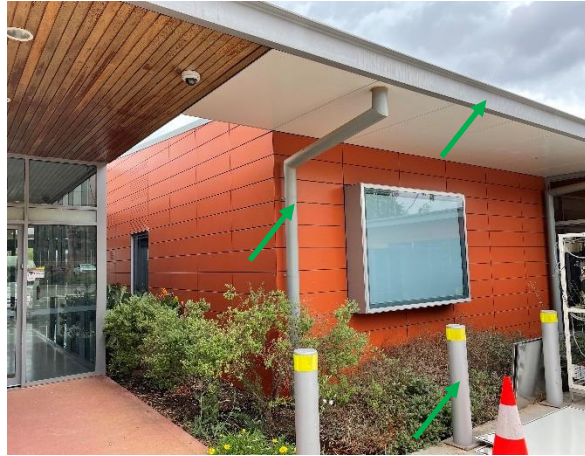
Photo 20: Sub-acute rehabilitation unit, external steel frame, down pipes and bollards – Non-lead based grey paint

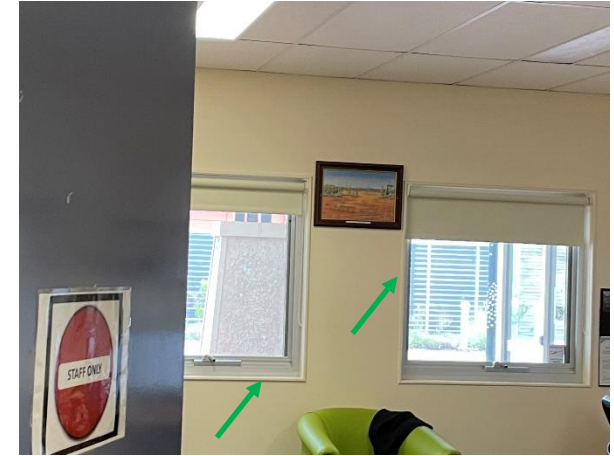
Photo 21: Throughout mental health unit interface, walls and window frames – Non-lead based white paint

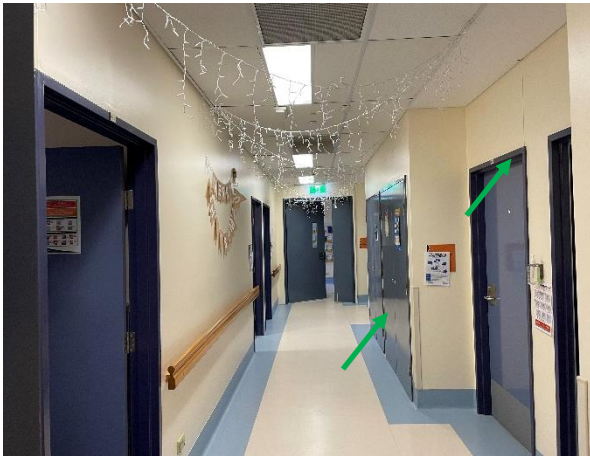
Photo 22: Throughout mental health unit interface, doors and door frames – Non-lead based blue paint

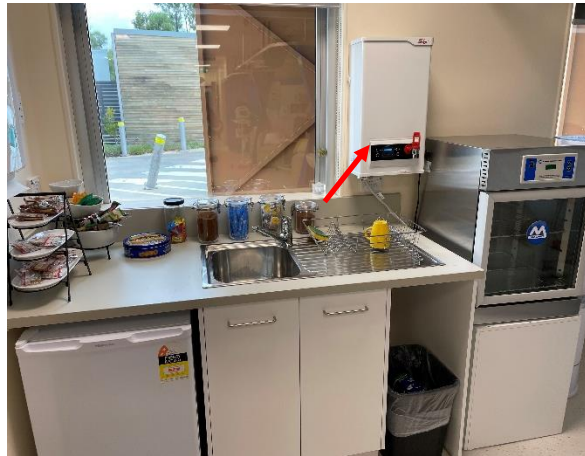
Photo 23: Oncology ward kitchenette, zip instant hot water – Assumed SMF insulation core

The synthetic mineral fibres encountered during this inspection were generally contained and deemed to be low risk. These SMF materials can be removed with the building and demolition waste with care taken not to generate fibres. Appropriate PPE is recommended including the use of P2 respirator as minimum and appropriate removal methodology as outlined in [NOHSC: 1004(1990)] and [NOHSC: 2006(1990)].

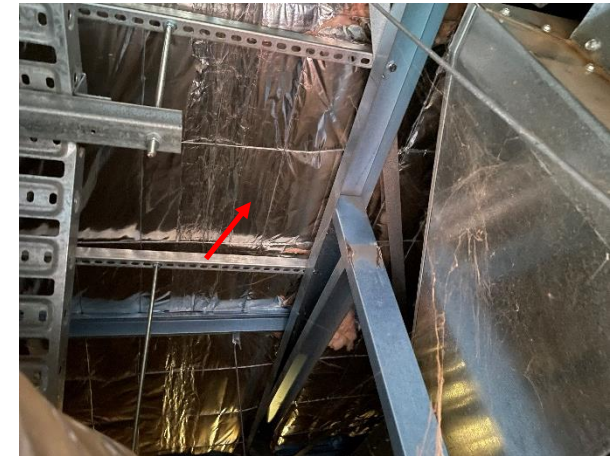
Photo 24: Throughout Mental Heal Unit interface, ceiling cavity underside of roof – Assumed SMF sarking

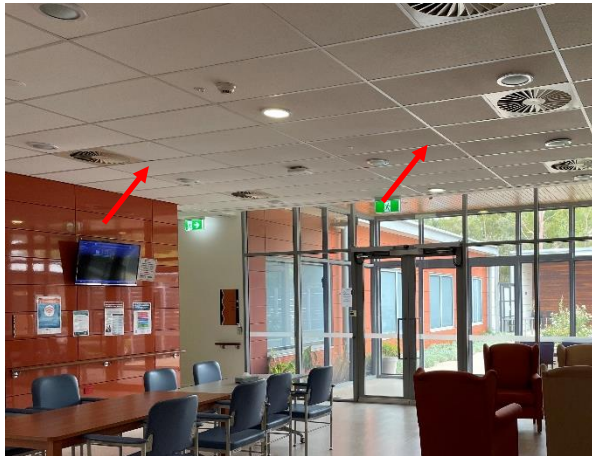
Photo 25: Throughout Mental Heal Unit interface, ceiling – Assumed SMF suspended ceiling tiles

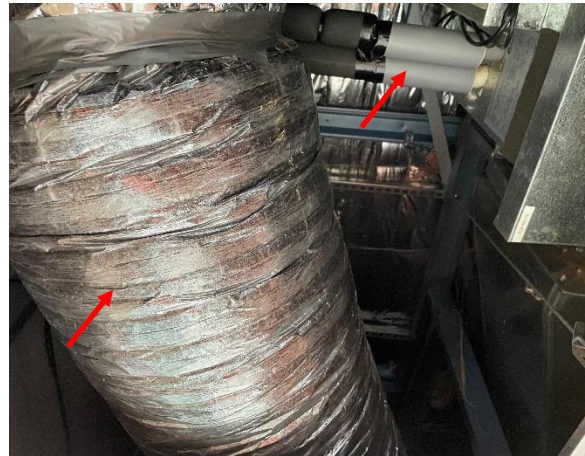
Photo 26: Throughout Mental Heal Unit interface, ceiling cavity ducting and pipework – Assumed SMF insulation

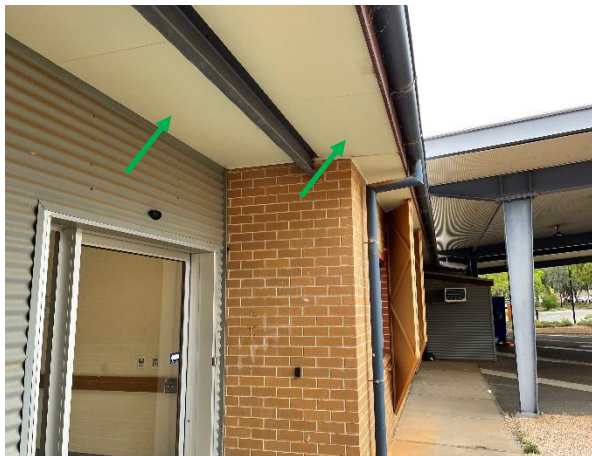
Photo 28: Emergency department, external eaves – Non-asbestos containing fibre cement sheeting

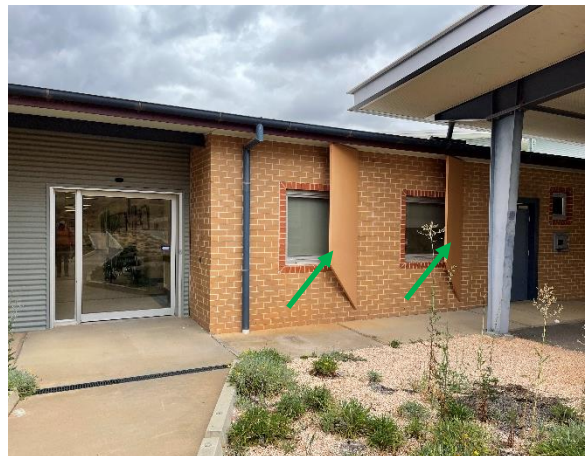
Photo 29: Emergency department, external window covers – Non-asbestos containing compressed fibre cement sheeting

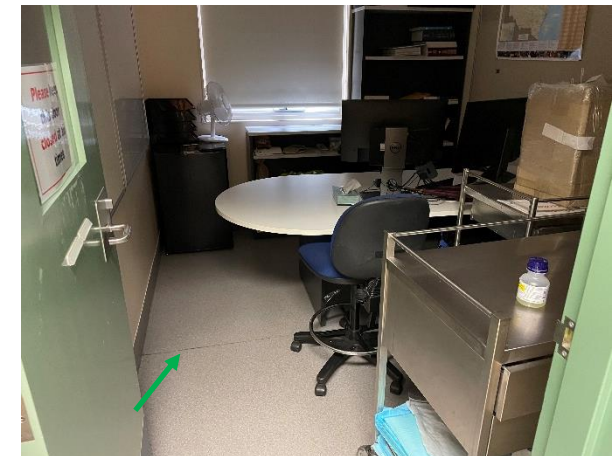
Photo 30: Emergency department, internal floors – Assumed non-asbestos containing grey speckled vinyl sheeting

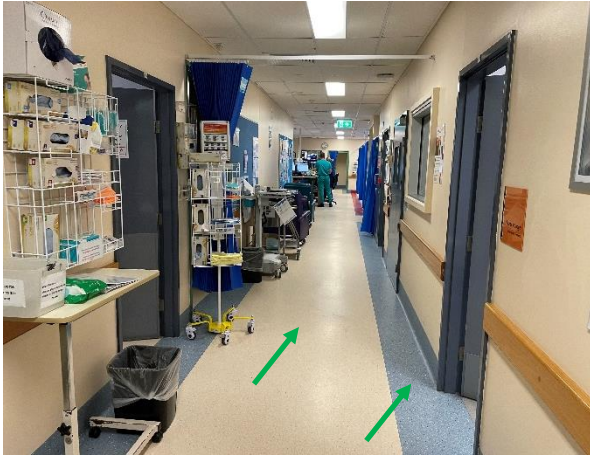
Photo 31: Emergency department, internal floors – Assumed non-asbestos containing beige and blue speckled vinyl sheeting

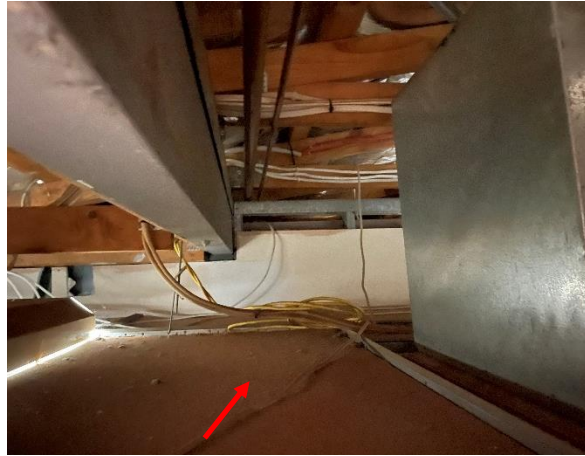
Photo 32: Emergency department ceiling cavity – elevated levels of lead within settled dust, it is noted this dust does not contain asbestos

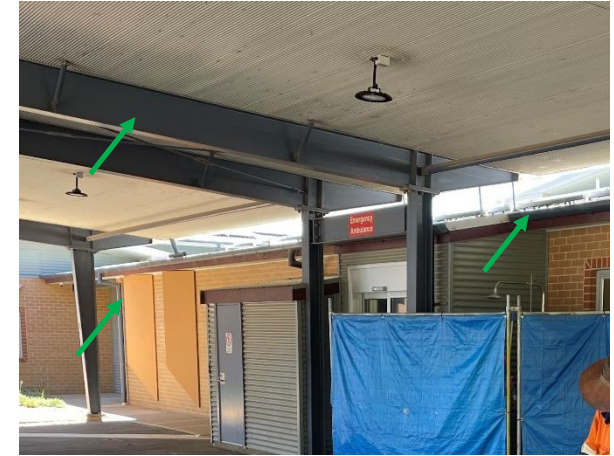
Photo 33: Emergency department, external downpipes, gutters and I beams
External ground surface – Assumed non-lead based blue paint

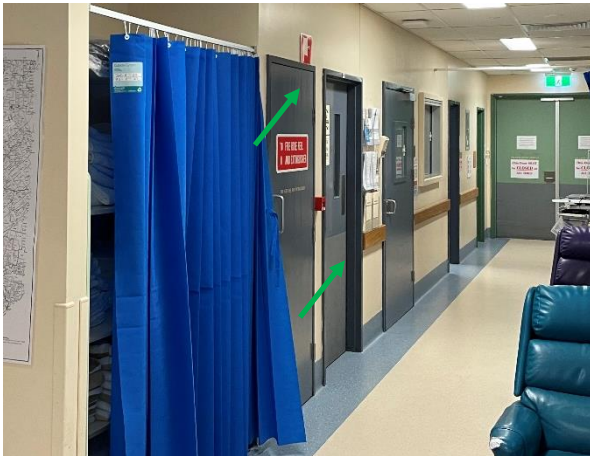
Photo 34: Emergency department, door and door frame – Assumed non-lead based blue paint

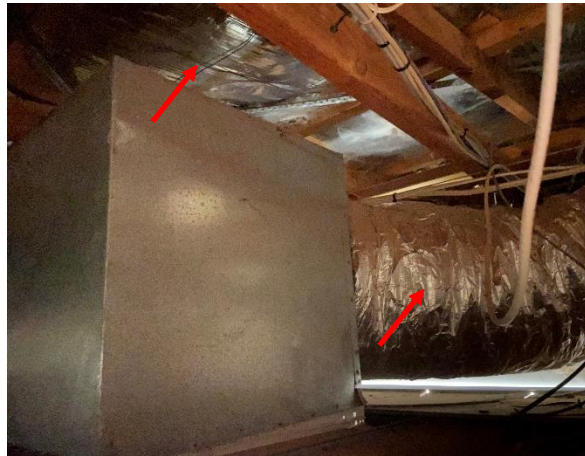
Photo 35: Emergency department, ceiling cavity – Assumed SMF sarking and ducting

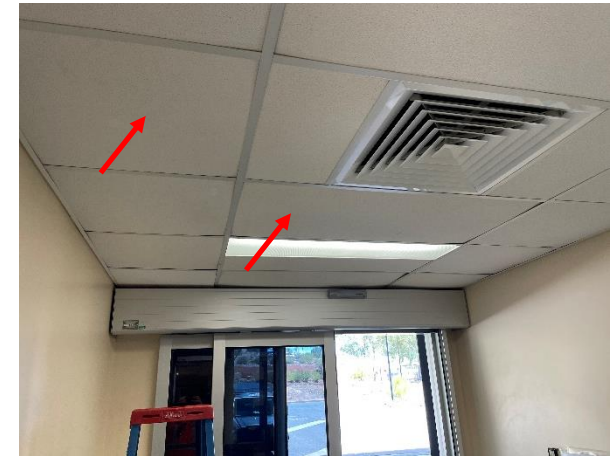
Photo 36: Emergency department, ceiling – Assumed SMF suspended ceiling tiles
