**REPORT TO
HEALTH INFRASTRUCTURE**

**ON
HAZARDOUS BUILDING MATERIALS SURVEY**

**FOR
PROPOSED MAJOR REFURBISHMENT AND NEW
ACUTE SERVICES**

**AT
COWRA HOSPITAL, CORNER LIVERPOOL &
BRISBANSE STREETS, NSW**

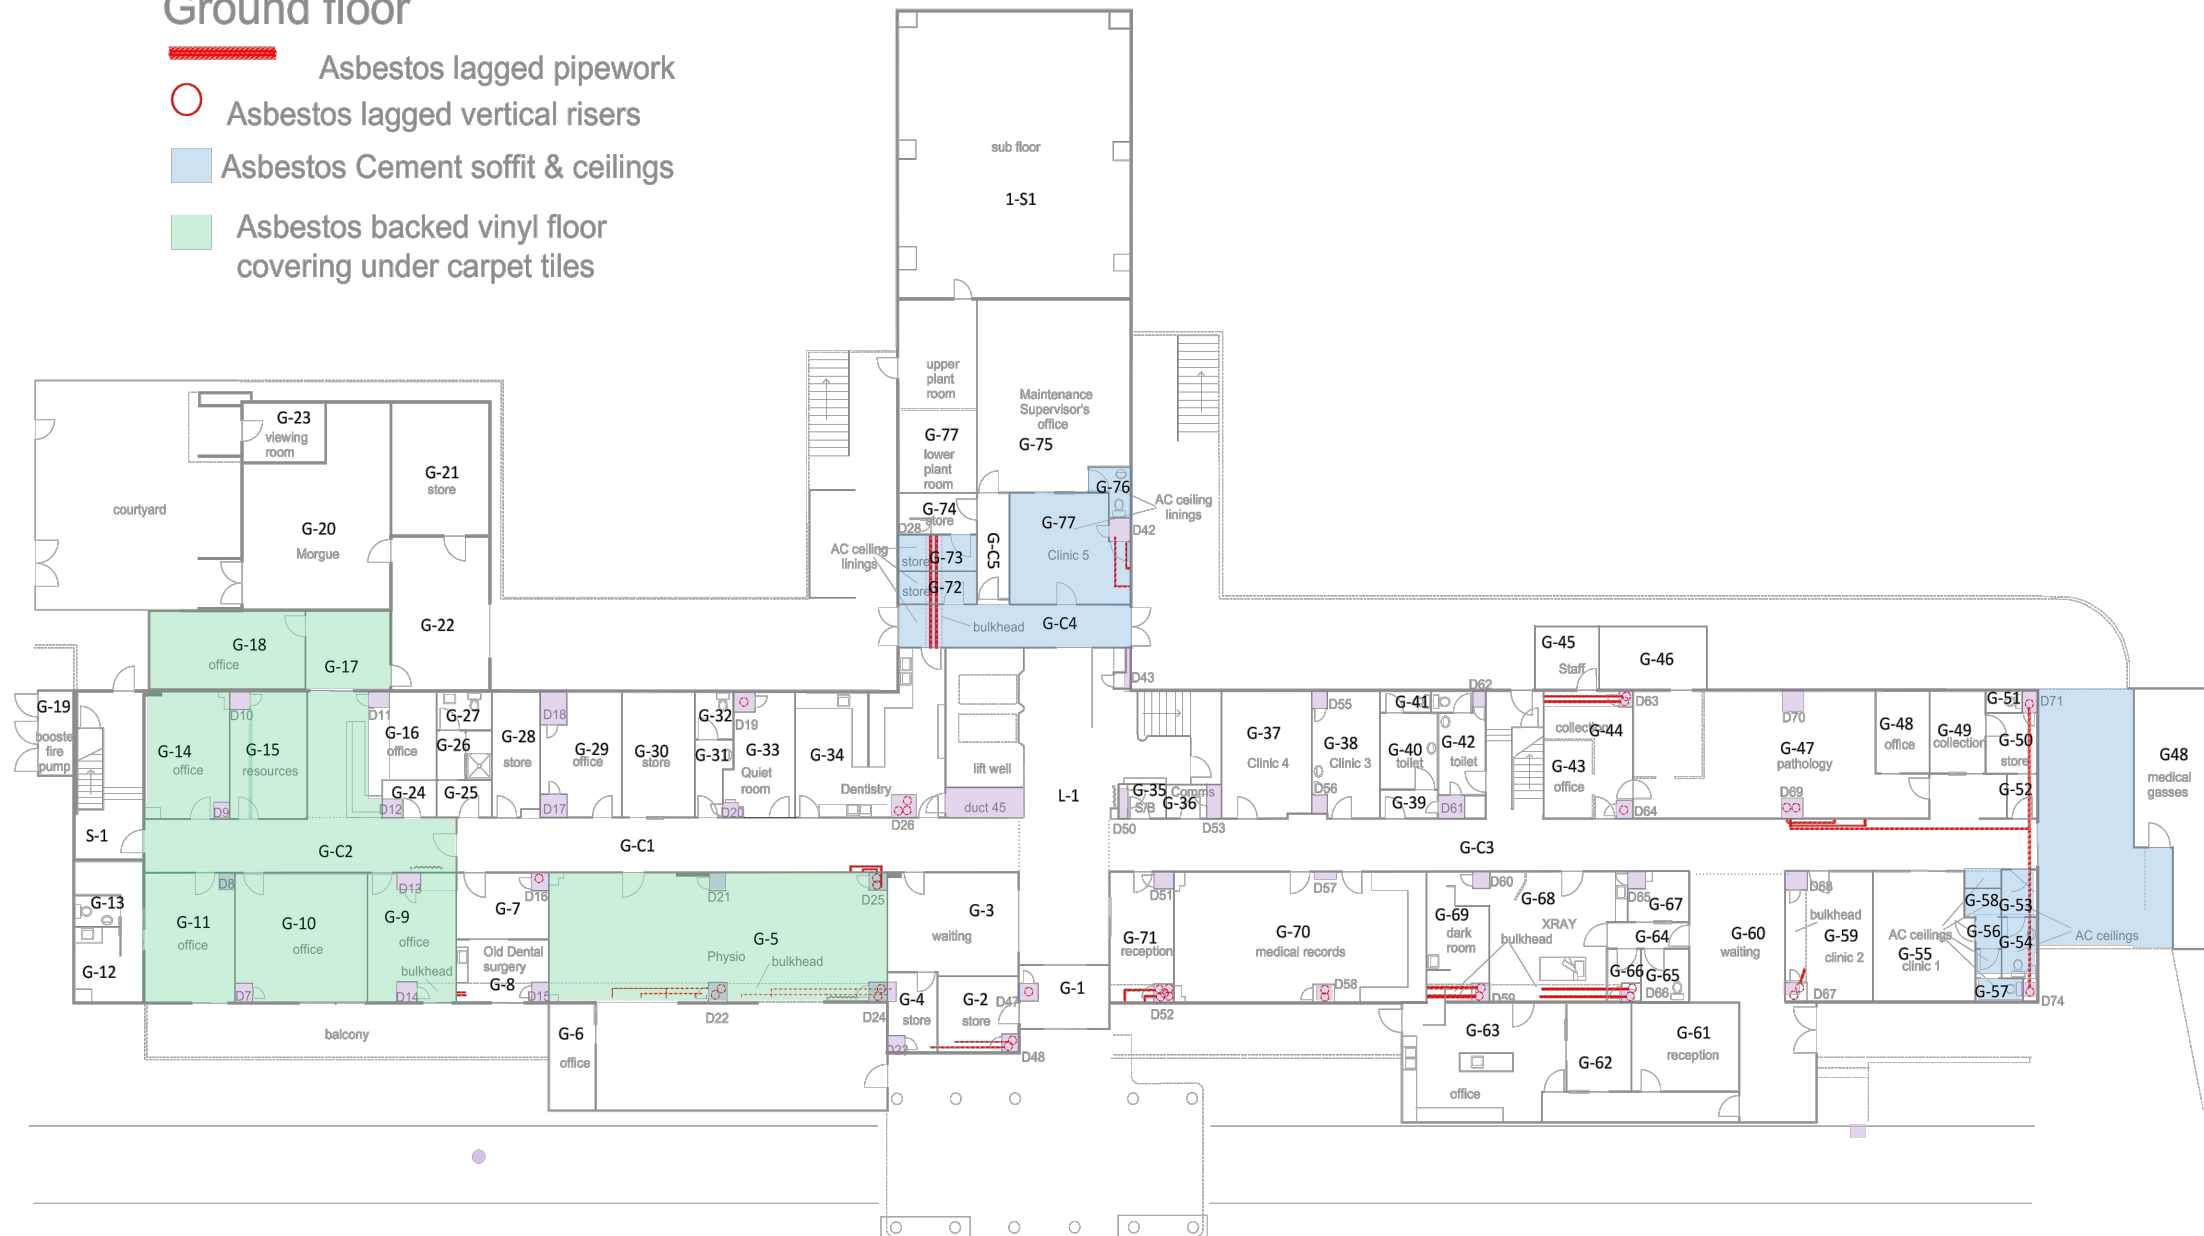
Title:	BUILDING 1	
	MAIN HOSPITAL GROUND FLOOR	
Location:	COWRA HOSPITAL, CORNER LIVERPOOL AND BRISBANE STREET, COWRA, NSW	
Project No:	E34853PT	Figure No: 3a
JKEnvironments

Asbestos backed vinyl floor covering under carpet tiles

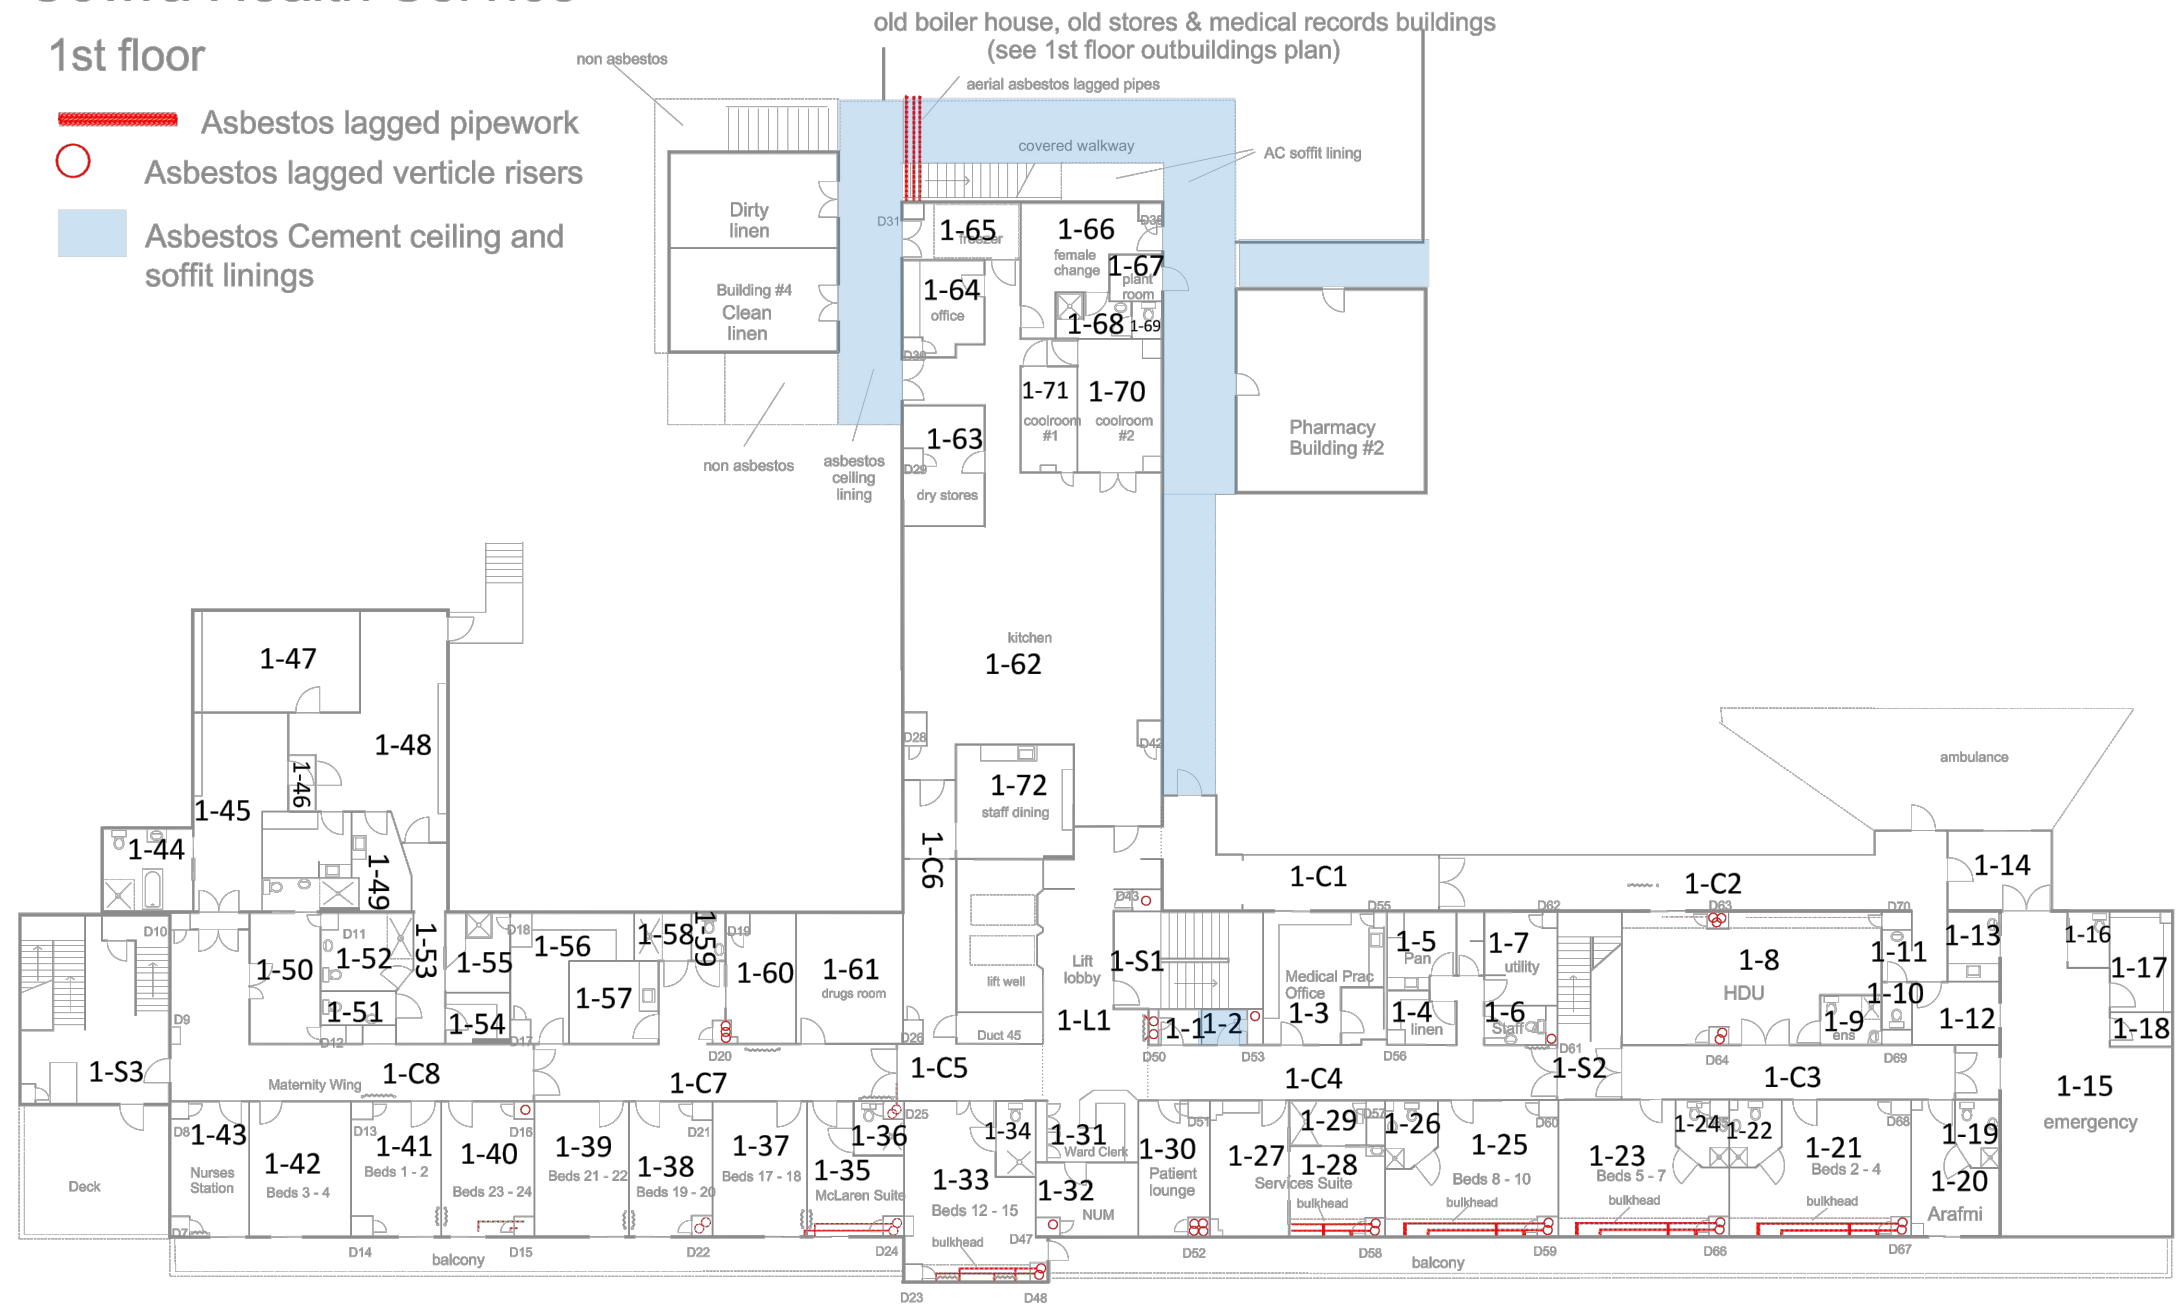
<p>This plan should be read in conjunction with the Environmental report.</p>	<p>Title: BUILDING 1</p>	
	<p>MAIN HOSPITAL FIRST FLOOR</p>	
	<p>Location: COWRA HOSPITAL, CORNER LIVERPOOL AND BRISBANE STREET, COWRA, NSW</p>	
	<p>Project No: E34853PT</p>	<p>Figure No: 3b</p>
<p>JKEnvironments</p>

Asbestos Cement ceiling and soffit linings

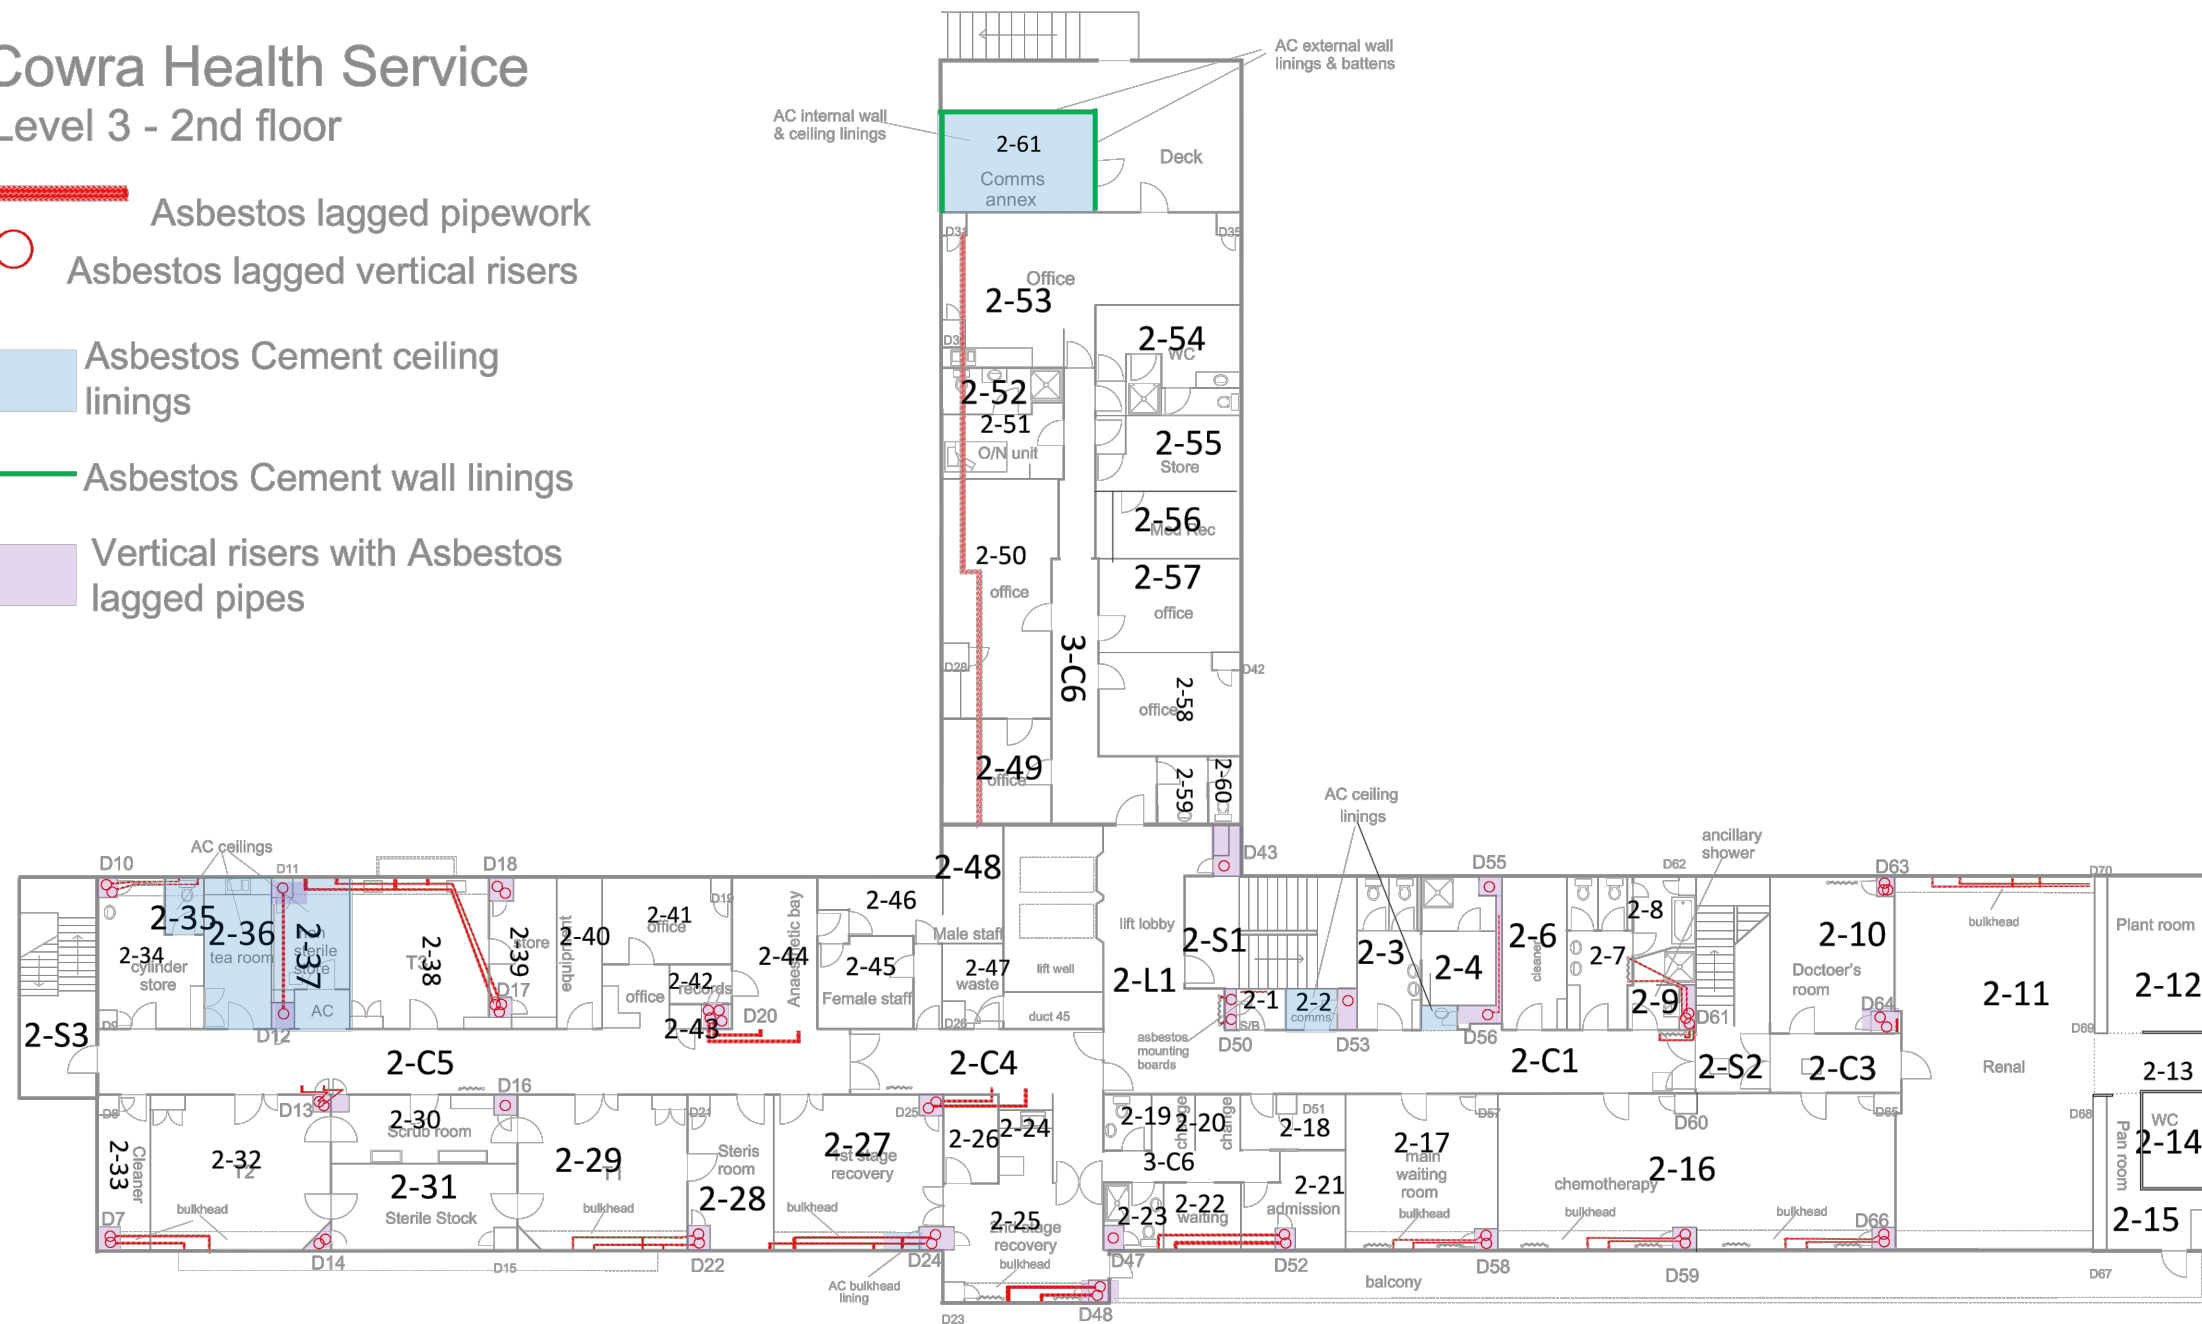
<p>This plan should be read in conjunction with the Environmental report.</p>	<p>Title: BUILDING 1</p>	
	<p>Location: MAIN HOSPITAL SECOND FLOOR</p>	
	<p>Project No: E34853PT</p>	<p>Figure No: 3c</p>
	<p>JKEnvironments</p>

- Asbestos lagged pipework
- Asbestos lagged vertical risers
- Asbestos Cement ceiling linings
- Asbestos Cement wall linings
- Vertical risers with Asbestos lagged pipes

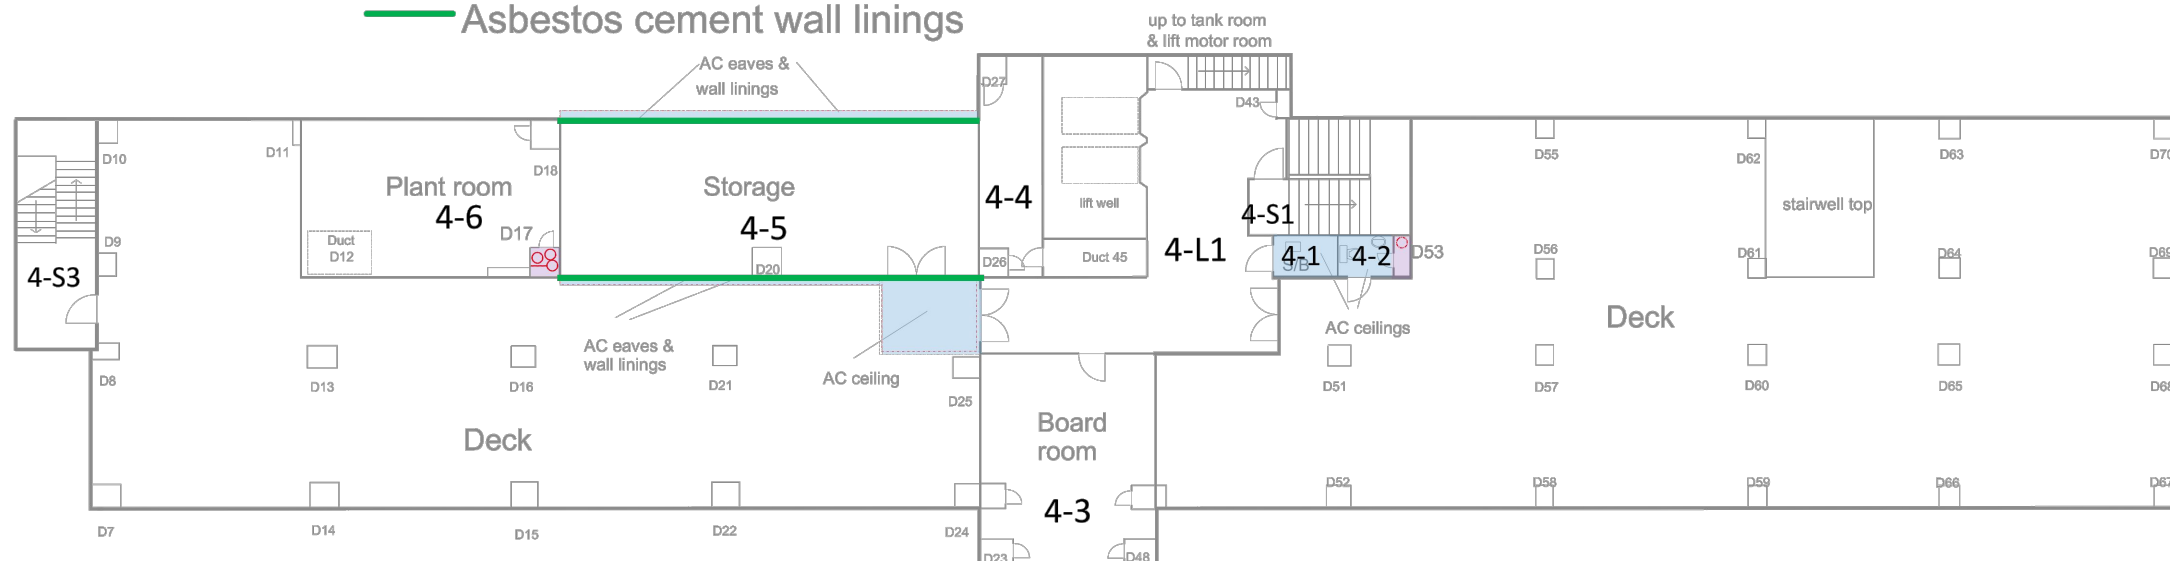
Title: BUILDING 1	
MAIN HOSPITAL FOURTH FLOOR	
Location: COWRA HOSPITAL, CORNER LIVERPOOL AND BRISBANE STREET, COWRA, NSW	
Project No: E34853PT	Figure No: 3e
JKEnvironments

Asbestos cement wall linings
