# ARBORIST'S STAGE A REPORT

PROPERTY:	47 – 49 Curry Street and 38 Davis Avenue, Wallsend NSW
NUMBER OF SUBJECT TREES:	3 (38 Davis Avenue)
DATE OF REPORT:	27 October 2021
REQUESTED BY:	Sam Crawford Architects

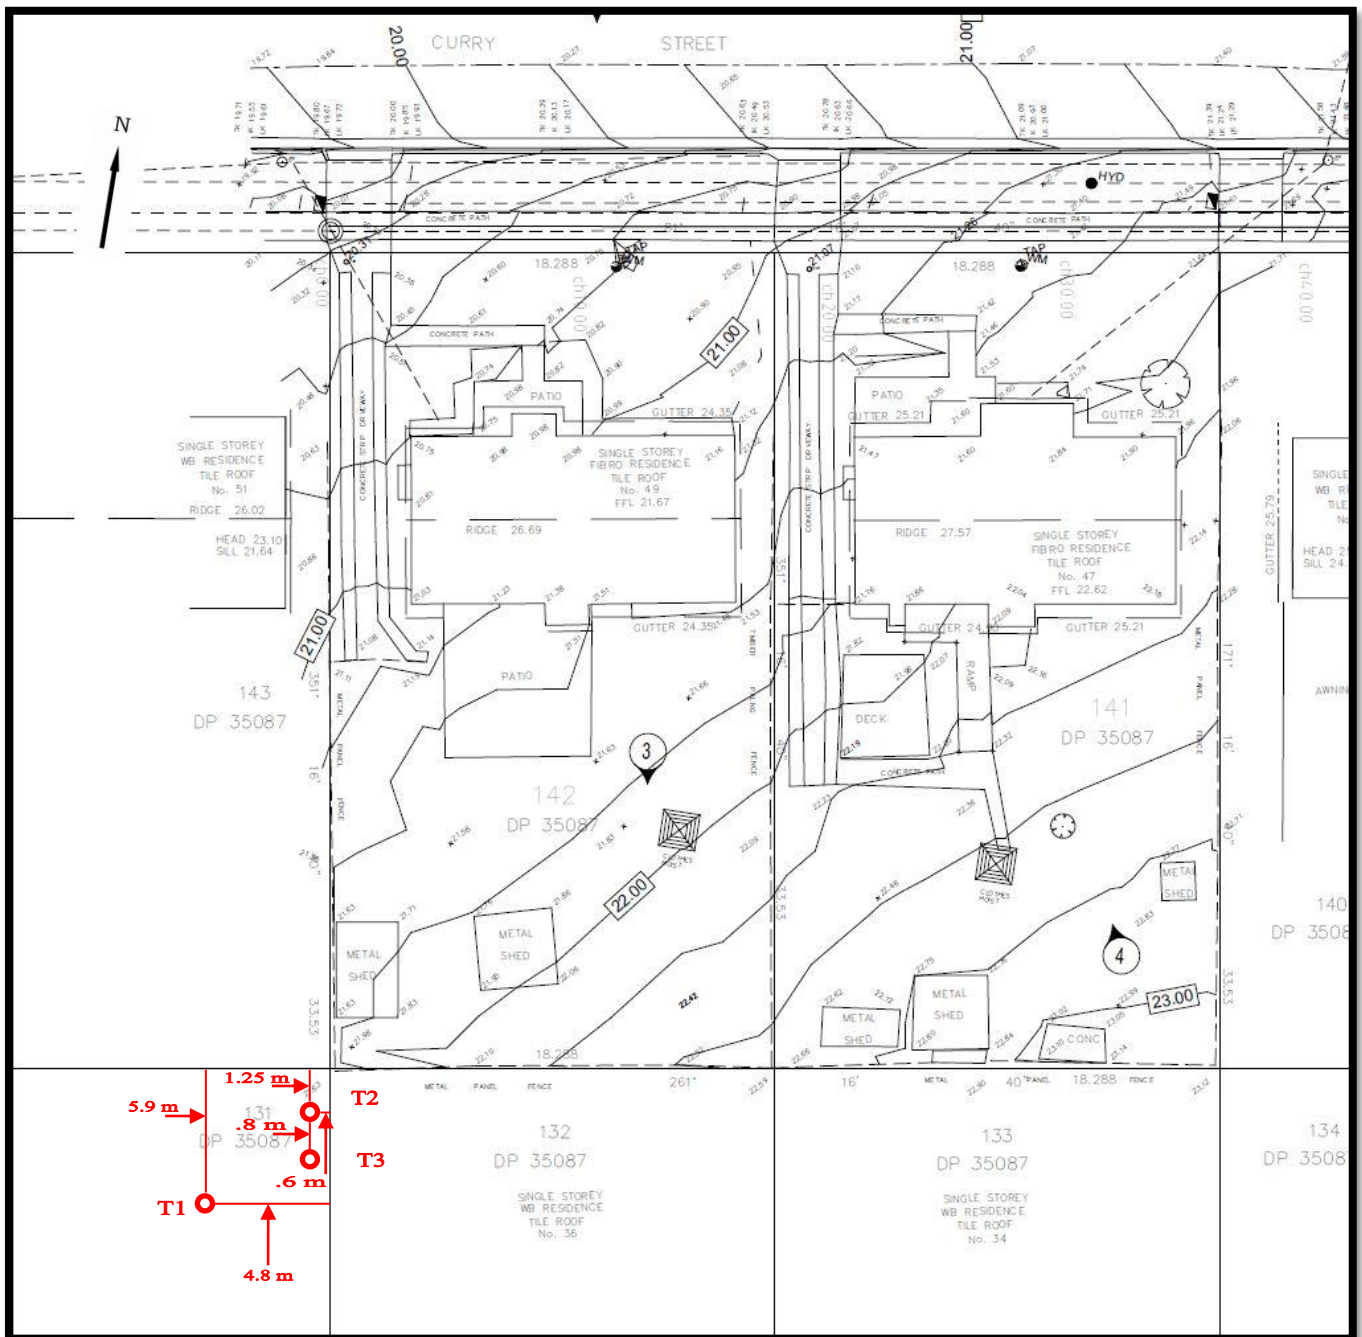
A supplied survey showing the positions of Trees 1 – 3 (as inserted by the Arborist).

The TPZ of T1 encroaches into the yard of 49 Curry Street by approximately 2.1 metres at its longest point. This encompasses the TPZs of T2 & T3, so any protection for T3 will be effective for the other trees.

Steel mesh fencing [around the TPZs] should be used where practical. Where this may be impractical, the TPZ of each tree should be measured and marked with road marking paint, and construction staff informed that the area is a Tree Protection Zone.

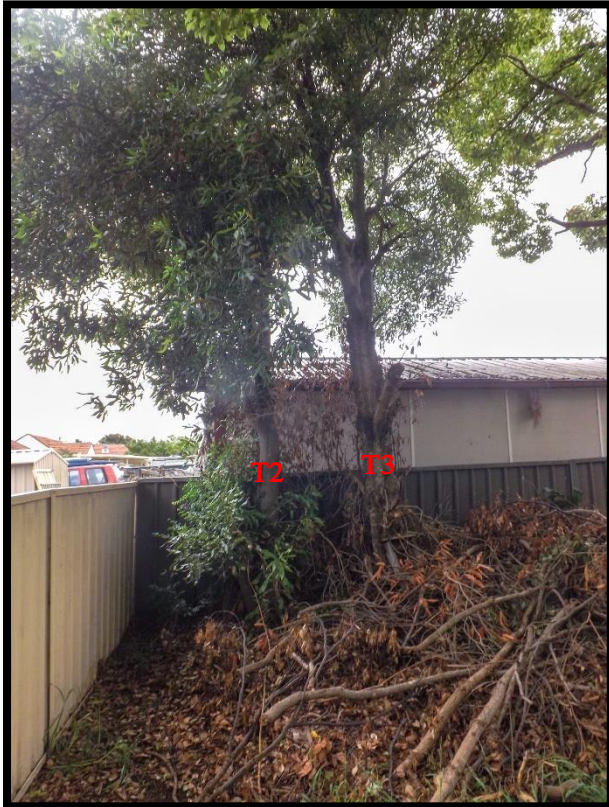
- Good health with a leaf density of 95% coverage and slight deadwood to 10 mm diameter.
- Structurally sound with good form.
- 1.25 metres from the north fence.

- Good health with a leaf density of 90% coverage and slight deadwood to 50 mm diameter.
- Structurally sound with fair form (co – dominant stems from 3 metres high (stem union stable)).
- 800 mm from T2.

Trees 2 & 3 viewed from the west.

Based on the observations made during the inspection, information supplied and the considerations in the conclusion, it is recommended that trees 1 – 3 be retained and protected as discussed.

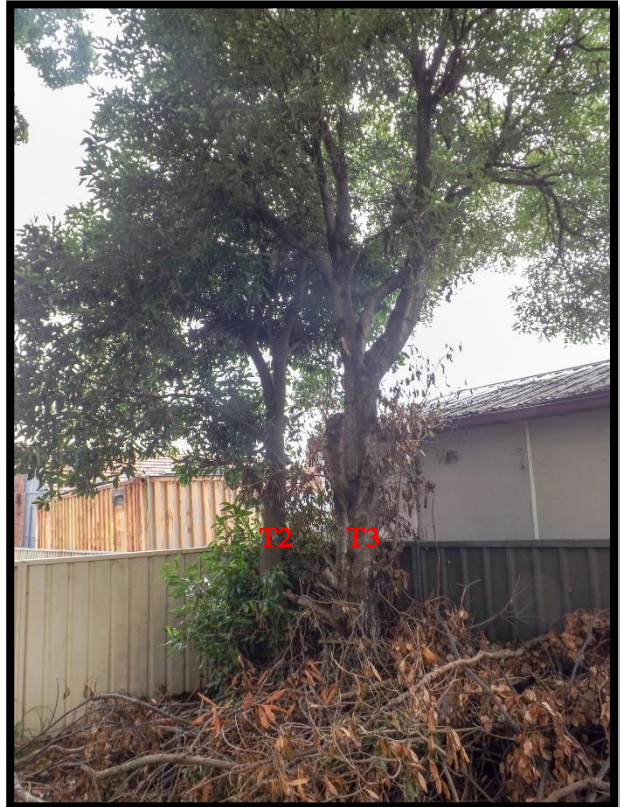
Trees 2 & 3 viewed from the SW.

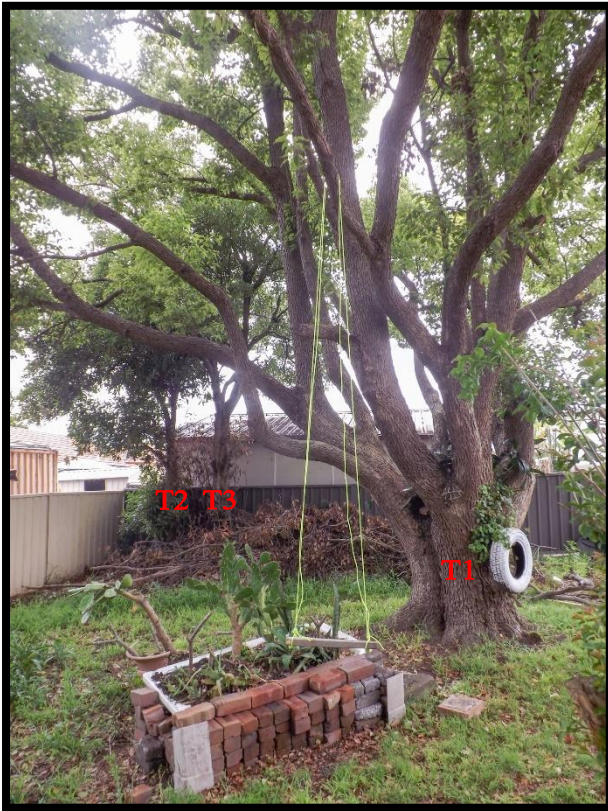
- Good health with a leaf density of 80% coverage and slight deadwood to 50 mm diameter.
- Structurally sound with fair form (six dominant stems from 1.5 metres high (stem union stable)).
- 5.9 metres from the north fence.

Trees 1, 2 and 3 viewed from the west.

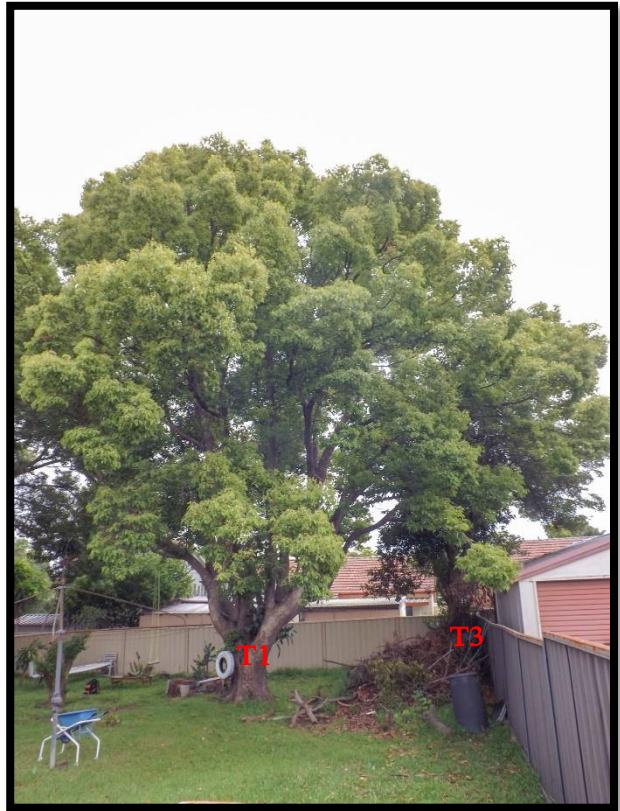
Trees 1 and 3 viewed from the south.
