Arboricultural Impact Assessment and Tree Protection Plan and specification

Site: 13 Latty Street, Fairfield

Date: 27/10/2022

Reference: 13 Latt /AIA/020522 Rev 4

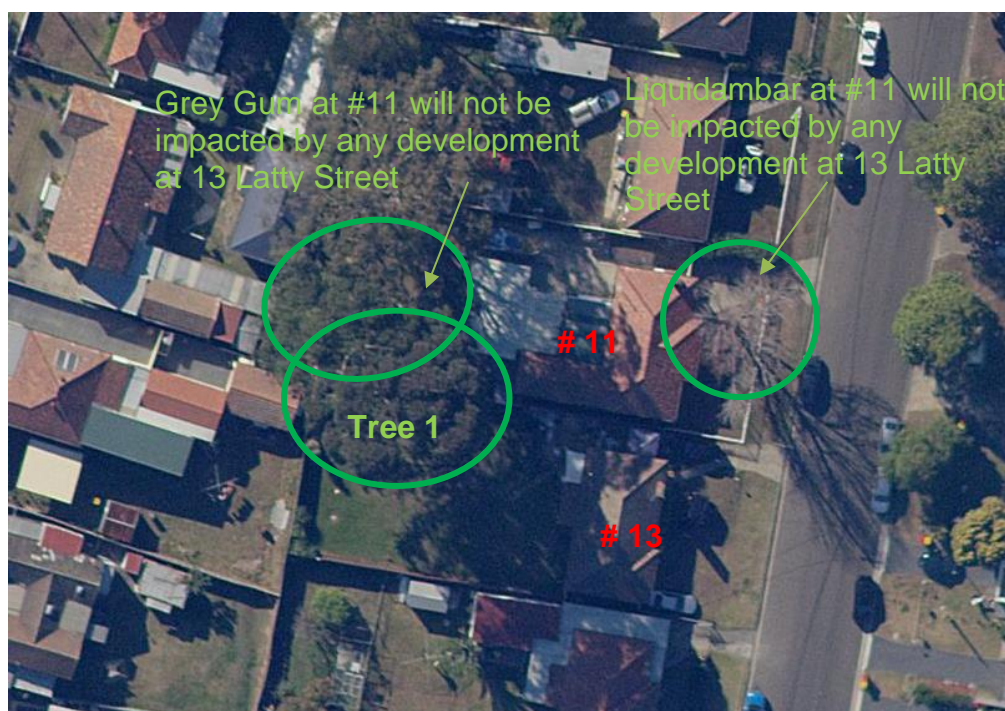
Image 2 – Tree 1 (*Eucalyptus punctata*) is located at 11 Latty Street, close to the common rear side boundary with 13 Latty Street

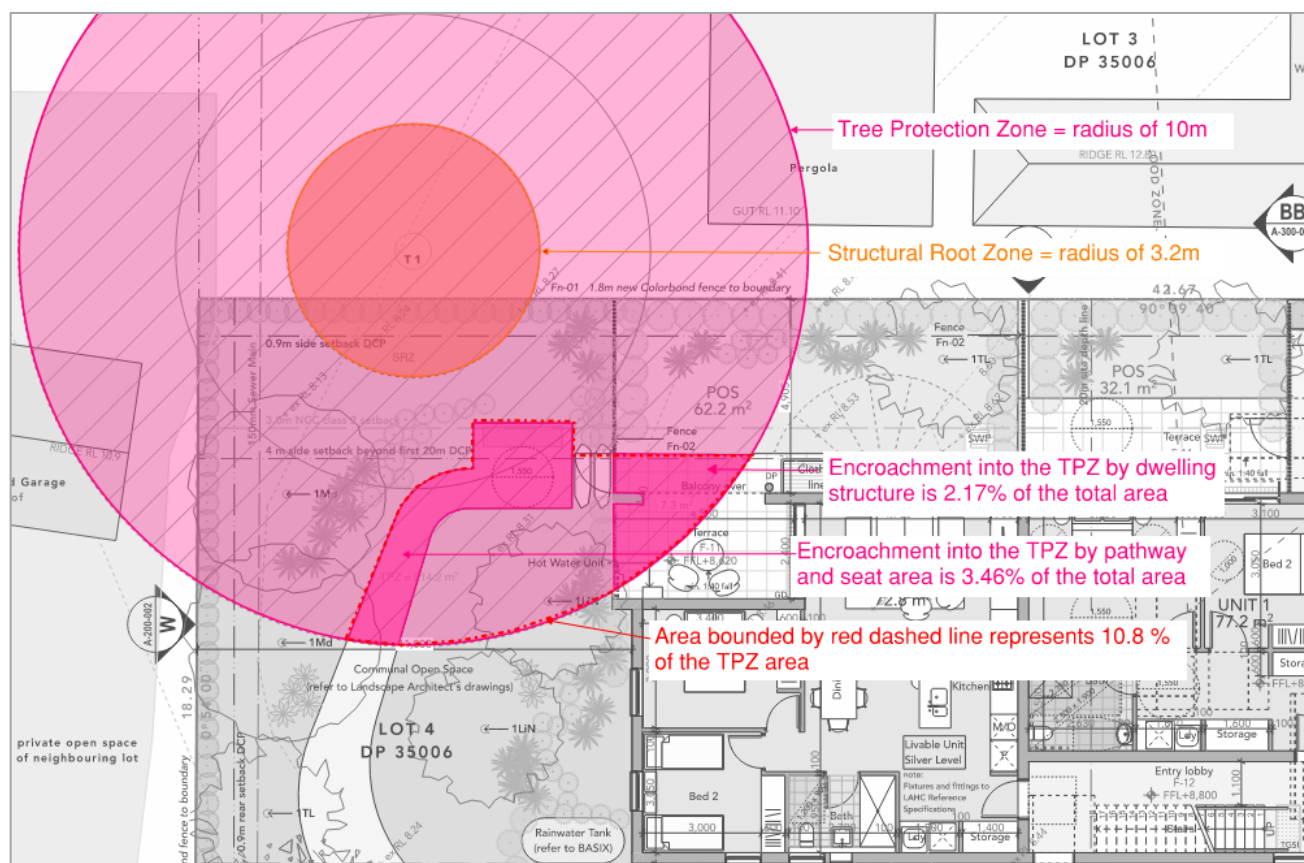
The proposed development encroachment is less than 10% ($2.17\% + 3.46\% = 5.63\%$) of the area of the TPZ and is outside the SRZ and is therefore considered to be 'Minor' in accordance with Clause 3.2.2 of AS4970. The area lost to this encroachment can be compensated elsewhere and contiguous with the TPZ. Refer to Figure 2.

Figure 2 – Showing the SRZ (3.2m) and TPZ (10m) of Tree 1 including encroachments into the TPZ

By way of a more detailed discussion, the areas of the dwelling and pathway encroachment together represent 5.63% of the total TPZ area. In the unlikely event that the installation of the paved path requires woody roots to be pruned resulting in the entire area to the south of the path being considered an encroachment (area bounded by red dashed line in Figure 2) it is only 10.82 % of the total TPZ area. If the path including subgrade can be installed above existing ground level the total area bounded in the red dashed line does not need to be considered.

The proposed drainage lines and pits are clear of the TPZ.

It is considered that the proposed development will have little, if any, impact to Tree 1 provided the tree protection is installed and works undertaken as specified in Part 10 of this report.

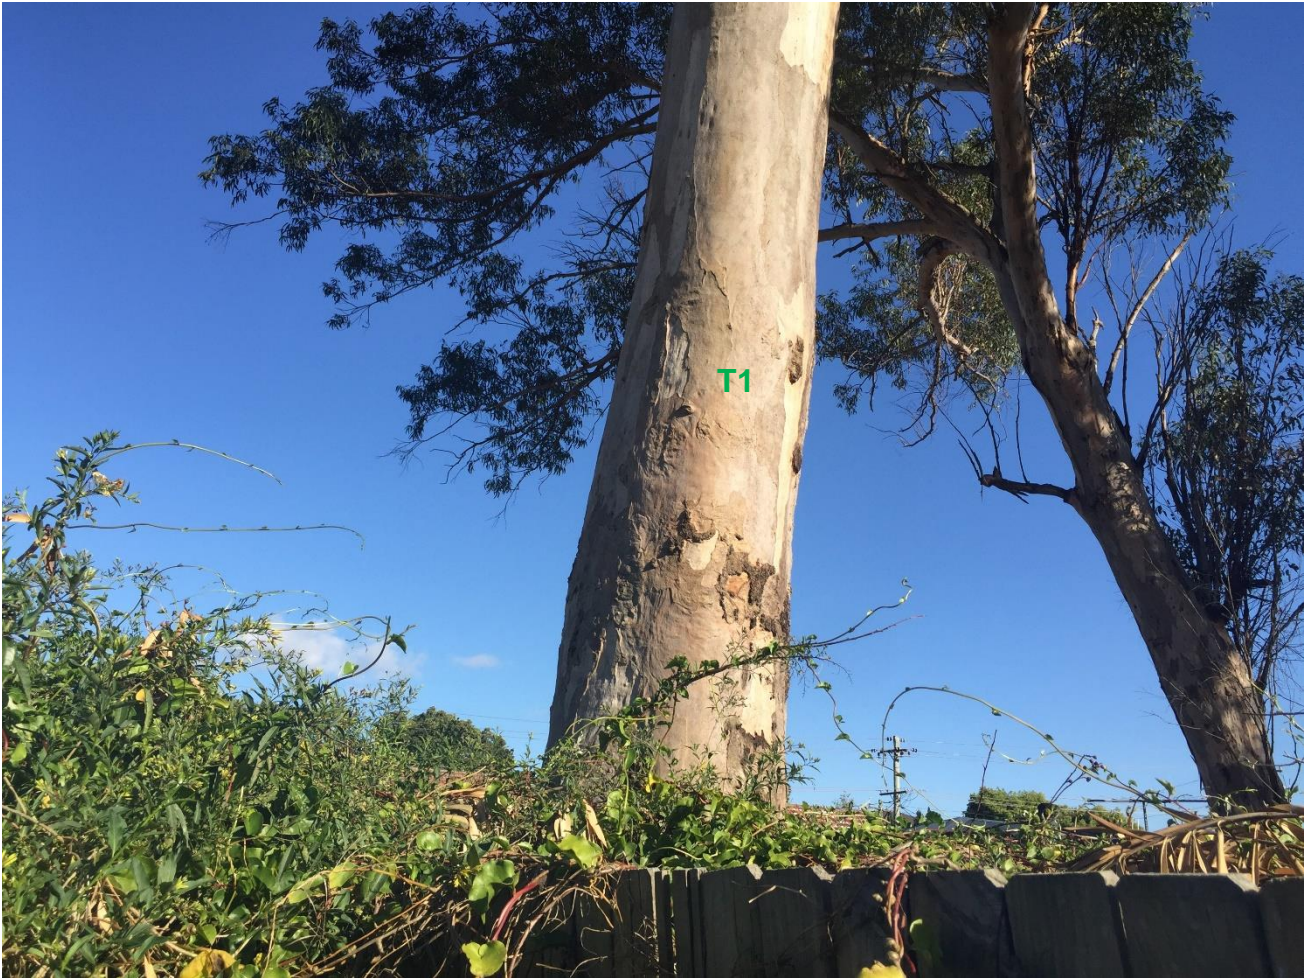
Image 3 - Looking at the mid to the lower trunk of T1 from within the rear of the subject site at 13 Latty Street

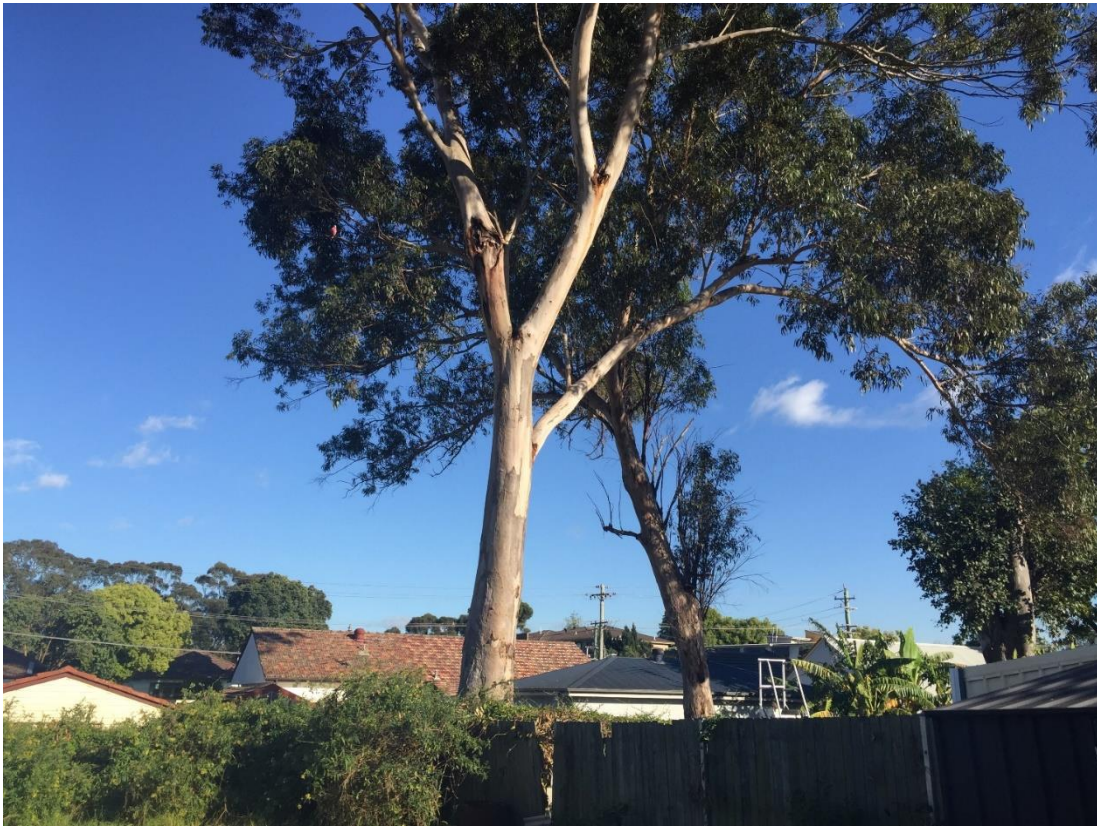
Image 4 - Looking at T1 from the rear of the subject site at 13 Latty Street

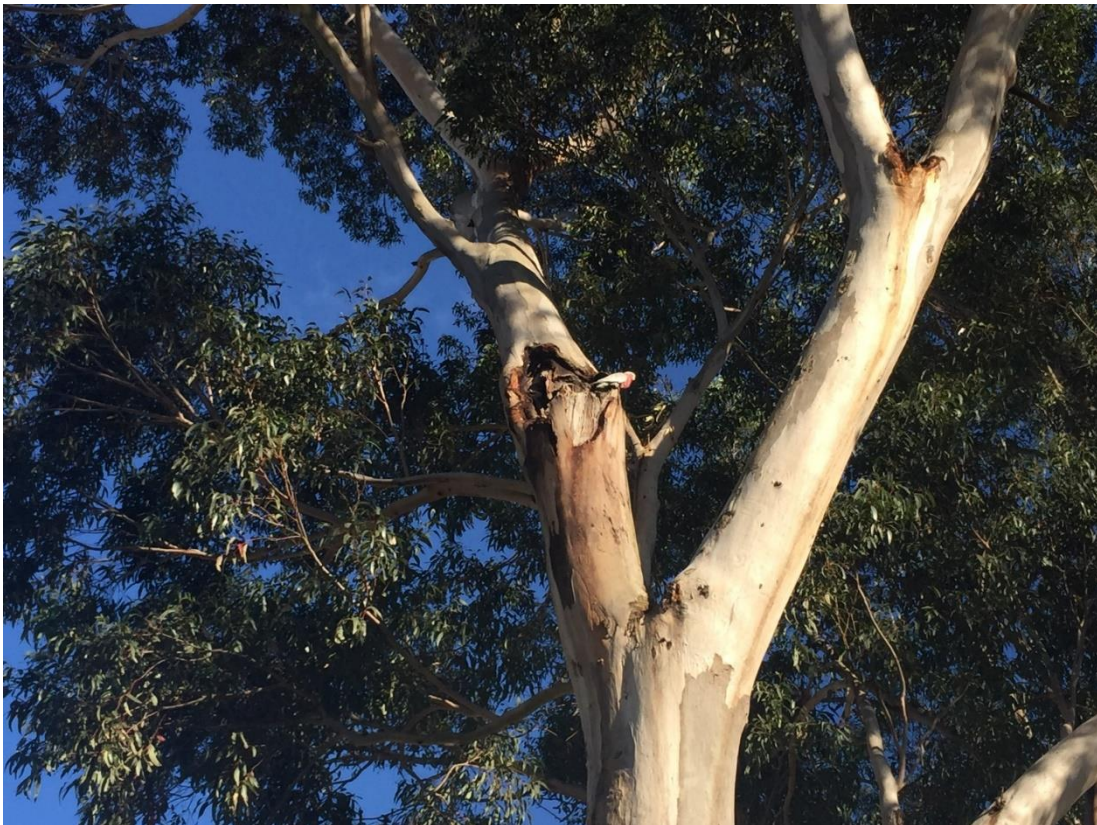
Image 5 - Looking up into the canopy of T1. There is a hollow (possibly originally started as a branch tearout and likely providing habitat for the Galahs) at a height of approx. 1 metre above where the main trunk becomes co-dominant. It looks from the ground-based inspection that there may be some damage (possibly cockatoo) at a couple of the lower branch unions. It is not possible to determine if there is any loss of structural integrity associated with these wounds without an aerial inspection.

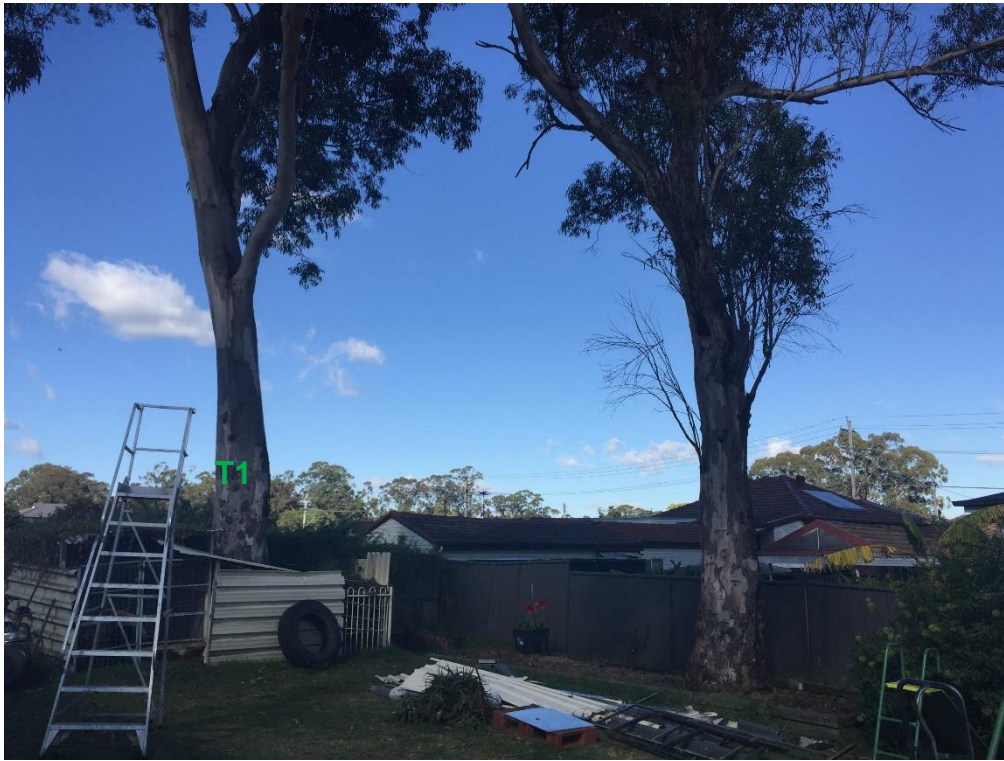
Image 5 - Looking at T1 and a second *Eucalyptus punctata* (Grey Gum - on the right of image) from within 11 Latty Street. The tree on the rear boundary of 11 Latty Street will not be impacted by any development on the subject site at 13 Latty Street.

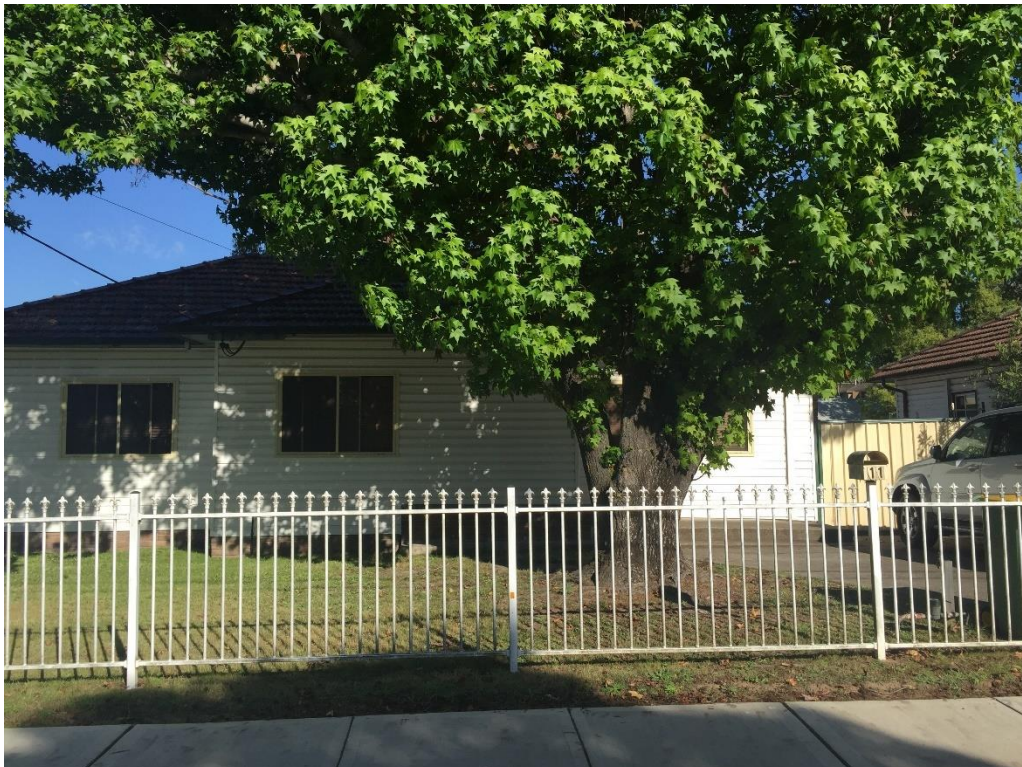
Image 6 – The *Liquidambar styraciflua* (Liquidambar) located within the front setback of 11 Latty Street. This tree will not be impacted by any development at the subject site at 13 Latty Street.
