12 May 2022  
File No. E25060.E99.007\_Rev3

## **RE: Asbestos Removal Works associated with the Western Shoring Wall Trench (Stage 1) and demolition of the Concrete Slab, 42-50 Parramatta Road, Forest Lodge NSW**

Project: 50 Parramatta Road, Forest Lodge  
Job Number: 60609

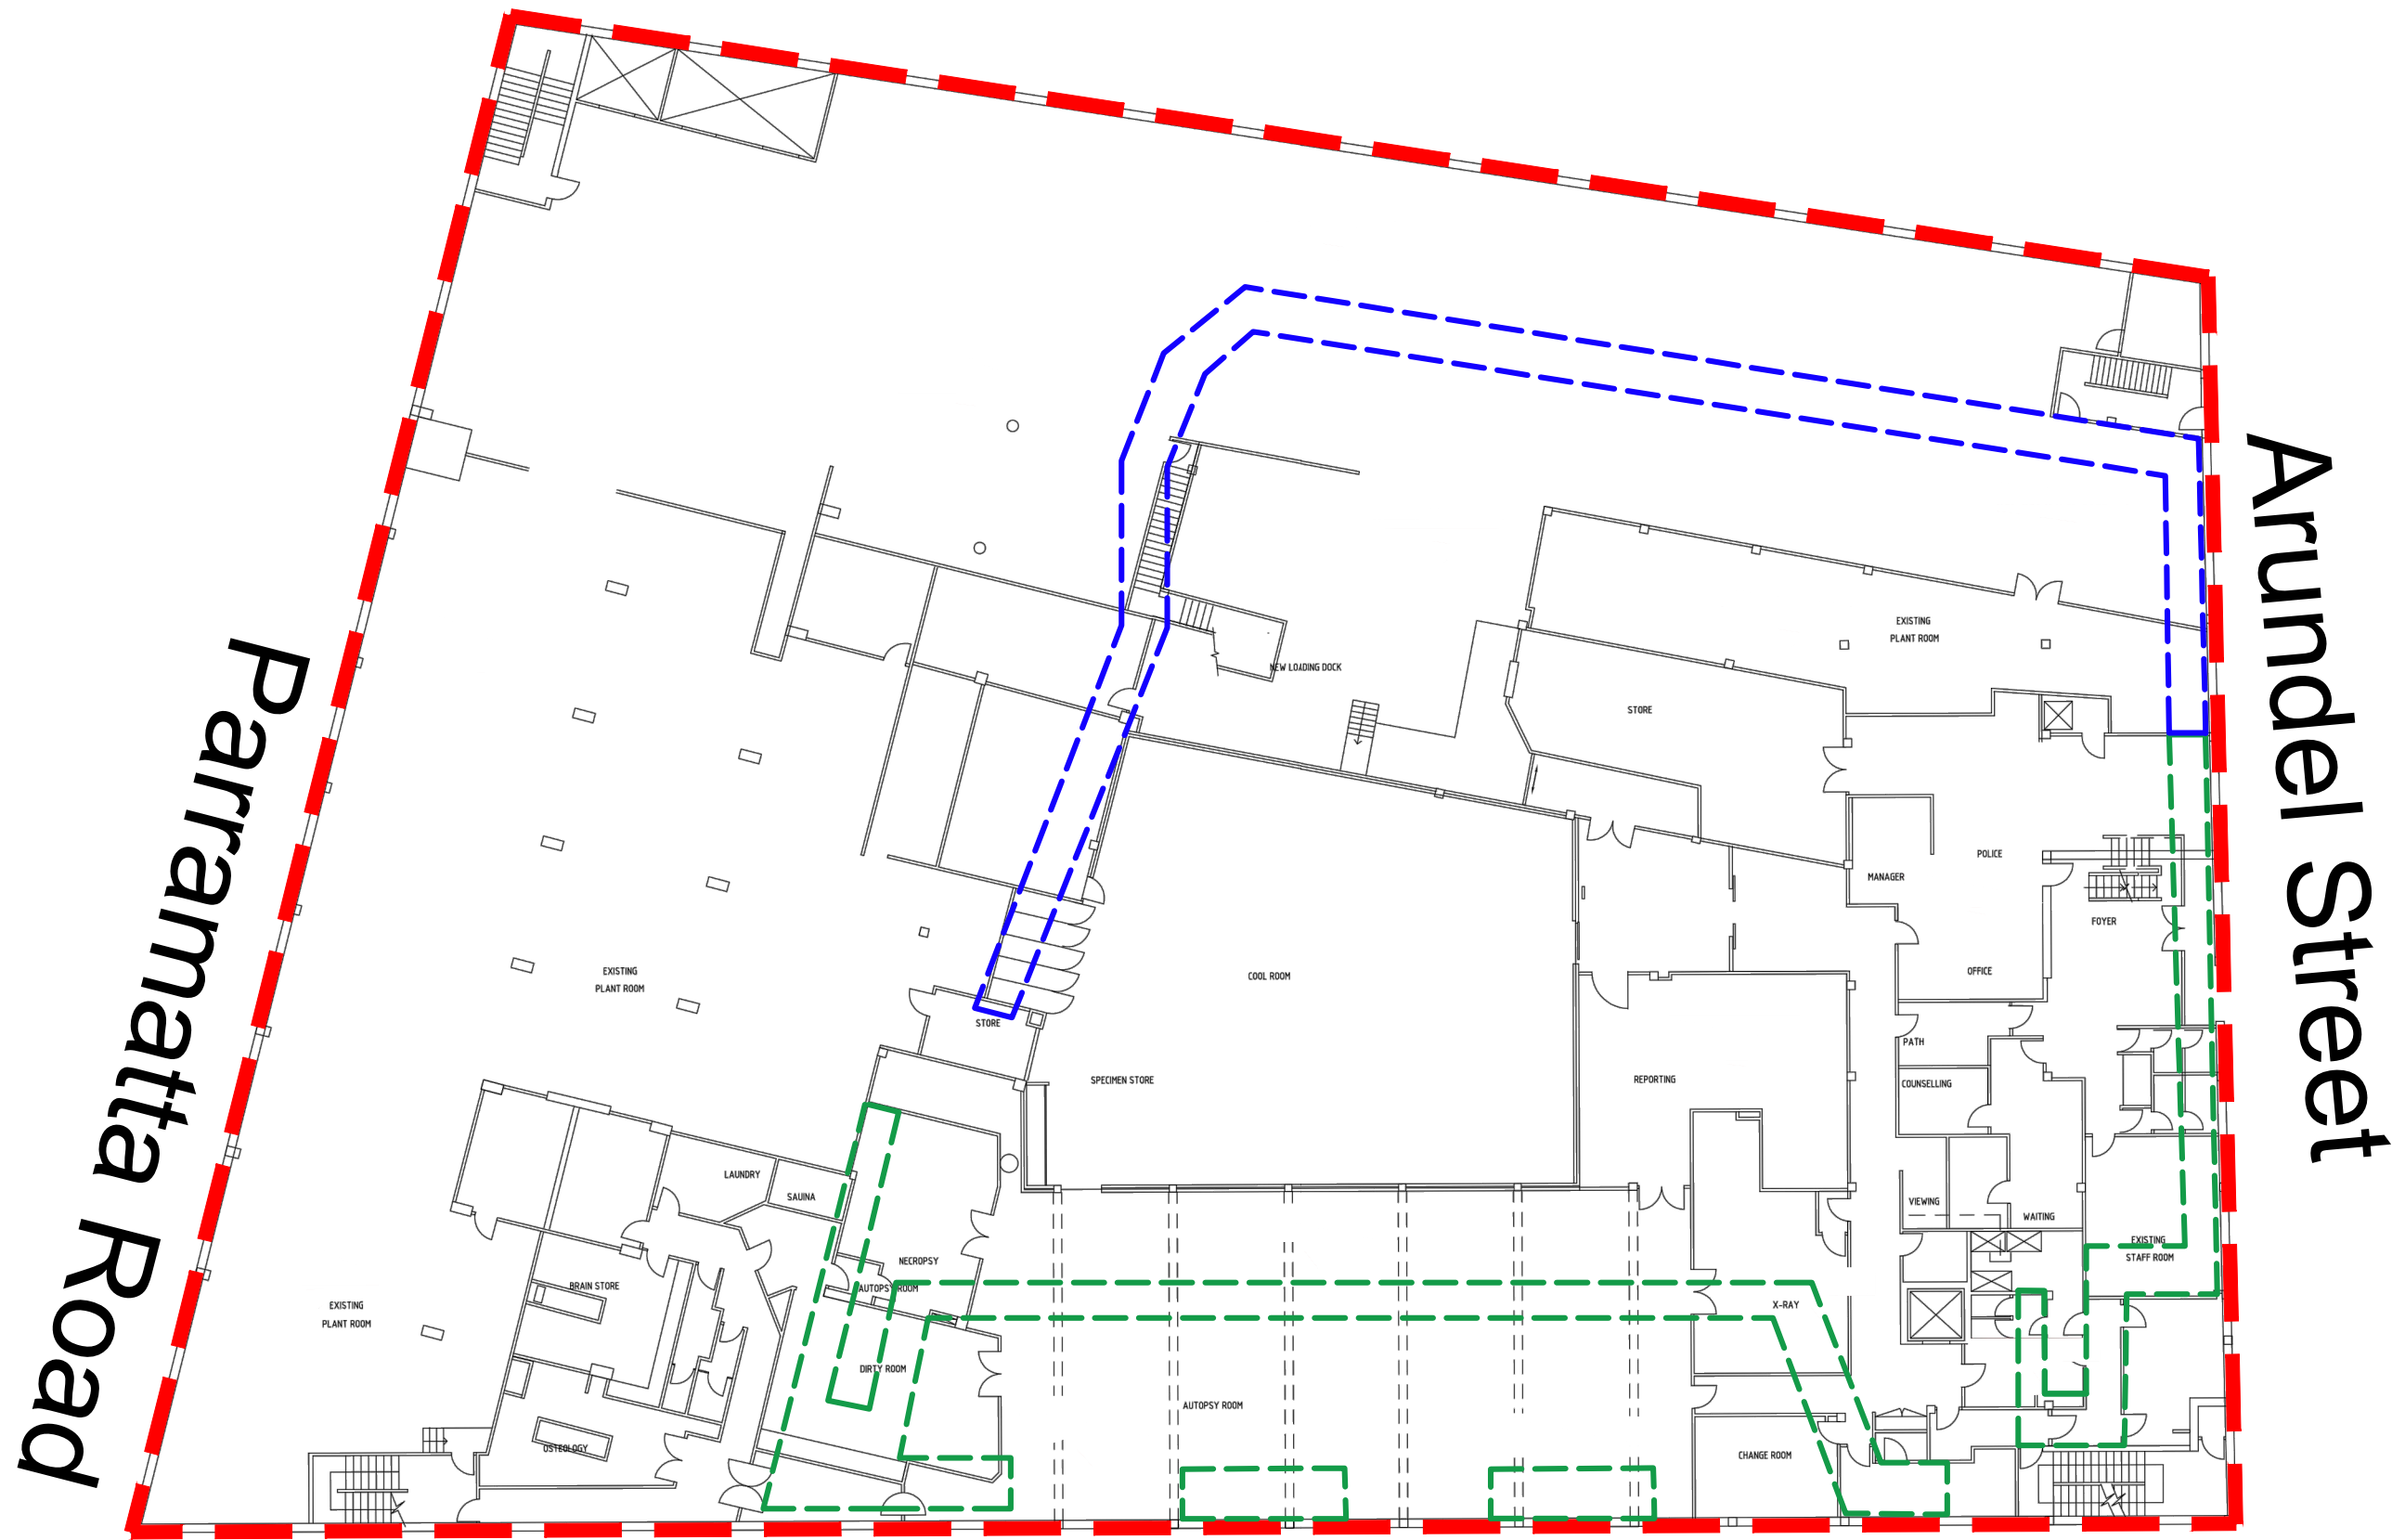
**1**

At the request of Seng Chea of Kane Constructions Pty Ltd, El Australia (El) have been asked to provide recommendations for works associated with the western shoring wall trench (Stage 1), as depicted in the attached site plan (**Appendix A**), along with the demolition of the slab (excluding the cool room/freezer room area).

It is understood that works for the second stage of slab cutting, on the lower slab level, is to commence following the completion of the upper slab trench removal works. Based on information provided by the client, the next area can be found along the western lower slab level of the site and is believed to contain similar if not the same asbestos cement sheeting.

Further to the above it is of El's understanding that one side of the boundary line for the next stage of trenches was mechanically cut throughout the depth of the slab impacting the asbestos cement sheeting below. The other side was cut following the discovery of the asbestos cement sheeting below and then cut at a shallow depth so as to not impact the sheeting. El therefore consider that works associated with the next area of the shoring wall trench (**Figure 1**) should be conducted under friable control measures, as the resultant slurry from mechanical cutting may have deposited residual loose asbestos fibre within the underlying fill soils.

Following demolition of the concrete it is recommended that the exposed soils, be excavated until a clean soil profile is observed, and the area be inspected and sampled for any remaining asbestos contamination for clearance purposes.

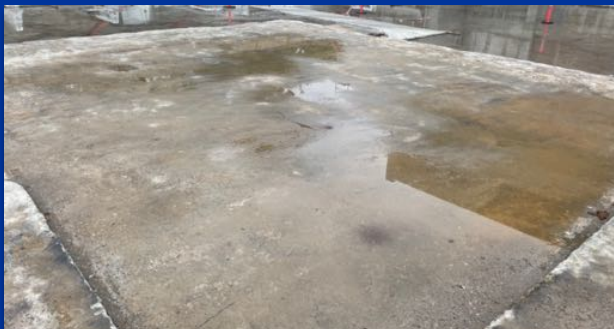
**Photo 1**

Southern rear elevated concrete slab following satisfactory asbestos removal works.

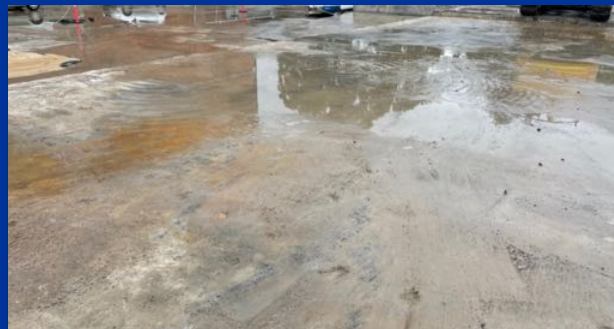
**Photo 2**

Southern rear elevated concrete slab following satisfactory asbestos removal works.

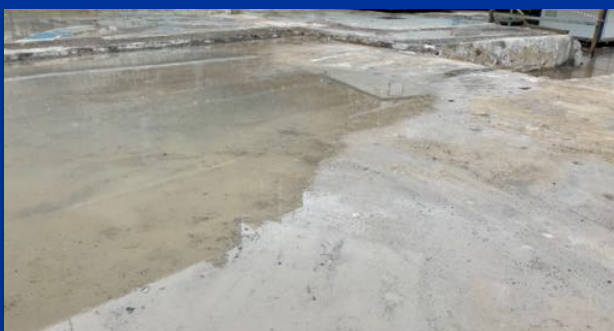
**Photo 3**

Southern rear elevated concrete slab following satisfactory asbestos removal works.

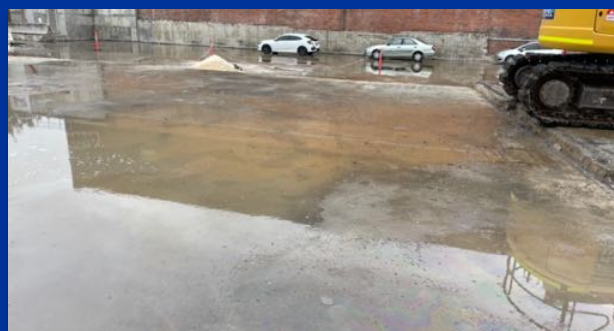
**Photo 4**

Southern rear elevated concrete slab following satisfactory asbestos removal works.

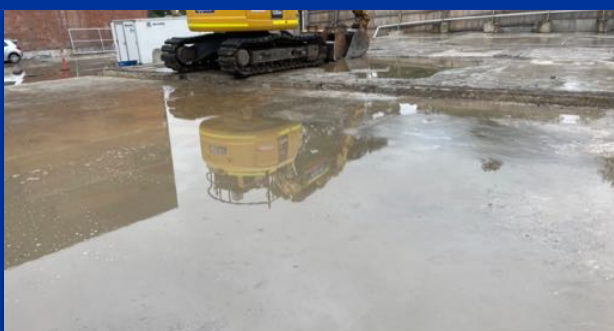
**Photo 5**

Southern rear elevated concrete slab following satisfactory asbestos removal works.
