HAZMAT Survey Report

Prepared for	Ben Matarranz ADCO Constructions Pty Ltd
Site	Admin Building and Adjacent Complex Buildings Bowral Hospital 97-103 Bowral St, Bowral NSW 2576
Prepared by	Jeffrey Yu Principal Environmental Consultant & Occupational Hygienist CEnvP (#1516) Licensed Asbestos Assessor (#001366) PhD (EnvEng), PhD (MediChem)
Date of field work	01/12/2021
Reference No.	JDRYU060_V1_HAZMAT

07 December 2021

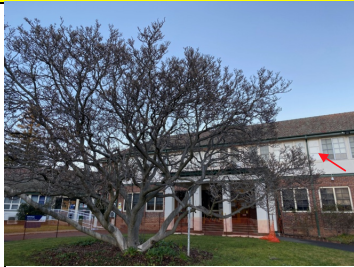
Exterior																		
Admin Building, Yeoman, Pathology	Exterior	Wall claddings, throughout, 200m2	Asbestos	FC sheeting	Similar to 7	Presumed negative

1	Non-Friable	NA	NA	NA	NA	NA	NA		Height Restriction. Limited Access for sampling at Sample 7.	
Admin Building,	Exterior	Admin building, exterior, Level 1, northern elevation, Front Verandah rooms, wall claddings	Asbestos	FC sheeting	7	NAD

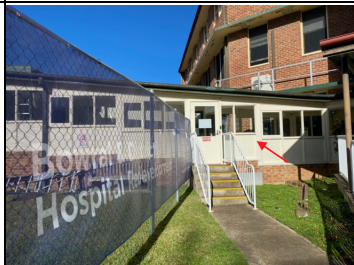
2	Non-Friable	NA	NA	NA	NA	NA	NA		Confined space; inspection required during demoltion as previous removal in stages could/may not be completed in some inaccessible/non-practical areas (only feasible during structure damage demoltion). Most of pipes were sealed with black plastic foams.	
Admin Building	Interior and Exterior	Admin Building, to Milton park Link; To Quit Room- exterior and interior - wall claddings and ceiling	Asbestos	FC sheeting	15	NAD

3	Non-Friable	NA	NA	NA	NA	NA	NA	Y	Greencap Asbestos Sticker should be removed.

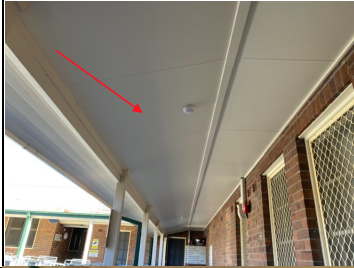
Building Level / Floor	Location Description	Material Location	Type of Material	Hazard Type	Sample No.	Sample Result	Photos	Photo No.	Asbestos Risk Assessment							Labelled	Comments/ Condition	Action Taken
									Asbestos Type	Condition	Location	Airborne Potential	Exposure	Hazard Level	Health Risk/Action Priority Level			
Admin Building	Exterior	Admin Building, Southern elevation, adjacent to Kitchen, verandah, ceiling, 60m2	Asbestos	FC sheeting	23	NAD

4	Non-Friable	NA	NA	NA	NA	NA	NA			
Admin Building	Interior	Admin Building, Northwestern elevation, intill panels, eaves, ceilings, 40m2	Asbestos	FC Sheetting	24	NAD

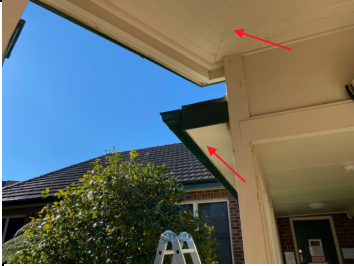
5	Non-Friable	NA	NA	NA	NA	NA	NA			
Admin Building	Interior	Admin Building, Quiet Room, exterior, external cladding, 40m2	Asbestos	FC sheeting	25	NAD

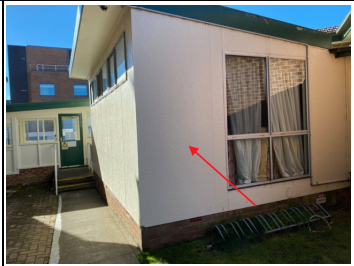
6	Non-Friable	NA	NA	NA	NA	NA	NA			
Admin Building	Exterior	Admin Building, Parent Lounge Room, Low Manhole Entry - Isolated Eave, 4m2	Asbestos	FC sheeting	Similar to 26	Presumed negative

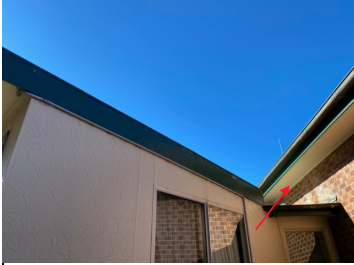
Building Level / Floor	Location Description	Material Location	Type of Material	Hazard Type	Sample No.	Sample Result	Photos	Photo No.	Asbestos Risk Assessment							Labelled	Comments/ Condition	Action Taken
									Asbestos Type	Condition	Location	Airborne Potential	Exposure	Hazard Level	Health Risk/Action Priority Level			
Admin Building	Interior	Admin Building, Quiet Room, exterior, eaves, throughout	Asbestos	FC sheeting	26	NAD

8	Non-Friable	NA	NA	NA	NA	NA	NA		NO access; Live. Inspection required during demolition.	
No PCB containing capacitors were identified to the exterior of the building at the time of the survey. All live, sealed or encapsulated, or inaccessible capacitors containing or suspected as containing PCB should be inspected prior to demolition.																		
Interior																		
Admin Building	Interior	Admin building, exterior, Level 1, northern elevation, Front Verandah rooms, wall claddings	Asbestos	FC sheeting	7	NAD

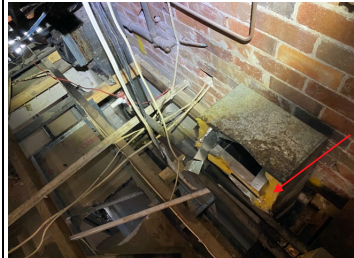
Yeoman Ward	Interior	Yeoman Ward, ceiling space, Aircon duct, insulation, throughout - adjacent to Admin Building Ceiling Western Entry Gate	Asbestos	Insulation	10	NAD, SMF

10	Friable	NA	NA	NA	NA	NA	NA		Confined space, two or three layers of ceilings with duct throughout and encapsulated. Inspection required prior to demolition.

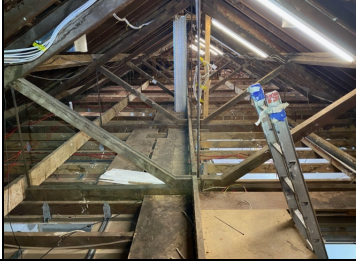
Building Level / Floor	Location Description	Material Location	Type of Material	Hazard Type	Sample No.	Sample Result	Photos	Photo No.	Asbestos Risk Assessment							Labelled	Comments/ Condition	Action Taken
									Asbestos Type	Condition	Location	Airborne Potential	Exposure	Hazard Level	Health Risk/Action Priority Level			
Yeoman Ward	Interior	Yeoman Ward, northern section of ceiling space, ceiling tiles, around 200m2	Asbestos	NIL	NIL	NIL

11	NA	NA	NA	NA	NA	NA	NA		Most of tiles in the northern section of the ceiling space were removed.	
Yeoman Ward	Interior	9 Yeoman Ward, ceiling space, asbestos in dust	Asbestos	Settled Dust	9	NAD; SMF

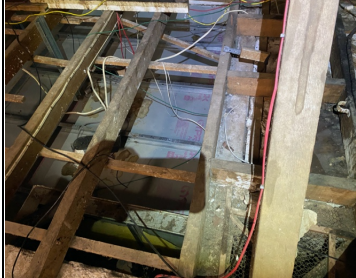
12	Friable	NA	NA	NA	NA	NA	NA		Only one piece sighted. Most of the suspended tiles were removed. Visually Insulation and Dust in Ceiling Cavity were almost removed. There are some uncertainties of asbestos debris in ceiling cavities (~80m2) adjacent to Admin Building Western Entry Gate have two or three layers of ceilings (confined space, no access).

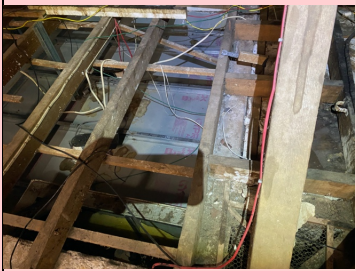
Yeoman Ward	Interior	11 Yeoman Ward, ceiling space, minor asbestos debris, pipe lagging	Asbestos	Lagging Debris	11	Positive

13	Friable	3	1	3	1	27	P2 / Moderate		Only one piece sighted. Most of the suspended tiles were removed. Visually most of Insulation and Dust in Ceiling Cavity were removed. There are uncertainties of asbestos debris in ceiling space (~80m2) adjacent to Admin Building Western Entry Gate have two or three layers of ceilings (confined space, no access). Class A Removalist.

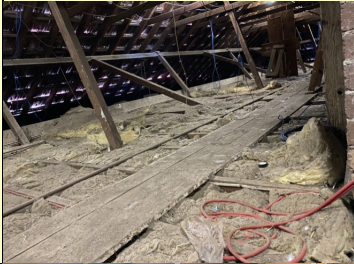
Building Level / Floor	Location Description	Material Location	Type of Material	Hazard Type	Sample No.	Sample Result	Photos	Photo No.	Asbestos Risk Assessment							Labelled	Comments/ Condition	Action Taken
									Asbestos Type	Condition	Location	Airborne Potential	Exposure	Hazard Level	Health Risk/Action Priority Level			
Admin Building and Pathology Building	Interior	Admin Building and Pathology Building, Level 1, ceiling space, Asbestos in dust	Asbestos	FC sheeting	13	NAD; SMF

14	Friable	NA	NA	NA	NA	NA	NA		Ceiling cavities were covered with insulation; inspection required prior to demolition. Presumed to be hidden service risers containing asbestos and contamination, under SMF insulation	
Admin Building	Interior	Admin Building, Level 1, ceiling space, Lift Room, Lift shaft	Asbestos	Pad	-	Presumed Positive

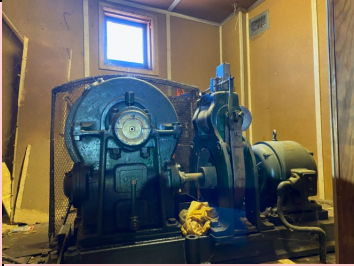
15	Non-Friable	1	1	1	1	2	P4 / Negligible		Energized, encapsulated. Inspection required prior to demolition.

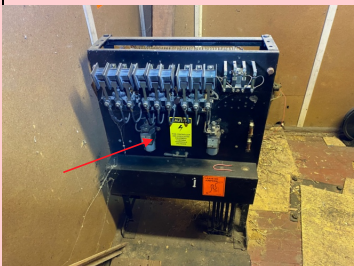
Admin Building	Interior	Admin Building, Level 1, ceiling space, Lift Room, disused board	Asbestos	Mastic like material	-	Presumed Positive

16	Non-Friable	1	1	1	1	2	P4 / Negligible		Removal and disposal according to NOHSC 2006 and local guidelines prior to demolition	
Admin Building, Pathology Building	Exterior	Admin Building and Pathology Building, ceiling space, ceiling cavity, insulation and pipe lagging	Asbestos	FC sheeting	5	NAD; SMF

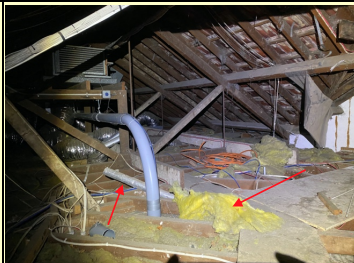
17	Friable	NA	NA	NA	NA	NA	NA		Ceiling cavities were covered with insulation; inspection required prior to demolition. Presumed to be hidden service risers containing asbestos and contamination, under SMF insulation

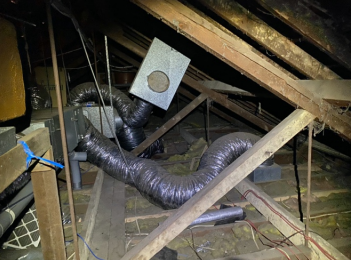
19	Friable	NA	NA	NA	NA	NA	NA		Ceiling cavities were covered with insulation; inspection required prior to demolition. Presumed to be hidden service risers containing asbestos and contamination, under SMF insulation

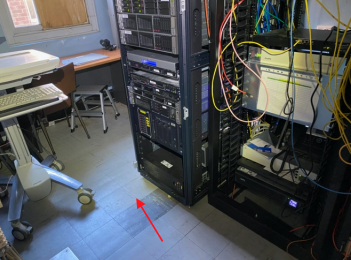
Admin Building	Interior	Admin Building, Ground floor, IT room, flooring, vinyl tiles, 12m2	Asbestos	Vinyl tiles	17	Positive

20	Non-Friable	1	1	1	1	2	P4 / Negligible		Removal and disposal according to NOHSC 2006 and local guidelines prior to demolition	
Admin Building	Interior	Admin Building, Ground floor, Pharmacy, entry room and office room, blue vinyl tiles, 20m2	Asbestos	Vinyl tiles	19	Positive

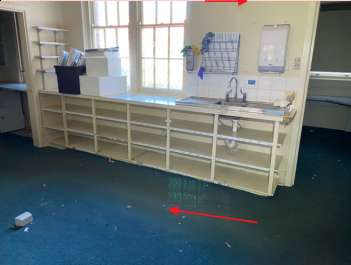
21	Non-Friable	1	1	1	1	2	P4 / Negligible		Removal and disposal according to NOHSC 2006 and local guidelines prior to demolition

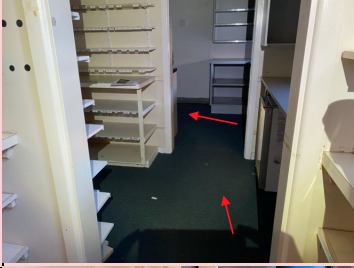
Building Level / Floor	Location Description	Material Location	Type of Material	Hazard Type	Sample No.	Sample Result	Photos	Photo No.	Asbestos Risk Assessment							Labelled	Comments/ Condition	Action Taken
									Asbestos Type	Condition	Location	Airborne Potential	Exposure	Hazard Level	Health Risk/Action Priority Level			
Admin Building	Interior	Admin Building, Ground floor, Pharmacy, back two rooms, blue vinyl tiles under carpet and grey tiles under table, 16 m2	Asbestos	Vinyl tiles	19	Positive

22	Non-Friable	1	1	1	1	2	P4 / Negligible		Removal and disposal according to NOHSC 2006 and local guidelines prior to demolition	
Admin Building	Interior	Admin Building, Kitchen, Fire door core, insulation, poor	Asbestos	Insulation	20	NAD; SMF

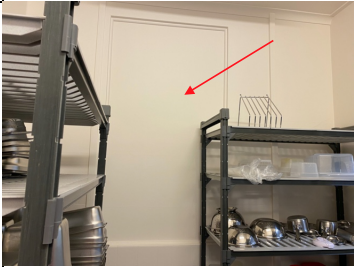
24	Non-Friable	NA	NA	NA	NA	NA	NA

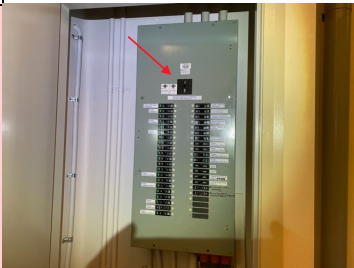
Admin Building / Pathology	Interior	Electrical distribution board - 1 unit	Asbestos	Backing	-	Presumed Positive

25	Non-Friable	1	1	1	1	2	P4 / Negligible		Energized, encapsulated.

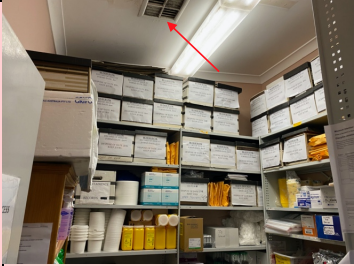
27	Non-Friable	NA	NA	NA	NA	NA	NA	Visually black mould contamination.	
Admin Building	Interior	Electrical distribution board - 1 unit	Asbestos	Backing	-	Presumed Positive

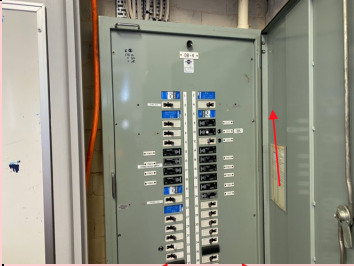
28	Non-Friable	1	1	1	1	2	P4 / Negligible	Energized, encapsulated. Inspection required prior to demolition.

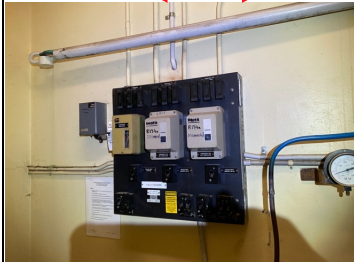
Admin Building	Interior	Kitchen, Compressor Plant Room	Asbestos	Mastic like material	NIL	Presumed positive

29	Non-Friable	NA	NA	NA	NA	NA	NA	Electrical Hazards

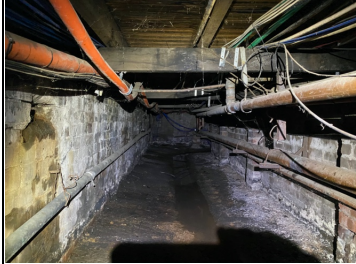
Building Level / Floor	Location Description	Material Location	Type of Material	Hazard Type	Sample No.	Sample Result	Photos	Photo No.	Asbestos Risk Assessment							Labelled	Comments/ Condition	Action Taken
									Asbestos Type	Condition	Location	Airborne Potential	Exposure	Hazard Level	Health Risk/Action Priority Level			
Admin Building, Yeoman, Pathology	Interior	Admin building, subfloor - pipes throughout, entry through southern verandah, floor hole, adjacent to Kitchen	Asbestos	soil surfaces, pipes, gaskets	-	Presumed negative

30	NA	NA	NA	NA	NA	NA	NA		Confined space; on-site inspection for all subfloors (Admin, Pathology, Yeoman Ward) recommended prior to demolition.	
Admin Building	Interior	34 Admin building, subfloor, soil with debris	Asbestos	Debris	34	Negative

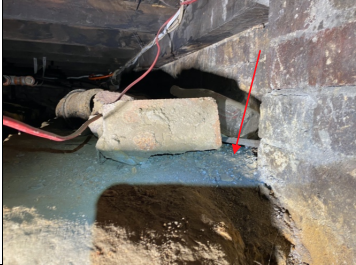
31	Friable	NA	NA	NA	NA	NA	NA		Confined space; on-site inspection for all subfloors (Admin, Pathology, Yeoman Ward) recommended prior to demolition.

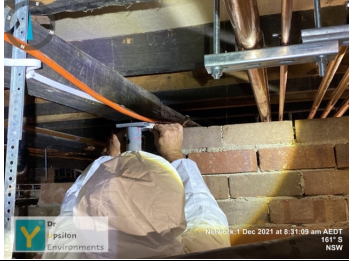
Building Level / Floor	Location Description	Material Location	Type of Material	Hazard Type	Sample No.	Sample Result	Photos	Photo No.	Asbestos Risk Assessment							Labelled	Comments/ Condition	Action Taken
									Asbestos Type	Condition	Location	Airborne Potential	Exposure	Hazard Level	Health Risk/Action Priority Level			
Yeomans Building	Interior	Subfloor, Northern Middle Section - Partition Wall - 2 packers; Far north end - 2 piers	Asbestos	FC sheeting	-	Negative

34	Non-Friable	-	-	-	-	-	NA	N	New FC sheeting packers with metal cover were used to replace the 2 asbestos packers. 2 new FC packers with metal were added to the far northern end piers.	Replaced on 1st December, 2021.
Yeomans Building	Interior	Subfloor, Northern Middle Section - north-eastern corner	Asbestos	FC debris	-	Negative

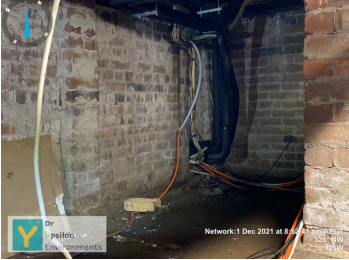
35	-	-	-	-	-	NA	NA	N	Big visible FC fragments were removed. Source from ground floor FC addition.	Removed visible big pieces.

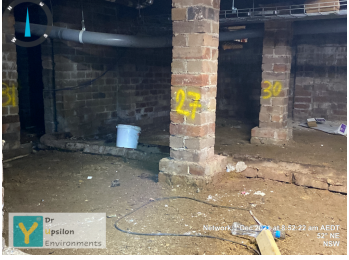
Yeomans Building	Interior	Subfloor, Northern Middle Section - north-eastern corner	Asbestos	FC debris	-	Negative

36	-	-	-	-	-	-	NA	N	Big visible FC fragments were removed. Source from ground floor FC drilling.	Removed big visible pieces.
Yeomans Building	Interior	Subfloor, Northern Middle Section - Presumed Negative FC Area 2 (20m2)	Asbestos	FC debris	-	Presumed Negative

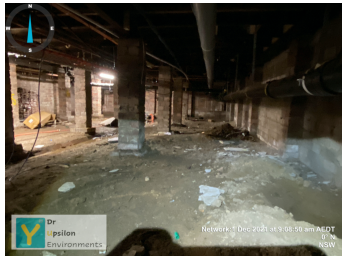
37	-	-	-	-	-	-	NA	N	Source from ground floor FC drilling.
