Building TA 34 (Staff Accommodation)

Asbestos Audit

Asbestos Register Review & Update

April 2016

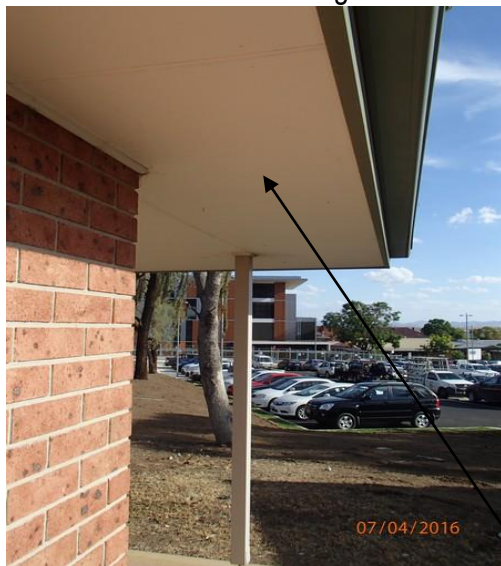
PHOTO N°1: Eave Soffit Lining

<i>Sample No.</i>	<i>Date Analysed</i>	<i>Sample Description</i>	<i>Asbestos ID in materials</i>
TA34-01	13/04/2016	Sample of FFCS soffit lining to eaves and front verandah.	No Asbestos Detected

The FFCS material used to line the soffit of eaves and the front verandah was tested and proved **NOT** to be asbestos-containing material
