Building TA 08 Rotary Hostel

Smith Street, Tamworth Base Hospital NSW

Asbestos Audit

Asbestos Register Review & Update

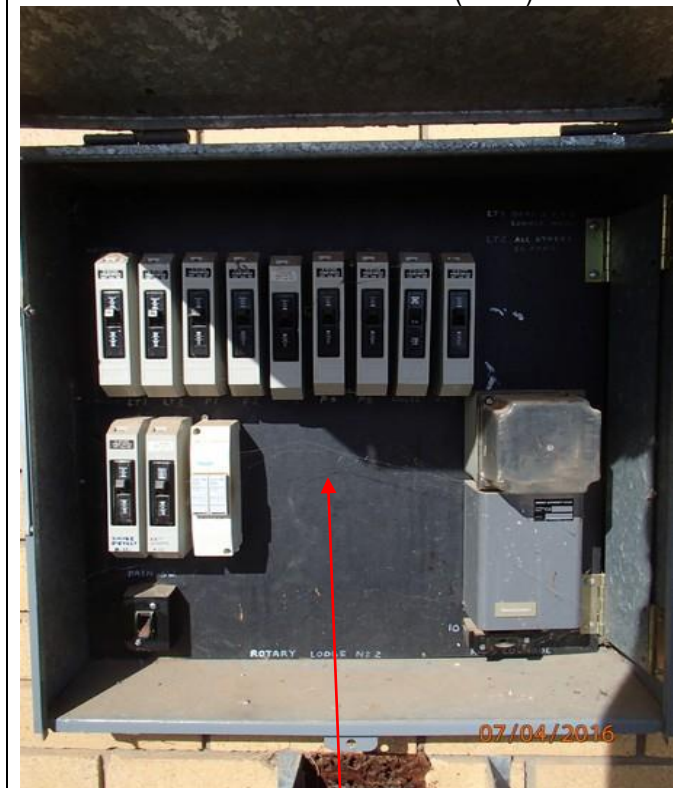
PHOTO N°1: Electrical Switch board (TA08)

- The insulation panel to the electrical switchboard is of like age and appearance to a known asbestos-containing material commonly used for this application and, as such, SHALL be regarded as an asbestos containing material.

The insulation panel to the electrical switchboard is of like age & appearance to a known asbestos-containing materials and as such shall be regarded as an asbestos containing material

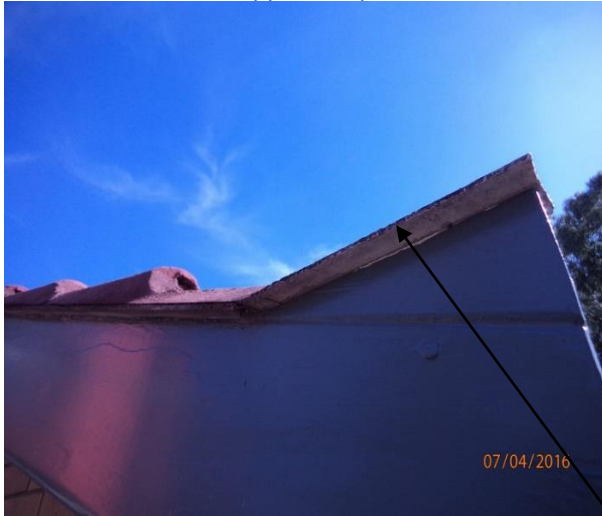
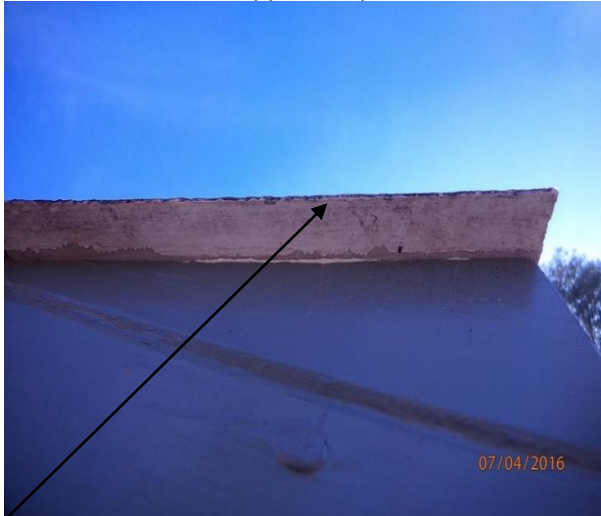
The FFCS tile support strip (undercloaking) TA08 was tested and **proved NOT to be asbestos containing material**

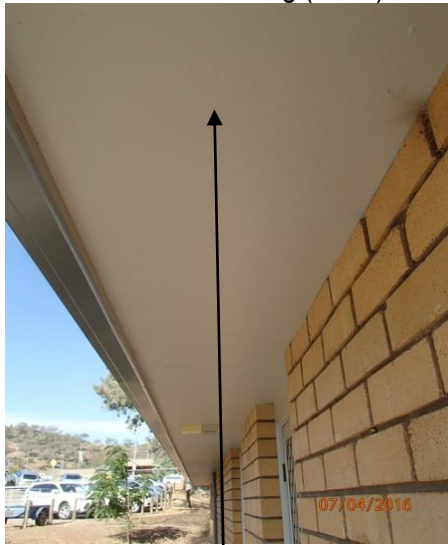
PHOTO N°4: Eave Soffit Lining (TA08)

The FFCS eave soffit lining TA08 was tested and **proved NOT to be asbestos containing material**

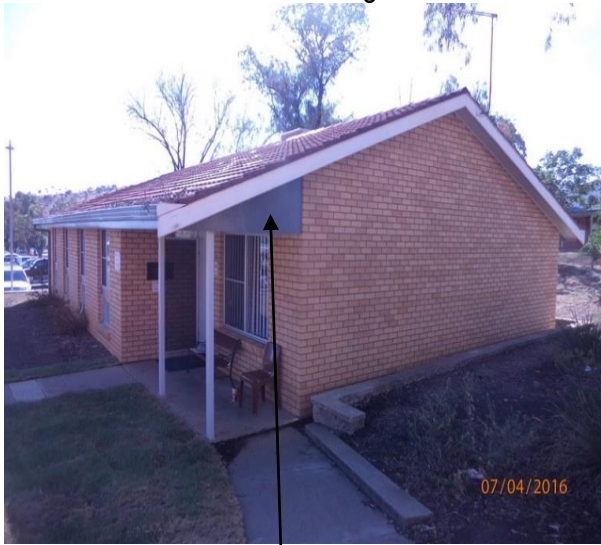
PHOTO N°5: Gable Over Hangs

The FFCS gable overhangs TA08 were tested and **proved NOT to be asbestos containing material**

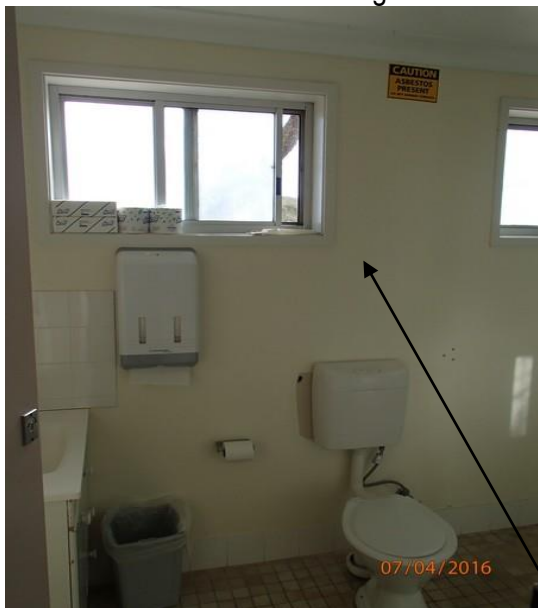
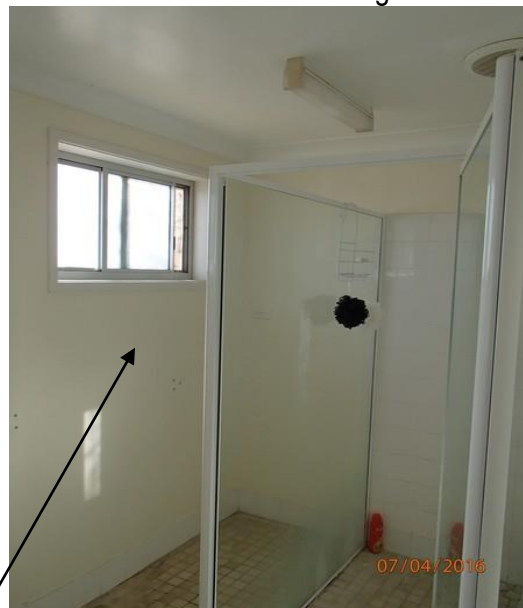
The FFCS wall lining to bathrooms (TA0800008, TA0800007) were tested and **proved**
NOT to be asbestos containing material
