CIVICA

20 February 2023

Arboricultural Impact Assessment Report regarding eighteen (18) trees located within the vicinity of the proposed Tamworth Hospital - Banksia Unit development

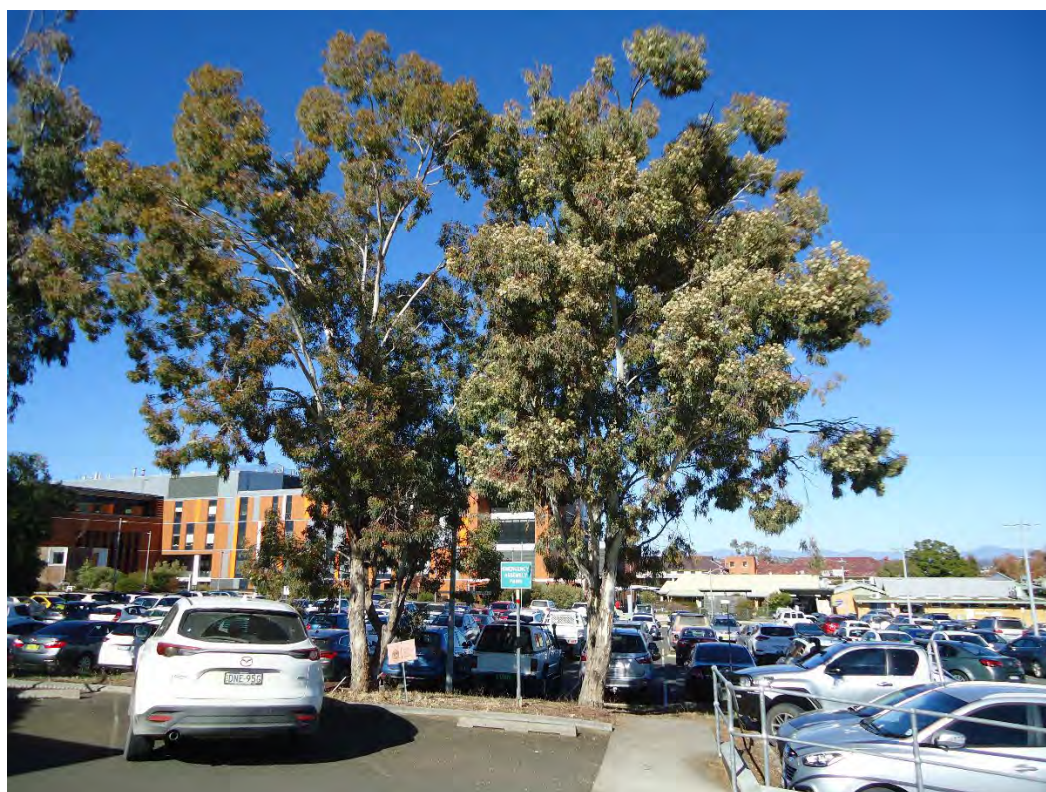
Figure 3. View to south of Trees 1 & 2 *Eucalyptus melliodora* (Yellow Box) in their growing environment. (ArborSafe, May 2021).

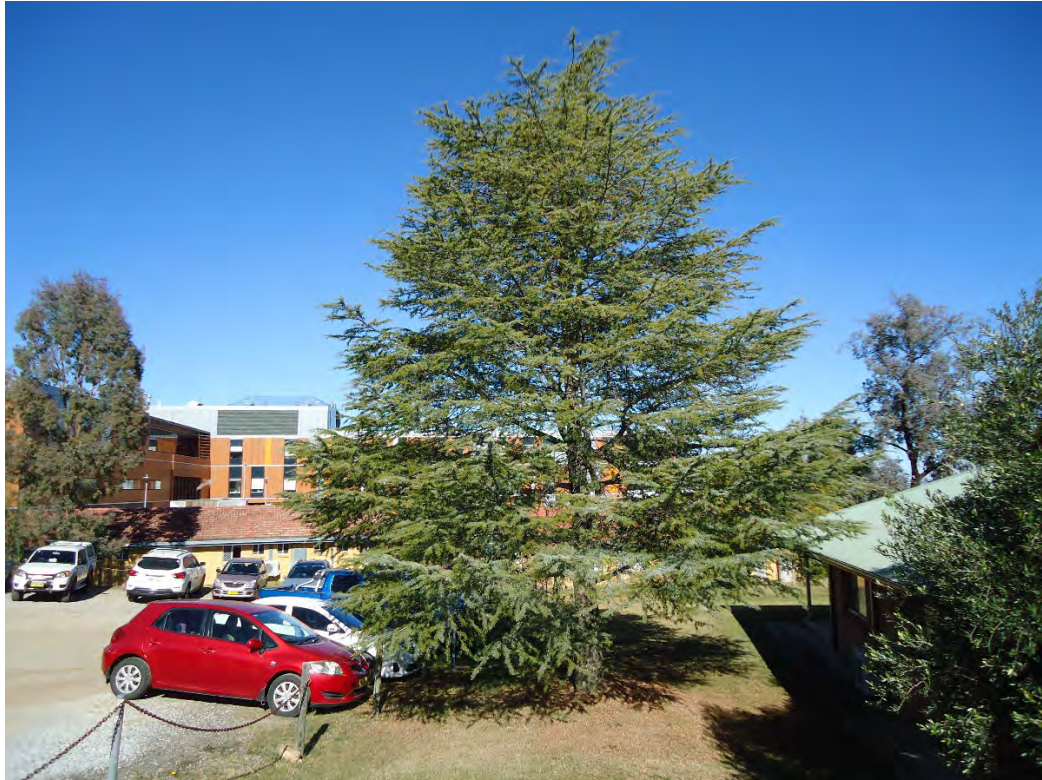
Figure 4. View to south of Tree 7 *Cedrus deodara* (Himalayan Cedar) in its growing environment. (ArborSafe, May 2021).

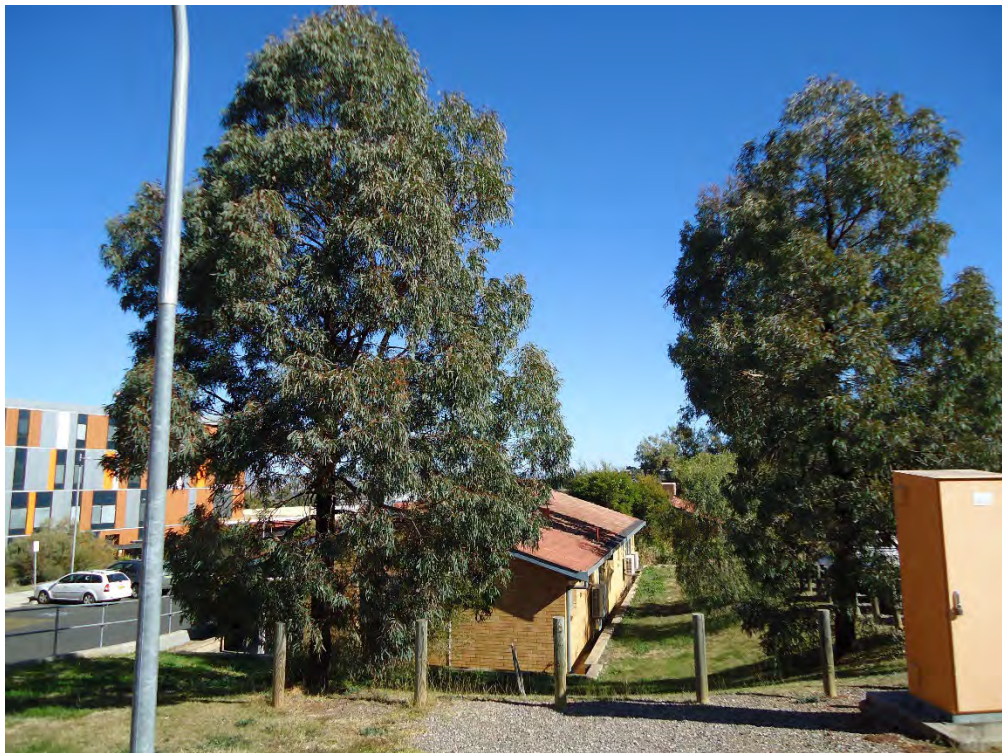
- 5.2.3 The dominant species within the site was *Eucalyptus sideroxylon* (Red Ironbark) with a line of juvenile trees having been planted at the eastern end of the area to complement the existing declining mature specimen. The structure within the young trees was not good with multiple included unions observed which would limit future ULE.

Figure 5. View to west of Trees 8 & 9 *Eucalyptus sideroxylon* (Red Ironbark) in their growing environment. (ArborSafe, May 2021).

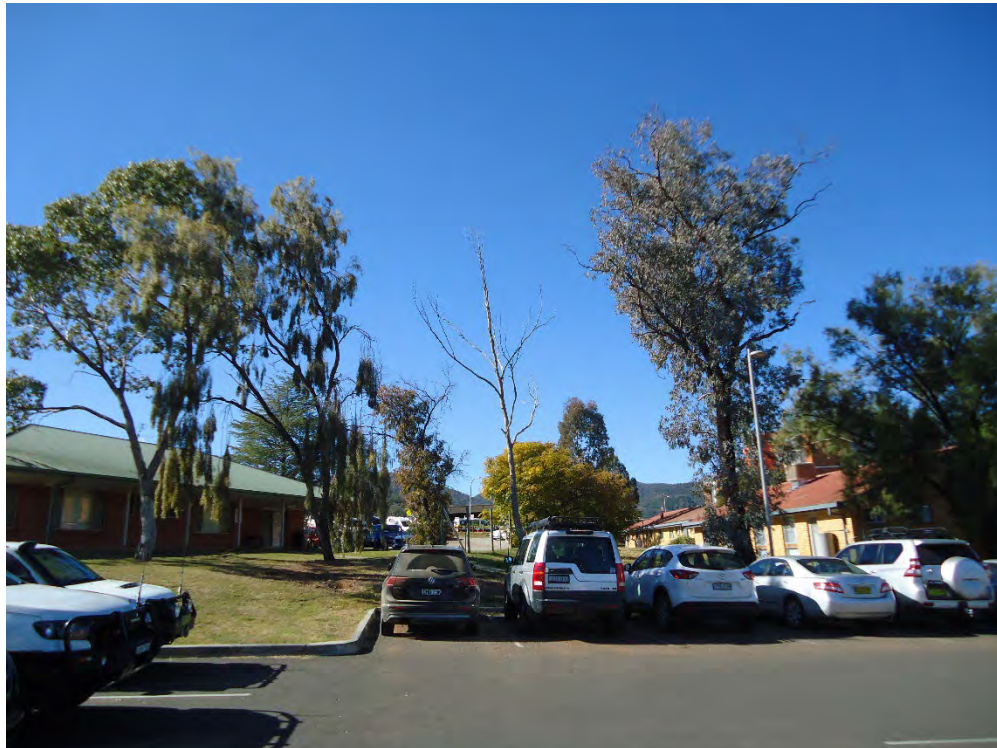
Figure 6. View to south of Trees 13 – 18 in their growing environment. (ArborSafe, May 2021).

14	<i>Eucalyptus sideroxylon</i>	Red Ironbark	Endemic	1	85		10.2	326.53		15-20	5-10	Fair	Fair	Mature	15-25	Deadwood/stubs > 60mm;Dieback;Epicormic growth;Suckers;	Amenity value/shade;Significant due to age/size;	- 27-05-2021 : Andy Clark : The tree is in a reduced state of health with moderate canopy density, small terminal branch dieback & the remaining foliage consisting of 70% epicormic growth. Recent health improvement observed, possibly following good seasonal rains. Remove dead and declining branches back to live wood to encourage epicormic growth. Estimated height to base of canopy is 6m.	B	2	Remove - tree located within proposed development footprint or has major encroachment into its TPZ.
15	<i>Dead Tree</i>	Dead tree	Native	1	36		4.3	59.04		5-10	<5	Dead	Hazardous	Semi-Mature	0	Deadwood/stubs > 100mm;Decay;Previous failure(s);Weak union(s);		- 27-05-2021 : Andy Clark : Dead tree requires removal.	U		Remove tree irrespective of future development.

16	<i>Eucalyptus sideroxylon</i>	Red Ironbark	Endemic	1	32		3.8	46.01		5-10	<5	Poor	Poor	Juvenile	0	Deadwood/stubs > 30mm;Epicormic growth;Excessive thinning;		- 27-05-2021 : Andy Clark : The tree is in a reduced state of health with minimal canopy density, all branches dead & the remaining foliage consisting of 100% epicormic growth growing from the trunk.	U		Remove tree irrespective of future development.
17	<i>Acacia pendula</i>	Weeping Myall	Endemic	1	45		5.4	93.06		10-15	10-15	Good	Hazardous	Mature	<5	Co-dominant stems;Crack(s)/split(s);Included bark;Weak union(s);		- 27-05-2021 : Andy Clark : Tree presents with multiple included unions throughout crown structure. Removal recommended due to separation observed between main included stem union at 5m.	U		Remove tree irrespective of future development.
18	<i>Eucalyptus bridgesiana</i>	Apple Box	Endemic	1	56		6.7	141.73		10-15	10-15	Good	Fair	Semi-Mature	25-50	Co-dominant stems;Wound(s);	Amenity value/shade;Attractive landscape feature;	- 27-05-2021 : Andy Clark : Good response growth around lower trunk wound, western aspect, with no sap exudation, fungal fruiting bodies, cambial dieback or significant decay observed. Slight canopy bias to the north. Estimated height to base of canopy is 7m. Target prune to provide 2m clearance from building edge.	B	1	Remove - tree located within proposed development footprint or has major encroachment into its TPZ.

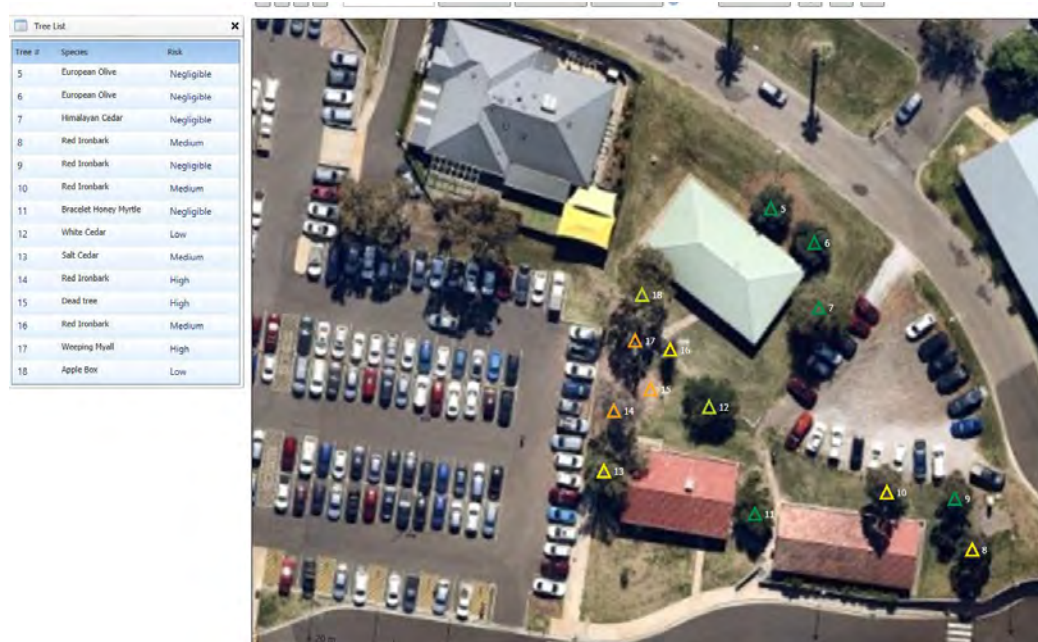
Figure 9. Site map showing trees recommended for/requiring removal to facilitate development. (ArborSafe, May 2021).

- 7.1.1 Eleven (11) trees would require removal, based on the supplied design proposal, to facilitate the development.
- 7.1.2 A further three (3) trees should be removed irrespective of development (Cat U) due to poor health and/or structure.

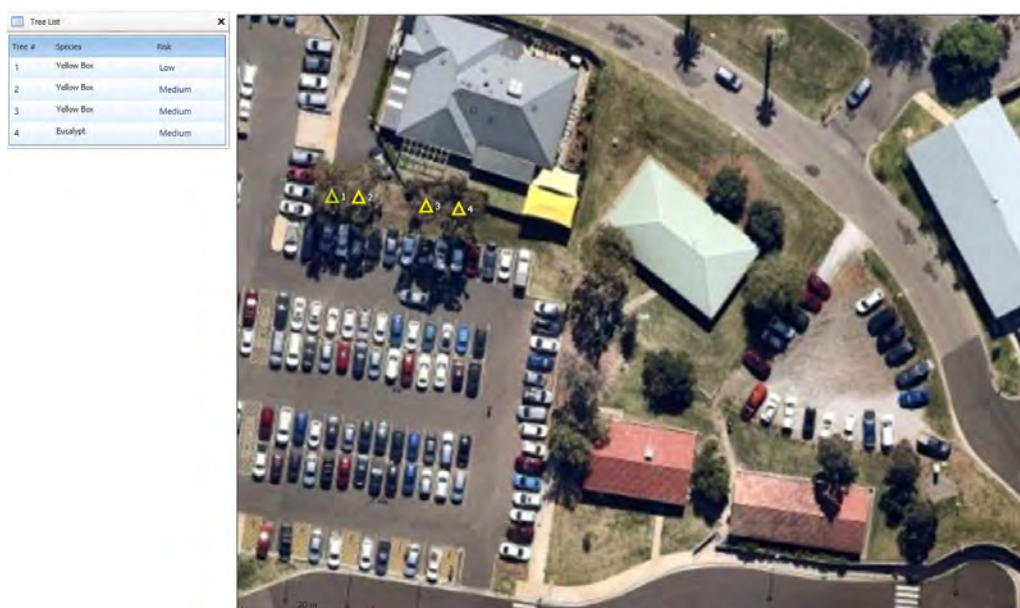
Figure 10. Site map showing tree requiring generic protection measures. (ArborSafe, May 2021).

7.2.1 Four (4) trees were recommended for retention and require generic protection measures during construction to ensure they remain viable following the completion of works.

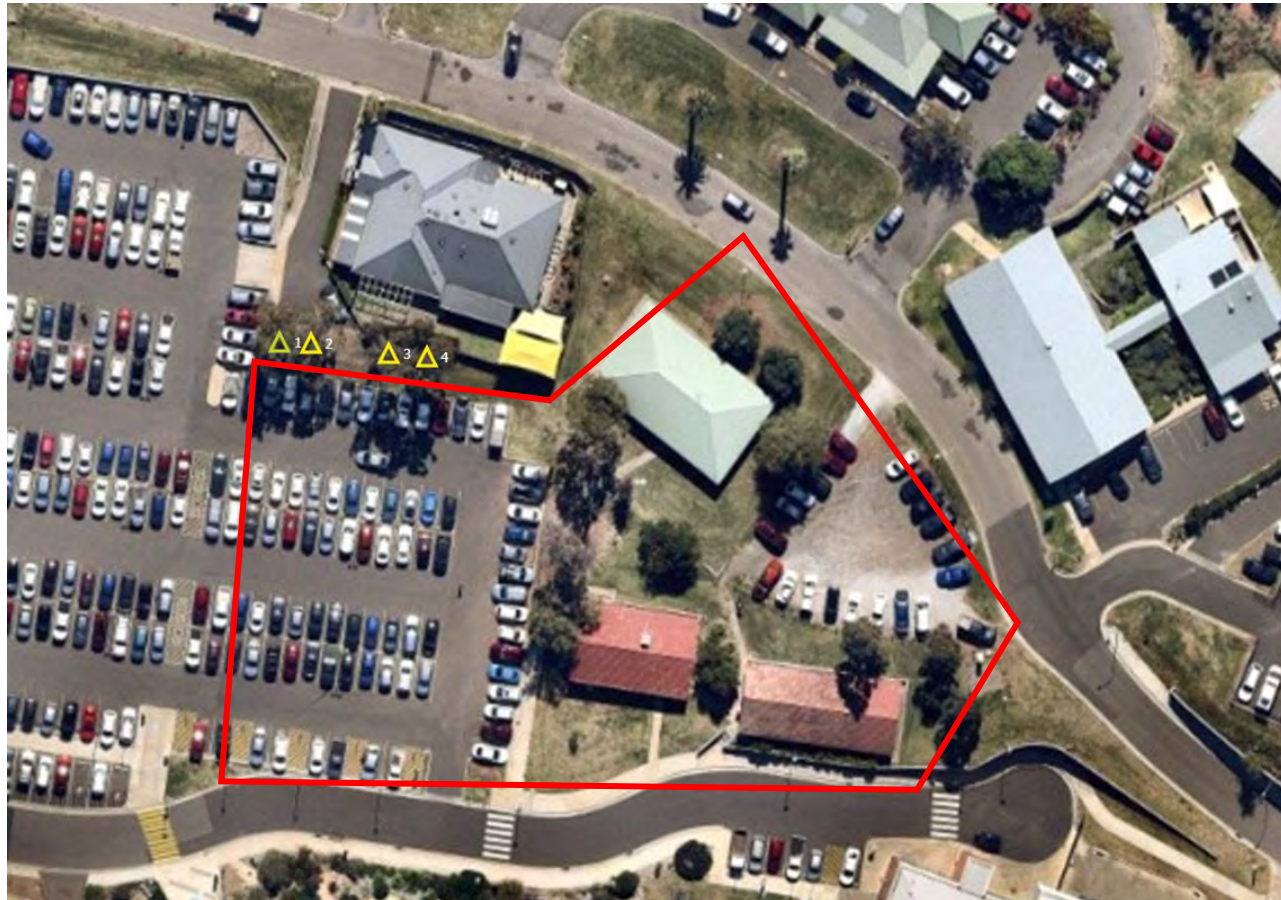
Figure 18. Site map showing retained trees with suggested Tree Protection/Site perimeter Fence locations. (ArborSafe, May 2021).
