CIVICA

20 February 2023

Arboricultural Impact Assessment Report regarding forty-eight (48) trees located within the vicinity of the proposed carparking zones at Tamworth Hospital

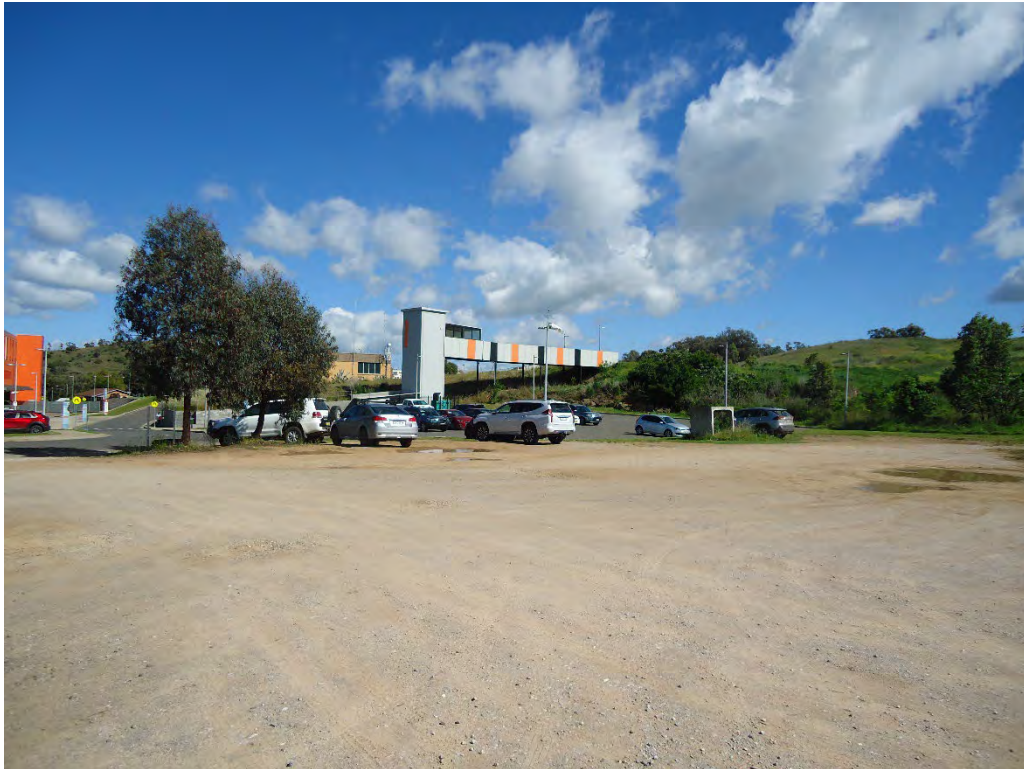
Figure 4. Overview image of carparking Zone 1 with Trees 19 and 20 to the left. (ArborSafe, 28 October 2022).

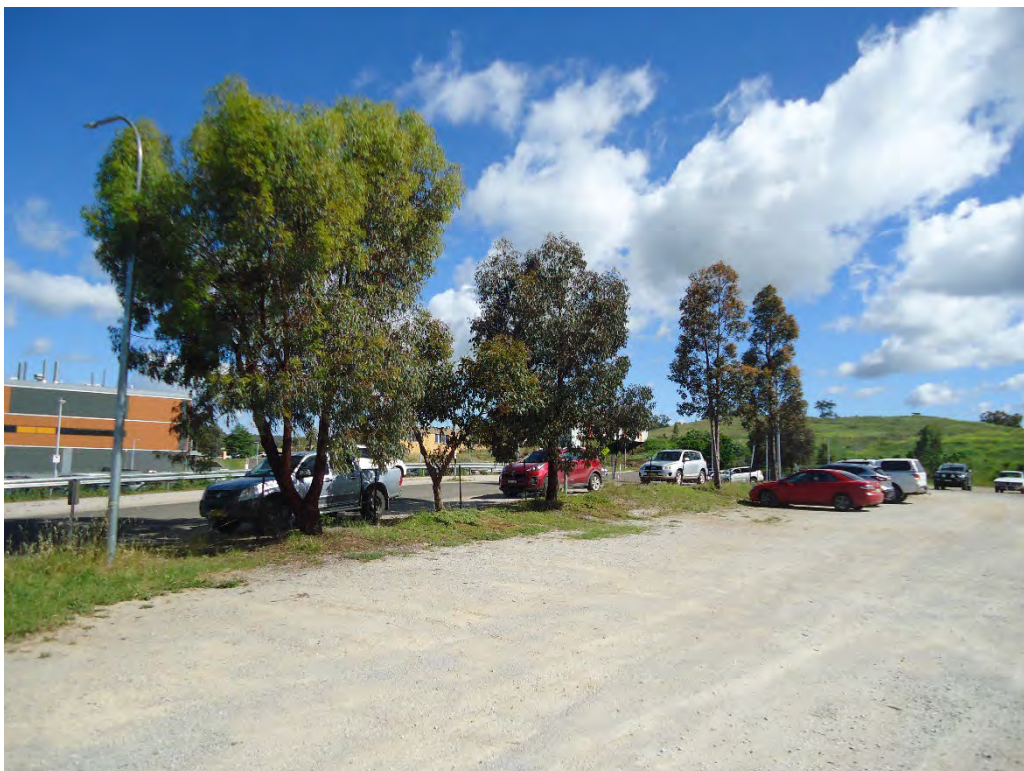
Figure 5. Overview image of the Zone 1 – extension area (refer to Figure 2), showing Trees 22–25. (ArborSafe, 28 October 2022).

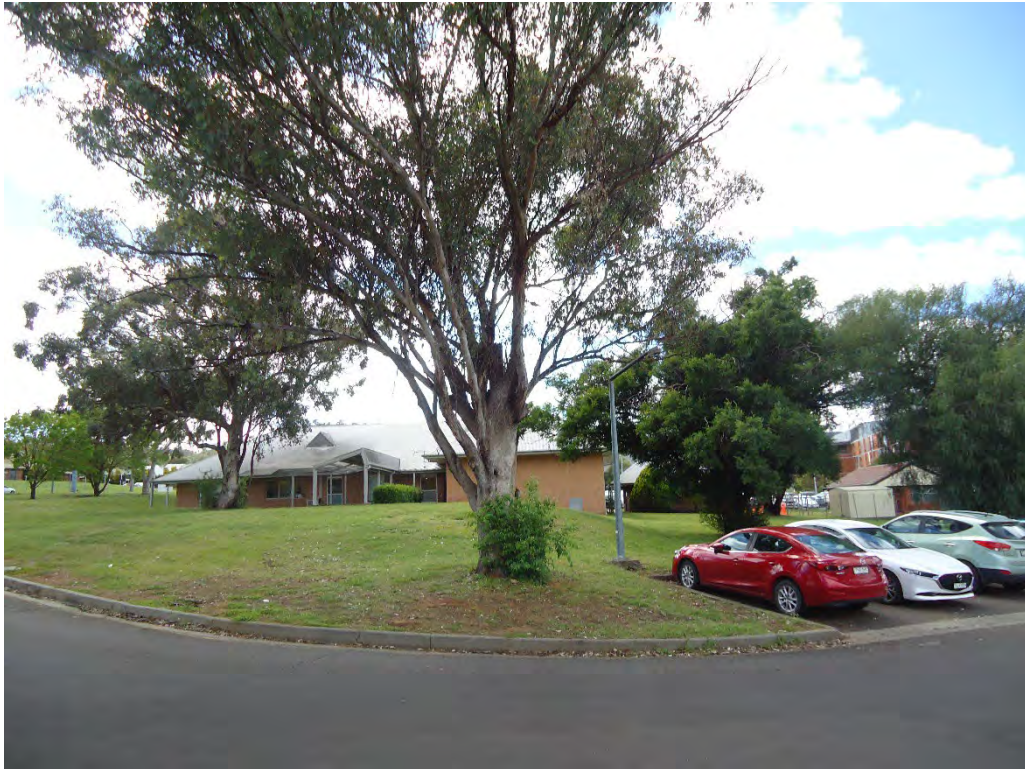
Figure 7. Overview image of carparking Zone 2, with Tree 27 in the foreground. (ArborSafe, 28 October 2022).

- 5.6.1 The site trees were considered common species in the local area and as such hold limited botanical significance.
- 5.6.2 A number of the trees were observed to have cavities or hollows which may have been of use to local fauna. These trees were identified as 26, 27, 29, 40 and 52.

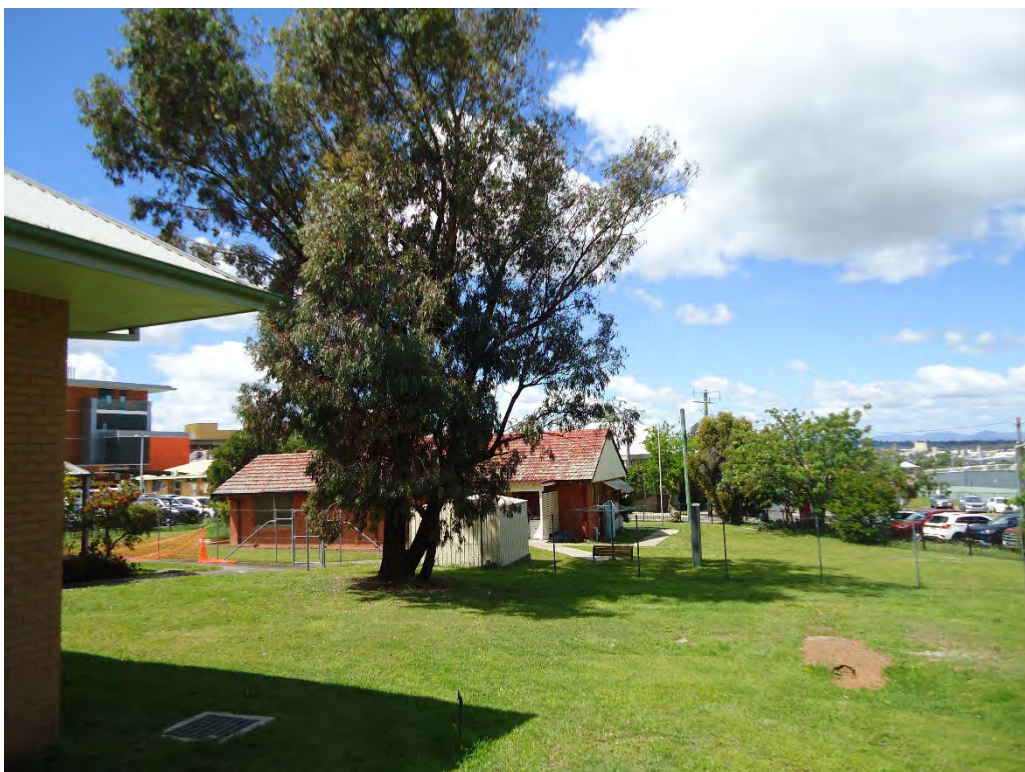
Figure 8. Overview image of carparking Zone 2, with Tree 30 in the foreground. (ArborSafe, 28 October 2022).

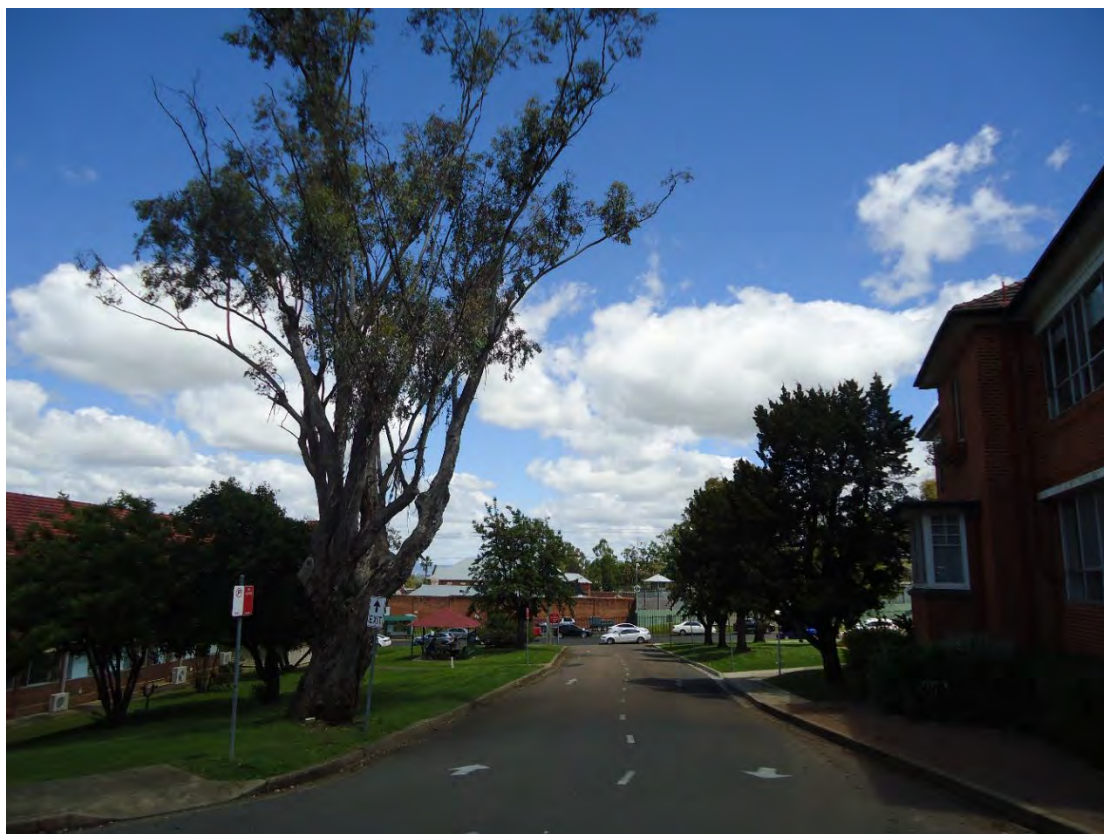
Figure 10. Overview image of carparking Zone 3, with Tree 40 in the left foreground. (ArborSafe, 28 October 2022).

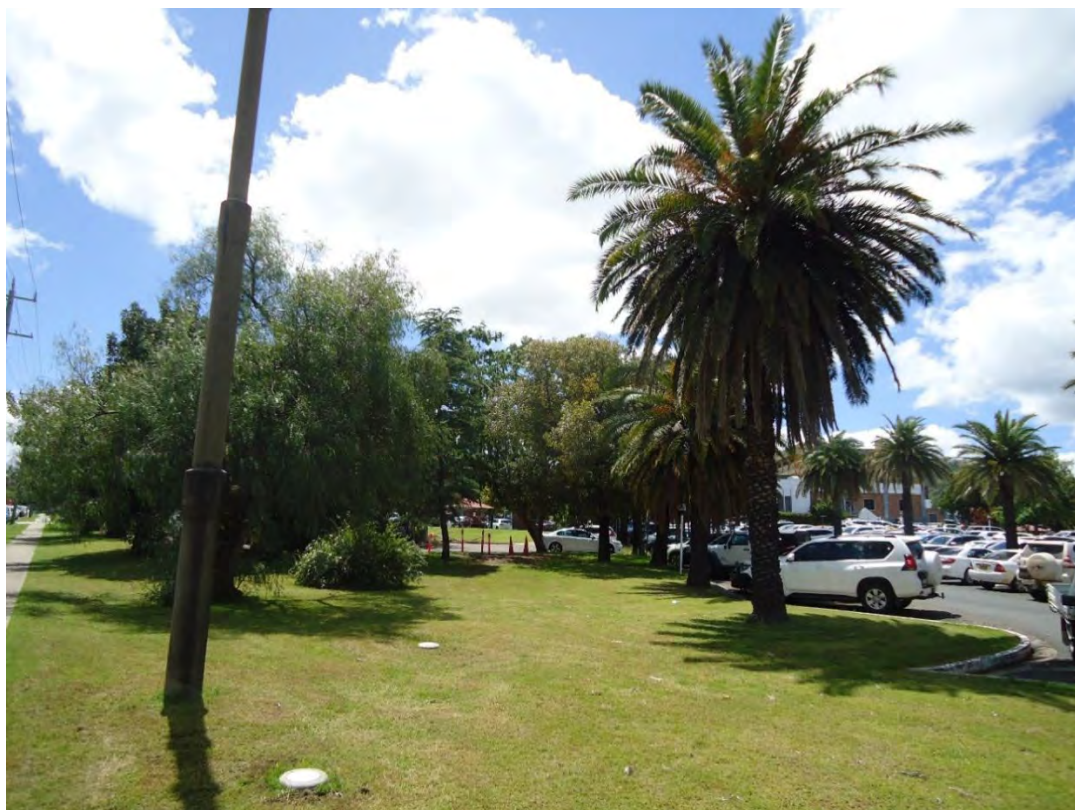
Figure 12. Overview image of carparking Zone 4, with Tree 52 and 46 in the foreground. (ArborSafe, 28 October 2022).

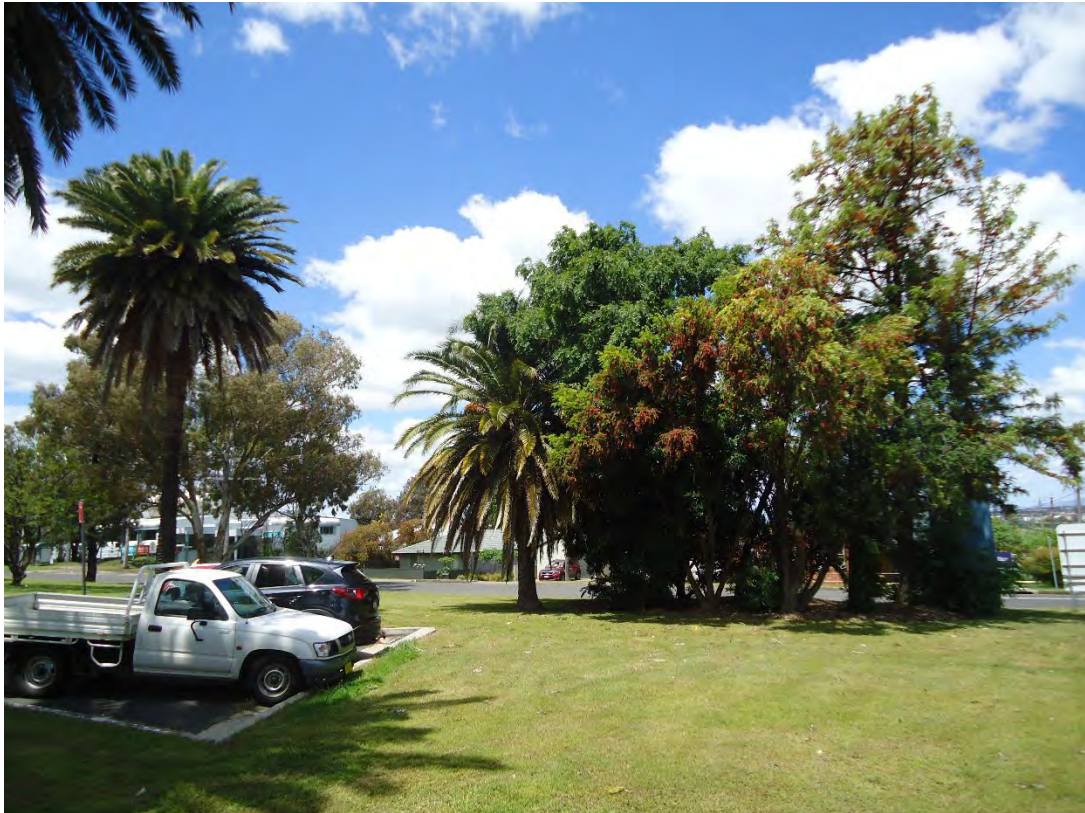
Figure 13. Overview image of carparking Zone 4, with Palm 60 in the left foreground and Trees 53-59 in the group. (ArborSafe, 28 October 2022).

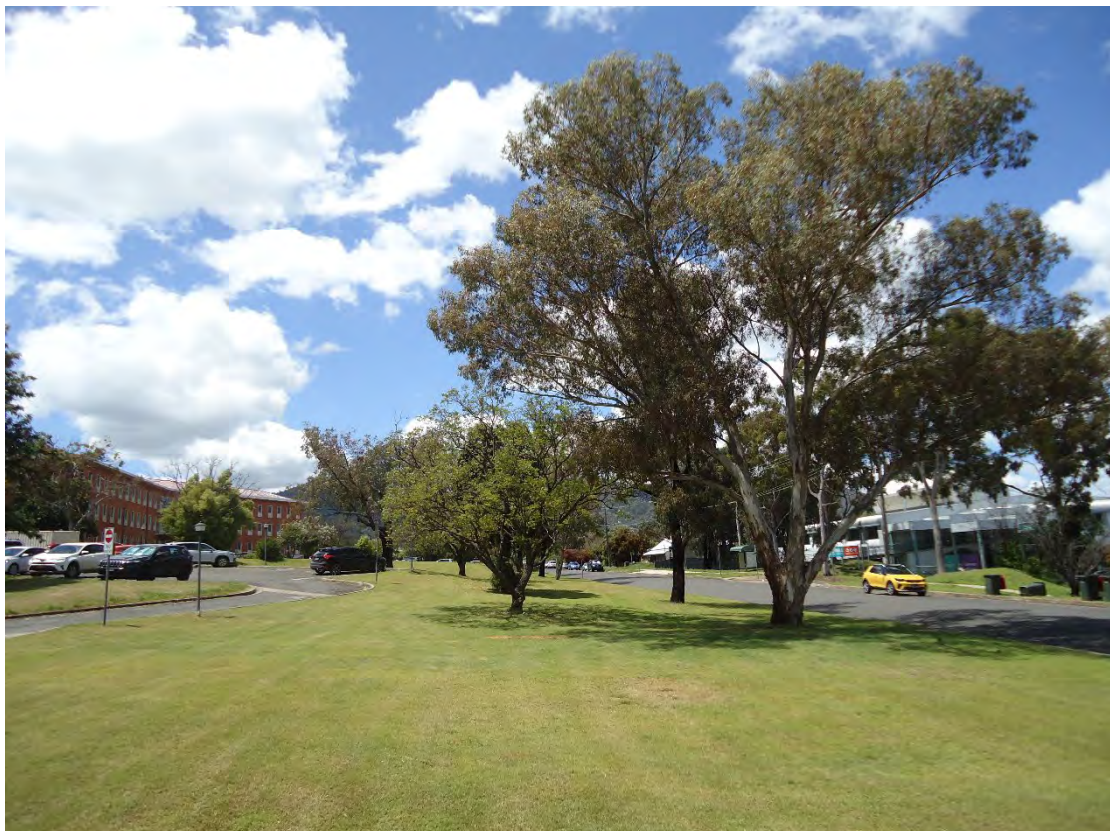
Figure 14. Overview image of carparking Zone 4, with Tree 62 in the right foreground. (ArborSafe, 28 October 2022).

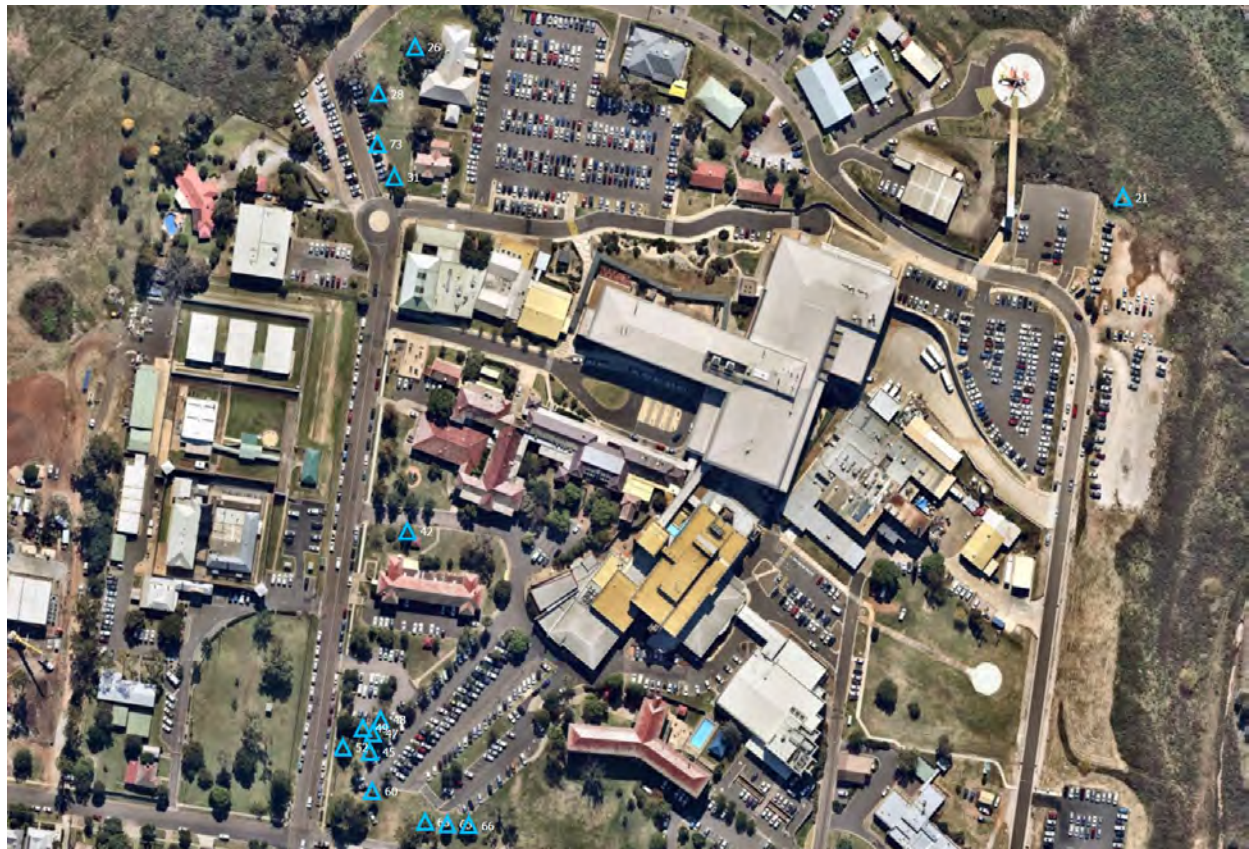
Figure 16. Site map showing trees requiring removal. (ArborSafe, October 2022).

- 7.1.1 Fifteen (15) trees would require removal, based on the supplied design, to facilitate development. Ten (10) of these have direct conflict with the proposed carparking spaces, numbered 21, 26, 28, 42, 45, 49, 60, 65, 66 and 73, while the remaining five (5), numbered 31, 47, 48, 52, and 63, have major TPZ encroachment of greater than 40%.
- 7.1.2 A further two (2) trees should be removed, in the context of development (Category U), due to poor health and/or structure, although both trees would also require removal due to either direct conflict or major TPZ encroachment

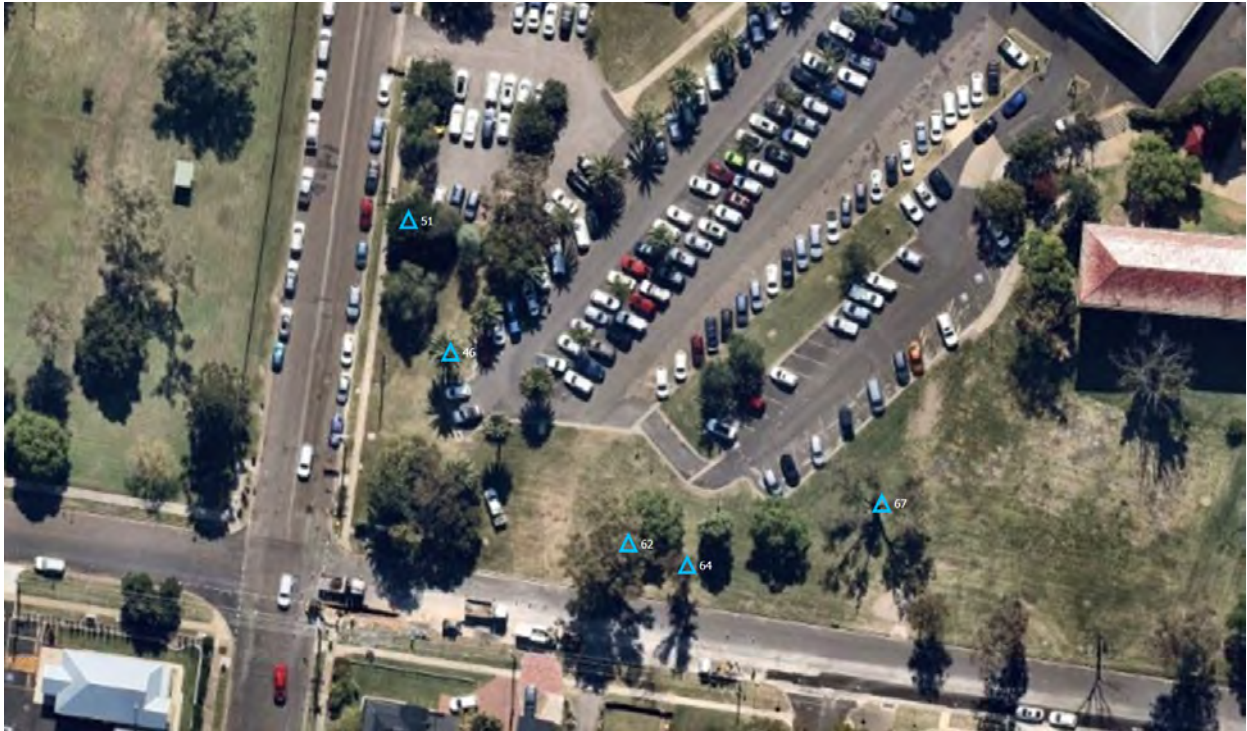
Figure 17. Site map showing trees requiring specific protection measures. (ArborSafe, October 2022).

- 1.1.6 The remaining thirty-one (31) trees are recommended for retention. Within this number, Trees 46, 51, 62, 64 and 67 have proposed development within their TPZ (Figure 17) of a TPZ encroachment percentage that should enable retention with some specific protection measures, such as further assessment following detailed design and/or site arborist supervision during initial excavation.

7.4.2 If no further design reviews are undertaken, site preparation excavation is to be carried out only under arborist supervision and works should be undertaken using techniques that are sensitive to tree roots to avoid unnecessary damage. Such techniques include:

- Arborist supervision
- The use of machinery should be undertaken from areas of hardstand to avoid potential root compaction
- The proposed excavation should commence at the outer extent of the TPZ and move inwards to minimise root damage to the tree
- No excavation should occur within the SRZ of these trees
- Roots discovered are to be treated with care and minor roots (<40mm diameter) pruned with a sharp, sterile handsaw or secateurs. All significant roots (>40mm diameter) are to be recorded, photographed and reported to the project arborist.
