Hazardous Materials Survey of Tamworth Base Hospital Johnston and Dean Streets Tamworth NSW 2340

30 April 2009

Document No.: E257043_Rpt_30APR09.doc

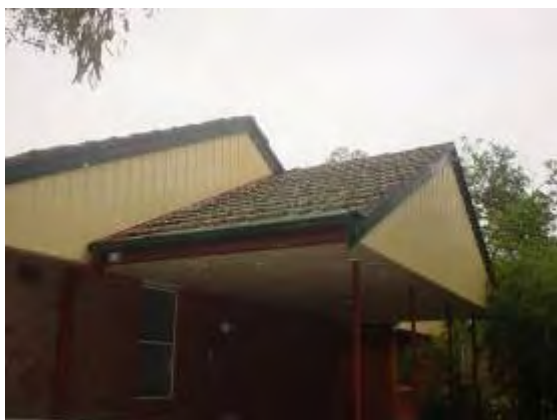
Plate P9: Building TA05 - asbestos cement linings to roof gables, eaves and ceiling of carport

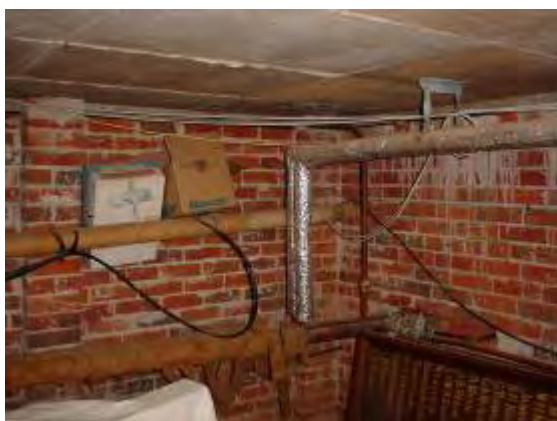
Plate P16: Building TA07 - boiler and pipework to south west boiler room which are insulated with SMF. Note: asbestos gaskets to flanged joints presumed.

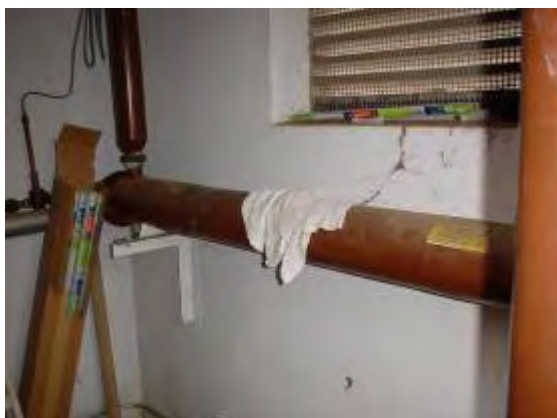
Plate P34: Building TA12 - asbestos cement ceiling linings to south east boiler room, including damaged panel

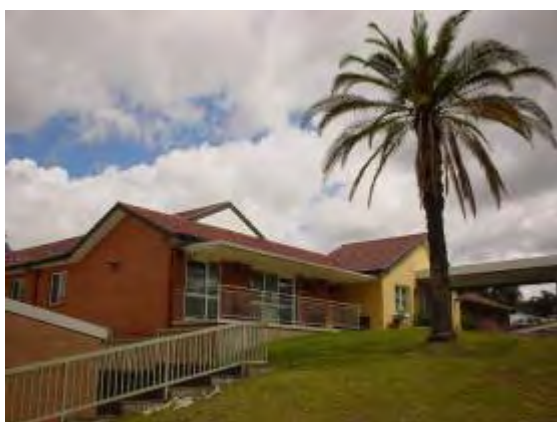
Plate P44: Building TA13 - asbestos cement wall linings to east side "Open Covered Area"

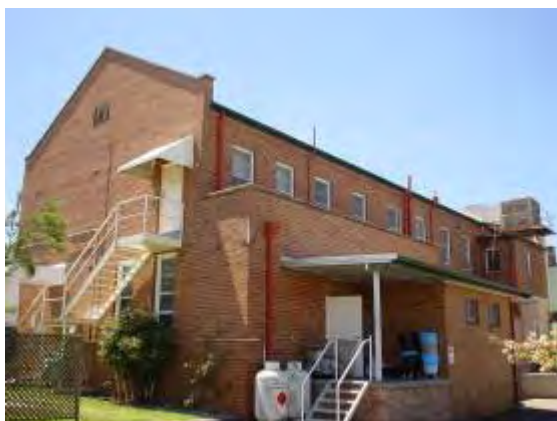
Plate P46: Building TA14 - fibrous cement fascia and ceiling linings to entry porte cochere which do not contain asbestos

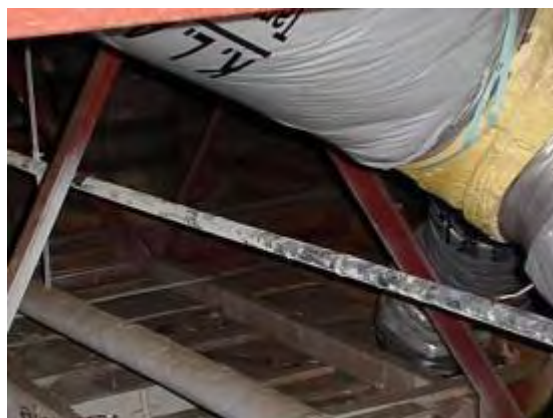
Plate P59: Building TA15- hot water pipes in roof space which are insulated with SMF

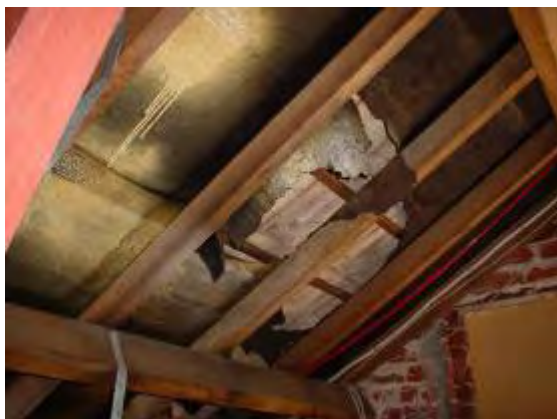
Plate P60: Building TA15 - air conditioning ductwork in roof space which is insulated with SMF and residue to pipework which does not contain asbestos

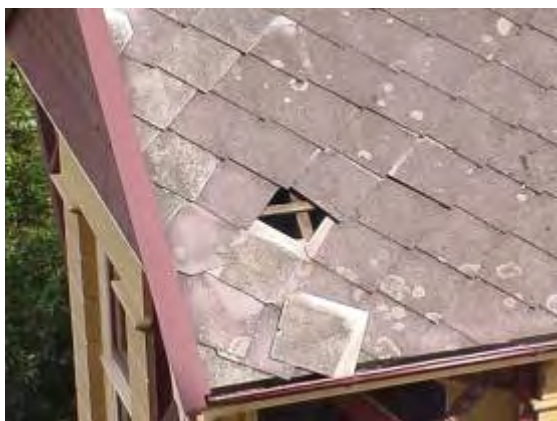
Plate P76: Building TA19 - asbestos cement shingle tiles to south east projecting wing

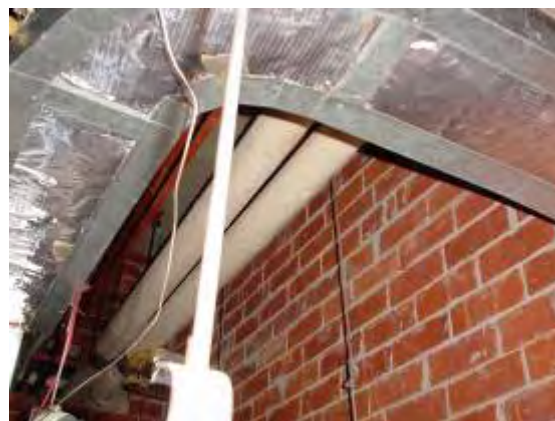
Plate P93: Building TA20 - typical asbestos lagged pipework to ceiling spaces

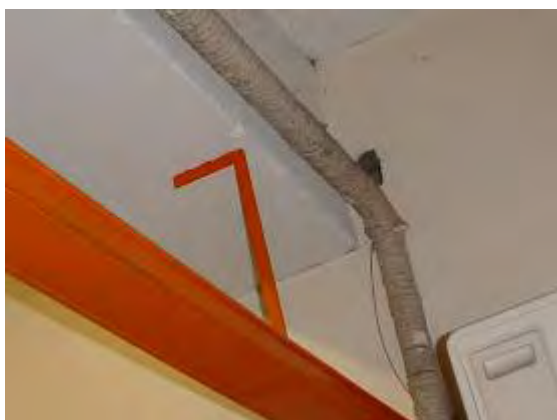
Plate P94: Building TA20 - asbestos lagged pipework to ceiling space and air conditioning ductwork which is insulated with SMF

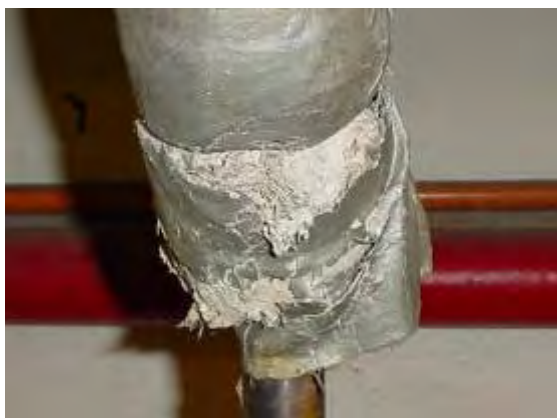
Plate P98: Building TA20 - typical asbestos lagged pipework and manifold to basement plant area

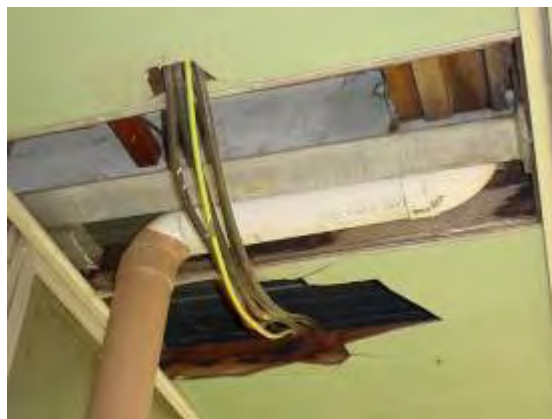
Plate P103: Building TA21 – asbestos cement fascia soffit linings to southern workshop wing

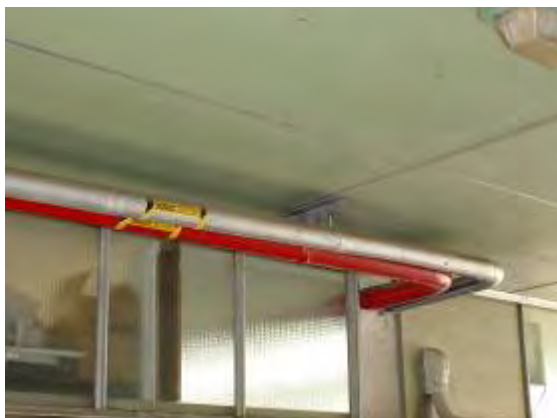
Plate P104: Building TA21 - damaged asbestos cement ceiling lining to breezeway adjacent workshop offices

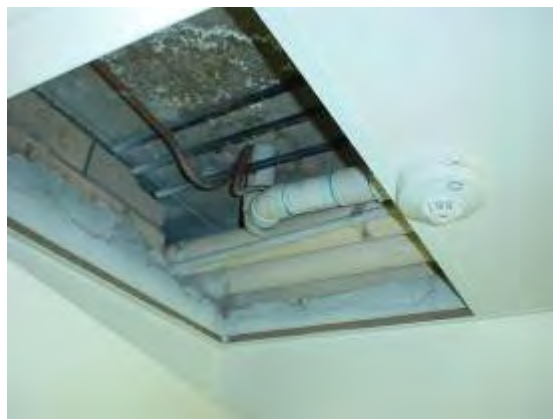
Plate P133: Building TA26 - asbestos lagged pipework in foundation space

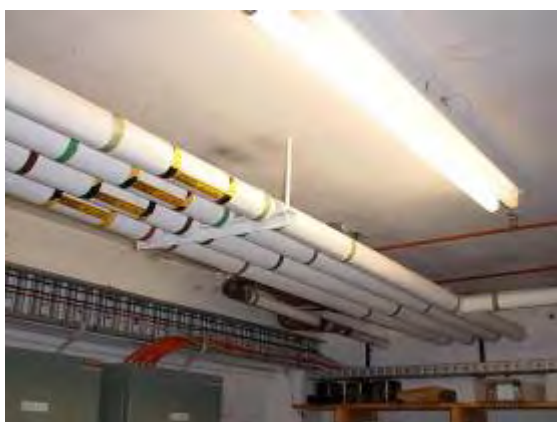
Plate P134: Building TA26 - asbestos lagged pipework in ceiling space

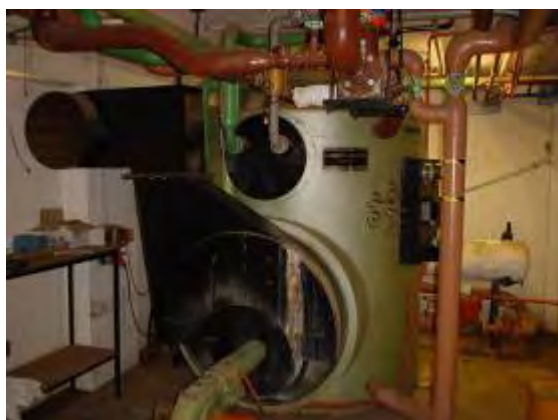
Plate P136: Building TA26 - asbestos lagged calorifier to plant/boiler room

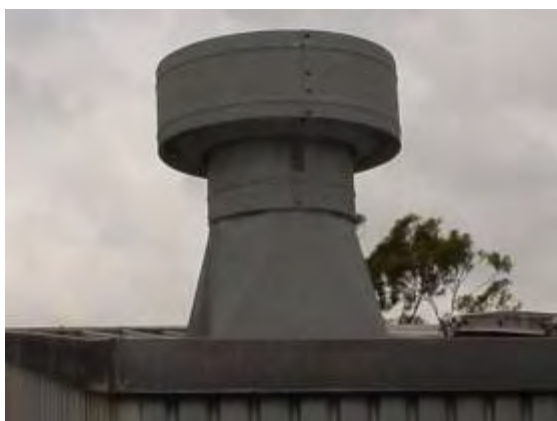
Plate P148: Building TA30 - Flammable Liquid Store
