# POLO FLAT ROAD PRECINCT 2 TREE ASSESSMENT

Lots 2 and 4 DP1285072

Issue B: 17.10.2022

**Stantec Australia**

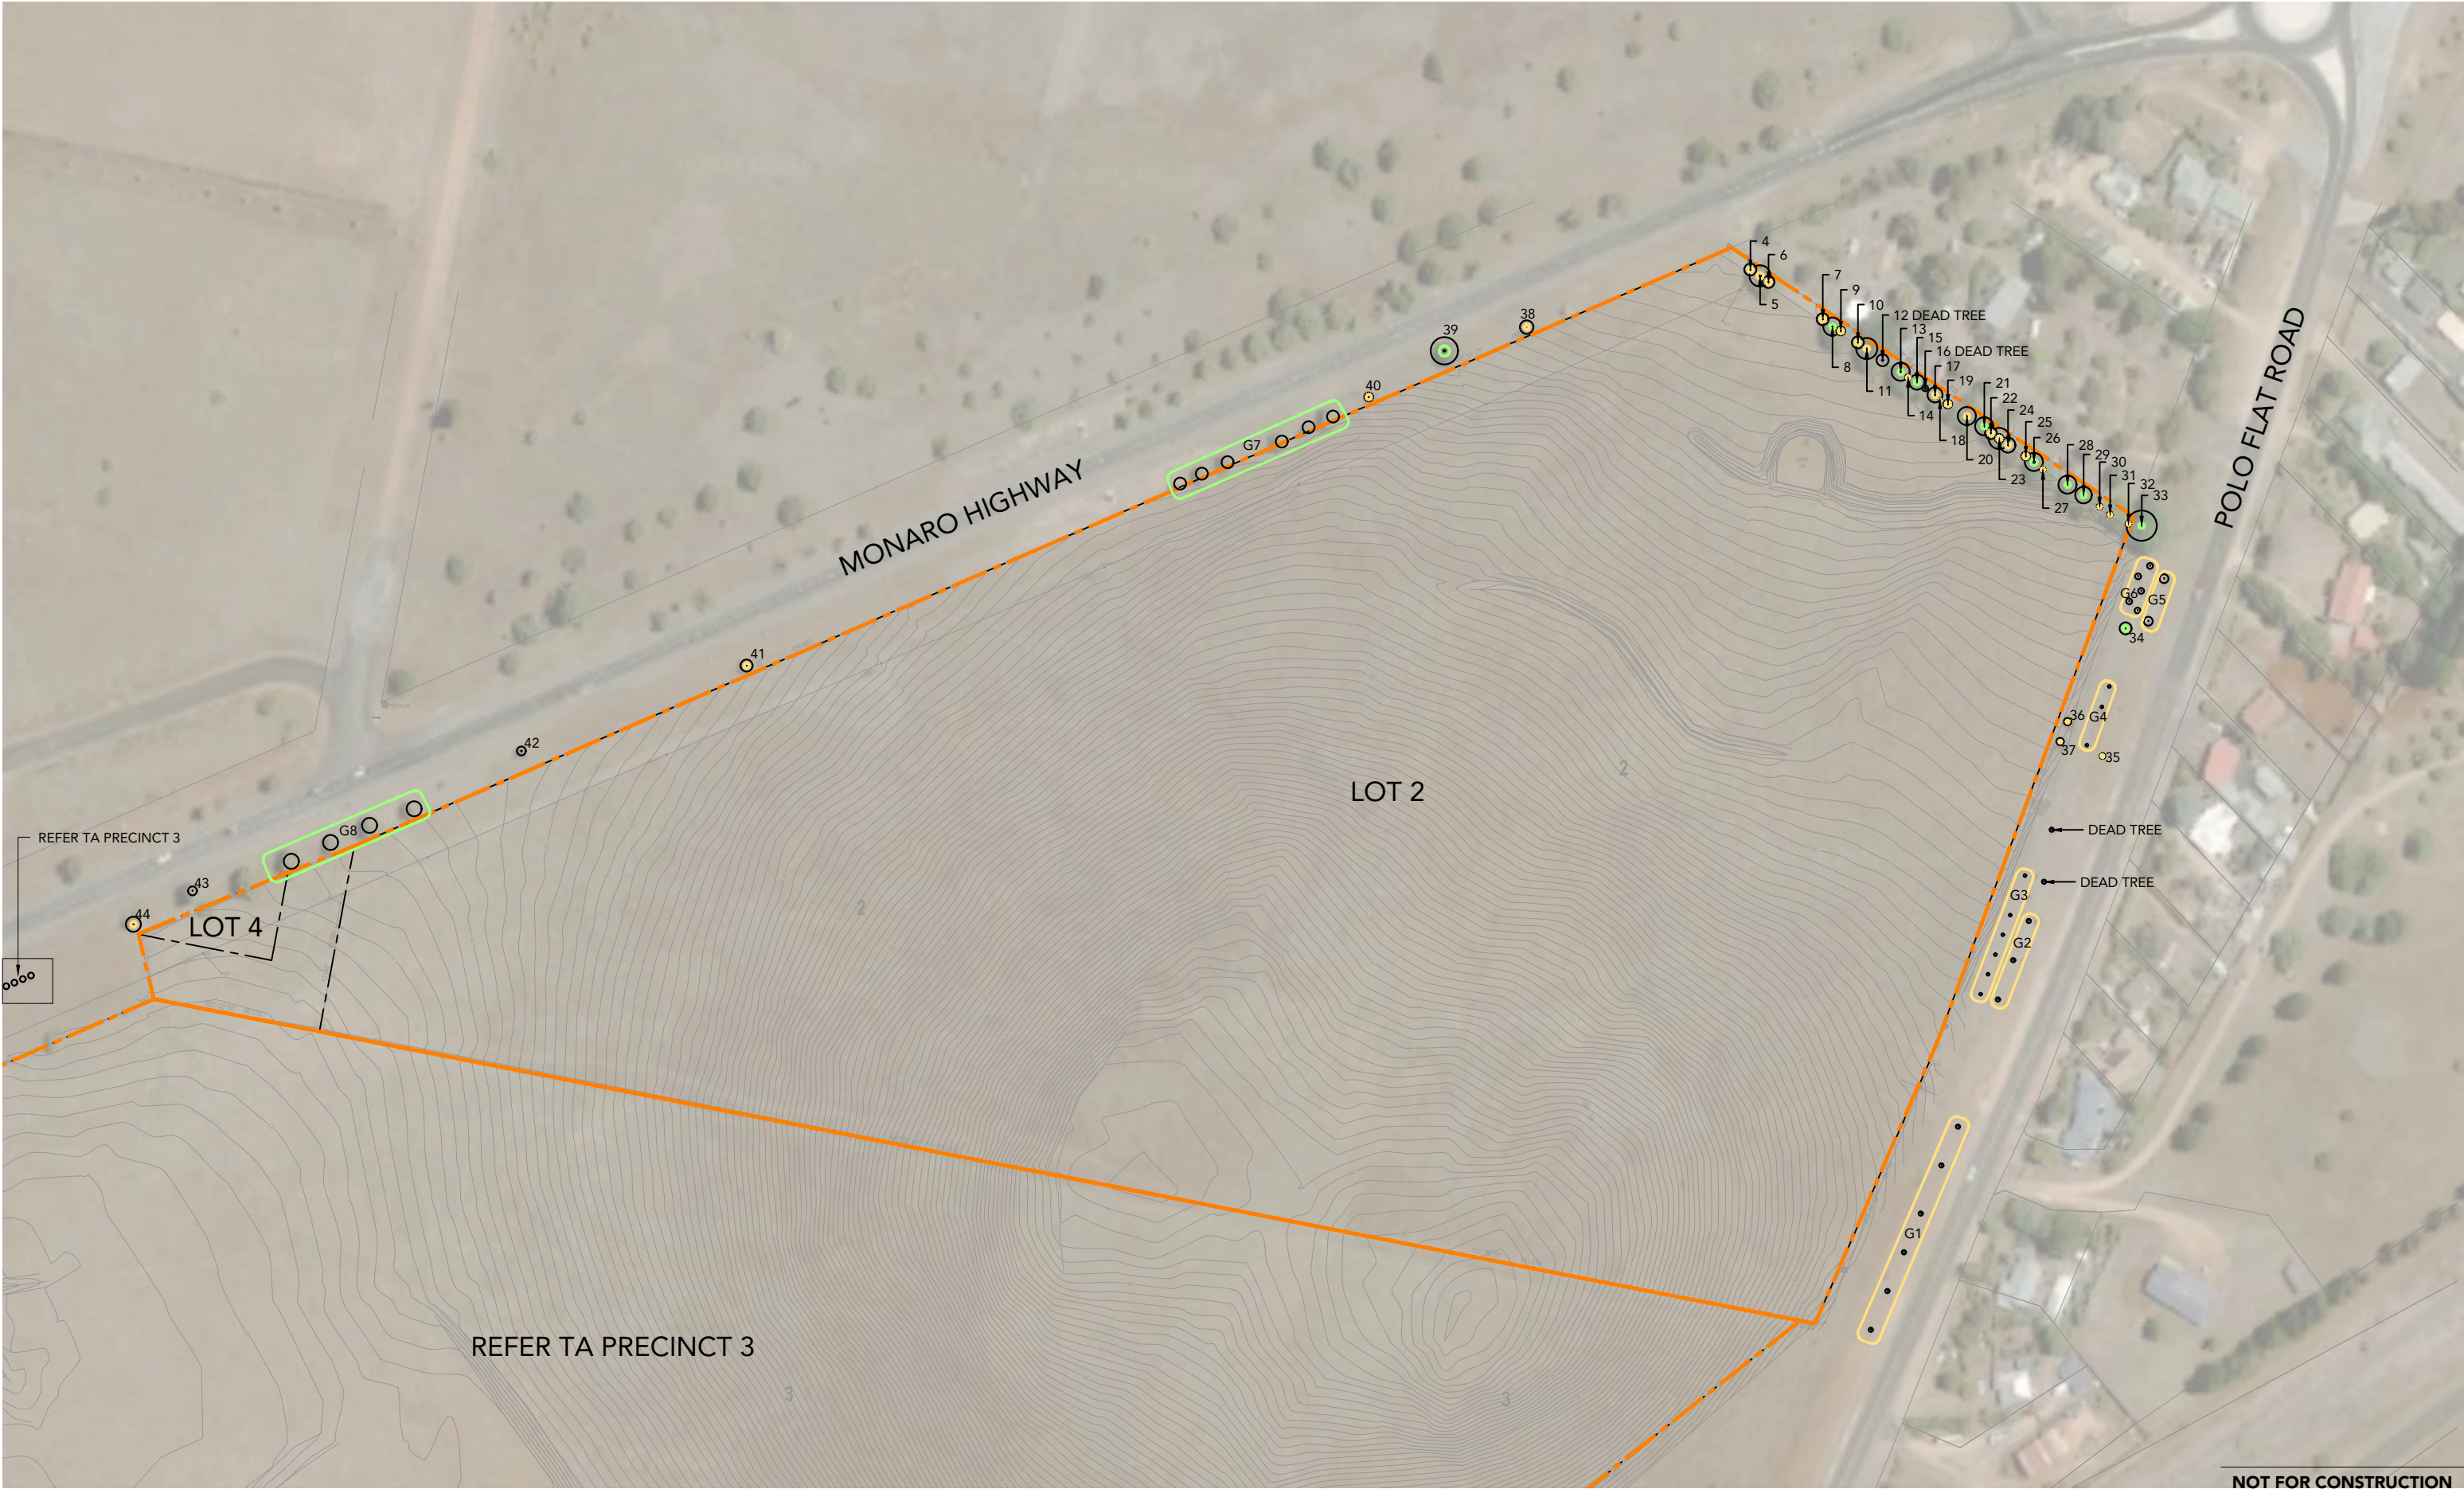
**TREE ASSESSMENT  
PLAN 1**

Trees 34, 35, 36, 37 and tree groups G1, G2, G3, G4, G5 and G6 are verge trees to Polo Road. They are typically juvenile trees, some malus trees are stunted and it would be beneficial to remove and replant with ameliorate soils. G6 are Quercus sp that appears to be recently planted, they have substantial deadwood throughout and new growth is only showing close to the trunk, many branches appear to have died off.

Tree groups G7 and G8 are verge plantings to Monaro Highway. They form part of the landscape language at this entry to Cooma. They are typically paired with plantings on the opposite side of the road.

Trees 42, 43 and 44 are a deciduous species and weren't in leaf at the time of the survey. They showed signs of decline (dead branches), significant epicormic growth from the base, and there were beetles present on the trunks.

Trees 4 – 33 are located along the boundary with lot 2, as a group they offer some screening value but individually are not of significant landscape value. The trees are various Cupressus species, predominantly Cupressus sempervirens. The trees are an aging stand and some have declined or are dead (trees 22 and 26).
