# Residential Site Investigation Report

Site Address: 10 Lagoon Sttreet and 75-77 Murray Street, Moruya NSW  
2537

Client: NSW Land and Housing Corporation, Locked Bag 4009, Ashfield NSW  
2131

<b>Project Name:</b>	10 Lagoon Street and 75-77 Murray Street, Moruya NSW 2537
<b>Client:</b>	NSW Land and Housing Corporation
<b>Project No.</b>	34884
<b>Report Reference</b>	34884-GR01_A
<b>Date:</b>	9.11.2020
<b>Revision:</b>	Revision A

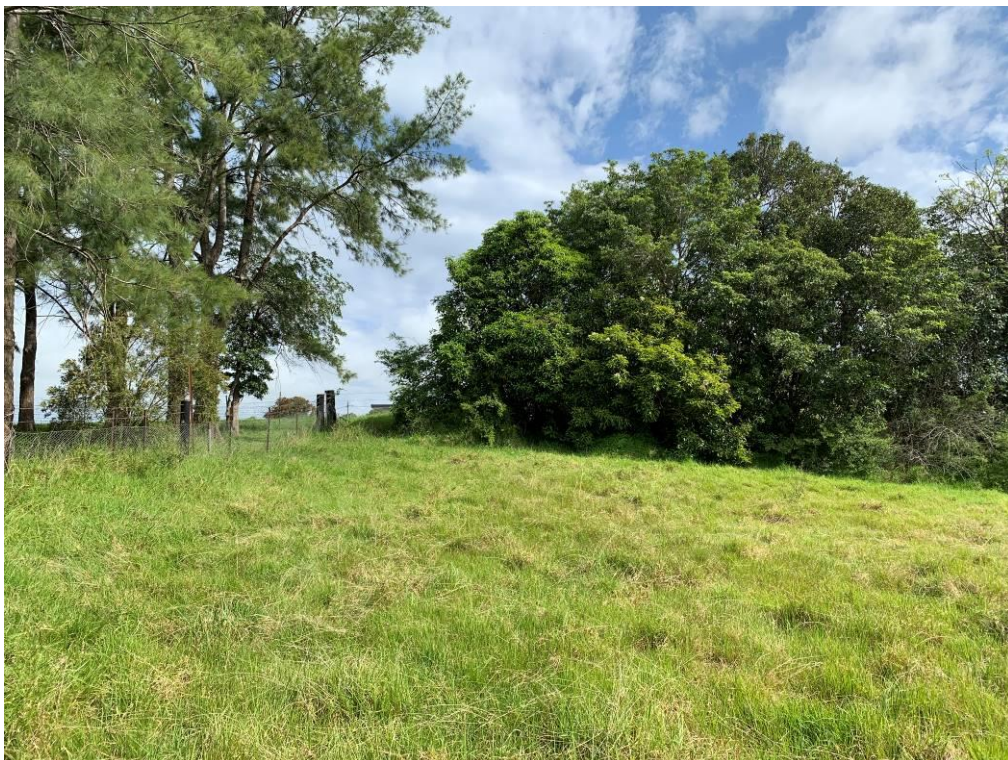
Plate 1 – North facing view.

The site is sloping slightly to the north. The block has existing dwelling on block with vacant blocks in the vicinity.

Any trees noted to be within the building zone, should be removed and the excavation remaining should be backfilled with natural material and reinstated in layers to a minimum of 95% Standard Maximum Dry Density.
