Hazardous Building Materials Survey Report

Portion of Building 28, Medical Gas Loading Bay,
Royal Prince Alfred Hospital Camperdown NSW

Report No: 1284-HBMS-13-041022.v1f

Report Date: 4 October 2022

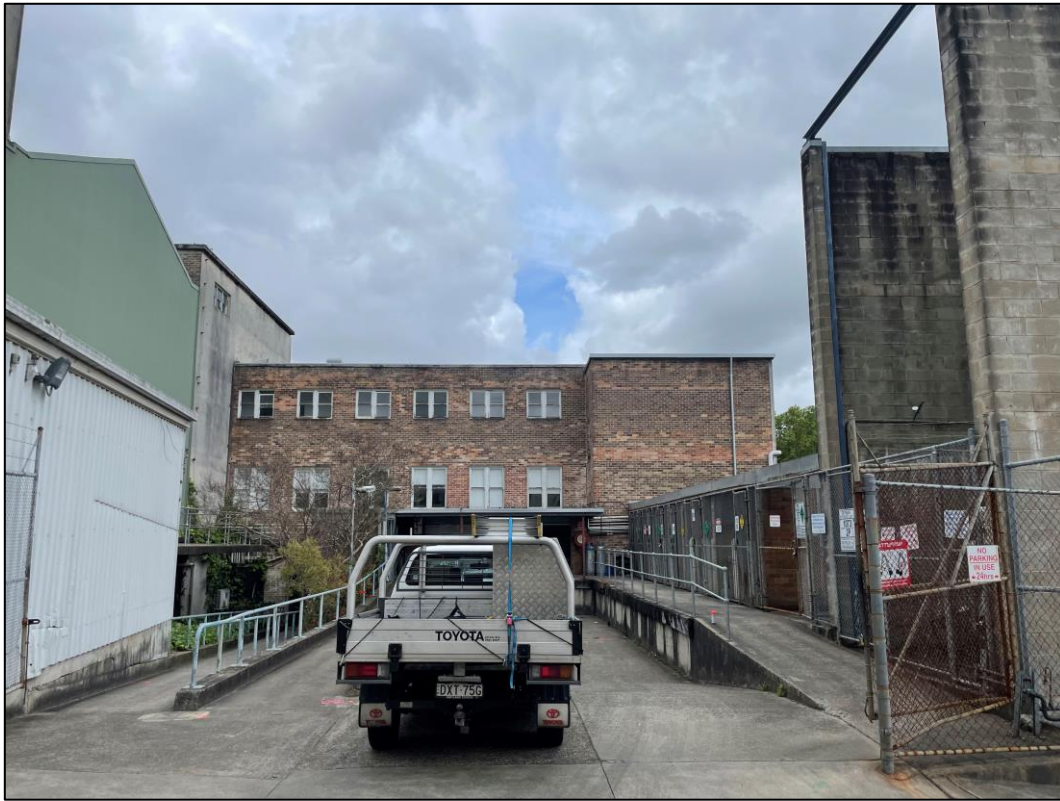
Photograph 1 Medical gas loading bay, as viewed from Rochester Street.

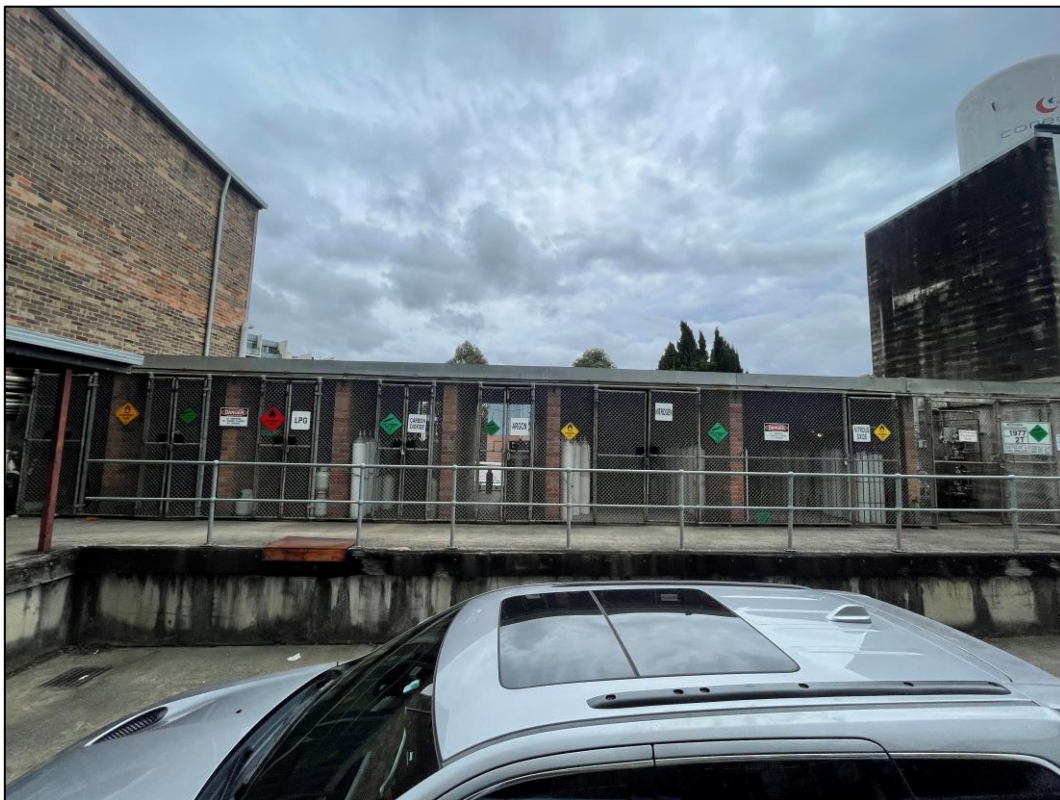
Photograph 2 Medical gas loading bay, as viewed from the loading dock.

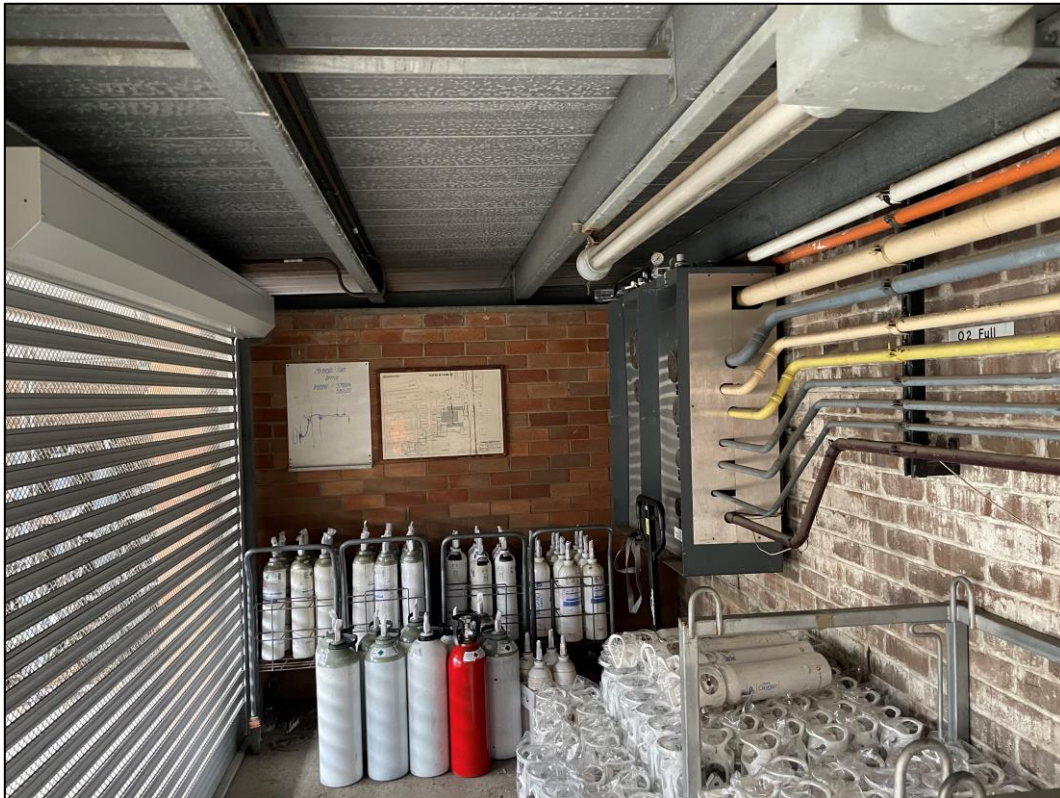
Photograph 3 Example of internal medical gas storage area.

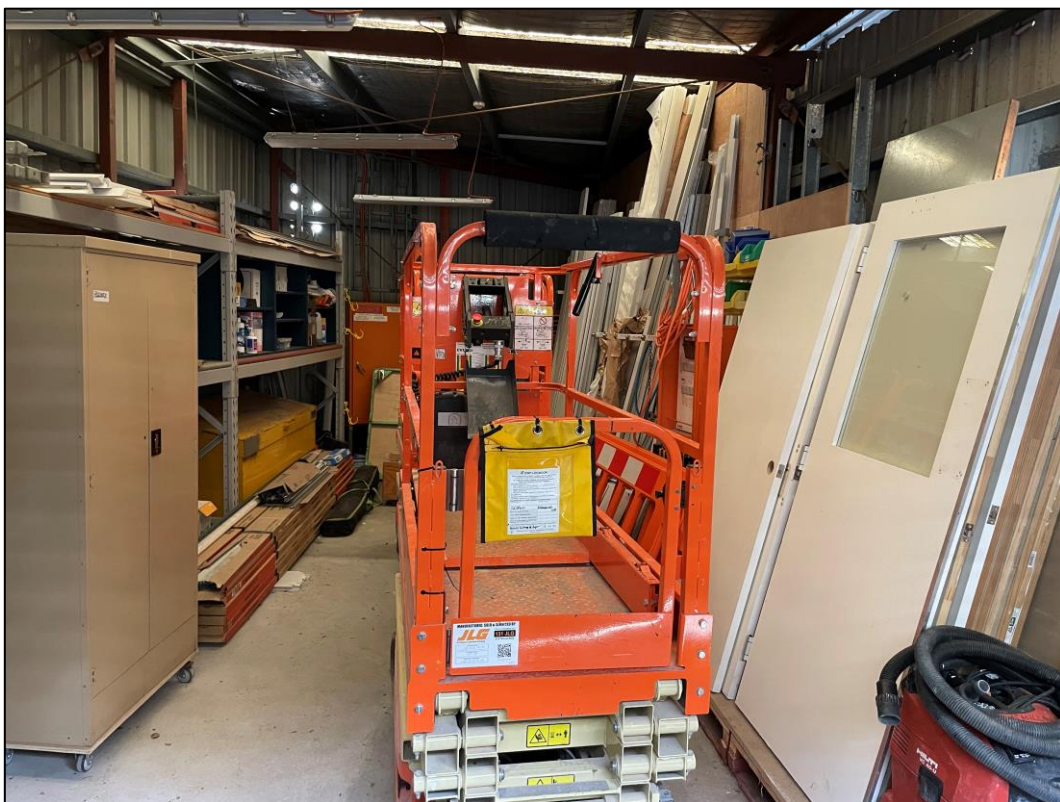
Photograph 4 View of shed interior.
