Hazardous Materials Management Survey and Register

Wyong Hospital- Building C, 664 Pacific Hwy, Hamlyn Terrace NSW 2259

JOB NUMBER: JN05003
ISSUED DATE: 11 April 2024
PREPARED FOR: Capital Insight Pty Ltd
CLIENT ADDRESS: 99 Walker St, North Sydney NSW 2060
INSPECTED BY: Alex Clark, Hazmat Team Leader
REPORT BY: Alex Clark, Hazmat Team Leader
APPROVED BY: Alex Thompson, Hazmat Manager
ISSUE NUMBER: Rev_0

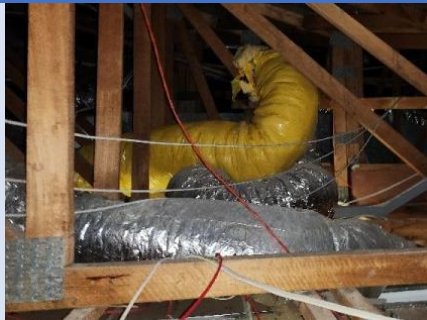
All areas, ceiling cavity, pipework	Insulation	SMF02	SMF	TH	F	Negligible	Remove under controlled conditions prior to refurbishment/demolition.

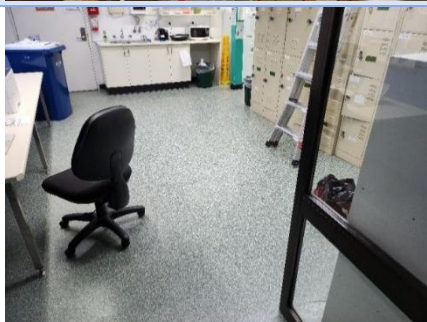
All areas, light green & white mottled flooring	Vinyl sheeting	J127382-009-EDUC-006	Presumed non-asbestos	TH	NA	-	No further action required. Presumed to continue under carpets. No sample taken at request of client.

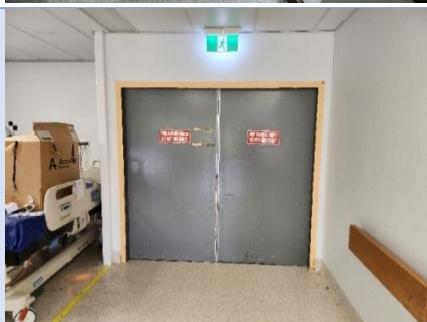
Bed Store, eastern double doors "Cemac Associated Limited"	Fire door cores	Asb01	AM	2 units	F	Low	The item should be removed prior to commencement of refurbishment works by a Class A asbestos removalist as intact units. Air monitoring should be undertaken during removal works. An asbestos clearance certificate should be gained following the completion of removal works.

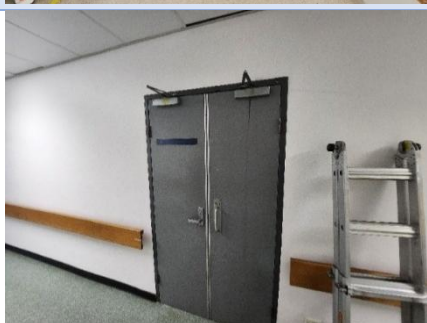
Cleaners Room attached to Bed Store "Cemac Associated Limited"	Fire door cores	Asb01/R1	AM	2 units	F	Low	The item should be removed prior to commencement of refurbishment works by a Class A asbestos removalist as intact units. Air monitoring should be undertaken during removal works. An asbestos clearance certificate should be gained following the completion of removal works.

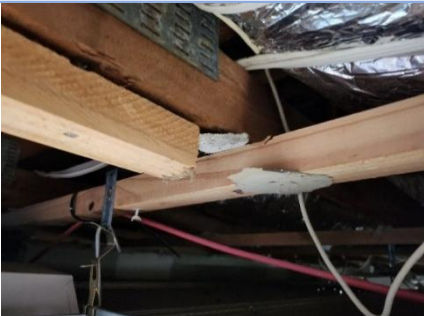
Bed Store, ceiling cavity, packing material to original ceiling structure	Fibre cement packers	Asb02	CH	TH	NF	Negligible	The item should be removed prior to commencement of refurbishment works by a Class A or B asbestos removalist. An asbestos clearance certificate should be gained following the completion of removal works. Consideration should be given to air monitoring during removal works.

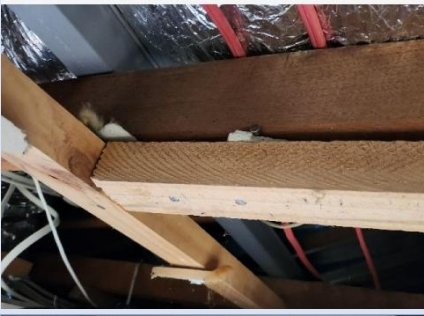
All areas, ceiling cavity, packing material to original ceiling structure	Fibre cement packers	Asb02/R1	CH	TH	NF	Negligible	The item should be removed prior to commencement of refurbishment works by a Class A or B asbestos removalist. An asbestos clearance certificate should be gained following the completion of removal works. Consideration should be given to air monitoring during removal works.

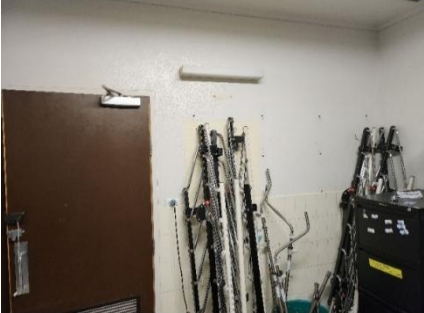
Bed Store, northern store room, walls	Beige paint system	Pb02	0.16% Lead	20 sqm	NA	Negligible	This material it should be removed prior to the commencement of refurbishment works by competent person(s) under localised dust control conditions. Lead contaminated waste should be disposed of in accordance with EPA requirements.

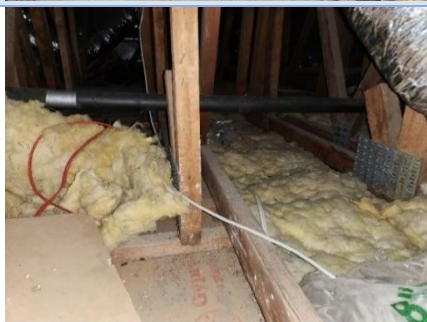
Southern Wing, JMO Room, ceiling cavity	Batts insulation	SMF01/R2	SMF	TH	F	Low	Remove under controlled conditions prior to refurbishment/demolition.

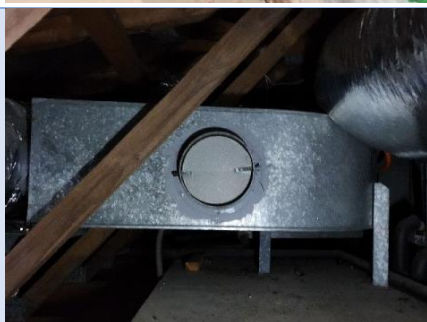
Southern Wing, JMO Room, ceiling cavity, ducting	Mastic	P3	Presumed asbestos	TH	NF	Negligible	The item should be removed prior to commencement of refurbishment works by a Class A or B asbestos removalist. An asbestos clearance certificate should be gained following the completion of removal works. Consideration should be given to air monitoring during removal works.

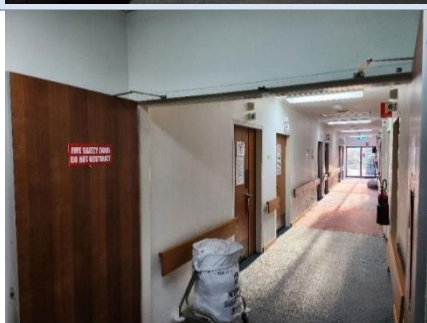
Southern Wing, mid hallway double doors "Cemac Associated Limited"	Fire door cores	Asb01/R3	AM	2 units	F	Low	The item should be removed prior to commencement of refurbishment works by a Class A asbestos removalist as intact units. Air monitoring should be undertaken during removal works. An asbestos clearance certificate should be gained following the completion of removal works.

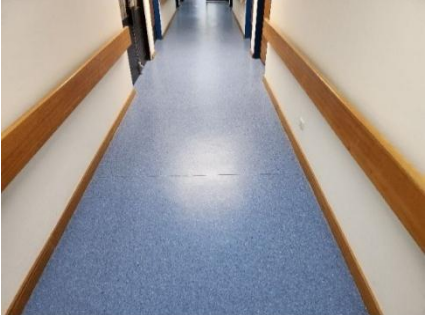
Northern Wing, hallway, blue flooring	Vinyl sheeting	NAI	Presumed non-asbestos	TH	NA	-	No further action required. No sample taken at request of client.

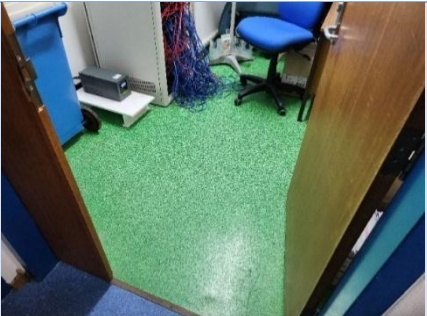
Northern Wing, southeast corner room, opposite Cleaners, green terrazzo flooring	Vinyl sheeting	Asb07	CH	6 sqm	F	Negligible	The item should be removed prior to commencement of refurbishment works by a Class A asbestos removalist. Air monitoring should be undertaken during removal works. An asbestos clearance certificate should be gained following the completion of removal works.

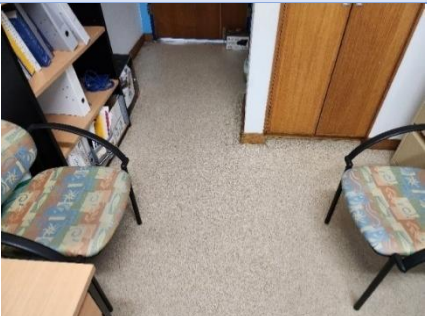
Northern Wing, Office Room 28, beige terrazzo flooring	Vinyl sheeting	Asb07/R1	CH	8 sqm	F	Negligible	The item should be removed prior to commencement of refurbishment works by a Class A asbestos removalist. Air monitoring should be undertaken during removal works. An asbestos clearance certificate should be gained following the completion of removal works. No sample taken at request of client.

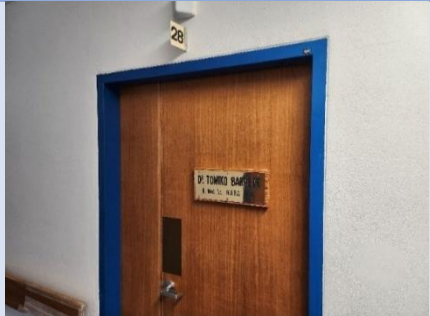
Northern Wing, All Offices, beige terrazzo flooring	Vinyl sheeting	Asb07/R2	CH	TH	F	Negligible	Confirm presence of item throughout northern wing. The item should be removed prior to commencement of refurbishment works by a Class A asbestos removalist. Air monitoring should be undertaken during removal works. An asbestos clearance certificate should be gained following the completion of removal works. No sample taken at request of client.	-

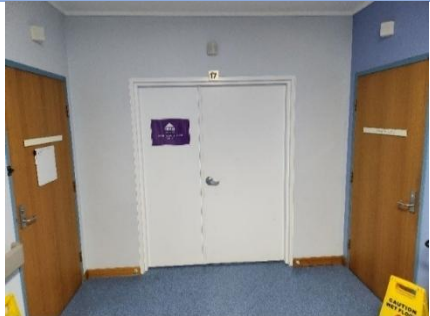
Northern Wing, door frames	Medium blue paint system	Pb04	<0.01% Lead	TH	NA	Low	No further action required.

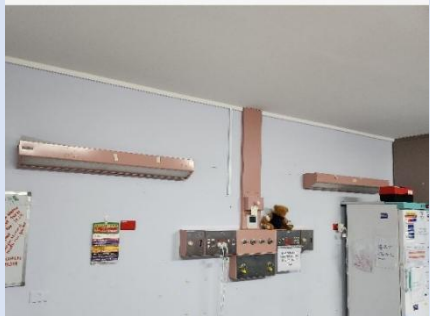
Northern Wing, two northwest rooms, wall light fittings and medical equipment conduits	Brown paint system	P4	Presumed lead	12 units	NA	Negligible	This material it should be removed prior to the commencement of refurbishment works by competent person(s) under localised dust control conditions. Lead contaminated waste should be disposed of in accordance with EPA requirements. No sample taken at request of client.

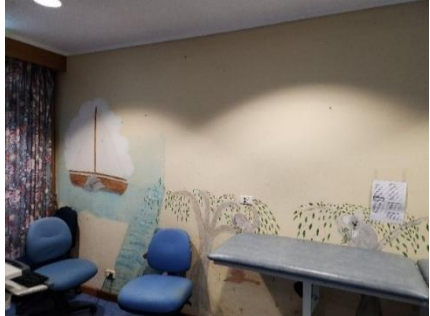
Northern Wing, Staff Room/Tea Room, walls	Beige paint system	Pb05	<0.01% Lead	TH	NA	Low	No further action required.

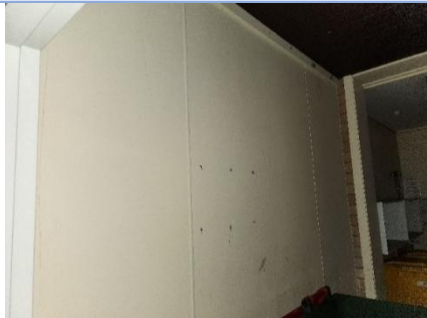
Northern Wing, Cleaners, internal wall lining	Fibre cement sheeting	P6	Presumed asbestos	8 sqm	NF	Low	The item should be removed prior to commencement of refurbishment works by a Class A or B asbestos removalist. An asbestos clearance certificate should be gained following the completion of removal works. Consideration should be given to air monitoring during removal works. No sample taken at request of client.

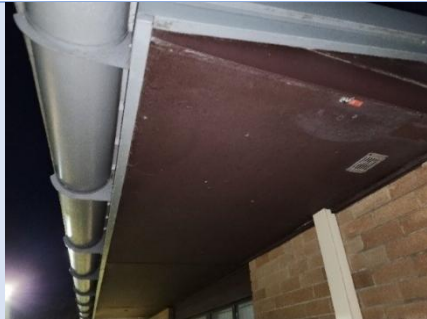
Northern Wing, external, eave lining	Fibre cement sheeting	P7	Presumed asbestos	50 sqm	NF	Low	The item should be removed prior to commencement of refurbishment works by a Class A or B asbestos removalist. An asbestos clearance certificate should be gained following the completion of removal works. Consideration should be given to air monitoring during removal works. No sample taken at request of client.

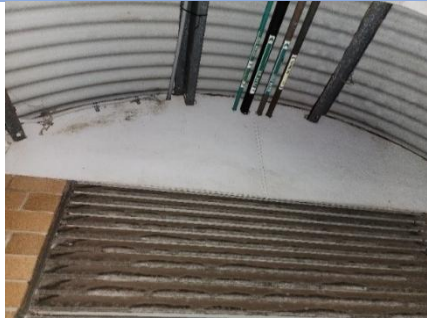
Northern Wing, external, infill panel above western entrance	Fibre cement sheeting	P8	Presumed asbestos	<1 sqm	NF	Low	The item should be removed prior to commencement of refurbishment works by a Class A or B asbestos removalist. An asbestos clearance certificate should be gained following the completion of removal works. Consideration should be given to air monitoring during removal works. No sample taken at request of client.

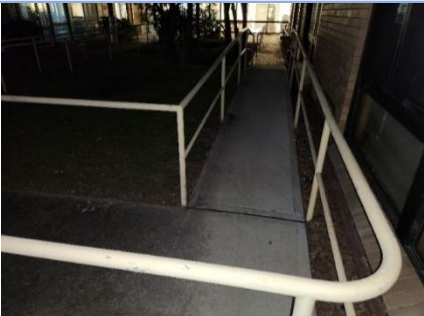
External, central courtyard, handrail	Cream paint system	P10	Presumed lead	TH	NA	Medium	This material it should be removed prior to the commencement of refurbishment works by competent person(s) under localised dust control conditions. Lead contaminated waste should be disposed of in accordance with EPA requirements. No sample taken at request of client.

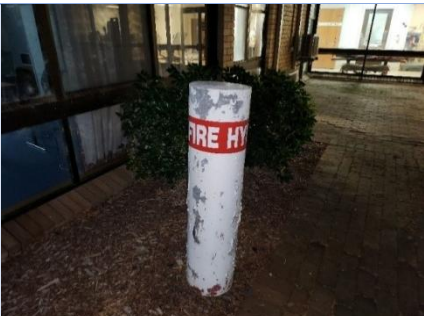
External, central courtyard, fire hydrants	White paint system	P11	Presumed lead	TH	NA	Low	This material it should be removed prior to the commencement of refurbishment works by competent person(s) under localised dust control conditions. Lead contaminated waste should be disposed of in accordance with EPA requirements. No sample taken at request of client.

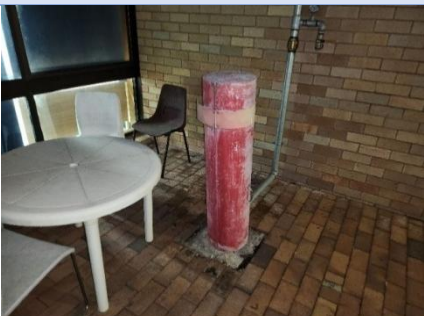
External, Southern Wing, south east side, fire hydrant	Red paint system	P12	Presumed lead	1 unit	NA	Medium	This material it should be removed prior to the commencement of refurbishment works by competent person(s) under localised dust control conditions. Lead contaminated waste should be disposed of in accordance with EPA requirements. No sample taken at request of client.
