HAZARDOUS MATERIAL RISK ASSESSMENT

DATE: NOVEMBER 2019

SITE REFERENCE:
ISLHD-PKH-H

NSW HEALTH
PORT KEMBLA DISTRICT HOSPITAL - H - STORAGE SHED
COWPER STREET, WARRAWONG NSW 2502

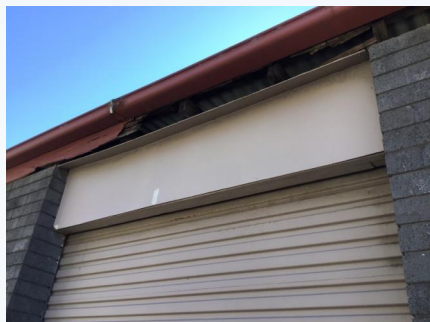
PHOTO NO.: J161155-03-ISLHD-PKH-H-PHOTO001

RESULT: ASBESTOS - PREVIOUSLY SAMPLED NEGATIVE

ROOM/LOCATION: STORE SHED - SOUTH

FEATURE/MATERIAL: INFILL PANELS - HIGH LEVEL - FIBRE CEMENT SHEETING
