HAZARDOUS MATERIAL RISK ASSESSMENT

DATE: NOVEMBER 2019

OUR REFERENCE:
C109541 : J161155-03

NSW HEALTH
PORT KEMBLA DISTRICT HOSPITAL - E - STAFF QUARTERS, OLU AND INTERPRETERS
COWPER STREET, WARRAWONG NSW 2502

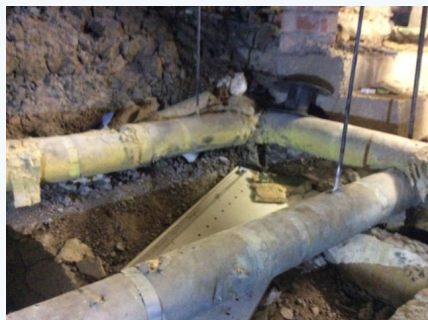
ITEM NO.: 1
 PHOTO NO.: J161155-03-ISLHD-PKH-E-PHOTO042
 RESULT: SMF - PRESUMED POSITIVE
 BUILDING/LEVEL: STAFF QUARTERS, OLU & INTERPRETERS - SUB FLOOR
 ROOM/LOCATION: SUB FLOOR - NORTHEAST
 FEATURE/MATERIAL: PIPEWORK INSULATION - INSULATION MATERIAL
 SAMPLE NO.: -

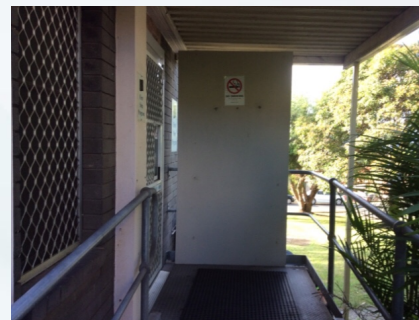
ITEM NO.: 2
 PHOTO NO.: J161155-03-ISLHD-PKH-E-PHOTO038
 RESULT: ASBESTOS - PREVIOUSLY SAMPLED NEGATIVE
 BUILDING/LEVEL: STAFF QUARTERS, OLU & INTERPRETERS - LEVEL 00
 ROOM/LOCATION: - SOUTH
 FEATURE/MATERIAL: WALL CLADDING - COMPRESSED CEMENT SHEETING
 SAMPLE NO.: PREVIOUSLY SAMPLED GREENCAP J149255-03-PKDH - E-011

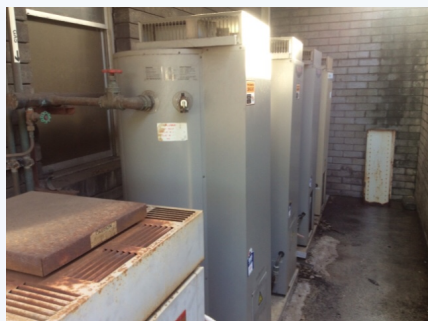
ITEM NO.: 3
 PHOTO NO.: J161155-03-ISLHD-PKH-E-PHOTO039
 RESULT: SMF - PRESUMED POSITIVE
 BUILDING/LEVEL: STAFF QUARTERS, OLU & INTERPRETERS - LEVEL 00
 ROOM/LOCATION: - SOUTHEAST
 FEATURE/MATERIAL: HOT WATER HEATER - INSULATION MATERIAL
 SAMPLE NO.: -

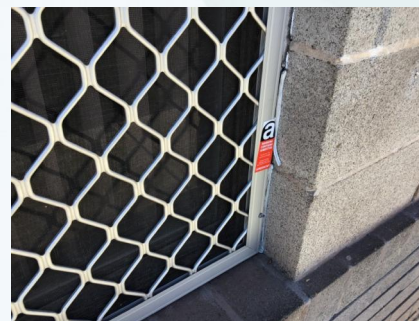
4	Surrounding Window Frames - Putty	Asbestos	Previously Sampled Greencap Similar to J149255-03-PKDH - E-003	Presumed Positive	J161155-03-ISLHD-PKH-E-Photo052	20 m	Poor	Non Friable	Medium	Medium	Confirmed	13/02/2020	P2	Engage a licensed asbestos contractor to undertake remedial/removal works on this item as soon as practicable (within 3 months).	
5	Verandah - West Fluorescent Light Fitting - Capacitor	PCB		Presumed Positive	J161155-03-ISLHD-PKH-E-Photo001	4 Unit/s	Good							Confirm status and maintain in good condition and incorporate into a HMMP. Remove under controlled conditions and dispose of in accordance with environmental protection requirements prior to demolition or refurbishment.	
Staff Quarters, OLU & Interpreters - Interior - Level 00															
6	Riser D1 - Various Throughout Pipework Insulation - Insulation Material	SMF		Presumed Positive	J161155-03-ISLHD-PKH-E-Photo004	4 Unit/s	Fair	Bonded (SMF)						Maintain condition and incorporate into a HMMP. Remove under controlled conditions prior to demolition or refurbishment.

ITEM NO.: 4
 PHOTO NO.: J161155-03-ISLHD-PKH-E-PHOTO052
 RESULT: ASBESTOS - PRESUMED POSITIVE
 BUILDING/LEVEL: STAFF QUARTERS, OLU & INTERPRETERS - LEVEL 00
 ROOM/LOCATION: - SURROUNDING
 FEATURE/MATERIAL: WINDOW FRAMES - PUTTY
 SAMPLE NO.: PREVIOUSLY SAMPLED GREENCAP SIMILAR TO J149255-03-PKDH - E-003

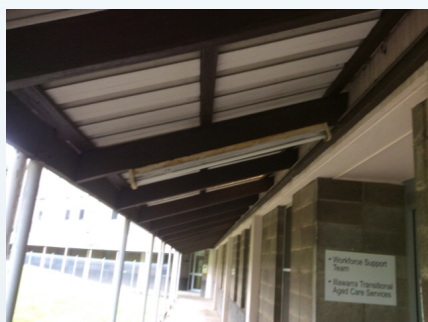
ITEM NO.: 5
 PHOTO NO.: J161155-03-ISLHD-PKH-E-PHOTO001
 RESULT: PCB - PRESUMED POSITIVE
 BUILDING/LEVEL: STAFF QUARTERS, OLU & INTERPRETERS - LEVEL 00
 ROOM/LOCATION: VERANDAH - WEST
 FEATURE/MATERIAL: FLUORESCENT LIGHT FITTING - CAPACITOR
 SAMPLE NO.: -

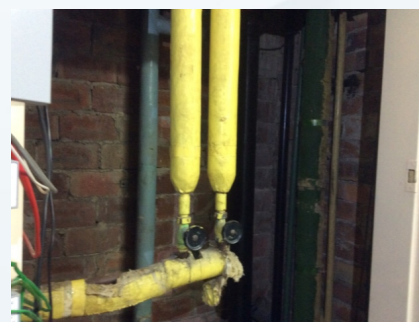
ITEM NO.: 6
 PHOTO NO.: J161155-03-ISLHD-PKH-E-PHOTO004
 RESULT: SMF - PRESUMED POSITIVE
 BUILDING/LEVEL: STAFF QUARTERS, OLU & INTERPRETERS - LEVEL 00
 ROOM/LOCATION: RISER D1 - VARIOUS THROUGHOUT
 FEATURE/MATERIAL: PIPEWORK INSULATION - INSULATION MATERIAL
 SAMPLE NO.: -

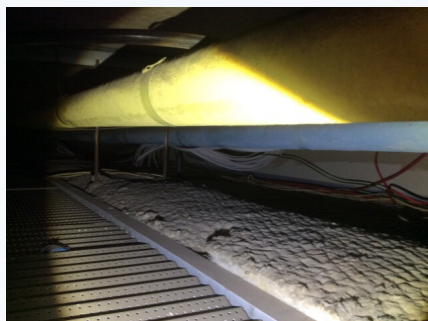
7	CORR Dental EO PKBE 0059 - Ceiling space Insulation Batts - Insulation Material	SMF		Presumed Positive	J161155-03-ISLHD-PKH-E-Photo035	50 m ²	Good	Bonded (SMF)						Maintain in good condition and incorporate into a HMMP. Remove under controlled conditions prior to demolition or refurbishment.	
8	CORR Dental EO PKBE 0059 - Ceiling space Pipework Insulation - Insulation Material	SMF		Presumed Positive	J161155-03-ISLHD-PKH-E-Photo034	3 Unit/s	Good	Bonded (SMF)						Maintain in good condition and incorporate into a HMMP. Remove under controlled conditions prior to demolition or refurbishment.

ITEM NO.: 7
 PHOTO NO.: J161155-03-ISLHD-PKH-E-PHOTO035
 RESULT: SMF - PRESUMED POSITIVE
 BUILDING/LEVEL: STAFF QUARTERS, OLU & INTERPRETERS - LEVEL 00
 ROOM/LOCATION: CORR DENTAL EO PKBE 0059 - CEILING SPACE
 FEATURE/MATERIAL: INSULATION BATTS - INSULATION MATERIAL
 SAMPLE NO.: -

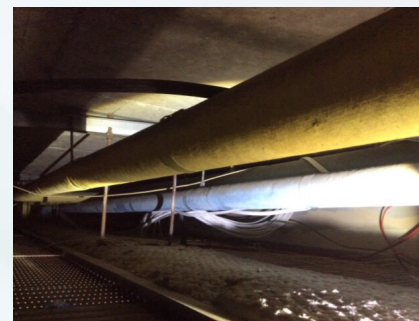
ITEM NO.: 8
 PHOTO NO.: J161155-03-ISLHD-PKH-E-PHOTO034
 RESULT: SMF - PRESUMED POSITIVE
 BUILDING/LEVEL: STAFF QUARTERS, OLU & INTERPRETERS - LEVEL 00
 ROOM/LOCATION: CORR DENTAL EO PKBE 0059 - CEILING SPACE
 FEATURE/MATERIAL: PIPEWORK INSULATION - INSULATION MATERIAL
 SAMPLE NO.: -

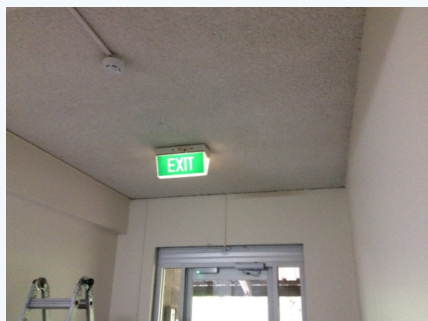
ITEM NO.: 9
 PHOTO NO.: J161155-03-ISLHD-PKH-E-PHOTO003
 RESULT: ASBESTOS - PREVIOUSLY SAMPLED NEGATIVE
 BUILDING/LEVEL: STAFF QUARTERS, OLU & INTERPRETERS - LEVEL 00
 ROOM/LOCATION: CORR DENTAL EO PKBE 0059 - WEST
 FEATURE/MATERIAL: CEILING - SPRAYED VERMICULITE
 SAMPLE NO.: PREVIOUSLY SAMPLED GREENCAP J149255-03-PKDH - E-002

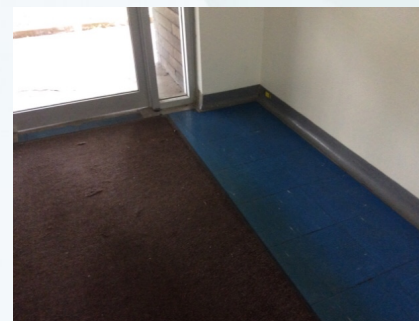
ITEM NO.: 10
 PHOTO NO.: J161155-03-ISLHD-PKH-E-PHOTO002
 RESULT: ASBESTOS - PREVIOUSLY SAMPLED NEGATIVE
 BUILDING/LEVEL: STAFF QUARTERS, OLU & INTERPRETERS - LEVEL 00
 ROOM/LOCATION: CORR DENTAL EO PKBE 0059 - WEST
 FEATURE/MATERIAL: FLOOR COVERING - VINYL TILES
 SAMPLE NO.: PREVIOUSLY SAMPLED GREENCAP J149255-03-PKDH - E-001

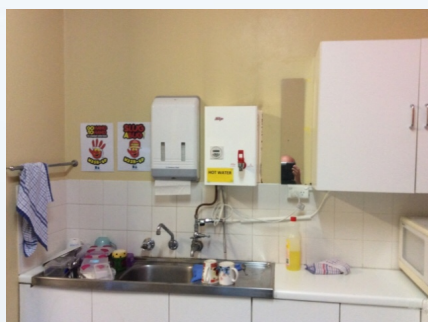
ITEM NO.: 11
 PHOTO NO.: J161155-03-ISLHD-PKH-E-PHOTO033
 RESULT: SMF - PRESUMED POSITIVE
 BUILDING/LEVEL: STAFF QUARTERS, OLU & INTERPRETERS - LEVEL 00
 ROOM/LOCATION: KITCHEN STAFF EO PKBE0025 - ABOVE SINK
 FEATURE/MATERIAL: HOT WATER HEATER - INSULATION MATERIAL
 SAMPLE NO.: -

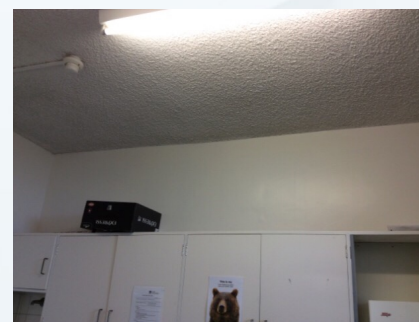
ITEM NO.: 12
 PHOTO NO.: J161155-03-ISLHD-PKH-E-PHOTO036
 RESULT: ASBESTOS - PRESUMED NEGATIVE
 BUILDING/LEVEL: STAFF QUARTERS, OLU & INTERPRETERS - LEVEL 00
 ROOM/LOCATION: THROUGHOUT INTERIOR - THROUGHOUT
 FEATURE/MATERIAL: CEILING - SPRAYED VERMICULITE
 SAMPLE NO.: PREVIOUSLY SAMPLED GREENCAP SIMILAR TO J149255-03-PKDH - E-002

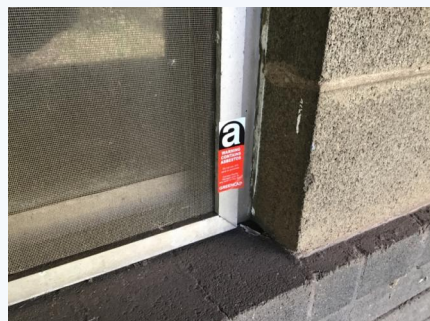
ITEM NO.: 17
 PHOTO NO.: J161155-03-ISLHD-PKH-E-PHOTO053
 RESULT: ASBESTOS - PREVIOUSLY SAMPLED POSITIVE
 BUILDING/LEVEL: STAFF QUARTERS, OLU & INTERPRETERS - LEVEL 01
 ROOM/LOCATION: - SURROUNDING
 FEATURE/MATERIAL: WINDOW FRAMES - PUTTY
 SAMPLE NO.: PREVIOUSLY SAMPLED GREENCAP J149255-03-PKDH - E-003

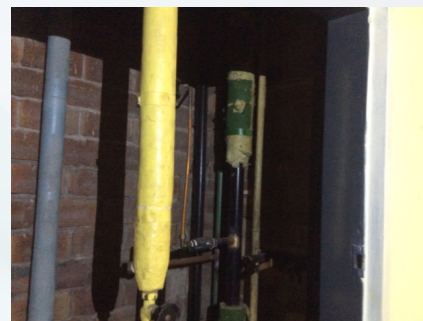
ITEM NO.: 18
 PHOTO NO.: J161155-03-ISLHD-PKH-E-PHOTO013
 RESULT: SMF - PRESUMED POSITIVE
 BUILDING/LEVEL: STAFF QUARTERS, OLU & INTERPRETERS - LEVEL 01
 ROOM/LOCATION: RISER D1 - THROUGHOUT
 FEATURE/MATERIAL: PIPEWORK INSULATION - INSULATION MATERIAL
 SAMPLE NO.: -

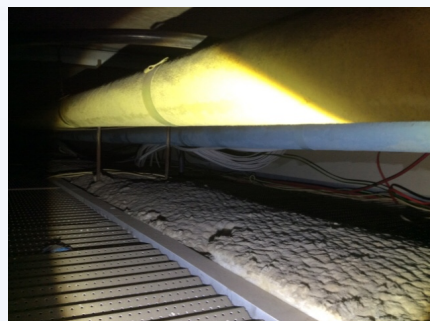
ITEM NO.: 19
 PHOTO NO.: J161155-03-ISLHD-PKH-E-PHOTO011
 RESULT: SMF - PRESUMED POSITIVE
 BUILDING/LEVEL: STAFF QUARTERS, OLU & INTERPRETERS - LEVEL 01
 ROOM/LOCATION: CORRIDOR PKBE0191 - THROUGHOUT
 FEATURE/MATERIAL: INSULATION - INSULATION BATTS
 SAMPLE NO.: -

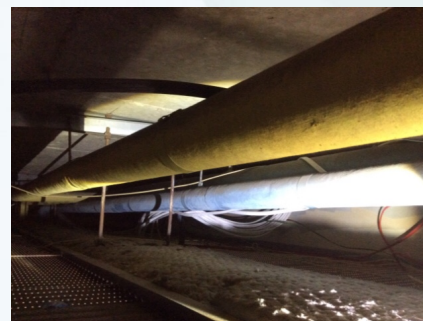
ITEM NO.: 20
 PHOTO NO.: J161155-03-ISLHD-PKH-E-PHOTO010
 RESULT: SMF - PRESUMED POSITIVE
 BUILDING/LEVEL: STAFF QUARTERS, OLU & INTERPRETERS - LEVEL 01
 ROOM/LOCATION: CORRIDOR PKBE0191 - THROUGHOUT
 FEATURE/MATERIAL: PIPEWORK INSULATION - INSULATION MATERIAL
 SAMPLE NO.: -

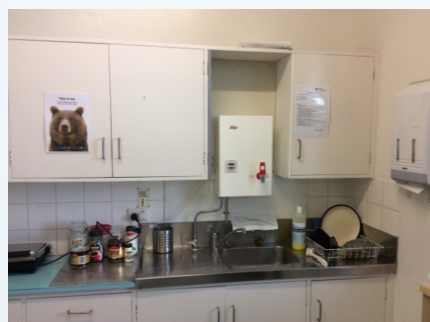
ITEM NO.: 21
 PHOTO NO.: J161155-03-ISLHD-PKH-E-PHOTO005
 RESULT: SMF - PRESUMED POSITIVE
 BUILDING/LEVEL: STAFF QUARTERS, OLU & INTERPRETERS - LEVEL 01
 ROOM/LOCATION: KITCHEN PKBE0110 - EAST
 FEATURE/MATERIAL: HOT WATER HEATER - INSULATION MATERIAL
 SAMPLE NO.: -

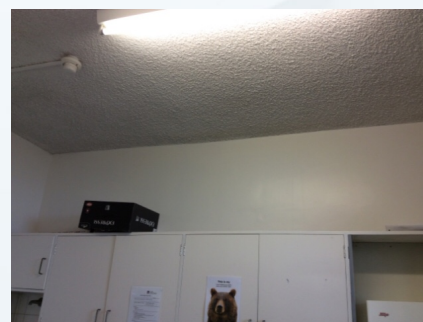
ITEM NO.: 22
 PHOTO NO.: J161155-03-ISLHD-PKH-E-PHOTO006
 RESULT: ASBESTOS - PRESUMED NEGATIVE
 BUILDING/LEVEL: STAFF QUARTERS, OLU & INTERPRETERS - LEVEL 01
 ROOM/LOCATION: KITCHEN PKBE0110 - THROUGHOUT
 FEATURE/MATERIAL: CEILING - SPRAYED VERMICULITE
 SAMPLE NO.: PREVIOUSLY SAMPLED GREENCAP SIMILAR TO J149255-03-PKDH - E-002

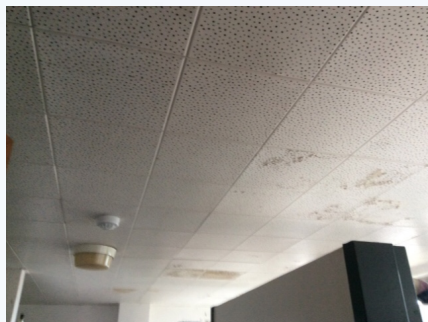
ITEM NO.: 23
 PHOTO NO.: J161155-03-ISLHD-PKH-E-PHOTO015
 RESULT: SMF - PRESUMED POSITIVE
 BUILDING/LEVEL: STAFF QUARTERS, OLU & INTERPRETERS - LEVEL 01
 ROOM/LOCATION: BATHROOM PKBE0120 - THROUGHOUT
 FEATURE/MATERIAL: CEILING - COMPRESSED CEILING TILES
 SAMPLE NO.: -

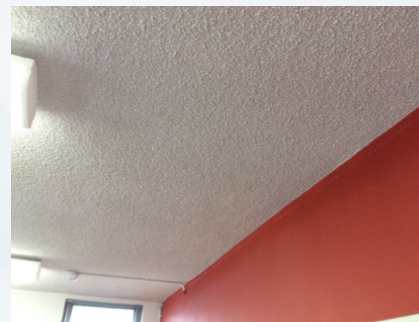
ITEM NO.: 24
 PHOTO NO.: J161155-03-ISLHD-PKH-E-PHOTO009
 RESULT: ASBESTOS - PRESUMED NEGATIVE
 BUILDING/LEVEL: STAFF QUARTERS, OLU & INTERPRETERS - LEVEL 01
 ROOM/LOCATION: LEVEL 01 - THROUGHOUT
 FEATURE/MATERIAL: CEILING - SPRAYED VERMICULITE
 SAMPLE NO.: PREVIOUSLY SAMPLED GREENCAP SIMILAR TO J149255-03-PKDH - E-002

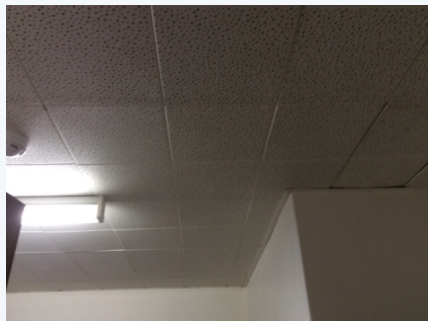
25	BATHROOM PKBE0122 - Throughout Ceiling - Compressed Ceiling Tiles	SMF		Presumed Positive	J161155-03-ISLHD-PKH-E-Photo016	40 m ²	Fair	Bonded (SMF)						Maintain condition and incorporate into a HMMP. Remove under controlled conditions prior to demolition or refurbishment.	
26	CLEANER PKBE0105 - Throughout Ceiling - Compressed Ceiling Tiles	SMF		Presumed Positive	J161155-03-ISLHD-PKH-E-Photo014	5 m ²	Good	Bonded (SMF)						Maintain in good condition and incorporate into a HMMP. Remove under controlled conditions prior to demolition or refurbishment.	
27	Riser D4 - Throughout Pipework Insulation - Insulation Material	SMF		Presumed Positive	J161155-03-ISLHD-PKH-E-Photo018	4 Unit/s	Good	Bonded (SMF)						Maintain in good condition and incorporate into a HMMP. Remove under controlled conditions prior to demolition or refurbishment.

ITEM NO.: 25
 PHOTO NO.: J161155-03-ISLHD-PKH-E-PHOTO016
 RESULT: SMF - PRESUMED POSITIVE
 BUILDING/LEVEL: STAFF QUARTERS, OLU & INTERPRETERS - LEVEL 01
 ROOM/LOCATION: BATHROOM PKBE0122 - THROUGHOUT
 FEATURE/MATERIAL: CEILING - COMPRESSED CEILING TILES
 SAMPLE NO.: -

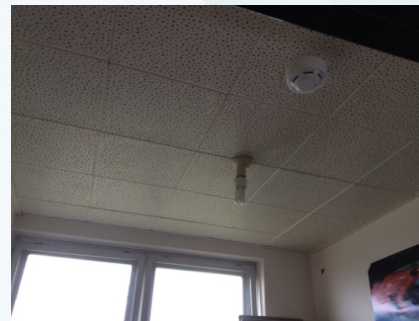
ITEM NO.: 26
 PHOTO NO.: J161155-03-ISLHD-PKH-E-PHOTO014
 RESULT: SMF - PRESUMED POSITIVE
 BUILDING/LEVEL: STAFF QUARTERS, OLU & INTERPRETERS - LEVEL 01
 ROOM/LOCATION: CLEANER PKBE0105 - THROUGHOUT
 FEATURE/MATERIAL: CEILING - COMPRESSED CEILING TILES
 SAMPLE NO.: -

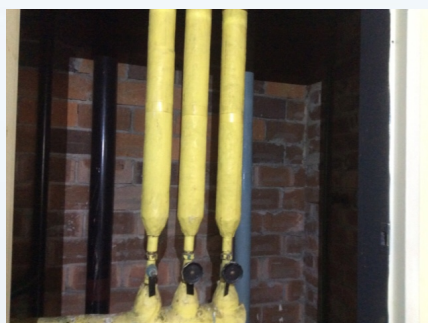
ITEM NO.: 27
 PHOTO NO.: J161155-03-ISLHD-PKH-E-PHOTO018
 RESULT: SMF - PRESUMED POSITIVE
 BUILDING/LEVEL: STAFF QUARTERS, OLU & INTERPRETERS - LEVEL 01
 ROOM/LOCATION: RISER D4 - THROUGHOUT
 FEATURE/MATERIAL: PIPEWORK INSULATION - INSULATION MATERIAL
 SAMPLE NO.: -

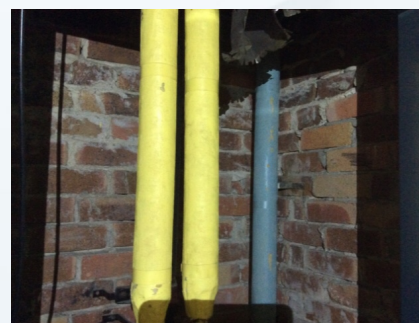
ITEM NO.: 28
 PHOTO NO.: J161155-03-ISLHD-PKH-E-PHOTO017
 RESULT: SMF - PRESUMED POSITIVE
 BUILDING/LEVEL: STAFF QUARTERS, OLU & INTERPRETERS - LEVEL 01
 ROOM/LOCATION: RISER D2 - THROUGHOUT
 FEATURE/MATERIAL: PIPEWORK INSULATION - INSULATION MATERIAL
 SAMPLE NO.: -

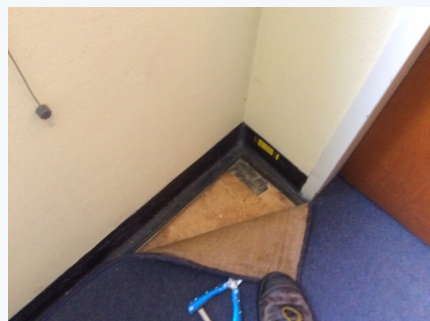
ITEM NO.: 29
 PHOTO NO.: J161155-03-ISLHD-PKH-E-PHOTO012
 RESULT: ASBESTOS - PREVIOUSLY SAMPLED NEGATIVE
 BUILDING/LEVEL: STAFF QUARTERS, OLU & INTERPRETERS - LEVEL 01
 ROOM/LOCATION: CORRIDOR PKBE 0191 - THROUGHOUT
 FEATURE/MATERIAL: FLOOR COVERING - VINYL TILES
 SAMPLE NO.: PREVIOUSLY SAMPLED GREENCAP J149255-03-PKDH - E-004

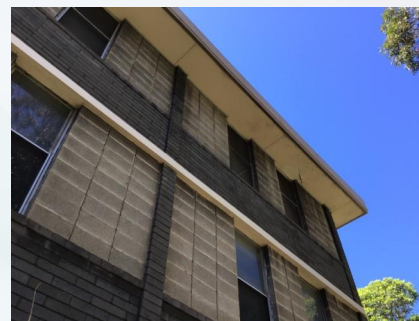
32	Surrounding Eaves - Fibre Cement Sheeting	Asbestos	Not Sampled Height Restricted	Presumed Positive	J161155-03-ISLHD-PKH-E-Photo054	100 m ²	Fair	Non Friable	Low	Low	Not Labelled	13/11/2020	P3	Confirm status, maintain in current condition and incorporate into a HMMP. Remove by licensed asbestos contractor prior to demolition or refurbishment.	
33	Lounge PKBE0225 - Surrounding Window Frames - Putty	Asbestos	Previously Sampled Greencap Similar to J149255-03-PKDH - E-003	Presumed Positive	J161155-03-ISLHD-PKH-E-Photo055	500 m	Poor	Non Friable	Medium	Medium	Confirmed	13/02/2020	P2	Engage a licensed asbestos contractor to undertake remedial/removal works on this item as soon as practicable (within 3 months).

ITEM NO.: 32
 PHOTO NO.: J161155-03-ISLHD-PKH-E-PHOTO054
 RESULT: ASBESTOS - PRESUMED POSITIVE
 BUILDING/LEVEL: STAFF QUARTERS, OLU & INTERPRETERS - LEVEL 02
 ROOM/LOCATION: - SURROUNDING
 FEATURE/MATERIAL: EAVES - FIBRE CEMENT SHEETING
 SAMPLE NO.: NOT SAMPLED HEIGHT RESTRICTED

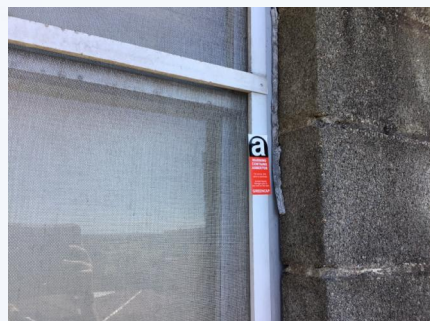
ITEM NO.: 33
 PHOTO NO.: J161155-03-ISLHD-PKH-E-PHOTO055
 RESULT: ASBESTOS - PRESUMED POSITIVE
 BUILDING/LEVEL: STAFF QUARTERS, OLU & INTERPRETERS - LEVEL 02
 ROOM/LOCATION: LOUNGE PKBE0225 - SURROUNDING
 FEATURE/MATERIAL: WINDOW FRAMES - PUTTY
 SAMPLE NO.: PREVIOUSLY SAMPLED GREENCAP SIMILAR TO J149255-03-PKDH - E-003

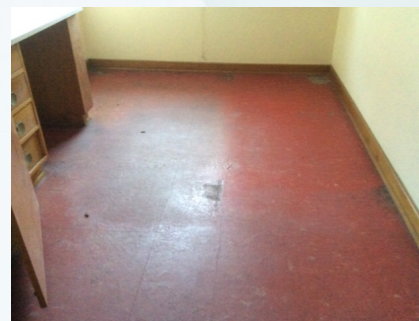
ITEM NO.: 34
 PHOTO NO.: J161155-03-ISLHD-PKH-E-PHOTO026
 RESULT: ASBESTOS - PREVIOUSLY SAMPLED NEGATIVE
 BUILDING/LEVEL: STAFF QUARTERS, OLU & INTERPRETERS - LEVEL 02
 ROOM/LOCATION: VARIOUS ROOMS - THROUGHOUT
 FEATURE/MATERIAL: FLOOR COVERING - VINYL TILES
 SAMPLE NO.: PREVIOUSLY SAMPLED GREENCAP J149255-03-PKDH - E-007

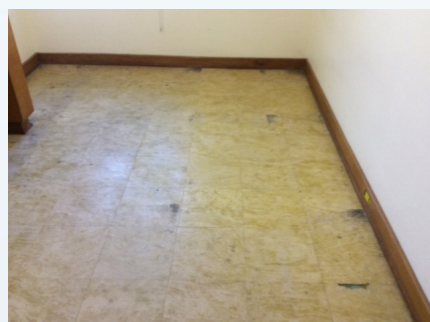
ITEM NO.: 35
 PHOTO NO.: J161155-03-ISLHD-PKH-E-PHOTO028
 RESULT: ASBESTOS - PREVIOUSLY SAMPLED NEGATIVE
 BUILDING/LEVEL: STAFF QUARTERS, OLU & INTERPRETERS - LEVEL 02
 ROOM/LOCATION: VARIOUS ROOMS - THROUGHOUT
 FEATURE/MATERIAL: FLOOR COVERING - VINYL TILES
 SAMPLE NO.: PREVIOUSLY SAMPLED GREENCAP J149255-03-PKDH - E-009

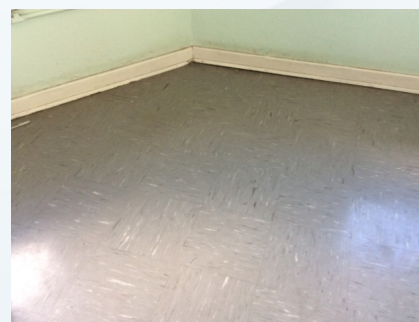
ITEM NO.: 36
 PHOTO NO.: J161155-03-ISLHD-PKH-E-PHOTO029
 RESULT: ASBESTOS - PREVIOUSLY SAMPLED NEGATIVE
 BUILDING/LEVEL: STAFF QUARTERS, OLU & INTERPRETERS - LEVEL 02
 ROOM/LOCATION: VARIOUS ROOMS - THROUGHOUT
 FEATURE/MATERIAL: FLOOR COVERING - VINYL TILES
 SAMPLE NO.: PREVIOUSLY SAMPLED GREENCAP J149255-03-PKDH - E-010

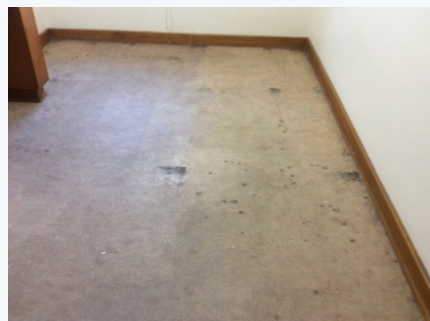
ITEM NO.: 37
 PHOTO NO.: J161155-03-ISLHD-PKH-E-PHOTO025
 RESULT: ASBESTOS - PREVIOUSLY SAMPLED NEGATIVE
 BUILDING/LEVEL: STAFF QUARTERS, OLU & INTERPRETERS - LEVEL 02
 ROOM/LOCATION: VARIOUS ROOMS - THROUGHOUT
 FEATURE/MATERIAL: FLOOR COVERING - VINYL TILES
 SAMPLE NO.: PREVIOUSLY SAMPLED GREENCAP J149255-03-PKDH - E-006

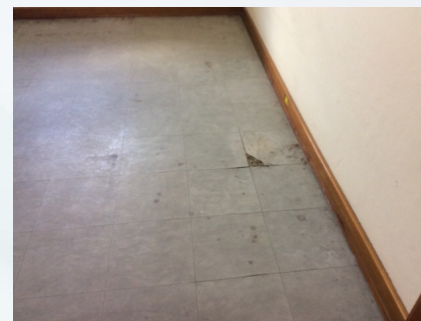
ITEM NO.: 38
 PHOTO NO.: J161155-03-ISLHD-PKH-E-PHOTO027
 RESULT: ASBESTOS - PREVIOUSLY SAMPLED NEGATIVE
 BUILDING/LEVEL: STAFF QUARTERS, OLU & INTERPRETERS - LEVEL 02
 ROOM/LOCATION: VARIOUS ROOMS - THROUGHOUT
 FEATURE/MATERIAL: FLOOR COVERING - VINYL TILES
 SAMPLE NO.: PREVIOUSLY SAMPLED GREENCAP J149255-03-PKDH - E-008

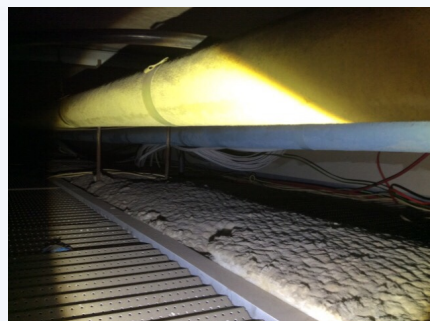
ITEM NO.: 39
 PHOTO NO.: J161155-03-ISLHD-PKH-E-PHOTO022
 RESULT: SMF - PRESUMED POSITIVE
 BUILDING/LEVEL: STAFF QUARTERS, OLU & INTERPRETERS - LEVEL 02
 ROOM/LOCATION: CORRIDOR (PKBE0259) - CEILING SPACE
 FEATURE/MATERIAL: INSULATION BATTS - INSULATION MATERIAL
 SAMPLE NO.: -

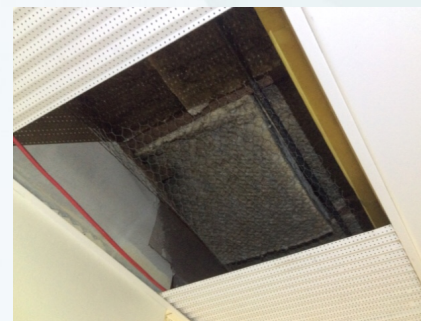
40	Corridor (PKBE0259) - Ceiling space Insulation Batts - Insulation Material	SMF		Presumed Positive	J161155-03-ISLHD-PKH-E-Photo023	500 m ²	Fair	Bonded (SMF)						Maintain condition and incorporate into a HMMP. Remove under controlled conditions prior to demolition or refurbishment.	
41	Corridor (PKBE0259) - Ceiling Space Pipework Insulation - Insulation Material	SMF		Presumed Positive	J161155-03-ISLHD-PKH-E-Photo021	4 Unit/s	Good	Bonded (SMF)						Maintain in good condition and incorporate into a HMMP. Remove under controlled conditions prior to demolition or refurbishment.	
42	Kitchen (PKBE0224) - West Hot Water Heater - Insulation Material	SMF		Presumed Positive	J161155-03-ISLHD-PKH-E-Photo019	1 Unit/s	Good	Bonded (SMF)						Maintain in good condition and incorporate into a HMMP. Remove under controlled conditions prior to demolition or refurbishment.	
43	Roof access - West Infill Panels - Fibre Cement Sheeting - Adjacent DUCT 1	Asbestos	Previously Sampled Greencap J149255-03-PKDH - E-005	Previously Sampled Positive	J161155-03-ISLHD-PKH-E-Photo056	2 m ²	Good	Non Friable	Low	Low	Suspect	13/11/2020	P4	Maintain in current condition and incorporate into a HMMP. Remove by licensed asbestos contractor prior to demolition or refurbishment.

ITEM NO.: 40
 PHOTO NO.: J161155-03-ISLHD-PKH-E-PHOTO023
 RESULT: SMF - PRESUMED POSITIVE
 BUILDING/LEVEL: STAFF QUARTERS, OLU & INTERPRETERS - LEVEL 02
 ROOM/LOCATION: CORRIDOR (PKBE0259) - CEILING SPACE
 FEATURE/MATERIAL: INSULATION BATTS - INSULATION MATERIAL
 SAMPLE NO.: -

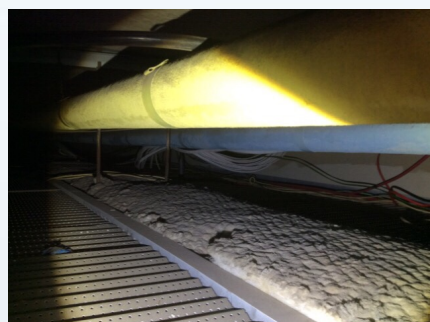
ITEM NO.: 41
 PHOTO NO.: J161155-03-ISLHD-PKH-E-PHOTO021
 RESULT: SMF - PRESUMED POSITIVE
 BUILDING/LEVEL: STAFF QUARTERS, OLU & INTERPRETERS - LEVEL 02
 ROOM/LOCATION: CORRIDOR (PKBE0259) - CEILING SPACE
 FEATURE/MATERIAL: PIPEWORK INSULATION - INSULATION MATERIAL
 SAMPLE NO.: -

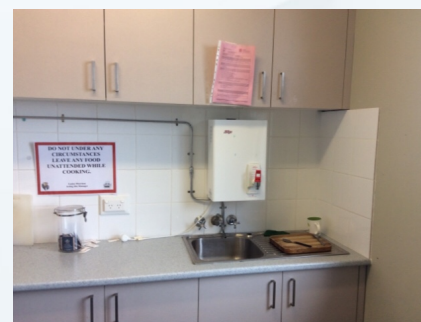
ITEM NO.: 42
 PHOTO NO.: J161155-03-ISLHD-PKH-E-PHOTO019
 RESULT: SMF - PRESUMED POSITIVE
 BUILDING/LEVEL: STAFF QUARTERS, OLU & INTERPRETERS - LEVEL 02
 ROOM/LOCATION: KITCHEN (PKBE0224) - WEST
 FEATURE/MATERIAL: HOT WATER HEATER - INSULATION MATERIAL
 SAMPLE NO.: -

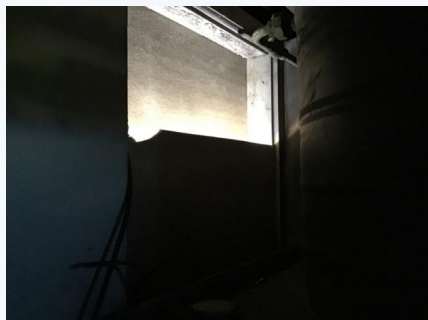
ITEM NO.: 43
 PHOTO NO.: J161155-03-ISLHD-PKH-E-PHOTO056
 RESULT: ASBESTOS - PREVIOUSLY SAMPLED POSITIVE
 BUILDING/LEVEL: STAFF QUARTERS, OLU & INTERPRETERS - LEVEL 02
 ROOM/LOCATION: ROOF ACCESS - WEST
 FEATURE/MATERIAL: INFILL PANELS - FIBRE CEMENT SHEETING
 SAMPLE NO.: PREVIOUSLY SAMPLED GREENCAP J149255-03-PKDH - E-005

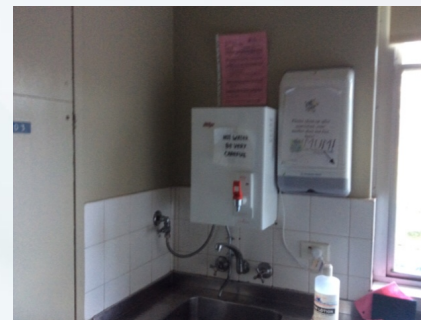
44	STAFF KITCHEN (PKDE0250) - Above sink Hot Water Heater - Insulation Material	SMF		Presumed Positive	J161155-03-ISLHD-PKH-E-Photo032	1 Unit/s	Good	Bonded (SMF)						Maintain in good condition and incorporate into a HMMP. Remove under controlled conditions prior to demolition or refurbishment.	
45	Riser D2 - Throughout Pipework Insulation - Insulation Material	SMF		Presumed Positive	J161155-03-ISLHD-PKH-E-Photo030	4 Unit/s	Good	Bonded (SMF)						Maintain in good condition and incorporate into a HMMP. Remove under controlled conditions prior to demolition or refurbishment.	
46	Riser D4 - Throughout Pipework Insulation - Insulation Material	SMF		Presumed Positive	J161155-03-ISLHD-PKH-E-Photo031	6 Unit/s	Fair	Bonded (SMF)						Maintain condition and incorporate into a HMMP. Remove under controlled conditions prior to demolition or refurbishment.

ITEM NO.: 44
 PHOTO NO.: J161155-03-ISLHD-PKH-E-PHOTO032
 RESULT: SMF - PRESUMED POSITIVE
 BUILDING/LEVEL: STAFF QUARTERS, OLU & INTERPRETERS - LEVEL 02
 ROOM/LOCATION: STAFF KITCHEN (PKDE0250) - ABOVE SINK
 FEATURE/MATERIAL: HOT WATER HEATER - INSULATION MATERIAL
 SAMPLE NO.: -

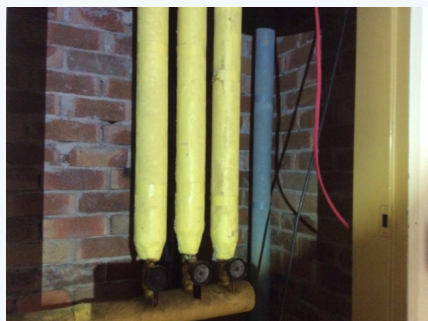
ITEM NO.: 45
 PHOTO NO.: J161155-03-ISLHD-PKH-E-PHOTO030
 RESULT: SMF - PRESUMED POSITIVE
 BUILDING/LEVEL: STAFF QUARTERS, OLU & INTERPRETERS - LEVEL 02
 ROOM/LOCATION: RISER D2 - THROUGHOUT
 FEATURE/MATERIAL: PIPEWORK INSULATION - INSULATION MATERIAL
 SAMPLE NO.: -

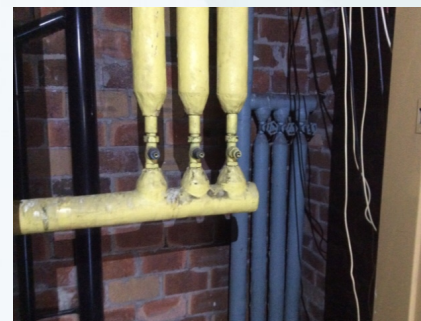
ITEM NO.: 46
 PHOTO NO.: J161155-03-ISLHD-PKH-E-PHOTO031
 RESULT: SMF - PRESUMED POSITIVE
 BUILDING/LEVEL: STAFF QUARTERS, OLU & INTERPRETERS - LEVEL 02
 ROOM/LOCATION: RISER D4 - THROUGHOUT
 FEATURE/MATERIAL: PIPEWORK INSULATION - INSULATION MATERIAL
 SAMPLE NO.: -
