85-91 Cowper Street, Warrawong NSW 2502 Warrawong Community Health Centre

December 2023
FINAL
Updated March 2024

Prepared for: Savills Australia, L25, Governor Phillip Tower

Prepared by: Paul Vezgoff

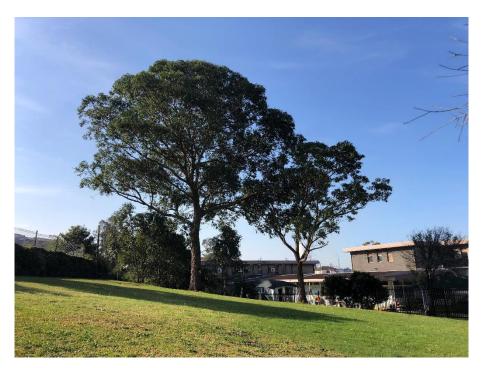
- 3.4 The most significant trees on site are Trees 6, 8, 14, 16-18, 20-27, 36-38 and 43-46. These trees are all in good health and condition. Their main trunks, first and second order branches are free of any cracks, splits or fruiting bodies. Old pruning wounds are showing good occlusion, a sign that the trees are photosynthesizing effectively. New extension growth was noted with leaf colour showing good vitality on most specimens. Most of these trees would be considered to have 90% live canopies that are codominant with each other. The basal area and woody root zones were free of any ground heaving or lifting. Due to the trees growing in close proximity to each other they will have grafted root zones.

Plate 1: Image showing Trees 6 (left) and 8 (right). P. Vezgoff.

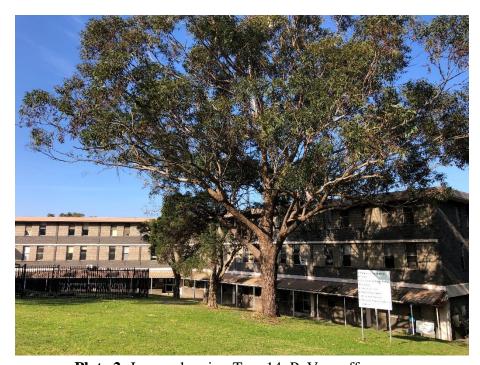
Plate 2: Image showing Tree 14. P. Vezgoff.

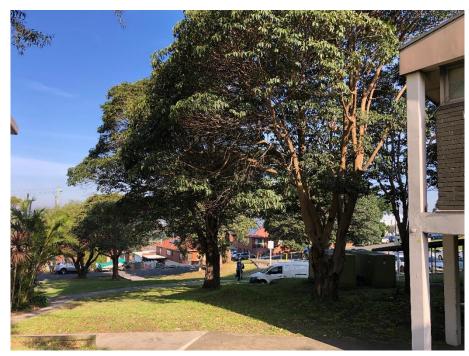
Plate 3: Image showing the Trees 16, 17 and 18 around the existing substation. P. Vezgoff.

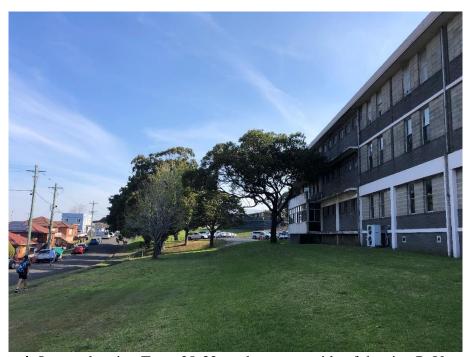
Plate 4: Image showing Trees 28-32 on the eastern side of the site. P. Vezgoff.

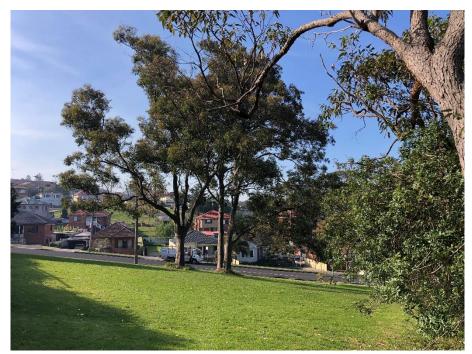
Plate 5: Image showing Trees 36, 37 and 38. P. Vezgoff.

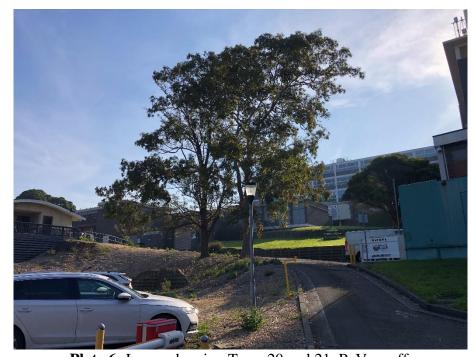
Plate 6: Image showing Trees 20 and 21. P. Vezgoff.

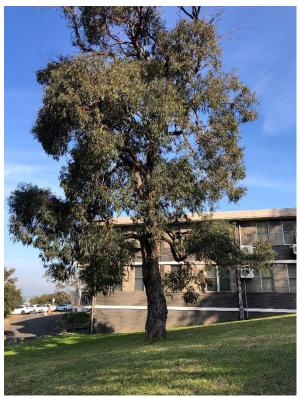
Plate 6: Image showing Tree 43. P. Vezgoff.

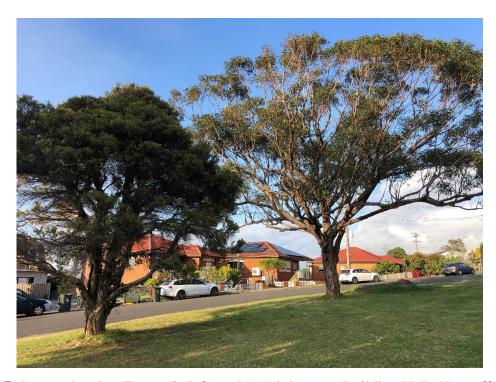
Plate 7: Image showing Trees 50 (left) and 51 (right) near Building H. P. Vezgoff.

| | | | | | | Live | | | | | | | |
|---|--|---|---|---|---|---|---|---|---|---|---|---|---|
| 51 | botryoides) | 10 | 8 | 0.55 | 0.65 | 80 | Storm damage | for 15-40 years | Fair | Mature | internal decay | 6.6 | 2.7 |

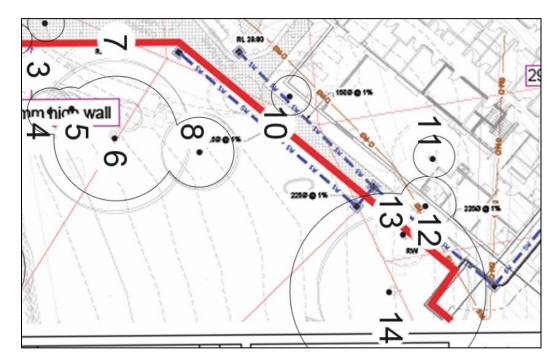
- 3.8 The proposed plans and landscape design (Plate 8) will not impact Trees 4, 5, 6 and 8, however the demolition and grading of surfaces to the north of these trees shall be undertaken carefully so as not to damage any woody surface roots that may be present.

Plate 8: Part plan showing the works near Trees 4-14.

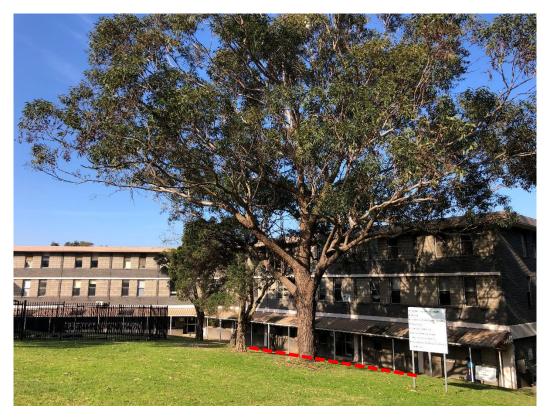
Plate 10: Canopy pruning of Tree 14 may be required. The red line is where lintels or concrete beams may have to be used to bridge woody roots.

- 4.5 Tree 14 may require reduction pruning of branches, for roof clearance, on the eastern portion of the canopy (Plate 10). These branches should be reduced back so as to maintain the canopy of the tree (ie, no lopping or 'flat topping'). Pruning points should be no greater than 100mm in diameter. This pruning is known as selective pruning and can be read about in more detail in the Australian Standard for the Pruning of Amenity Trees (AS 4373) 2007.

- **4.6** A footing detail within the TPZ of Tree 14 will need to specify that existing levels along the existing retaining wall will need to be retained and that any retaining wall in this area may require lintels or beams to bridge any woody roots that are exposed (Plate 10).
