HAZARDOUS MATERIAL RISK ASSESSMENT

DATE: NOVEMBER 2019

OUR REFERENCE:
C109541 : J161155-03

NSW HEALTH
PORT KEMBLA DISTRICT HOSPITAL - D - DENTAL AND CHILDCARE
COWPER STREET, WARRAWONG NSW 2502

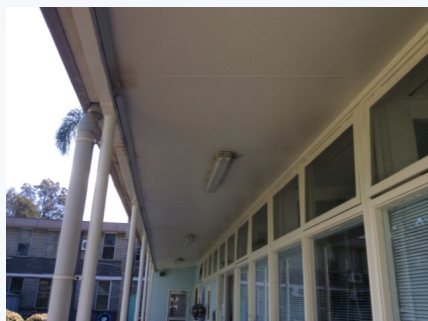
ITEM NO.: 1
 PHOTO NO.: J161155-03-ISLHD-PKH-D-PHOTO004
 RESULT: ASBESTOS - PREVIOUSLY SAMPLED NEGATIVE
 BUILDING/LEVEL: DENTAL & CHILDCARE - LEVEL 00
 ROOM/LOCATION: PLAYGROUND PKBD0039 - SOUTHWEST
 FEATURE/MATERIAL: AWNING - FIBRE CEMENT SHEETING
 SAMPLE NO.: PREVIOUSLY SAMPLED GREENCAP J149255-03-PKDH - D-002

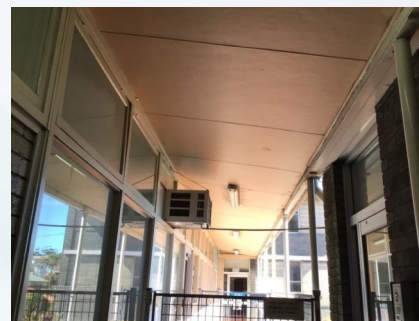
ITEM NO.: 2
 PHOTO NO.: J161155-03-ISLHD-PKH-D-PHOTO018
 RESULT: ASBESTOS - PRESUMED NEGATIVE
 BUILDING/LEVEL: DENTAL & CHILDCARE - LEVEL 00
 ROOM/LOCATION: VERANDAH EAST - THROUGHOUT
 FEATURE/MATERIAL: CEILING - FIBRE CEMENT SHEETING
 SAMPLE NO.: PREVIOUSLY SAMPLED GREENCAP SIMILAR TO J149255-03-PKDH - D-002

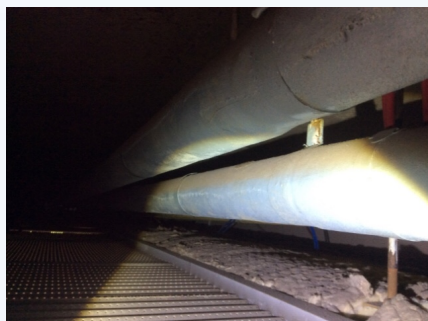
ITEM NO.: 3
 PHOTO NO.: J161155-03-ISLHD-PKH-D-PHOTO008
 RESULT: SMF - PRESUMED POSITIVE
 BUILDING/LEVEL: DENTAL & CHILDCARE - LEVEL 00
 ROOM/LOCATION: CORRIDOR INT PKBD0005 - CEILING SPACE
 FEATURE/MATERIAL: INSULATION BATTS - INSULATION MATERIAL
 SAMPLE NO.: -

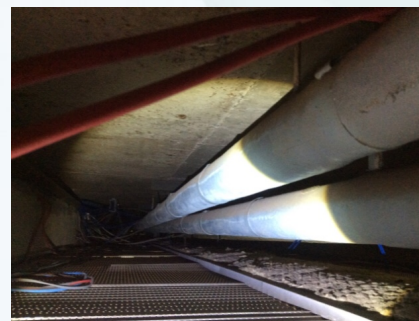
4	CORRIDOR INT PKBD0005 - Ceiling Space Pipework Insulation - Insulation Material	SMF		Presumed Positive	J161155-03-ISLHD-PKH-D-Photo007	4 Unit/s	Good	Bonded (SMF)						Maintain in good condition and incorporate into a HMMP. Remove under controlled conditions prior to demolition or refurbishment.	
5	OFFICE PKDB0012 - Ceiling Space Ceiling Above Suspended Ceiling - Fibre Cement Sheeting	Asbestos	Previously Sampled Greencap J149255-03-PKDH - D-001	Previously Sampled Positive	J161155-03-ISLHD-PKH-D-Photo020	10 m ²	Poor	Non Friable	Medium	Medium	Suspect	13/02/2020	P2	Engage a licensed asbestos contractor to undertake remedial/removal works on this item as soon as practicable (within 3 months).	
6	PLAYRM PKBD0011 - West Ceiling Space Ceiling Above Suspended Ceiling - Fibre Cement Sheeting	Asbestos	Previously Sampled Greencap Similar to J149255-03-PKDH - D-001	Presumed Positive	J161155-03-ISLHD-PKH-D-Photo019	15 m ²	Poor	Non Friable	Medium	Medium	Suspect	13/02/2020	P2	Engage a licensed asbestos contractor to undertake remedial/removal works on this item as soon as practicable (within 3 months).

ITEM NO.: 4
 PHOTO NO.: J161155-03-ISLHD-PKH-D-PHOTO007
 RESULT: SMF - PRESUMED POSITIVE
 BUILDING/LEVEL: DENTAL & CHILDCARE - LEVEL 00
 ROOM/LOCATION: CORRIDOR INT PKBD0005 - CEILING SPACE
 FEATURE/MATERIAL: PIPEWORK INSULATION - INSULATION MATERIAL
 SAMPLE NO.: -

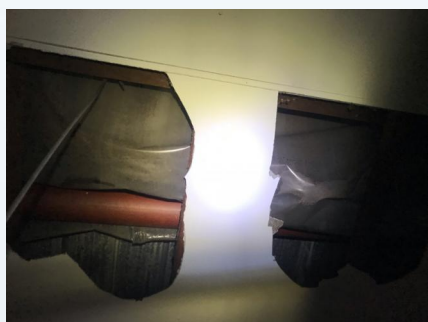
ITEM NO.: 5
 PHOTO NO.: J161155-03-ISLHD-PKH-D-PHOTO020
 RESULT: ASBESTOS - PREVIOUSLY SAMPLED POSITIVE
 BUILDING/LEVEL: DENTAL & CHILDCARE - LEVEL 00
 ROOM/LOCATION: OFFICE PKDB0012 - CEILING SPACE
 FEATURE/MATERIAL: CEILING ABOVE SUSPENDED CEILING - FIBRE CEMENT SHEETING
 SAMPLE NO.: PREVIOUSLY SAMPLED GREENCAP J149255-03-PKDH - D-001

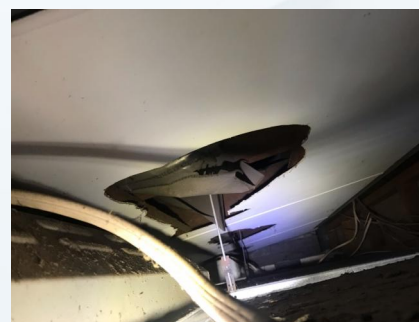
ITEM NO.: 6
 PHOTO NO.: J161155-03-ISLHD-PKH-D-PHOTO019
 RESULT: ASBESTOS - PRESUMED POSITIVE
 BUILDING/LEVEL: DENTAL & CHILDCARE - LEVEL 00
 ROOM/LOCATION: PLAYRM PKBD0011 - WEST CEILING SPACE
 FEATURE/MATERIAL: CEILING ABOVE SUSPENDED CEILING - FIBRE CEMENT SHEETING
 SAMPLE NO.: PREVIOUSLY SAMPLED GREENCAP SIMILAR TO J149255-03-PKDH - D-001

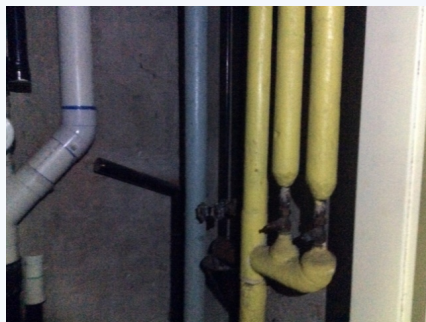
7	Riser D6 - Various Throughout Pipework Insulation - Insulation Material	SMF		Presumed Positive	J161155-03-ISLHD-PKH-D-Photo012	4 Unit/s	Good	Bonded (SMF)						Maintain in good condition and incorporate into a HMMP. Remove under controlled conditions prior to demolition or refurbishment.	
8	SUBFLOOR - Running north south Pipework Insulation - Insulation Material	SMF		Presumed Positive	J161155-03-ISLHD-PKH-D-Photo016	4 Unit/s	Good	Bonded (SMF)						Maintain in good condition and incorporate into a HMMP. Remove under controlled conditions prior to demolition or refurbishment.	
9	Various Rooms - Ceiling Sprayed Insulation - Sprayed Vermiculite	Asbestos	Previously Sampled Greencap J149255-03-PKDH - D-003	Previously Sampled Negative	J161155-03-ISLHD-PKH-D-Photo014

ITEM NO.: 7
 PHOTO NO.: J161155-03-ISLHD-PKH-D-PHOTO012
 RESULT: SMF - PRESUMED POSITIVE
 BUILDING/LEVEL: DENTAL & CHILDCARE - LEVEL 00
 ROOM/LOCATION: RISER D6 - VARIOUS THROUGHOUT
 FEATURE/MATERIAL: PIPEWORK INSULATION - INSULATION MATERIAL
 SAMPLE NO.: -

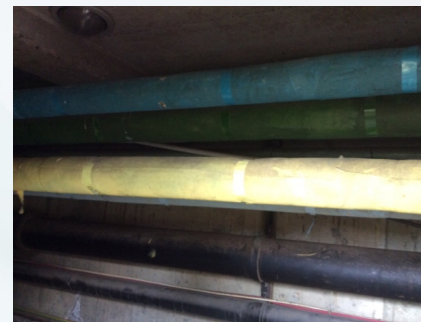
ITEM NO.: 8
 PHOTO NO.: J161155-03-ISLHD-PKH-D-PHOTO016
 RESULT: SMF - PRESUMED POSITIVE
 BUILDING/LEVEL: DENTAL & CHILDCARE - LEVEL 00
 ROOM/LOCATION: SUBFLOOR - RUNNING NORTH SOUTH
 FEATURE/MATERIAL: PIPEWORK INSULATION - INSULATION MATERIAL
 SAMPLE NO.: -

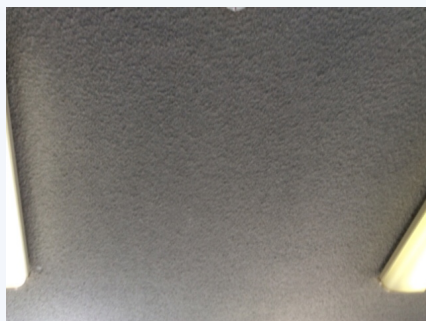
ITEM NO.: 9
 PHOTO NO.: J161155-03-ISLHD-PKH-D-PHOTO014
 RESULT: ASBESTOS - PREVIOUSLY SAMPLED NEGATIVE
 BUILDING/LEVEL: DENTAL & CHILDCARE - LEVEL 00
 ROOM/LOCATION: VARIOUS ROOMS - CEILING
 FEATURE/MATERIAL: SPRAYED INSULATION - SPRAYED VERMICULITE
 SAMPLE NO.: PREVIOUSLY SAMPLED GREENCAP J149255-03-PKDH - D-003

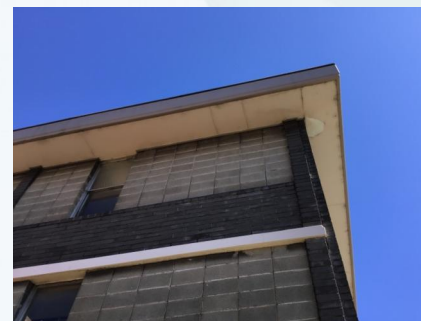
ITEM NO.: 10
 PHOTO NO.: J161155-03-ISLHD-PKH-D-PHOTO017
 RESULT: ASBESTOS - PRESUMED POSITIVE
 BUILDING/LEVEL: DENTAL & CHILDCARE - LEVEL 01
 ROOM/LOCATION: - SURROUNDING
 FEATURE/MATERIAL: EAVES - FIBRE CEMENT SHEETING
 SAMPLE NO.: NOT SAMPLED HEIGHT RESTRICTED

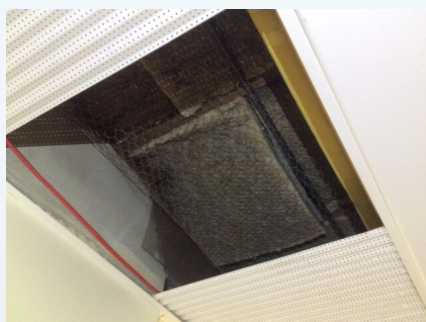
ITEM NO.: 11
 PHOTO NO.: J161155-03-ISLHD-PKH-D-PHOTO011
 RESULT: SMF - PRESUMED POSITIVE
 BUILDING/LEVEL: DENTAL & CHILDCARE - LEVEL 01
 ROOM/LOCATION: CEILING SPACE - THROUGHOUT
 FEATURE/MATERIAL: INSULATION BATTS - INSULATION MATERIAL
 SAMPLE NO.: -

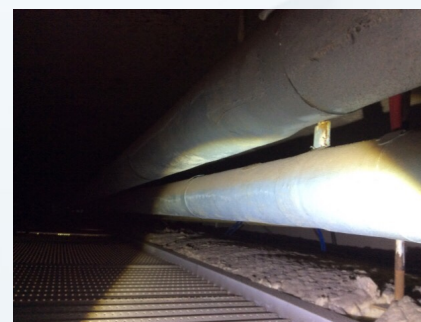
12	CORRIDOR - Ceiling Space Insulation Batts - Insulation Material	SMF		Presumed Positive	J161155-03-ISLHD-PKH-D-Photo010	60 m ²	Good	Bonded (SMF)						Maintain in good condition and incorporate into a HMMP. Remove under controlled conditions prior to demolition or refurbishment.	
13	CORRIDOR - Ceiling Space Pipework Insulation - Insulation Material	SMF		Presumed Positive	J161155-03-ISLHD-PKH-D-Photo009	4 Unit/s	Good	Bonded (SMF)						Maintain in good condition and incorporate into a HMMP. Remove under controlled conditions prior to demolition or refurbishment.	
14	KITCHEN PKBD0106 - Above sink Hot Water Heater - Insulation Material	SMF		Presumed Positive	J161155-03-ISLHD-PKH-D-Photo001	1 Unit/s	Good	Bonded (SMF)						Maintain in good condition and incorporate into a HMMP. Remove under controlled conditions prior to demolition or refurbishment.	
15	Riser D6 - Various Throughout Pipework Insulation - Insulation Material	SMF		Presumed Positive	J161155-03-ISLHD-PKH-D-Photo013	4 Unit/s	Good	Bonded (SMF)						Maintain in good condition and incorporate into a HMMP. Remove under controlled conditions prior to demolition or refurbishment.

ITEM NO.: 12
 PHOTO NO.: J161155-03-ISLHD-PKH-D-PHOTO010
 RESULT: SMF - PRESUMED POSITIVE
 BUILDING/LEVEL: DENTAL & CHILDCARE - LEVEL 01
 ROOM/LOCATION: CORRIDOR - CEILING SPACE
 FEATURE/MATERIAL: INSULATION BATTS - INSULATION MATERIAL
 SAMPLE NO.: -

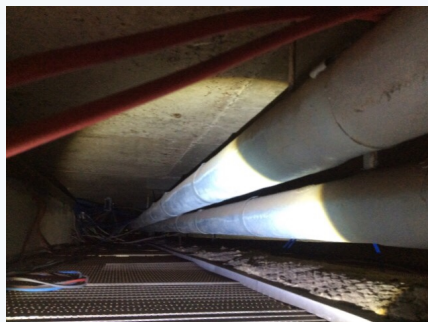
ITEM NO.: 13
 PHOTO NO.: J161155-03-ISLHD-PKH-D-PHOTO009
 RESULT: SMF - PRESUMED POSITIVE
 BUILDING/LEVEL: DENTAL & CHILDCARE - LEVEL 01
 ROOM/LOCATION: CORRIDOR - CEILING SPACE
 FEATURE/MATERIAL: PIPEWORK INSULATION - INSULATION MATERIAL
 SAMPLE NO.: -

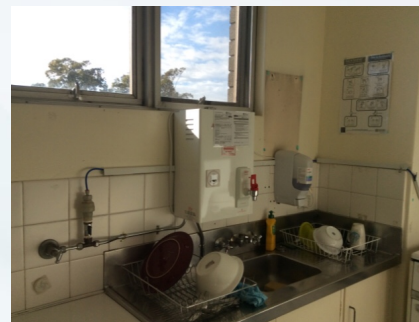
ITEM NO.: 14
 PHOTO NO.: J161155-03-ISLHD-PKH-D-PHOTO001
 RESULT: SMF - PRESUMED POSITIVE
 BUILDING/LEVEL: DENTAL & CHILDCARE - LEVEL 01
 ROOM/LOCATION: KITCHEN PKBD0106 - ABOVE SINK
 FEATURE/MATERIAL: HOT WATER HEATER - INSULATION MATERIAL
 SAMPLE NO.: -

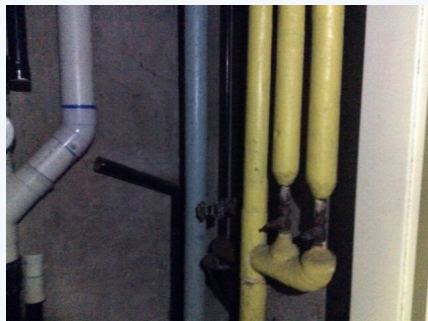
ITEM NO.: 15
 PHOTO NO.: J161155-03-ISLHD-PKH-D-PHOTO013
 RESULT: SMF - PRESUMED POSITIVE
 BUILDING/LEVEL: DENTAL & CHILDCARE - LEVEL 01
 ROOM/LOCATION: RISER D6 - VARIOUS THROUGHOUT
 FEATURE/MATERIAL: PIPEWORK INSULATION - INSULATION MATERIAL
 SAMPLE NO.: -
