Hazardous materials audit

Blayney Multi Purpose Service, 3 Osman Street, Blayney NSW 2799

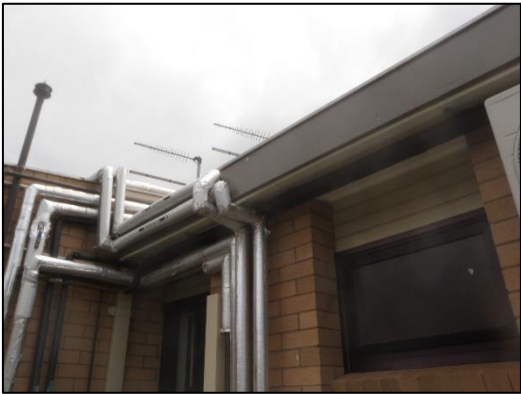
Job no	15064	Location	Blayney MPS, 3 Osman Street, Blayney NSW
ID	1	Building	Building 1
Location	External, eaves	Material description	Cement sheeting

Extent (m²)	
		Identification	Visual <input type="checkbox"/> Laboratory <input checked="" type="checkbox"/> Presumed <input type="checkbox"/> (15064-12)
		Asbestos	Yes <input type="checkbox"/> No <input checked="" type="checkbox"/> Possible <input type="checkbox"/>
		Type	Chrysotile <input type="checkbox"/> Amosite <input type="checkbox"/> Crocidolite <input type="checkbox"/>
		Classification	Non-friable (1) <input type="checkbox"/> Friable (2) <input type="checkbox"/>
		Condition:	Intact (1) <input type="checkbox"/> Damaged (2) <input type="checkbox"/> Poor (3) <input type="checkbox"/>
		Accessibility:	Low (1) <input type="checkbox"/> Medium (2) <input type="checkbox"/> High (3) <input type="checkbox"/>
		Risk rating:	- 1-2 – Very low to low, 3-4 – Moderate, 5-8 –high, 9-18 – very high

Recommendations:	
		Warning labels <input type="checkbox"/>	Remove/replace <input type="checkbox"/>

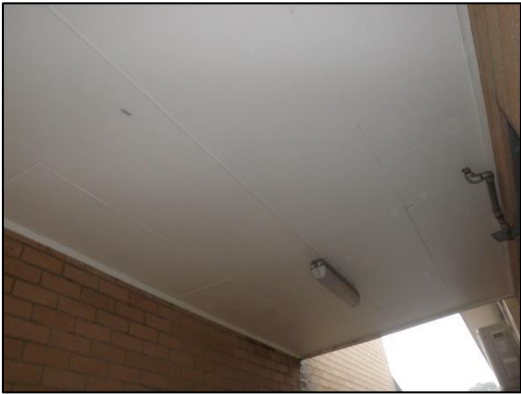
ID	3	Building	Building 1
Location	External, soffit ceiling breezeway	Material description	Cement sheeting

Extent (m²)	18
		Identification	Visual <input type="checkbox"/> Laboratory <input checked="" type="checkbox"/> Presumed <input type="checkbox"/> (15064-10)
		Asbestos	Yes <input checked="" type="checkbox"/> No <input type="checkbox"/> Possible <input type="checkbox"/>
		Type	Chrysotile <input checked="" type="checkbox"/> Amosite <input type="checkbox"/> Crocidolite <input type="checkbox"/>
		Classification	Non-friable (1) <input checked="" type="checkbox"/> Friable (2) <input type="checkbox"/>
		Condition:	Intact (1) <input type="checkbox"/> Damaged (2) <input checked="" type="checkbox"/> Poor (3) <input type="checkbox"/>
		Accessibility:	Low (1) <input checked="" type="checkbox"/> Medium (2) <input type="checkbox"/> High (3) <input type="checkbox"/>
		Risk rating:	2 1-2 – Very low to low, 3-4 – Moderate, 5-8 –high, 9-18 – very high

Recommendations:	
		Warning labels <input checked="" type="checkbox"/>	Remove/replace <input type="checkbox"/>

Monitor condition yearly <input checked="" type="checkbox"/>	Avoid mechanical damage <input checked="" type="checkbox"/>
		Repair required <input type="checkbox"/>	Remove for renovations <input checked="" type="checkbox"/>
		Restrict access <input type="checkbox"/>	Remove for demolition <input type="checkbox"/>
		Comments	Breezeway between building 1 and building 3

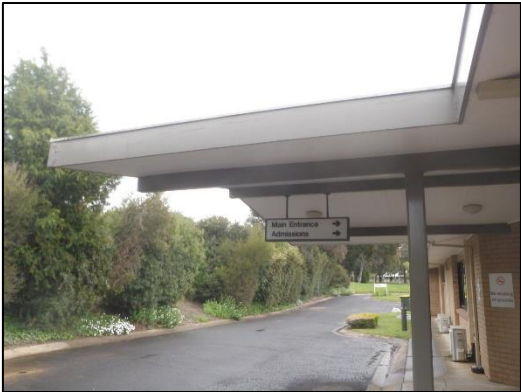
Job no	15064	Location	Blayney MPS, 3 Osman Street, Blayney NSW
ID	4	Building	Building 1
Location	External, southern entrance, ceiling/eaves	Material description	Cement sheeting
		Extent (m²)	50

Identification Visual <input type="checkbox"/> Laboratory <input checked="" type="checkbox"/> Presumed <input type="checkbox"/> (15064-11) Asbestos Yes <input type="checkbox"/> No <input checked="" type="checkbox"/> Possible <input type="checkbox"/> Type Chrysotile <input type="checkbox"/> Amosite <input type="checkbox"/> Crocidolite <input type="checkbox"/> Classification Non-friable (1) <input type="checkbox"/> Friable (2) <input type="checkbox"/> Condition: Intact (1) <input type="checkbox"/> Damaged (2) <input type="checkbox"/> Poor (3) <input type="checkbox"/> Accessibility: Low (1) <input type="checkbox"/> Medium (2) <input type="checkbox"/> High (3) <input type="checkbox"/> Risk rating: - 1-2 – Very low to low, 3-4 – Moderate, 5-8 –high, 9-18 – very high Recommendations: Warning labels <input type="checkbox"/> Remove/replace <input type="checkbox"/> Monitor condition yearly <input type="checkbox"/> Avoid mechanical damage <input type="checkbox"/> Repair required <input type="checkbox"/> Remove for renovations <input type="checkbox"/> Restrict access <input type="checkbox"/> Remove for demolition <input type="checkbox"/> Comments

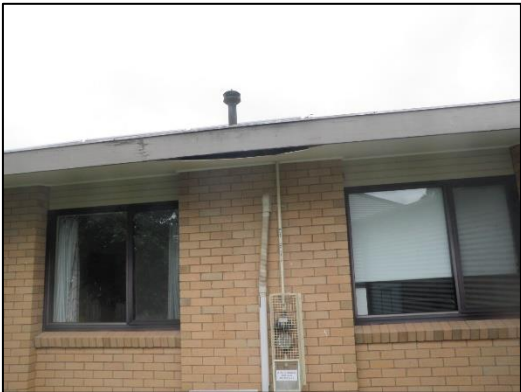
Job no	15064	Location	Blayney MPS, 3 Osman Street, Blayney NSW
ID	5	Building	Building 1
Location	External, eastern wing, eaves	Material description	Cement sheeting
		Extent (m²)	40

Identification Visual <input type="checkbox"/> Laboratory <input checked="" type="checkbox"/> Presumed <input type="checkbox"/> (15064-15) Asbestos Yes <input type="checkbox"/> No <input checked="" type="checkbox"/> Possible <input type="checkbox"/> Type Chrysotile <input type="checkbox"/> Amosite <input type="checkbox"/> Crocidolite <input type="checkbox"/> Classification Non-friable (1) <input type="checkbox"/> Friable (2) <input type="checkbox"/> Condition: Intact (1) <input type="checkbox"/> Damaged (2) <input type="checkbox"/> Poor (3) <input type="checkbox"/> Accessibility: Low (1) <input type="checkbox"/> Medium (2) <input type="checkbox"/> High (3) <input type="checkbox"/> Risk rating: - 1-2 – Very low to low, 3-4 – Moderate, 5-8 –high, 9-18 – very high Recommendations: Warning labels <input type="checkbox"/> Remove/replace <input type="checkbox"/> Monitor condition yearly <input type="checkbox"/> Avoid mechanical damage <input type="checkbox"/> Repair required <input type="checkbox"/> Remove for renovations <input type="checkbox"/> Restrict access <input type="checkbox"/> Remove for demolition <input type="checkbox"/> Comments

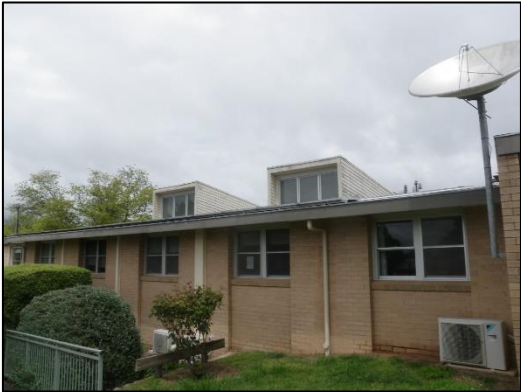
Job no	15064	Location	Blayney MPS, 3 Osman Street, Blayney NSW
ID	6	Building	Building 1
Location	External, eastern wing, eaves, inside below gutter	Material description	Cement sheeting
		Extent (m²)	40

Identification Visual <input type="checkbox"/> Laboratory <input checked="" type="checkbox"/> Presumed <input type="checkbox"/> (15064-16) Asbestos Yes <input type="checkbox"/> No <input checked="" type="checkbox"/> Possible <input type="checkbox"/> Type Chrysotile <input type="checkbox"/> Amosite <input type="checkbox"/> Crocidolite <input type="checkbox"/> Classification Non-friable (1) <input type="checkbox"/> Friable (2) <input type="checkbox"/> Condition: Intact (1) <input type="checkbox"/> Damaged (2) <input type="checkbox"/> Poor (3) <input type="checkbox"/> Accessibility: Low (1) <input type="checkbox"/> Medium (2) <input type="checkbox"/> High (3) <input type="checkbox"/> Risk rating: - 1-2 – Very low to low, 3-4 – Moderate, 5-8 –high, 9-18 – very high Recommendations: Warning labels <input type="checkbox"/> Remove/replace <input type="checkbox"/> Monitor condition yearly <input type="checkbox"/> Avoid mechanical damage <input type="checkbox"/> Repair required <input type="checkbox"/> Remove for renovations <input type="checkbox"/> Restrict access <input type="checkbox"/> Remove for demolition <input type="checkbox"/> Comments

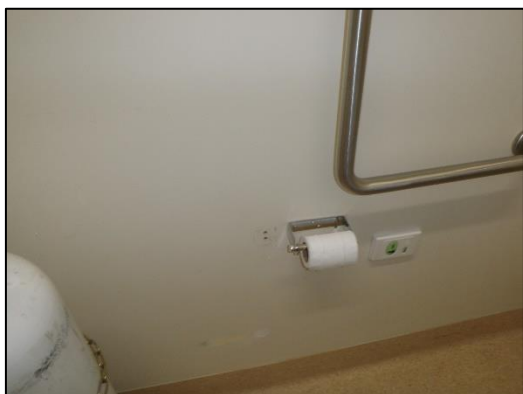
Job no	15064	Location	Blayney MPS, 3 Osman Street, Blayney NSW	
ID	7	Building	Building 1	
Location	Internal, hallway toilet, walls	Material description	Cement sheeting	
		Extent (m²)	20

Identification	Visual <input type="checkbox"/>	Laboratory <input checked="" type="checkbox"/> (15064-13)	Presumed <input type="checkbox"/>
	Asbestos	Yes <input type="checkbox"/>	No <input checked="" type="checkbox"/>	Possible <input type="checkbox"/>
	Type	Chrysotile <input type="checkbox"/>	Amosite <input type="checkbox"/>	Crocidolite <input type="checkbox"/>
	Classification	Non-friable (1) <input type="checkbox"/>	Friable (2) <input type="checkbox"/>	
	Condition:	Intact (1) <input type="checkbox"/>	Damaged (2) <input type="checkbox"/>	Poor (3) <input type="checkbox"/>
	Accessibility:	Low (1) <input type="checkbox"/>	Medium (2) <input type="checkbox"/>	High (3) <input type="checkbox"/>
	Risk rating:	- 1-2 – Very low to low, 3-4 – Moderate, 5-8 –high, 9-18 – very high

Recommendations:			
	Warning labels <input type="checkbox"/>	Remove/replace <input type="checkbox"/>		
	Monitor condition yearly <input type="checkbox"/>	Avoid mechanical damage <input type="checkbox"/>		
Repair required <input type="checkbox"/>	Remove for renovations <input type="checkbox"/>			
Restrict access <input type="checkbox"/>	Remove for demolition <input type="checkbox"/>			
Comments

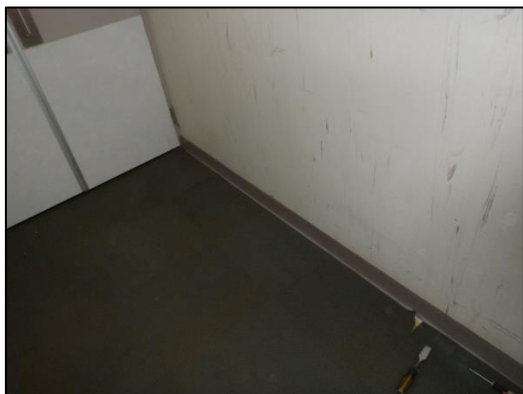
Job no	15064	Location	Blayney MPS, 3 Osman Street, Blayney NSW	
ID	8	Building	Building 1	
Location	Internal, eastern hallway, floor	Material description	Vinyl tiles	
		Extent (m²)	50

Identification	Visual <input type="checkbox"/>	Laboratory <input checked="" type="checkbox"/> (15064-14)	Presumed <input type="checkbox"/>
	Asbestos	Yes <input type="checkbox"/>	No <input checked="" type="checkbox"/>	Possible <input type="checkbox"/>
	Type	Chrysotile <input type="checkbox"/>	Amosite <input type="checkbox"/>	Crocidolite <input type="checkbox"/>
	Classification	Non-friable (1) <input type="checkbox"/>	Friable (2) <input type="checkbox"/>	
	Condition:	Intact (1) <input type="checkbox"/>	Damaged (2) <input type="checkbox"/>	Poor (3) <input type="checkbox"/>
	Accessibility:	Low (1) <input type="checkbox"/>	Medium (2) <input type="checkbox"/>	High (3) <input type="checkbox"/>
	Risk rating:	- 1-2 – Very low to low, 3-4 – Moderate, 5-8 –high, 9-18 – very high

Recommendations:			
	Warning labels <input type="checkbox"/>	Remove/replace <input type="checkbox"/>		
	Monitor condition yearly <input type="checkbox"/>	Avoid mechanical damage <input type="checkbox"/>		
Repair required <input type="checkbox"/>	Remove for renovations <input type="checkbox"/>			
Restrict access <input type="checkbox"/>	Remove for demolition <input type="checkbox"/>			
Comments		Below carpet

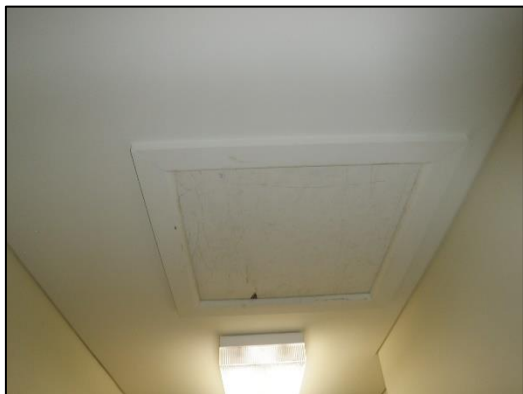
Job no	15064	Location	Blayney MPS, 3 Osman Street, Blayney NSW	
ID	9	Building	Building 1	
Location	Internal, eastern wing, manhole cover	Material description	Cement sheeting	
		Extent (m²)	<1

Identification	Visual <input type="checkbox"/>	Laboratory <input checked="" type="checkbox"/> (15064-17)	Presumed <input type="checkbox"/>
	Asbestos	Yes <input type="checkbox"/>	No <input checked="" type="checkbox"/>	Possible <input type="checkbox"/>
	Type	Chrysotile <input type="checkbox"/>	Amosite <input type="checkbox"/>	Crocidolite <input type="checkbox"/>
	Classification	Non-friable (1) <input type="checkbox"/>	Friable (2) <input type="checkbox"/>	
	Condition:	Intact (1) <input type="checkbox"/>	Damaged (2) <input type="checkbox"/>	Poor (3) <input type="checkbox"/>
	Accessibility:	Low (1) <input type="checkbox"/>	Medium (2) <input type="checkbox"/>	High (3) <input type="checkbox"/>
	Risk rating:	- 1-2 – Very low to low, 3-4 – Moderate, 5-8 –high, 9-18 – very high

Recommendations:			
	Warning labels <input type="checkbox"/>	Remove/replace <input type="checkbox"/>		
	Monitor condition yearly <input type="checkbox"/>	Avoid mechanical damage <input type="checkbox"/>		
Repair required <input type="checkbox"/>	Remove for renovations <input type="checkbox"/>			
Restrict access <input type="checkbox"/>	Remove for demolition <input type="checkbox"/>			
Comments

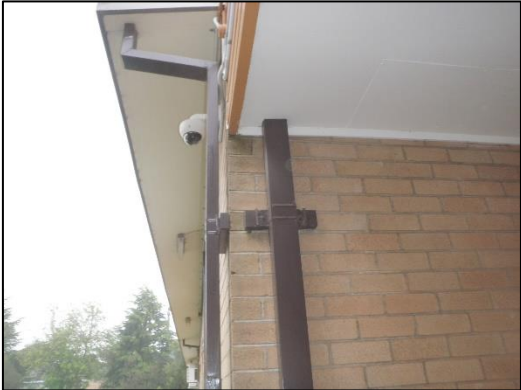
Job no	15064	Location	Blayney MPS, 3 Osman Street, Blayney NSW
ID	10	Building	Building 3
Location	External, eaves	Material description	Cement sheeting
		Extent (m²)	15

Identification	Visual <input type="checkbox"/>	Laboratory <input checked="" type="checkbox"/>	Presumed <input type="checkbox"/>
		(15064-9)	
Asbestos	Yes <input checked="" type="checkbox"/>	No <input type="checkbox"/>	Possible <input type="checkbox"/>
Type	Chrysotile <input checked="" type="checkbox"/>	Amosite <input type="checkbox"/>	Crocidolite <input type="checkbox"/>
Classification	Non-friable (1) <input checked="" type="checkbox"/>	Friable (2) <input type="checkbox"/>	
Condition:	Intact (1) <input checked="" type="checkbox"/>	Damaged (2) <input type="checkbox"/>	Poor (3) <input type="checkbox"/>
Accessibility:	Low (1) <input checked="" type="checkbox"/>	Medium (2) <input type="checkbox"/>	High (3) <input type="checkbox"/>
Risk rating:	1	1-2 – Very low to low, 3-4 – Moderate, 5-8 –high, 9-18 – very high	
Recommendations:			
Warning labels <input checked="" type="checkbox"/>		Remove/replace <input type="checkbox"/>

Monitor condition yearly <input checked="" type="checkbox"/>		Avoid mechanical damage <input checked="" type="checkbox"/>	
Repair required <input type="checkbox"/>		Remove for renovations <input checked="" type="checkbox"/>	
Restrict access <input type="checkbox"/>		Remove for demolition <input type="checkbox"/>	
Comments

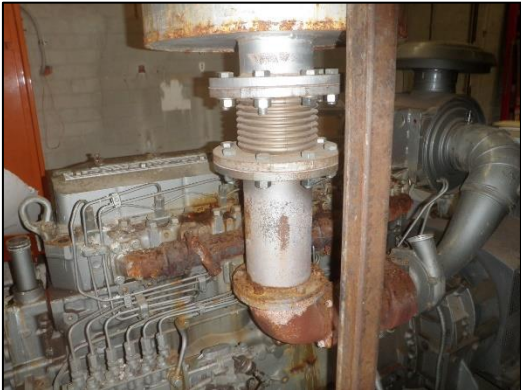
Job no	15064	Location	Blayney MPS, 3 Osman Street, Blayney NSW
ID	11	Building	Building 3, emergency generator room
Location	Internal, Rolls Royce generator, exhaust, gasket below coil	Material description	Fibrous gasket
		Extent (m²)	<1

Identification	Visual <input type="checkbox"/>	Laboratory <input checked="" type="checkbox"/>	Presumed <input type="checkbox"/>
		(15064-1)	
Asbestos	Yes <input checked="" type="checkbox"/>	No <input type="checkbox"/>	Possible <input type="checkbox"/>
Type	Chrysotile <input checked="" type="checkbox"/>	Amosite <input type="checkbox"/>	Crocidolite <input type="checkbox"/>
Classification	Non-friable (1) <input type="checkbox"/>	Friable (2) <input checked="" type="checkbox"/>	
Condition:	Intact (1) <input type="checkbox"/>	Damaged (2) <input checked="" type="checkbox"/>	Poor (3) <input type="checkbox"/>
Accessibility:	Low (1) <input type="checkbox"/>	Medium (2) <input checked="" type="checkbox"/>	High (3) <input type="checkbox"/>
Risk rating:	8	1-2 – Very low to low, 3-4 – Moderate, 5-8 –high, 9-18 – very high	
Recommendations:			
Warning labels <input checked="" type="checkbox"/>		Remove/replace <input type="checkbox"/>

Monitor condition yearly <input checked="" type="checkbox"/>		Avoid mechanical damage <input checked="" type="checkbox"/>	
Repair required <input type="checkbox"/>		Remove for renovations <input checked="" type="checkbox"/>	
Restrict access <input type="checkbox"/>		Remove for demolition <input type="checkbox"/>	
Comments

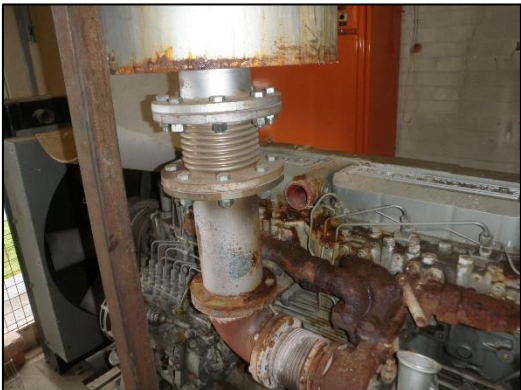
Job no	15064	Location	Blayney MPS, 3 Osman Street, Blayney NSW
ID	12	Building	Building 3, emergency generator room
Location	Internal, Rolls Royce generator, exhaust, gasket above coil	Material description	Fibrous gasket
		Extent (m²)	<1

Identification	Visual <input type="checkbox"/>	Laboratory <input checked="" type="checkbox"/>	Presumed <input type="checkbox"/>
		(15064-2)	
Asbestos	Yes <input checked="" type="checkbox"/>	No <input type="checkbox"/>	Possible <input type="checkbox"/>
Type	Chrysotile <input checked="" type="checkbox"/>	Amosite <input type="checkbox"/>	Crocidolite <input type="checkbox"/>
Classification	Non-friable (1) <input type="checkbox"/>	Friable (2) <input checked="" type="checkbox"/>	
Condition:	Intact (1) <input type="checkbox"/>	Damaged (2) <input checked="" type="checkbox"/>	Poor (3) <input type="checkbox"/>
Accessibility:	Low (1) <input type="checkbox"/>	Medium (2) <input checked="" type="checkbox"/>	High (3) <input type="checkbox"/>
Risk rating:	8	1-2 – Very low to low, 3-4 – Moderate, 5-8 –high, 9-18 – very high	
Recommendations:			
Warning labels <input checked="" type="checkbox"/>		Remove/replace <input type="checkbox"/>

Monitor condition yearly <input checked="" type="checkbox"/>		Avoid mechanical damage <input checked="" type="checkbox"/>	
Repair required <input type="checkbox"/>		Remove for renovations <input checked="" type="checkbox"/>	
Restrict access <input type="checkbox"/>		Remove for demolition <input type="checkbox"/>	
Comments

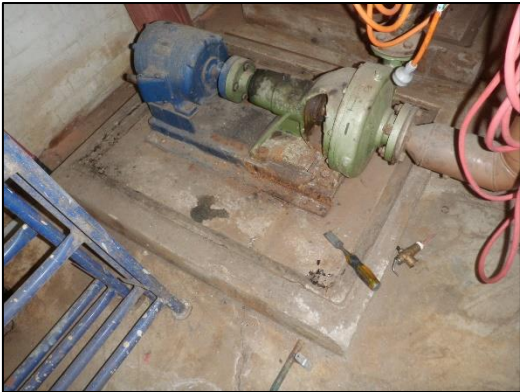
Job no	15064	Location	Blayney MPS, 3 Osman Street, Blayney NSW
ID	13	Building	Building 3, emergency generator room
Location	Internal, hot water pump tray, black mastic around edge	Material description	Bituminous mastic Extent (m²) <1

Identification	Visual <input type="checkbox"/>	Laboratory <input checked="" type="checkbox"/> (15064-3)	Presumed <input type="checkbox"/>
	Asbestos	Yes <input type="checkbox"/>	No <input checked="" type="checkbox"/>	Possible <input type="checkbox"/>
	Type	Chrysotile <input type="checkbox"/>	Amosite <input type="checkbox"/>	Crocidolite <input type="checkbox"/>
	Classification	Non-friable (1) <input type="checkbox"/>	Friable (2) <input type="checkbox"/>	
	Condition:	Intact (1) <input type="checkbox"/>	Damaged (2) <input type="checkbox"/>	Poor (3) <input type="checkbox"/>
	Accessibility:	Low (1) <input type="checkbox"/>	Medium (2) <input type="checkbox"/>	High (3) <input type="checkbox"/>
	Risk rating:	- 1-2 – Very low to low, 3-4 – Moderate, 5-8 –high, 9-18 – very high		
	Recommendations:			
	Warning labels <input type="checkbox"/>	Remove/replace <input type="checkbox"/>		
	Monitor condition yearly <input type="checkbox"/>	Avoid mechanical damage <input type="checkbox"/>

Repair required <input type="checkbox"/>	Remove for renovations <input type="checkbox"/>			
Restrict access <input type="checkbox"/>	Remove for demolition <input type="checkbox"/>			
Comments

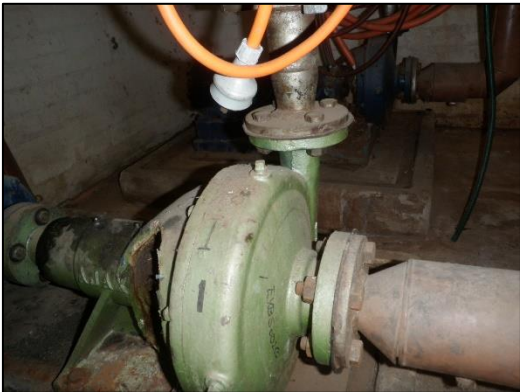
Job no	15064	Location	Blayney MPS, 3 Osman Street, Blayney NSW
ID	14	Building	Building 3, emergency generator room
Location	Internal, hot water pump gasket	Material description	Fibrous gasket (black) Extent (m²) <1

Identification	Visual <input type="checkbox"/>	Laboratory <input checked="" type="checkbox"/> (15064-4)	Presumed <input type="checkbox"/>
	Asbestos	Yes <input type="checkbox"/>	No <input checked="" type="checkbox"/>	Possible <input type="checkbox"/>
	Type	Chrysotile <input type="checkbox"/>	Amosite <input type="checkbox"/>	Crocidolite <input type="checkbox"/>
	Classification	Non-friable (1) <input type="checkbox"/>	Friable (2) <input type="checkbox"/>	
	Condition:	Intact (1) <input type="checkbox"/>	Damaged (2) <input type="checkbox"/>	Poor (3) <input type="checkbox"/>
	Accessibility:	Low (1) <input type="checkbox"/>	Medium (2) <input type="checkbox"/>	High (3) <input type="checkbox"/>
	Risk rating:	- 1-2 – Very low to low, 3-4 – Moderate, 5-8 –high, 9-18 – very high		
	Recommendations:			
	Warning labels <input type="checkbox"/>	Remove/replace <input type="checkbox"/>		
	Monitor condition yearly <input type="checkbox"/>	Avoid mechanical damage <input type="checkbox"/>

Repair required <input type="checkbox"/>	Remove for renovations <input type="checkbox"/>			
Restrict access <input type="checkbox"/>	Remove for demolition <input type="checkbox"/>			
Comments

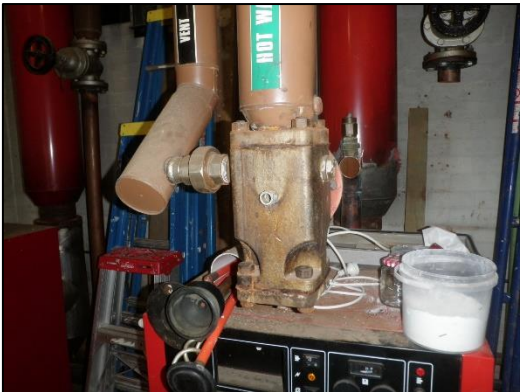
Job no	15064	Location	Blayney MPS, 3 Osman Street, Blayney NSW
ID	15	Building	Building 3, emergency generator room
Location	Internal, hot water pipes above gas heater, vertical gasket	Material description	Fibrous gasket (red) Extent (m²) <1

Identification	Visual <input type="checkbox"/>	Laboratory <input checked="" type="checkbox"/> (15064-5)	Presumed <input type="checkbox"/>
	Asbestos	Yes <input checked="" type="checkbox"/>	No <input type="checkbox"/>	Possible <input type="checkbox"/>
	Type	Chrysotile <input checked="" type="checkbox"/>	Amosite <input type="checkbox"/>	Crocidolite <input type="checkbox"/>
	Classification	Non-friable (1) <input type="checkbox"/>	Friable (2) <input checked="" type="checkbox"/>	
	Condition:	Intact (1) <input type="checkbox"/>	Damaged (2) <input checked="" type="checkbox"/>	Poor (3) <input type="checkbox"/>
	Accessibility:	Low (1) <input type="checkbox"/>	Medium (2) <input checked="" type="checkbox"/>	High (3) <input type="checkbox"/>
	Risk rating:	8 1-2 – Very low to low, 3-4 – Moderate, 5-8 –high, 9-18 – very high		
	Recommendations:			
	Warning labels <input checked="" type="checkbox"/>	Remove/replace <input type="checkbox"/>

Monitor condition yearly <input checked="" type="checkbox"/>	Avoid mechanical damage <input checked="" type="checkbox"/>		
Repair required <input type="checkbox"/>	Remove for renovations <input checked="" type="checkbox"/>			
Restrict access <input type="checkbox"/>	Remove for demolition <input type="checkbox"/>			
Comments

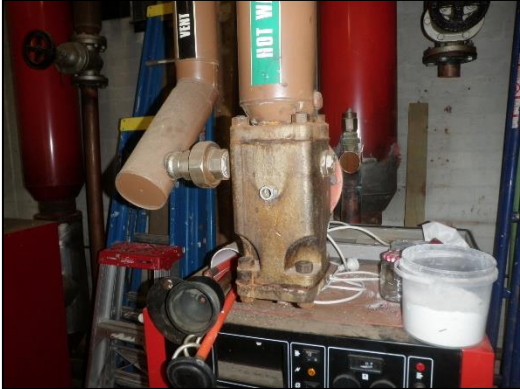
Job no	15064	Location	Blayney MPS, 3 Osman Street, Blayney NSW
ID	16	Building	Building 3, emergency generator room
Location	Internal, hot water pipes above gas heater, horizontal gasket	Material description	Fibrous gasket (red) Extent (m²) <1

Identification	Visual <input type="checkbox"/>	Laboratory <input checked="" type="checkbox"/> (15064-6)	Presumed <input type="checkbox"/>
	Asbestos	Yes <input checked="" type="checkbox"/>	No <input type="checkbox"/>	Possible <input type="checkbox"/>
	Type	Chrysotile <input checked="" type="checkbox"/>	Amosite <input type="checkbox"/>	Crocidolite <input type="checkbox"/>
	Classification	Non-friable (1) <input type="checkbox"/>	Friable (2) <input checked="" type="checkbox"/>	
	Condition:	Intact (1) <input type="checkbox"/>	Damaged (2) <input checked="" type="checkbox"/>	Poor (3) <input type="checkbox"/>
	Accessibility:	Low (1) <input type="checkbox"/>	Medium (2) <input checked="" type="checkbox"/>	High (3) <input type="checkbox"/>
	Risk rating:	8	1-2 – Very low to low, 3-4 – Moderate, 5-8 –high, 9-18 – very high	
	Recommendations:			
	Warning labels <input checked="" type="checkbox"/>	Remove/replace <input type="checkbox"/>

Monitor condition yearly <input checked="" type="checkbox"/>	Avoid mechanical damage <input checked="" type="checkbox"/>		
Repair required <input type="checkbox"/>	Remove for renovations <input checked="" type="checkbox"/>			
Restrict access <input type="checkbox"/>	Remove for demolition <input type="checkbox"/>			
Comments

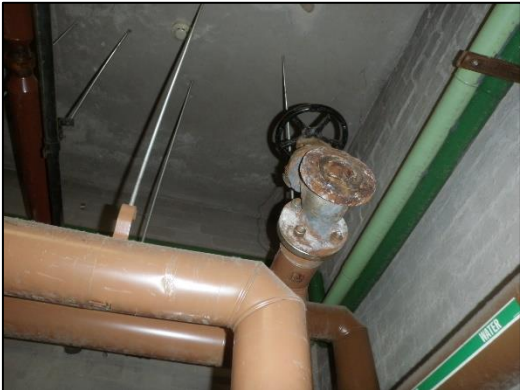
Job no	15064	Location	Blayney MPS, 3 Osman Street, Blayney NSW
ID	17	Building	Building 3, emergency generator room
Location	Internal, redundant pipe valve, gasket	Material description	Fibrous gasket Extent (m²) <1

Identification	Visual <input type="checkbox"/>	Laboratory <input checked="" type="checkbox"/> (15064-7)	Presumed <input type="checkbox"/>
	Asbestos	Yes <input checked="" type="checkbox"/>	No <input type="checkbox"/>	Possible <input type="checkbox"/>
	Type	Chrysotile <input checked="" type="checkbox"/>	Amosite <input type="checkbox"/>	Crocidolite <input type="checkbox"/>
	Classification	Non-friable (1) <input type="checkbox"/>	Friable (2) <input checked="" type="checkbox"/>	
	Condition:	Intact (1) <input type="checkbox"/>	Damaged (2) <input checked="" type="checkbox"/>	Poor (3) <input type="checkbox"/>
	Accessibility:	Low (1) <input type="checkbox"/>	Medium (2) <input checked="" type="checkbox"/>	High (3) <input type="checkbox"/>
	Risk rating:	8	1-2 – Very low to low, 3-4 – Moderate, 5-8 –high, 9-18 – very high	
	Recommendations:			
	Warning labels <input checked="" type="checkbox"/>	Remove/replace <input type="checkbox"/>

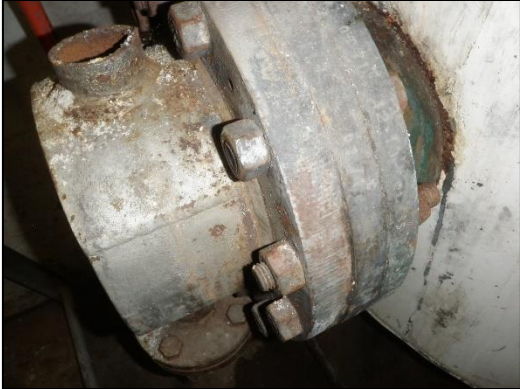
Job no	15064	Location	Blayney MPS, 3 Osman Street, Blayney NSW
ID	18	Building	Building 3, emergency generator room
Location	Internal, old heater, hot water gasket	Material description	Fibrous gasket Extent (m²) <1

Identification	Visual <input type="checkbox"/>	Laboratory <input checked="" type="checkbox"/> (15064-8)	Presumed <input type="checkbox"/>
	Asbestos	Yes <input checked="" type="checkbox"/>	No <input type="checkbox"/>	Possible <input type="checkbox"/>
	Type	Chrysotile <input checked="" type="checkbox"/>	Amosite <input type="checkbox"/>	Crocidolite <input type="checkbox"/>
	Classification	Non-friable (1) <input type="checkbox"/>	Friable (2) <input checked="" type="checkbox"/>	
	Condition:	Intact (1) <input type="checkbox"/>	Damaged (2) <input checked="" type="checkbox"/>	Poor (3) <input type="checkbox"/>
	Accessibility:	Low (1) <input type="checkbox"/>	Medium (2) <input checked="" type="checkbox"/>	High (3) <input type="checkbox"/>
	Risk rating:	8	1-2 – Very low to low, 3-4 – Moderate, 5-8 –high, 9-18 – very high	
	Recommendations:			
	Warning labels <input checked="" type="checkbox"/>	Remove/replace <input type="checkbox"/>

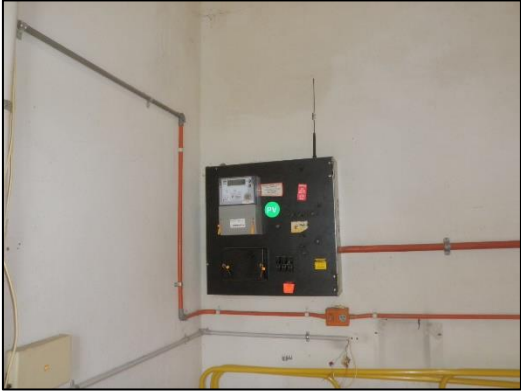
Job no	15064	Location	Blayney MPS, 3 Osman Street, Blayney NSW		
ID	19	Building	Building 3, emergency generator room		
Location	Internal, western wall, meter board	Material description	Bituminous resin board	Extent (m²)	1

Identification Visual ☒ Laboratory ☐ Presumed ☐

Asbestos Yes ☐ No ☐ Possible ☒

Condition: Intact (1) ☒ Damaged (2) ☐ Poor (3) ☐

Recommendations:

Warning labels ☒ Remove/replace ☐

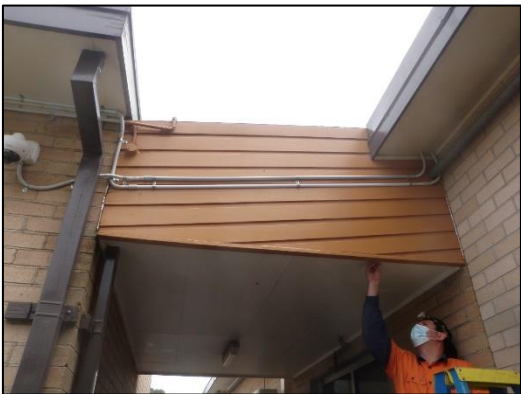
Job no	15064	Address	Blayney MPS, 248 Summer Street, Orange		
ID	20	Building	Building 1		
Location	External, breezeway, eastern fascia	Material description	Brown paint	Extent (m²) 5

Identification	Visual <input type="checkbox"/>	Laboratory <input checked="" type="checkbox"/> Field screening <input type="checkbox"/> (15034-103)	
		Lead	Yes (1) <input checked="" type="checkbox"/>	No (0) <input type="checkbox"/>	Possible (1) <input type="checkbox"/>
		Condition:	Sound (1) <input type="checkbox"/>	Fair (2) <input checked="" type="checkbox"/>	
			Poor (3) <input type="checkbox"/>	Very poor to extreme (4) <input type="checkbox"/>	
		Accessibility:	Low (1) <input type="checkbox"/>	Medium (2) <input checked="" type="checkbox"/>	High (3) <input type="checkbox"/>
		Risk rating:	4	1-2 – Very low to low, 3-4 – Moderate, 5-8 –high, 9-18 – very high	
		Concentration:	0.022% w/w		
		Recommendations:			
		Warning labels <input type="checkbox"/>	Remove/replace <input type="checkbox"/>

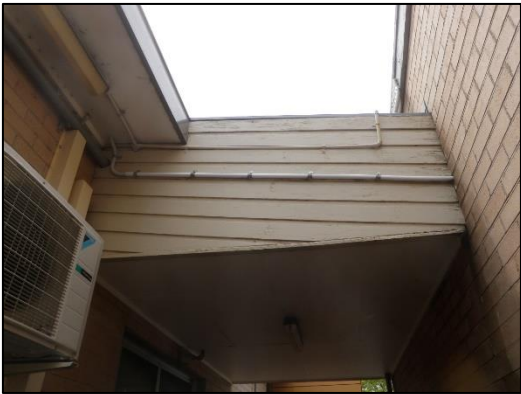
Job no	15064	Address	Blayney MPS, 248 Summer Street, Orange		
ID	21	Building	Building 1		
Location	External, breezeway, western fascia	Material description	Cream paint	Extent (m²) 5

Identification	Visual <input type="checkbox"/>	Laboratory <input type="checkbox"/> Field screening <input checked="" type="checkbox"/>	
		Lead	Yes (1) <input type="checkbox"/>	No (0) <input checked="" type="checkbox"/>	Possible (1) <input type="checkbox"/>
		Condition:	Sound (1) <input type="checkbox"/>	Fair (2) <input type="checkbox"/>	
			Poor (3) <input type="checkbox"/>	Very poor to extreme (4) <input type="checkbox"/>	
		Accessibility:	Low (1) <input type="checkbox"/>	Medium (2) <input type="checkbox"/>	High (3) <input type="checkbox"/>
		Risk rating:	-	1-2 – Very low to low, 3-4 – Moderate, 5-8 –high, 9-18 – very high	
		Concentration:	-		
		Recommendations:			
		Warning labels <input type="checkbox"/>	Remove/replace <input type="checkbox"/>

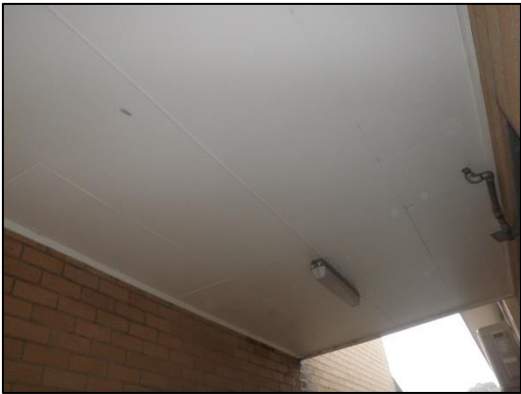
Job no	15064	Address	Blayney MPS, 248 Summer Street, Orange		
ID	22	Building	Building 1		
Location	External, soffit ceiling, breezeway	Material description	White paint	Extent (m²) 8

Identification	Visual <input type="checkbox"/>	Laboratory <input type="checkbox"/> Field screening <input checked="" type="checkbox"/>	
		Lead	Yes (1) <input type="checkbox"/>	No (0) <input checked="" type="checkbox"/>	Possible (1) <input type="checkbox"/>
		Condition:	Sound (1) <input type="checkbox"/>	Fair (2) <input type="checkbox"/>	
			Poor (3) <input type="checkbox"/>	Very poor to extreme (4) <input type="checkbox"/>	
		Accessibility:	Low (1) <input type="checkbox"/>	Medium (2) <input type="checkbox"/>	High (3) <input type="checkbox"/>
		Risk rating:	-	1-2 – Very low to low, 3-4 – Moderate, 5-8 –high, 9-18 – very high	
		Concentration:	-		
		Recommendations:			
		Warning labels <input type="checkbox"/>	Remove/replace <input type="checkbox"/>

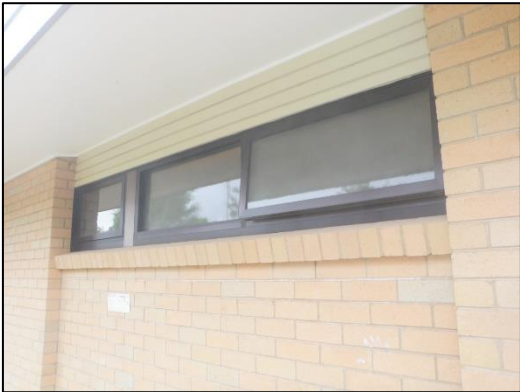
Identification	Visual <input type="checkbox"/>	Laboratory <input checked="" type="checkbox"/>	Field screening <input type="checkbox"/>	
			(15034-107)			
		Lead	Yes (1) <input checked="" type="checkbox"/>	No (0) <input type="checkbox"/>	Possible (1) <input type="checkbox"/>	
		Condition:	Sound (1) <input type="checkbox"/>	Fair (2) <input checked="" type="checkbox"/>		
			Poor (3) <input type="checkbox"/>	Very poor to extreme (4) <input type="checkbox"/>		
		Accessibility:	Low (1) <input type="checkbox"/>	Medium (2) <input checked="" type="checkbox"/>	High (3) <input type="checkbox"/>	
		Risk rating:	4	1-2 – Very low to low, 3-4 – Moderate, 5-8 –high, 9-18 – very high		
Concentration:	0.054%

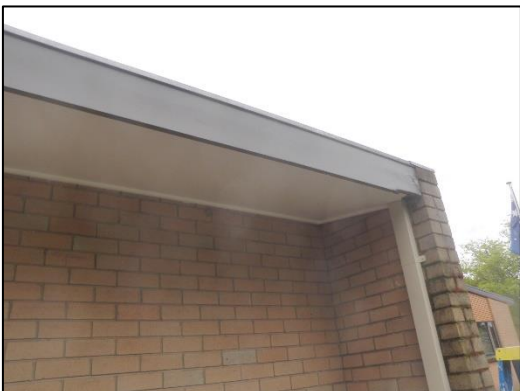
Identification	Visual <input type="checkbox"/>	Laboratory <input checked="" type="checkbox"/>	Field screening <input type="checkbox"/>	
			(15034-108)			
		Lead	Yes (1) <input checked="" type="checkbox"/>	No (0) <input type="checkbox"/>	Possible (1) <input type="checkbox"/>	
		Condition:	Sound (1) <input type="checkbox"/>	Fair (2) <input checked="" type="checkbox"/>		
			Poor (3) <input type="checkbox"/>	Very poor to extreme (4) <input type="checkbox"/>		
		Accessibility:	Low (1) <input checked="" type="checkbox"/>	Medium (2) <input type="checkbox"/>	High (3) <input type="checkbox"/>	
		Risk rating:	2	1-2 – Very low to low, 3-4 – Moderate, 5-8 –high, 9-18 – very high		
Concentration:	0.027% w/w					
		Recommendations:

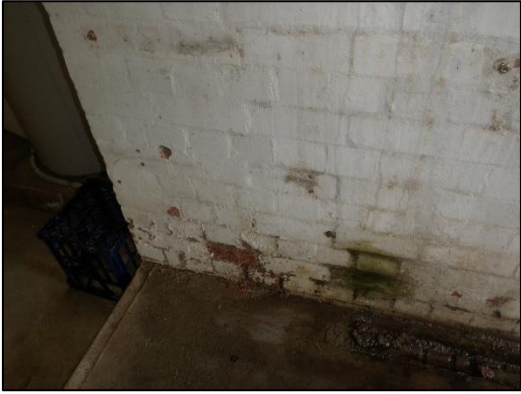
Identification	Visual <input type="checkbox"/>	Laboratory <input checked="" type="checkbox"/>	Field screening <input type="checkbox"/>
			(15034-101)	
	Lead	Yes (1) <input checked="" type="checkbox"/>	No (0) <input type="checkbox"/>	Possible (1) <input type="checkbox"/>
	Condition:	Sound (1) <input type="checkbox"/>	Fair (2) <input checked="" type="checkbox"/>	
		Poor (3) <input type="checkbox"/>	Very poor to extreme (4) <input type="checkbox"/>	
	Accessibility:	Low (1) <input type="checkbox"/>	Medium (2) <input checked="" type="checkbox"/>	High (3) <input type="checkbox"/>
	Risk rating:	4	1-2 – Very low to low, 3-4 – Moderate, 5-8 –high, 9-18 – very high	
	Concentration:	0.11% w/w		
	Recommendations:			
	Warning labels <input checked="" type="checkbox"/>	Remove/replace <input type="checkbox"/>		
Monitor condition yearly <input checked="" type="checkbox"/>	Avoid mechanical damage <input checked="" type="checkbox"/>
