RE: Job 436181v3 - Treeworks Visual Tree Assessment & Tree Management Plan dated 12/12/23

**Revised
Visual Tree Assessment
and
Tree Management Plan
for
24 Thurrallilly Street
Queanbeyan East NSW 2620**

Report Author	Steve Griffiths Level 5 Arborist Treeworks (ACT/NSW) Pty Ltd
Phone	1800 873 343
Report Date	12/12/2023

Job	436181
Site Address	24 Thurrallilly Street Queanbeyan East NSW 2620
Client	Lydia Powrie Shanel Erzeybek
Contact	02 9557 6466

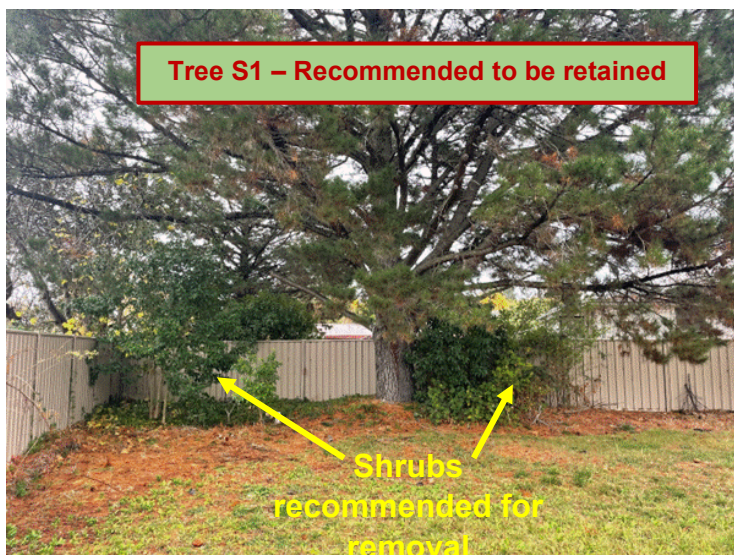
This results in a total of 7 trees and various small shrubs under the Canopy of S1 (see photo) that I advise for removal from this site once approval has been gained from the Queanbeyan City Council.

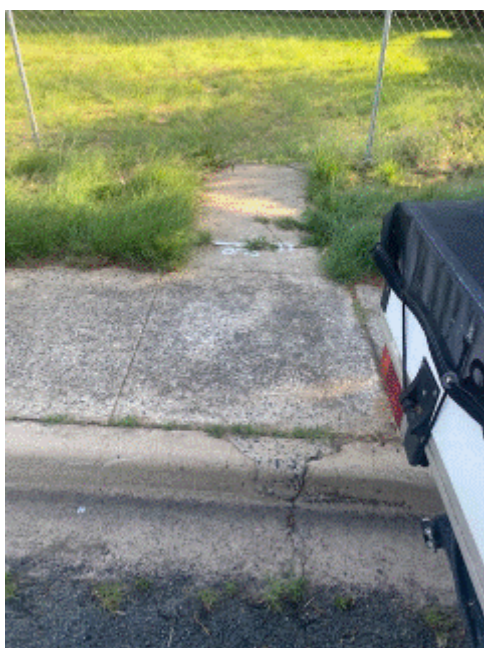
A dilapidation inspection was conducted on the **12/12/2023**, it was noted as shown in photos below that there was lifting and cracking of council footpath on Pound Place and Thurrallilly Street. Cracking was also observed on the council curb. The council footpath appeared to be non-compacted with good lawn.

Figure 2. Cracked curb on Thurrallilly Street (12/12/2023)

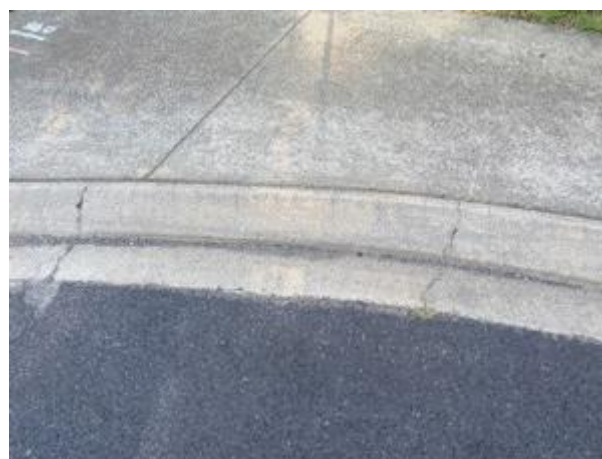
Figure 3. Cracked curb on Pound Street (12/12/2023)

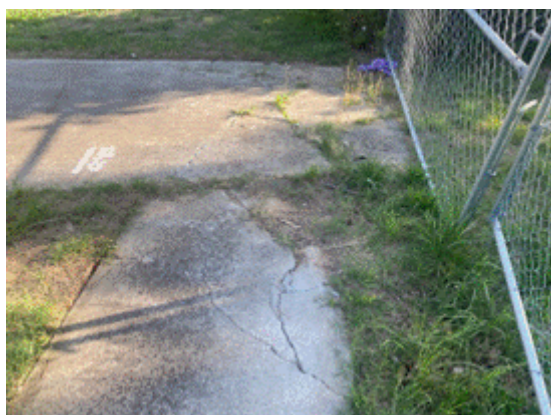
Figure 4. Damage to council footpath near driveway (12/12/2023)

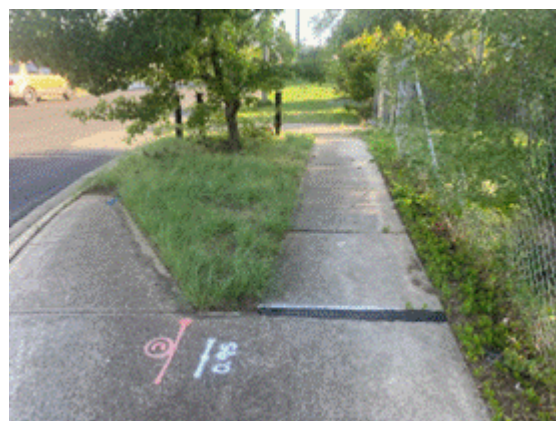
Figure 5. Roots lifting foot path on Pound Street (12/12/2023)

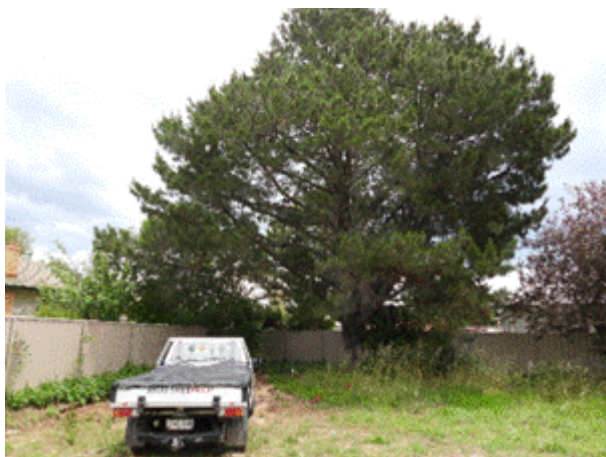
Figure 8. Tree S1 *Pinus radiata*

- The incursion into Tree S1's root zone is major due to being just over 10%. However, this incursion appears acceptable if all the methodologies outlined in this report are strictly followed and by using pier or screw pier foundation for the deck and waffle pod for the house while within the 10.44m Tree Protection Zone (TPZ) radius from the central trunk.

- We recommend the retention of Tree S1 and Tree S5 through all stages of development. The deck that is closest to Tree S1 requires piers or screw foundation. If the foundation selected is pier foundations, the holes must be either hydrovaced at half pressure or hand dug. Trees S1 and Tree S5 require compaction mats or secondary paths and Tree Protection Fencing (TPF) around them for the protection of their root system.

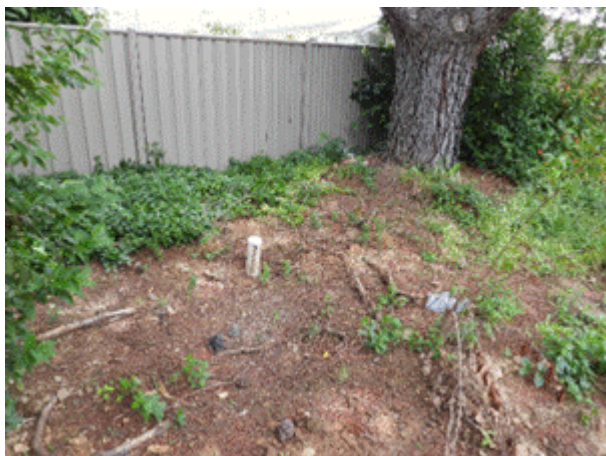
Figure 9. Tree S2 *Pinus radiata* - showing recent digging within the tree's root zone

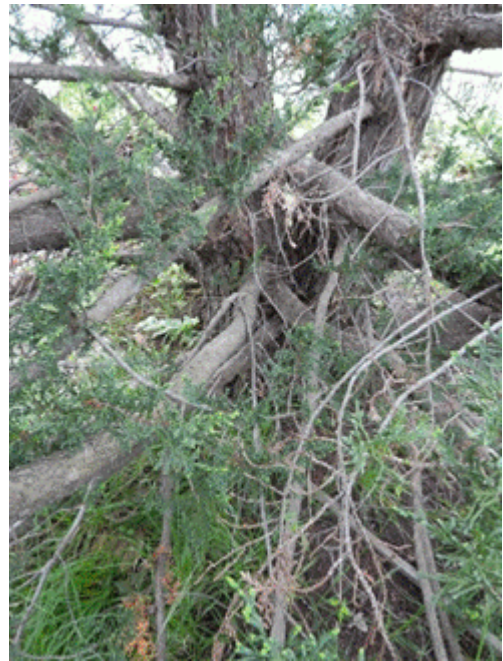
- The incursion into Tree S5's root zone is very minor being less than 5%. The incursion into this tree's TPZ will only be the boundary wall and pedestrian pathway to dwelling A. We recommend lightweight material such as colorbond fencing for the boundary wall, placed on pier foundation bases (hand dug or hydrovaced at half pressure from the nozzle). This incursion appears to be acceptable, provided there is minimal disturbance within the TPZ radius of 4.56m from the central trunk.

Figure 14. Tree S5 *Hesperocyparis macrocarpa* - with compression union

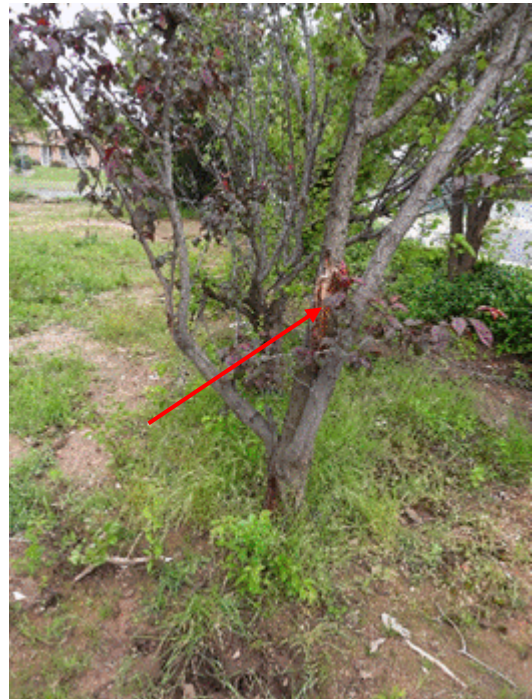
Figure 18. Tree S8 - showing mechanical damage

- and all the neighbouring trees on other blocks (Trees N9, N10, N11).
- We recommend the removal of trees S2, S3, S4, S6, S7 and S8 as they are low value to the area and will allow for a larger footprint for the proposed house. Approval for these must be granted by Queanbeyan City Council prior to removal.

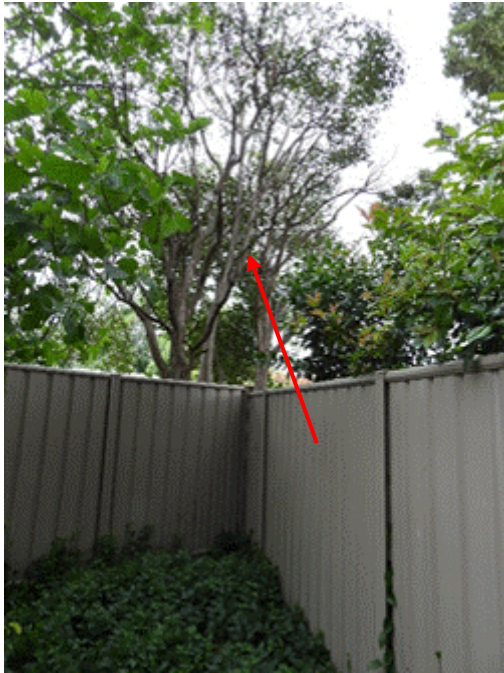
Figure 20. Tree N10 *Ligustrum lucidum* - neighbor's tree

- Trees N9, N10, and N11 are neighbour's trees that have their roots encroaching into this vacant site and must be protected during all phases of development.

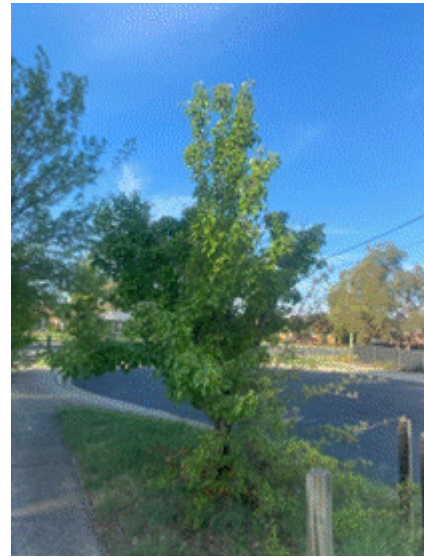
Figure 22. Tree C12 - Manchurian Pear

N11	<i>Hesperocyparis macrocarpa</i>	Good	-	Yes	4.32	2.43	Low	20	Neighbour's tree, close to powerlines, 2m from fence
C12	<i>Pyrus ussuriensis</i>	Fair	High	Yes	-	-	Low		Tree in decline
C13	<i>Malus sp.</i>	Good	High	Yes	-	-	Low		Close to bus stop

- The following trees must be protected during all phases of development with a 1.8-meter tree protection fencing:
 - Trees S1 and S5
 - Trees C12 and C13 are council verge trees

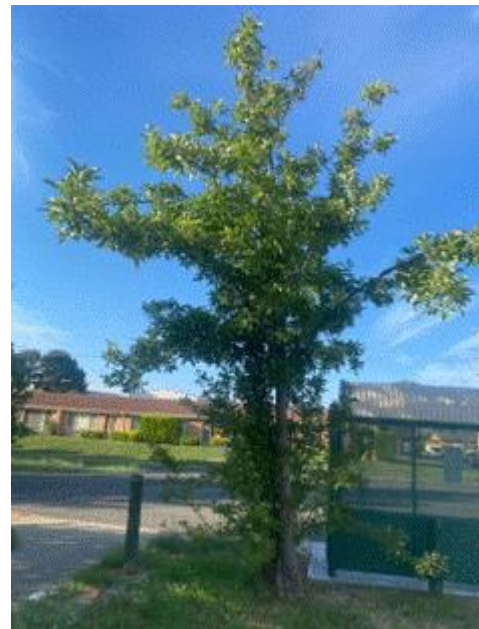
Figure 23. Tree C13 – Apple Tree

C13	Apple Tree	160	440	Lots of epicormic growth	7.00	3/2	3/2	Semi Mature	Fair	85

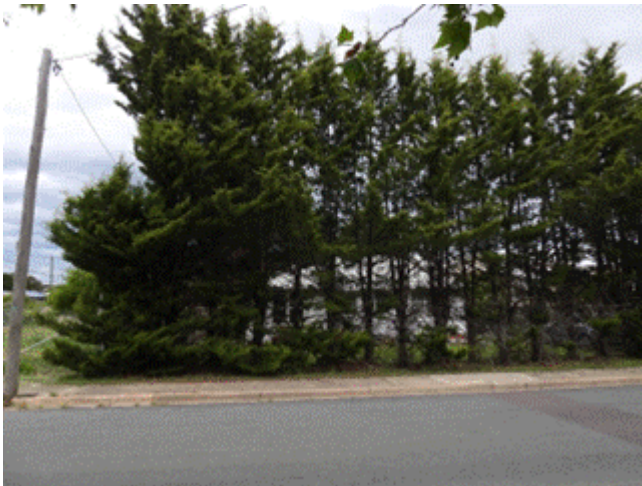
Figure 21. Tree N11 *Hesperocyparis macrocarpa* - neighbor's hedge
