Residential Site Investigation Report

Site Address: 7-9 Wattle Avenue,
Orange, NSW 2800

23 December 2022

Our Reference: 40519-GR01_A

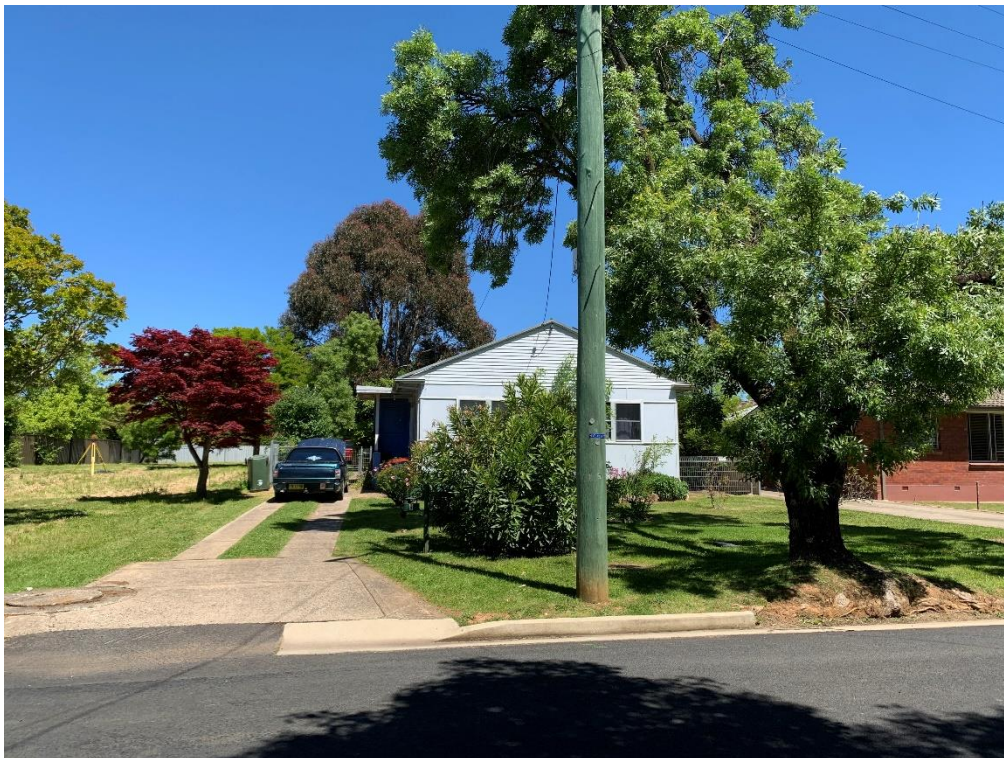
Plate 1 – West facing view

The site is sloping slightly to the east. The block has existing dwelling on block with existing buildings and established houses surrounding the area.

Any trees noted to be within the building zone, should be removed and the excavation remaining should be backfilled with natural material and reinstated in layers to a minimum of 95% Standard Maximum Dry Density

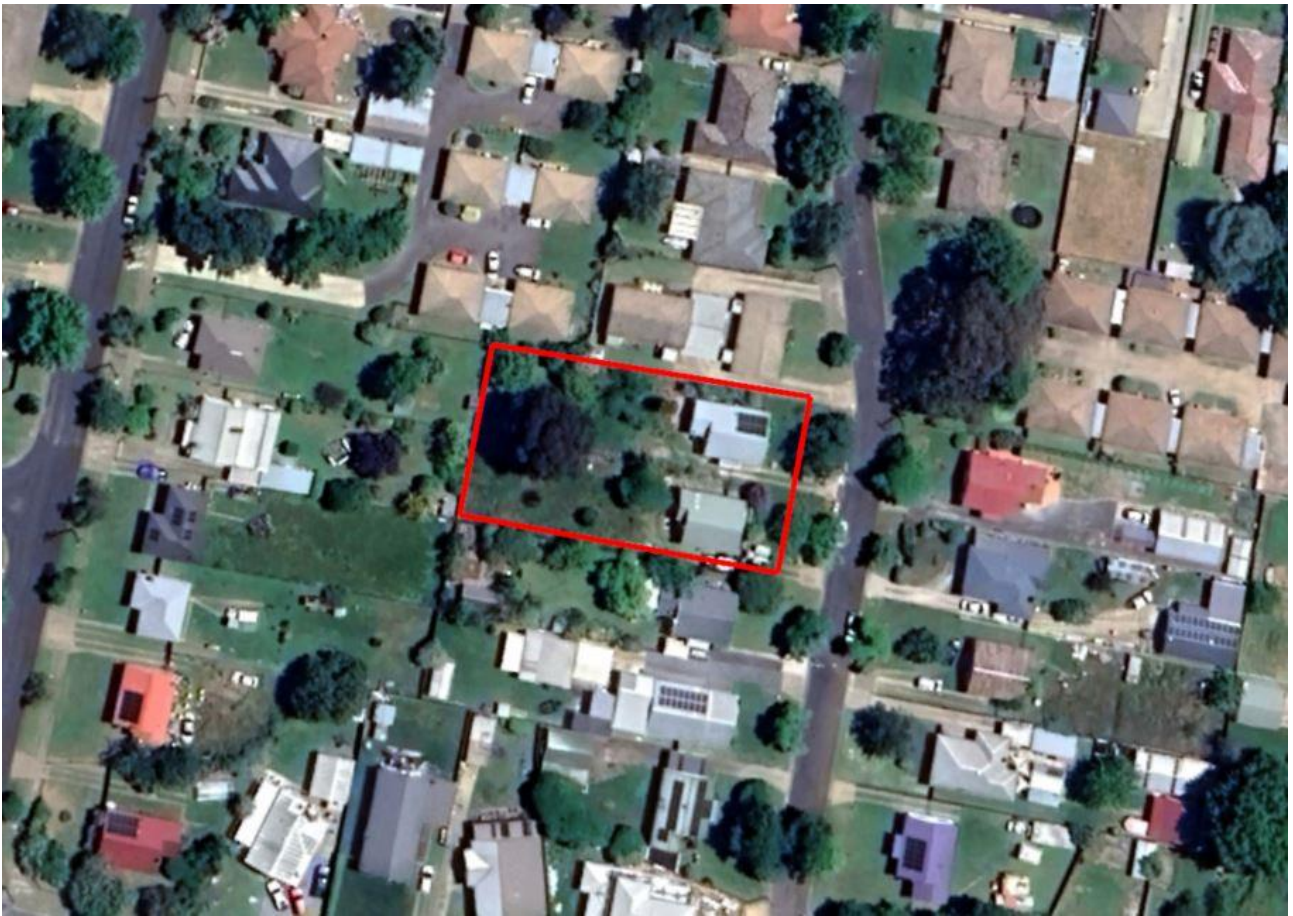
Plate 2 – Aerial Image 2021, Courtesy Google Earth.

A review of Google Earth imagery of the site indicates that a residential dwelling and large trees had existed on the site since before an image taken in 2021. Images exist back to 1985, yet the image is not clear enough to determine what was on the site. The residential dwelling is expected to have been constructed well before 2006. The trees have been removed from site but there is no evidence that the excavation was backfilled with natural material and reinstated in layers to a minimum of 95% Standard Maximum Dry Density. See 2021 aerial image below:
