ARBORICULTURAL REPORT

Callan Park Parklands Precinct

Prepared for: GREATER SYDNEY PARKLANDS

Revision F

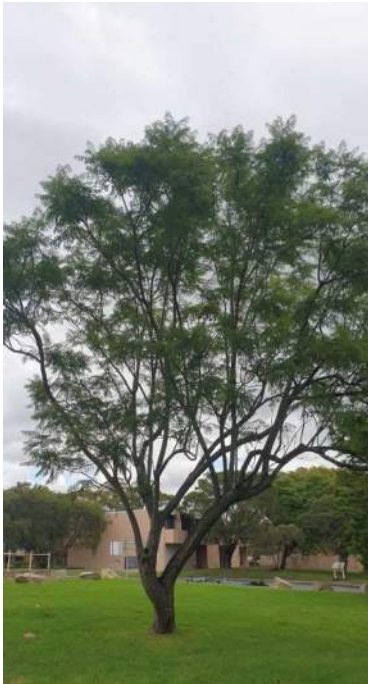
Figure 1: Tree 7 - pruning

Tree 7 was identified as *Jacaranda mimosifolia* (Jacaranda). A large, second order branch on Tree 7 has been subject to extensive damage. This branch should be removed by Selective Pruning.

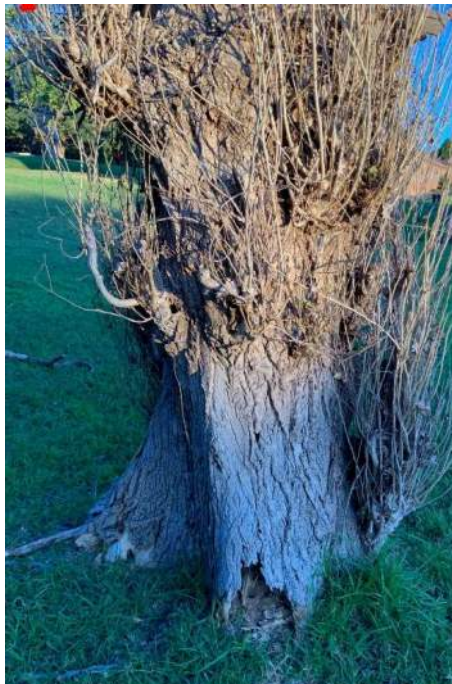
Figure 2: Tree 61 - removal

Trees 61, 161 and 658 were identified as *Populus nigra* 'Italica' (Lombardy Poplar). The trees are in poor health as evidenced by a reduced crown density and presence of high volumes of deadwood. They are in poor structural condition with extensive basal decay and major trunk cavities. Trees 61, 161 and 658 have reached the end of their useful life and should be removed.

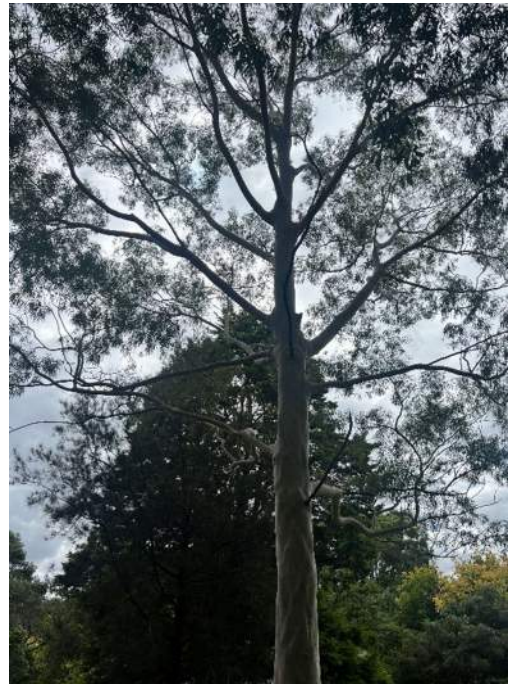
Figure 3: Tree 66 – pruning

Trees 66, 114, 276, 328, 376, 391, 454, 468, 473, 497 and 554 are a mix of species. Extensive deadwood is present within the crowns of the trees. The deadwood is beginning to shed and become hazardous. The deadwood should be removed from these trees.

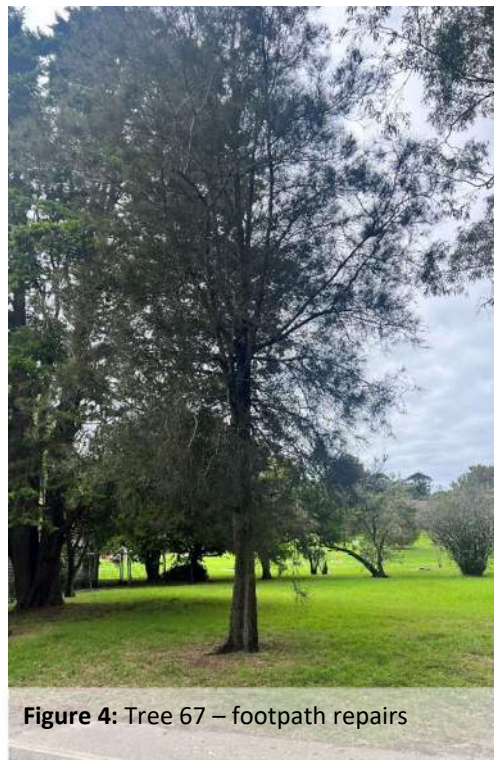
Figure 4: Tree 67 – footpath repairs

Tree 67 was identified as *Casuarina glauca* (Swamp She Oak). Root growth has lifted a section of pavement in close proximity to the tree. The pavement should be repaired to eliminate the trip hazard.

- 3.3.1 The cracked and raised section of pavement next to Tree 67 should be repaired to eliminate the trip hazard. Repair options may include grinding down the pavement or raising/ramping the section of pavement over roots. No root pruning should be undertaken as part of the repair works unless approved by AQF level 5 Arborist.
- 3.3.2 A dynamic restraint system (i.e. Cobra Brace) should be installed on Tree 126 to provide additional support to the inclusion. The Arborist installing the bracing system should hold a minimum qualification equivalent (using the Australian Qualifications Framework) of Level 3 or above in Arboriculture and be experienced in the installation of dynamic restraint systems.

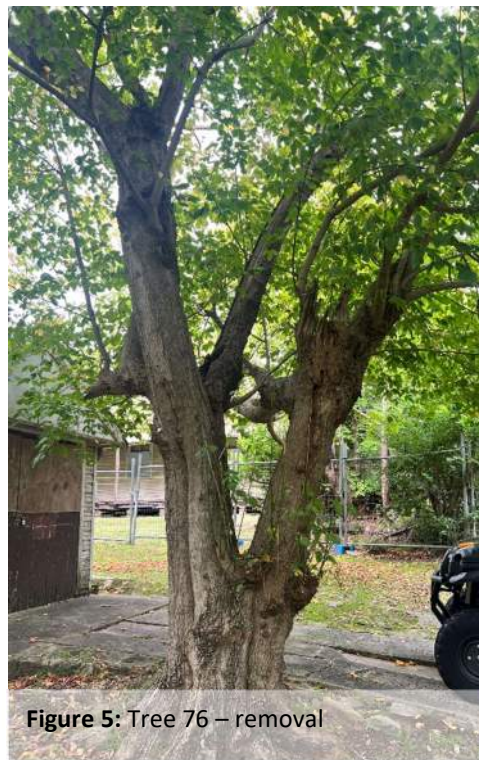
Figure 5: Tree 76 – removal

Trees 76, 78, 80 and 198 were identified as *Acer negundo* (Box Elder). The trees are in poor structural condition due to the presence of wounds with advanced stages of decay which have formed major cavities. Trees 76 and 198 have also been subject to previous branch failures. *Acer negundo* (Box Elder) is considered an environmental weed species. Based on the above, Trees 76, 78, 80 and 198 have a Useful Life Expectancy (ULE) of less than 5 years and should be removed.

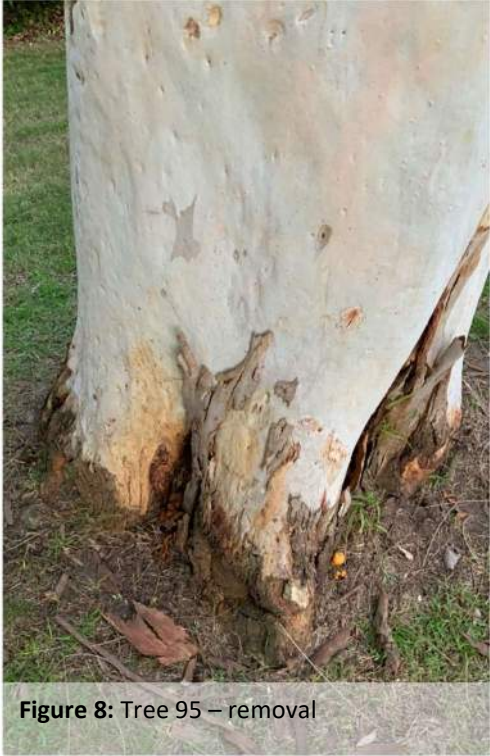
Figure 8: Tree 95 – removal

Tree 95 was identified as *Corymbia maculata* (Spotted Gum). The tree is in fair health as evidenced by a reduced crown density. It is in fair structural condition due to the presence of fungal fruiting bodies visually identified as *Armillaria luteobubalina*. *Armillaria* is a primary fungal plant pathogen causing white rot of the root and collar of trees and shrubs, and is commonly reported in the Eastern Suburbs of Sydney. The main symptoms are reduced shoot growth, stunted, chlorotic foliage and the characteristic 'dead top' often seen in mature trees.⁴ Early-stage root infection is often asymptomatic, with symptoms mostly developing once the collar and large roots are infected.⁵ Based on the reduced crown density and presence of *Armillaria* fruiting bodies, Tree 95 should be removed.

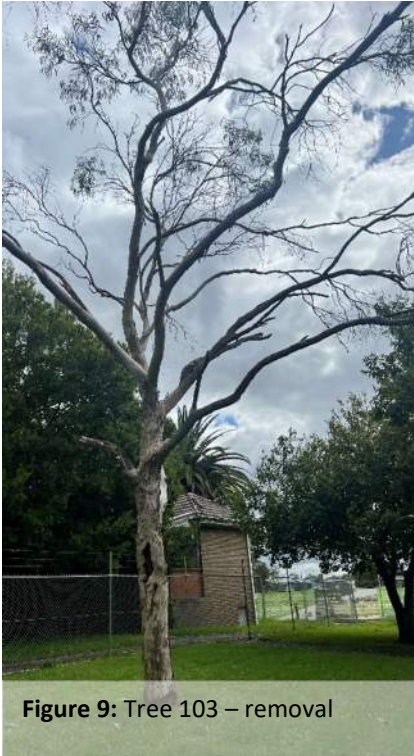
Figure 9: Tree 103 – removal

Trees 91 and 103 were identified as *Eucalyptus* spp. (Eucalypt) and Tree 174 was identified as *Schinus molle* var. *areira* (Peppercorn Tree). The trees are in poor health with a reduced crown density of 0-25%. Wounds with advanced stages of decay are also present on all trees. Trees 91, 103 and 174 have reached the end of their useful life and should be removed.

103	<i>Eucalyptus</i> sp. (Eucalypt)	Crown density 0-25%. Small (<25mmØ) & large (>75mmØ) deadwood in moderate volumes. Wound(s), advanced stages of decay.
156	<i>Cedrus atlantica</i> (Atlantic Cedar)	DEAD - 3x small trees in vicinity of Tree 156.
161	<i>Populus nigra</i> 'Italica' (Lombardy Poplar)	Crown density 0-25%. Small (<25mmØ), medium (25-75mmØ) & large (>75mmØ) deadwood in high volumes. Basal decay.
174	<i>Schinus molle</i> var. <i>areira</i> (Peppercorn Tree)	Crown density 0-25%. Wound(s), advanced stages of decay. Trunk cavity(s), major.
198	<i>Acer negundo</i> (Box Elder)	Weed species. Medium (25-75mmØ) & large (>75mmØ) deadwood in low volumes. Wound(s), advanced stages of decay. First Order branch cavity, major. Previous branch failure(s).
348	<i>Eucalyptus saligna</i> (Sydney Blue Gum)	Medium (25-75mmØ) & large (>75mmØ) deadwood in low volumes. Wound(s), early signs of decay. Poor form.

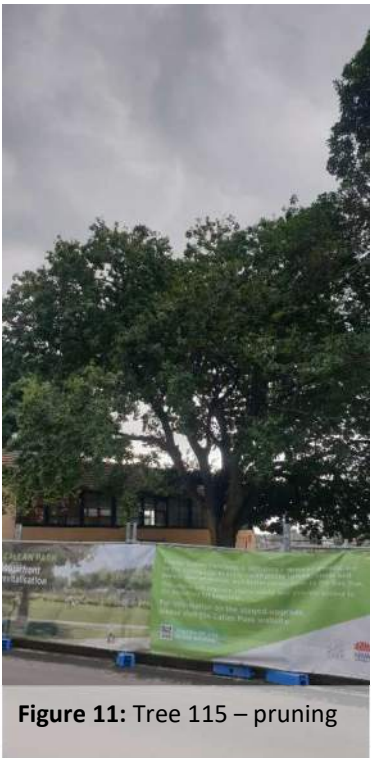
Figure 11: Tree 115 – pruning

Tree 115 was identified as *Celtis sinensis* (Chinese Nettle Tree). A significantly decayed branch is present within the crown of the tree which is weighted towards the road. This branch should be removed by Selective Pruning.

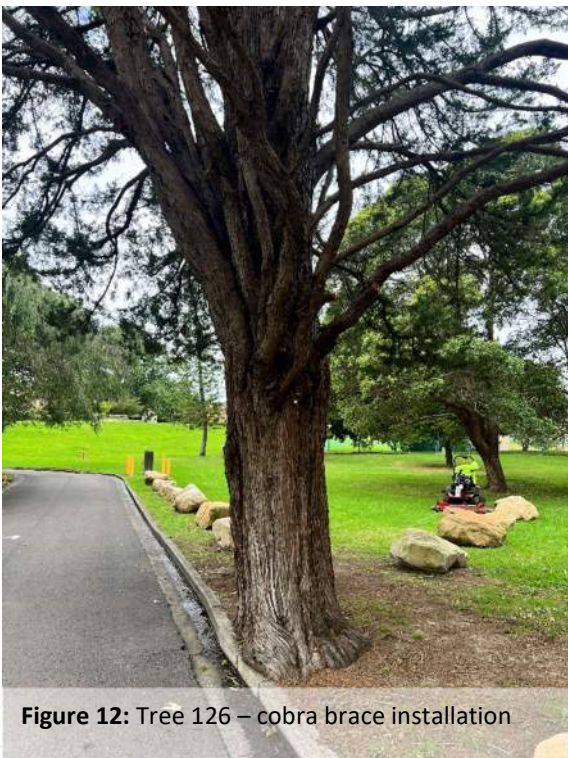
Figure 12: Tree 126 – cobra brace installation

Tree 126 was identified as *Cupressus guadalupensis* (Guadalupe Cypress). The co-dominant inclusion between the first order branches represents a significant structural defect. The installation of a dynamic restraint system (i.e. Cobra Brace) would provide additional support to the inclusion and may minimise the likelihood of branch failure.

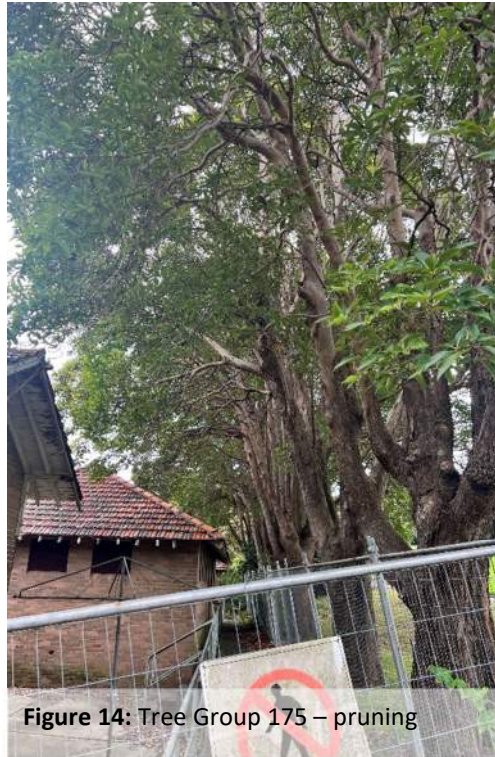
Figure 14: Tree Group 175 – pruning

Trees 175 and 178 were identified as *Lophostemon confertus* (Brush Box) and *Agonis flexuosa* (Willow Myrtle) respectively. There is limited clearance between the crowns of the trees and the adjacent building. These trees should be Reduction Pruned to reestablish adequate building clearances.

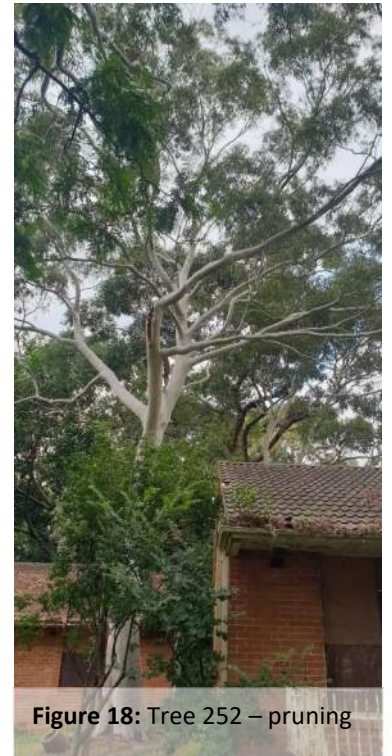
Figure 18: Tree 252 – pruning

Tree 252 was identified as *Corymbia citriodora* (Lemon Scented Gum). A large, significantly decayed branch is present within the crown of the tree. This branch should be removed by Selective Pruning.

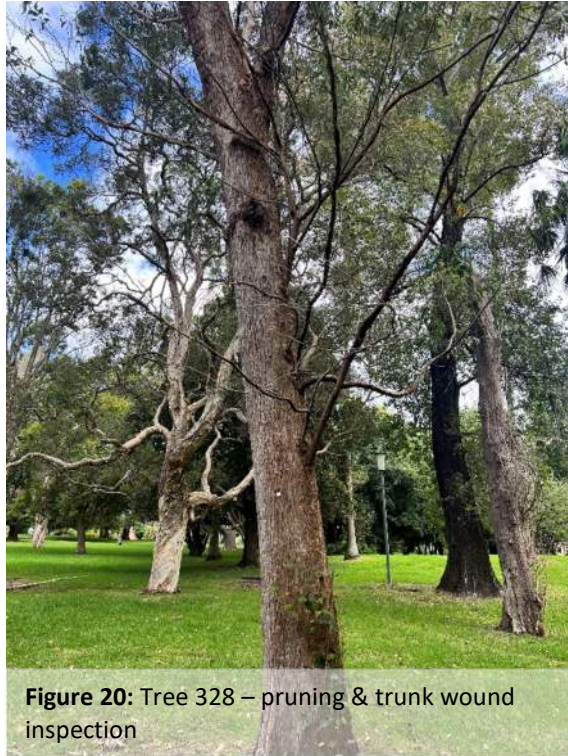
Figure 20: Tree 328 – pruning & trunk wound inspection

328	<i>Eucalyptus botryoides</i> (Bangalay)	Dead Wood: Remove dead wood >30mm. Inspect trunk wound at 8m.
376	<i>Eucalyptus botryoides</i> (Bangalay)	Dead Wood: Remove dead wood >30mm.
391	<i>Ficus rubiginosa</i> (Port Jackson Fig)	Dead Wood: Remove dead wood >30mm.
454	<i>Eucalyptus saligna</i> (Sydney Blue Gum)	Dead Wood: Remove dead wood >30mm.
468	<i>Pinus roxburghii</i> (Himalayan Pine)	Dead Wood: Remove dead wood >30mm.
473	<i>Lophostemon confertus</i> (Brush Box)	Dead Wood: Remove dead wood >30mm.
497	<i>Eucalyptus botryoides</i> (Bangalay)	Dead Wood: Remove dead wood >30mm.
554	<i>Ficus rubiginosa</i> (Port Jackson Fig)	Dead Wood: Remove dead wood >30mm.
618	<i>Jacaranda mimosifolia</i> (Jacaranda)	Selective Prune: Remove storm damaged branch. Dead Wood: Remove dead wood >30mm.

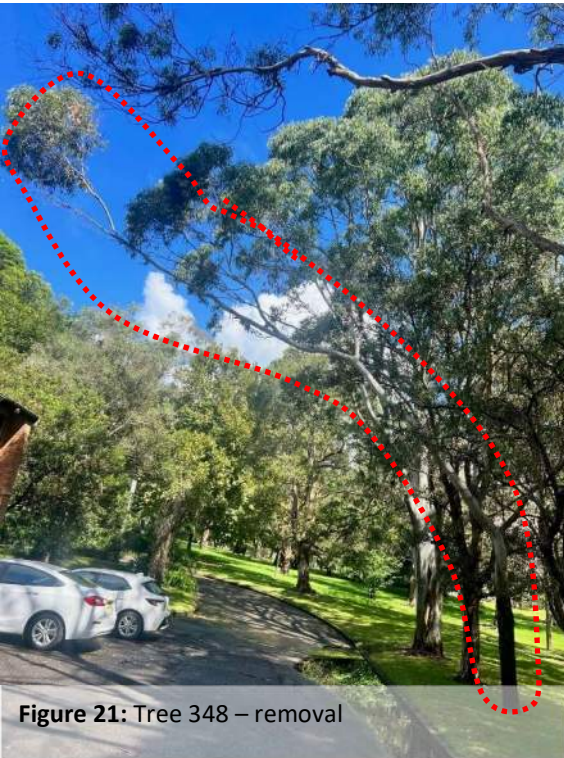
Figure 21: Tree 348 – removal

Tree 348 was identified as *Eucalyptus saligna* (Sydney Blue Gum). It is heavily suppressed by adjacent trees which has significantly impacted its form. Tree 348 has a ULE of less than 5 years and should be removed.

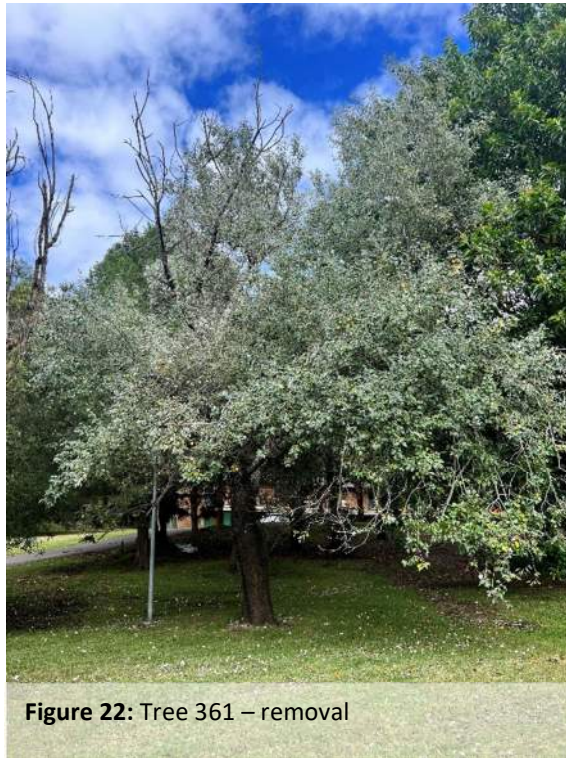
Figure 22: Tree 361 – removal

Trees 361 and 511 were identified as *Populus alba* (Silver Poplar) and *Eucalyptus botryoides* (Bangalay) respectively. The trees are in poor structural condition due to the presence of major trunk cavities. These structural defects have an increased likelihood of failure, and the trees should be removed.

361	<i>Populus alba</i> (Silver Poplar)	Small (<25mmØ) & medium (25-75mmØ) deadwood in moderate volumes. Trunk cavity(s), major.
400	<i>Cedrus atlantica</i> (Atlantic Cedar)	DEAD.
402	<i>Ficus rubiginosa</i> (Port Jackson Fig)	Crown density 0-25%. Crown consists mainly of epicormic growth. Wound(s), various stages of decay.
447	<i>Ficus rubiginosa</i> (Port Jackson Fig)	Crown density 0-25%. Small (<25mmØ) & medium (25-75mmØ) deadwood in high volumes. Crown consists mainly of epicormic growth.
511	<i>Eucalyptus botryoides</i> (Bangalay)	Small (<25mmØ), medium (25-75mmØ) & large (>75mmØ) deadwood in low volumes. Wound(s), advanced stages of decay. Trunk cavity(s), major.
575	<i>Ligustrum lucidum</i> (Large Leaf Privet)	Weed species. Wound(s), advanced stages of decay. Trunk cavity(s), major.
658	<i>Populus nigra</i> 'Italica' (Lombardy Poplar)	Group of 2 trees. Extensive basal decay. Trunk cavity(s), major.

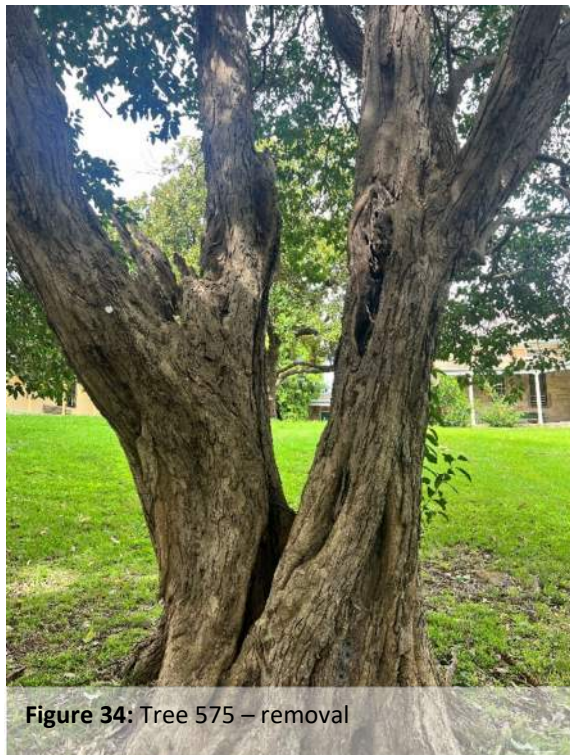
Figure 34: Tree 575 – removal

Tree 575 was identified as *Ligustrum lucidum* (Large Leaf Privet). Privet is considered an environmental weed species. This species is subject to a general biosecurity duty by the Department of Primary Industries and must not be sold within NSW.⁶ Tree 575 should be removed.

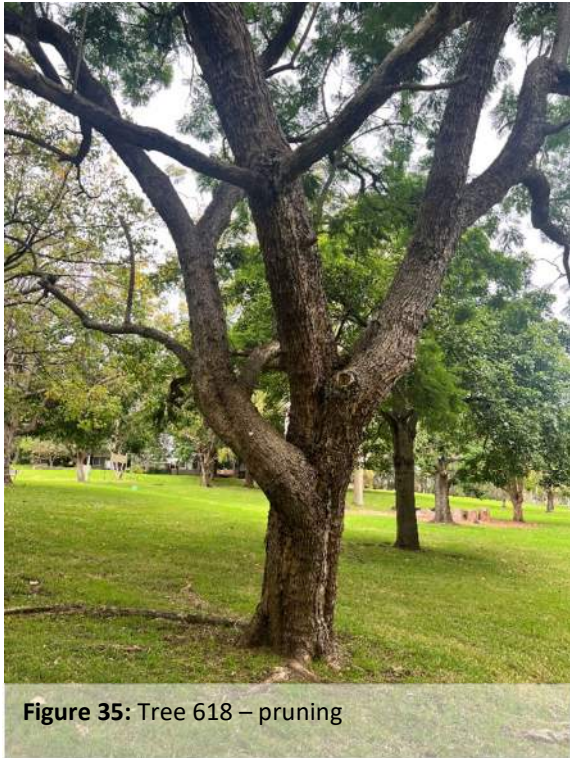
Figure 35: Tree 618 – pruning

Tree 618 was identified as *Jacaranda mimosifolia* (Jacaranda). A branch of the tree has been subject to storm damage. This branch should be removed by Selective Pruning.

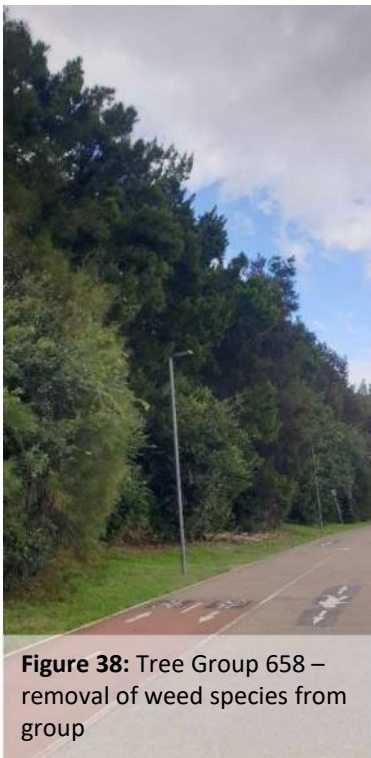
Figure 38: Tree Group 658 – removal of weed species from group

Tree Group 668 is a large group of *Casuarina glauca* (Swamp Oak). The tree group has become infested with a number of weed species, particularly *Celtis* sp. The weed species should be removed from this group of trees.

668	<i>Casuarina glauca</i> (Swamp She Oak)	Group of 200+ trees. Remove weed species from group only.
