Arboricultural Impact Assessment Report

**64-70 Stapleton Avenue Casino NSW –Land &
Housing Corporation NSW**

Date: 17 October 2023

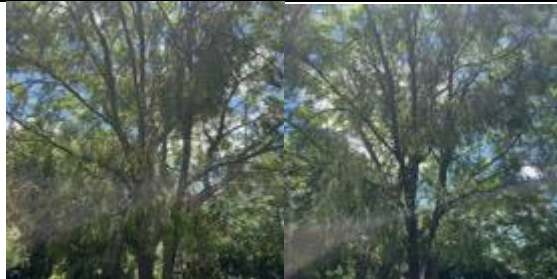
T7 Bangalow Palm <i>Archontophoenix cunninghamiana</i> Planted; Native rainforest palm TCV Moderate	25 30 7 2	Semi-Mature Good Good	3.0 2.0	REMOVE tree for construction Palm base is entirely within the construction footprint Upright; Crown in canopy of Jacaranda (T8), Low volume deadwood

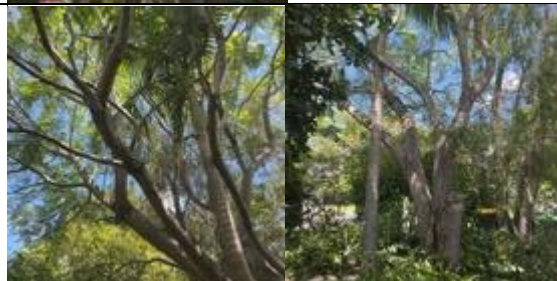
T8 Jacaranda <i>Jacaranda mimosifolia</i> Planted; Exotic ornamental tree, Environmental weed species TCV Low	45 51 9 12	Mature Fair Fair	5.4 2.5	REMOVE tree for construction and environmental weed status Tree base is entirely within the construction footprint Spreading; Codominant stems with narrow V-shaped union, Slight lean to S, Crown concentrated to S, Low volume deadwood

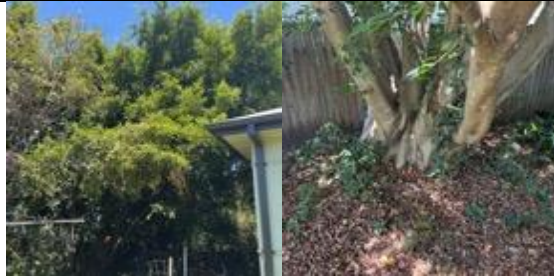
T19 African Tulip Tree <i>Spathodea campanulata</i> Likely planted; Exotic ornamental tree, Environmental weed species TCV Very Low	18 22 5 1	Semi- Mature Poor Near Dead Poor Near Dead	2.2 1.8	REMOVE tree for construction and environmental weed status Tree base is entirely within the construction footprint Upright; Slight lean in lower trunk upper trunk corrected, Large dead sections, Severely defoliated.

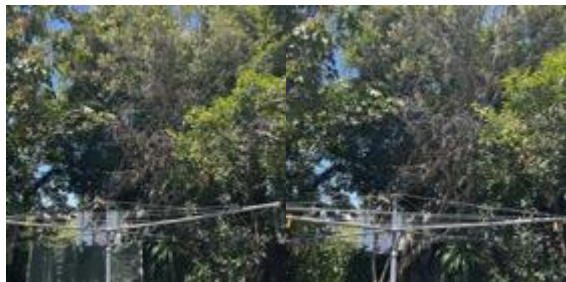
T20 Weeping Bottlebrush <i>Callistemon viminalis</i> Planted; Native ornamental and forest tree TCV Very Low	14 17 4 3	Semi- Mature Poor Very Poor	2.0 1.6	REMOVE tree for construction and Poor health and Very Poor condition Tree base is within the construction footprint Upright; Stunted, Low crown foliage density, Crown concentrated to SW, Moderate defoliation, Poor past pruning, Historic lopping and topping and target avoidance, Moderate mistletoe infestation, High volume deadwood ~10cmØ, Minimum TPZ under AS4970

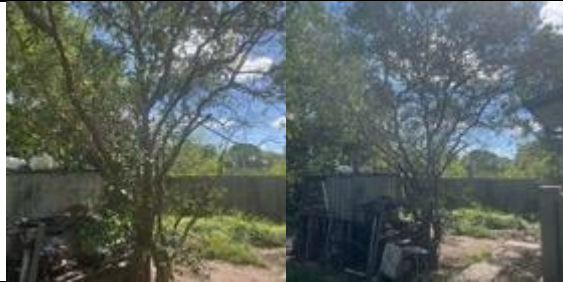
T38 Mulberry Tree <i>Morus alba</i> Planted; exotic fruit tree, Environmental weed species TCV Low	13 16 5 4	Semi- Mature Fair Fair	2.0 1.5	REMOVE tree for construction and environmental weed status Tree base is entirely within the construction footprint Spreading; Excessively shaded, exotic Asparagus Fern weed in crown, Low volume deadwood, Minimum SRZ and TPZ under AS4970

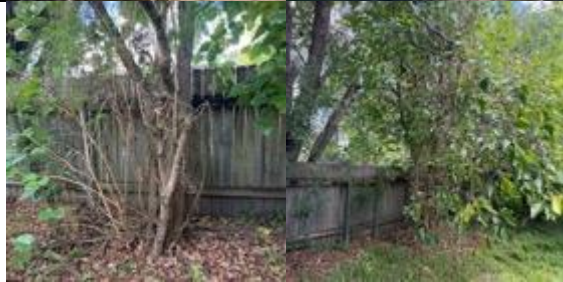
T39 Mango Tree <i>Mangifera indica</i> Planted; Exotic fruit tree TCV Very Low	24 29 3 2	Semi- Mature Very Poor Very Poor	2.9 2.0	REMOVE tree for construction Tree base is entirely within the construction footprint Upright; Multi-stemmed, Stunted, Low crown foliage density, Large dead sections in trunk and canopy, High volume deadwood~5cmØ

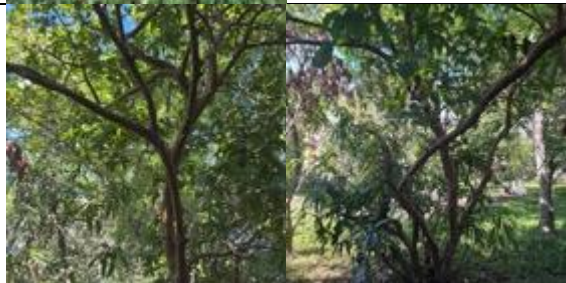
T42 Mango Tree <i>Mangifera indica</i> Planted; Exotic fruit tree TCV Low	15 19 5 3	Semi-Mature Fair Fair	2.0 1.7	REMOVE tree for construction Tree base is entirely within the construction footprint Spreading; Multi-stemmed, Moderate tip dieback, exotic Cats Claw weed infestation in crown, Moderate volume deadwood~5cmØ

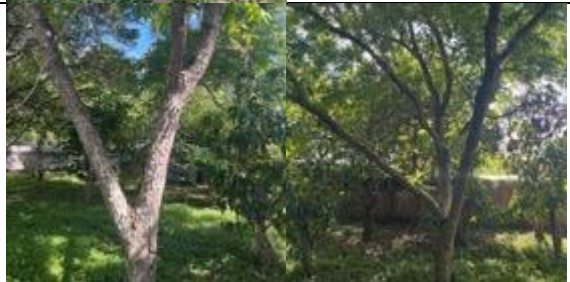
T45 Cheese Tree <i>Glochidion ferdinandi</i> Planted; Native rainforest tree TCV Moderate	36 42 6 8	Mature Good Fair	4.3 2.3	REMOVE tree for construction Tree base is entirely within the construction footprint Spreading; Multi-stemmed, Low volume deadwood

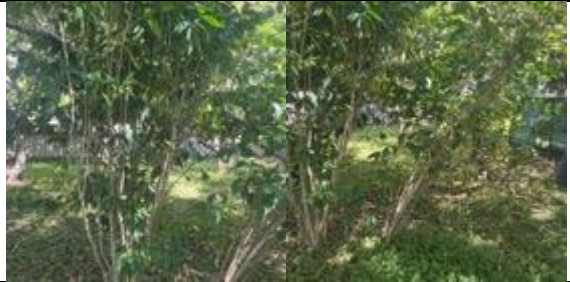
T47 Mango Tree <i>Mangifera indica</i> Planted; Exotic fruit tree TCV Low	11 14 4 2	Semi-Mature Fair Fair	2.0 1.5	REMOVE tree for construction Tree base is entirely within the construction footprint Spreading; Multi-stemmed, Excessively shaded, Moderate volume deadwood to ~5cmØ, Minimum SRZ and TPZ under AS4970

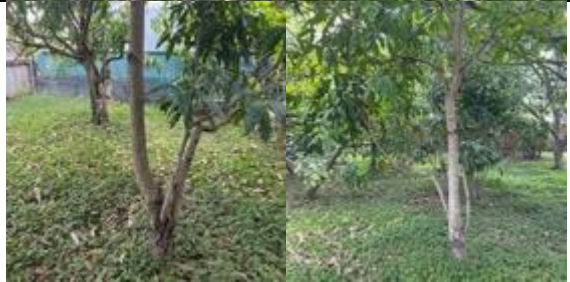
T48 Mango Tree <i>Mangifera indica</i> Planted; Exotic fruit tree TCV Low	14 19 4 3	Semi-Mature Fair Fair	2.0 1.5	REMOVE tree for construction Major TPZ encroachment 1.4m within SRZ from building construction Spreading; Multi-stemmed, Excessively shaded, Moderate volume deadwood to ~5cmØ, Minimum SRZ and TPZ under AS4970

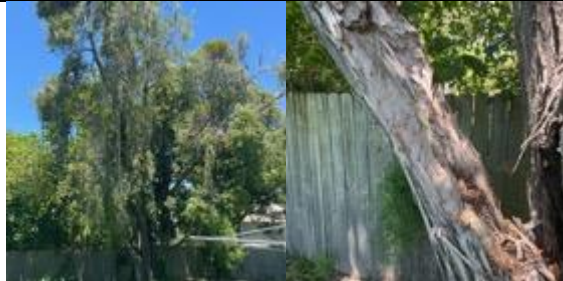
T71 Camphor Laurel <i>Cinnamomum camphora</i> Exotic tree, Environmental weed species TCV Very Low	32 39 6 7	Semi- Mature Good Poor	3.8 2.3	REMOVE tree due to environmental weed status and ongoing health of adjacent Silky Oak (T72) NA Spreading; Multi-stemmed from near base, Moderate lean on Northern stem, Low volume deadwood, Competing with adjacent native Silky Oak (T72)

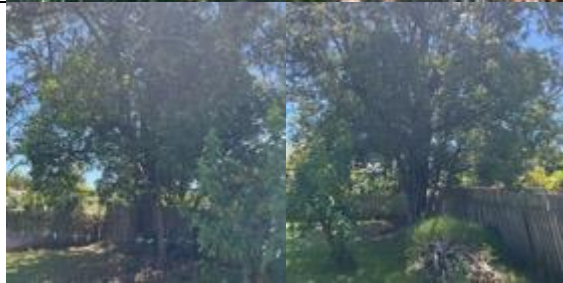
T72 Silky Oak <i>Grevillea robusta</i> Planted; Native forest tree TCV High	83 91 11 8	Mature Good Fair	10.0 3.2	RETAIN tree, install TPZ fence, Project Arborist to advise on tree impact avoidance and minimisation; and monitor excavation works within TPZ Major 22% TPZ encroachment marginally inside the SRZ from building construction and lesser from cut earthworks and installation of stormwater infrastructure Upright; Multi-stemmed, Low volume deadwood to ~5cmØ
