Surveying Consulting Services

Part 1 – Desktop Analysis Review for Milton Primary School

Project Name	SINSW Due Diligence – Milton PS	
Report Title	Survey Report	
File Name	Land Survey DD – Milton – 2565 - Astrea – DDW005391/23

School Name	Milton Public School	Consultancy Name	Astrea Pty Ltd
School ID Number	2565	Report Status	Final
School Address	9 Thomas Street, Milton.	Report Date:	30.10.2023
School Region	Southern NSW	Contract Number:	DDW005391/23

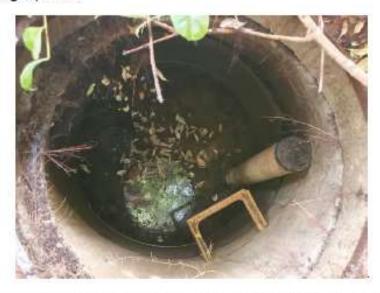
Image 2 – SW Pit 45, unable to visually inspect and measure pipes. Pit is full of water and has sealed plumbing features below the water line

In these instances, technicians have made best effort to assume the line of these services and the network in which they discharge into. The quality level of pipes should be noted in these scenarios.

Astrea can make recommendations on alternative methods such as CCTV or cleaning of pits that may assist in confirming these networks.

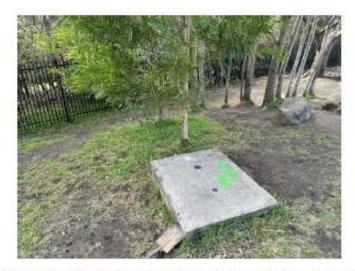
Image 3 – SW32, Stormwater pit cover that cannot be manually lifted by a two-person team 300kg +.

The lip fitting prevents the lid from being able to slide off for inspection- mechanical lift required for inspection.

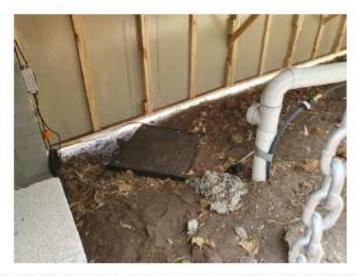
Image 5 – Sewer Rising Main pit locked –Licenced Plumber to provide access if internal information is required.
