Cessnock Hospital - Pre-Demolition Hazardous Materials Survey Report Summary

Asbestos and Hazardous Materials Pre-Demolition Assessment

Kitchen

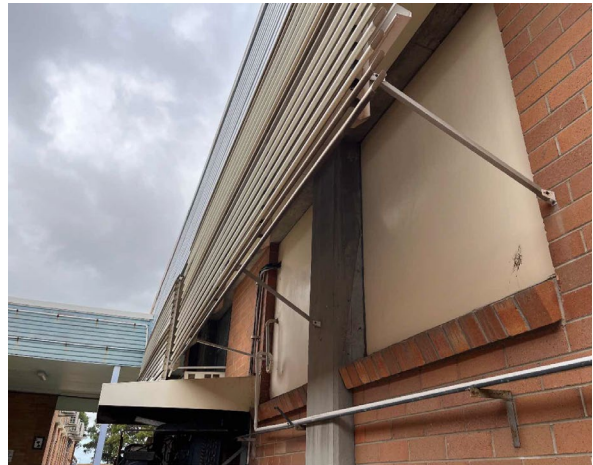
Line ID 2: External, GF, All Areas, Eaves, Throughout, Fibre Cement Sheetting - Chrysotile Asbestos Detected

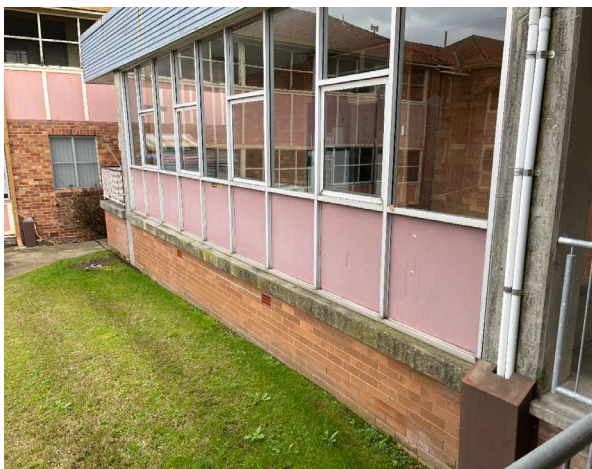
Line ID 3: External, GF, All Areas, Infill Panels, Adjacent Air Conditioning Refrigerator Pump, Fibre Cement Sheet - Chrysotile Asbestos Detected

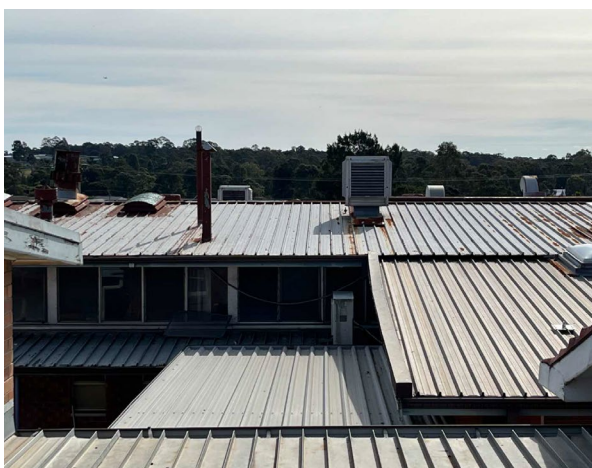
Line ID 71: External, GF, All Areas, Air conditioner, Various throughout, Unknown Refrigerant - Non ODS Refrigerant

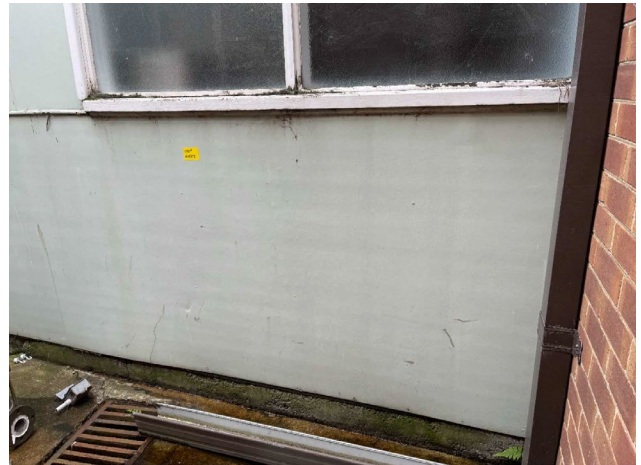
Line ID 1: External, GF, Central Wing, Central Courtyard, Timber Window Frames, Window Caulking - No Asbestos Detected

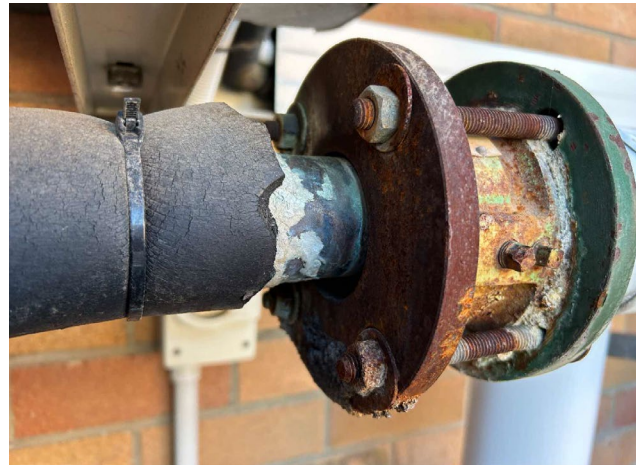
Line ID 8: External, GF, Central Wing, Northern Boiler Area, Metal Encased Pipework, Lagging - Suspected Asbestos

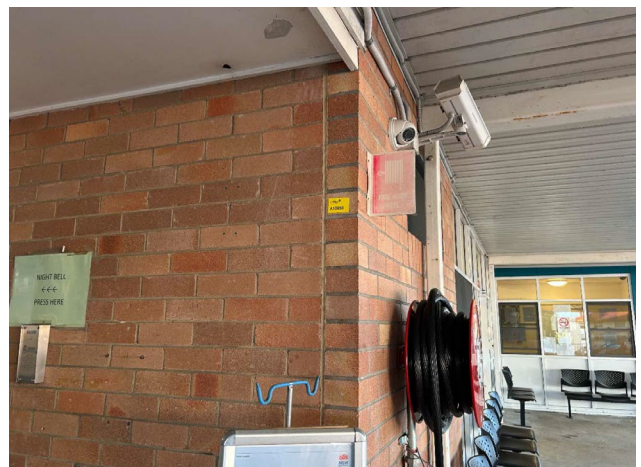
Line ID 15: External, GF, ED Wing, Emergency Entrance, Wall lining, Southwest, Compressed Cement Sheeting - No Asbestos Detected

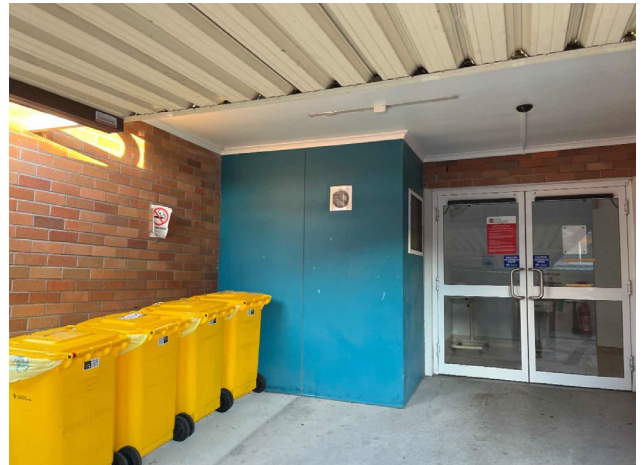
Line ID 17: External, GF, ED Wing, Main Entrance, Awning, Fibre Cement Sheeting - No Asbestos Detected

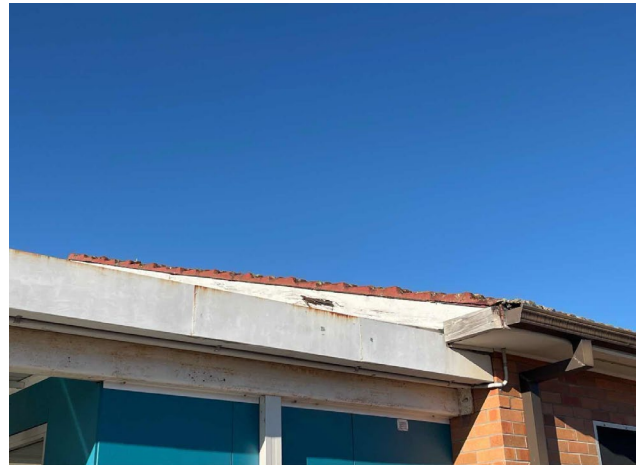
Line ID 19: External, GF, ED Wing, Roof, East and West Sides, Infill Panels Below Roof Gable, Fibre Cement Sheeting - Chrysotile Asbestos Detected

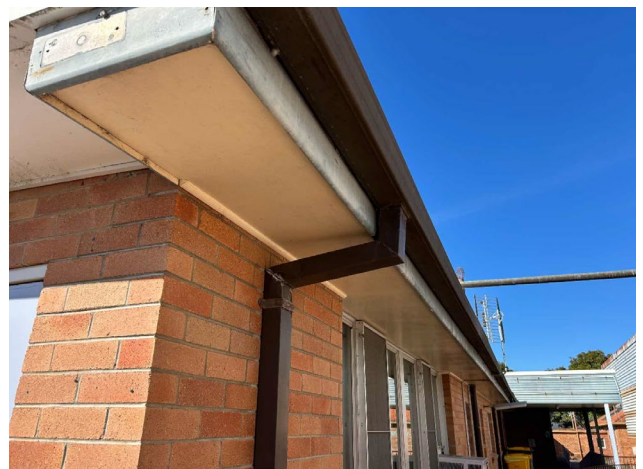
Line ID 21: External, GF, West Wing, Eastern Entrance Awning, Adjacent Room 1171, Fibre Cement Sheeting - Chrysotile & Amosite Asbestos Detected

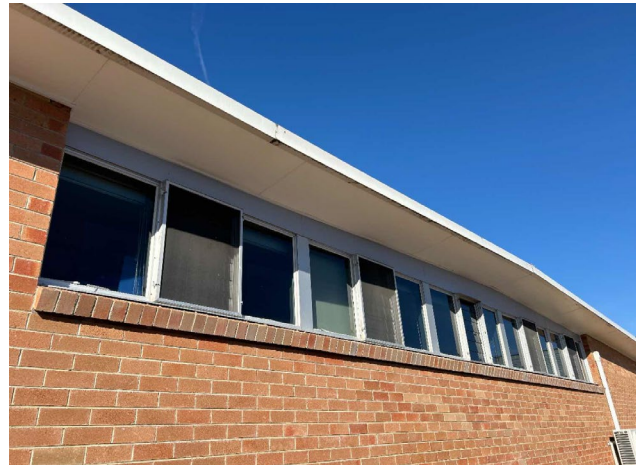
Line ID 23: External, GF, West Wing, North Section, Infill Panels Above Windows, Fibre Cement Sheetting - No Asbestos Detected

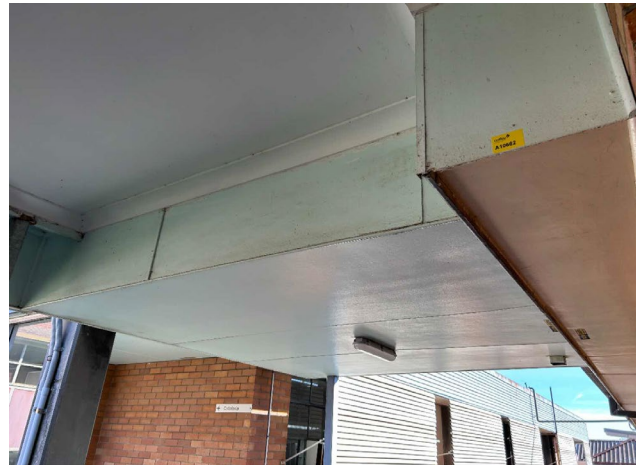
Line ID 24: External, GF, West Wing, South Side, Eaves, Fibre Cement Sheetting - Chrysotile Asbestos Detected

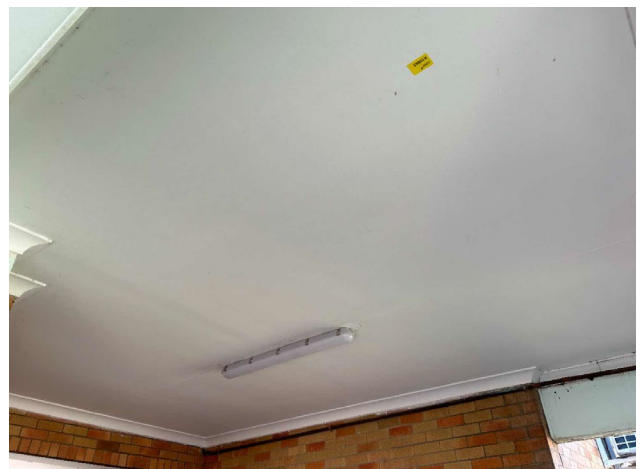
Line ID 25.1: External, GF, West Wing, Western Covered Area Adjacent Kitchen, Awning and Infill Panels, Fibre Cement Sheetting - Chrysotile Asbestos Detected

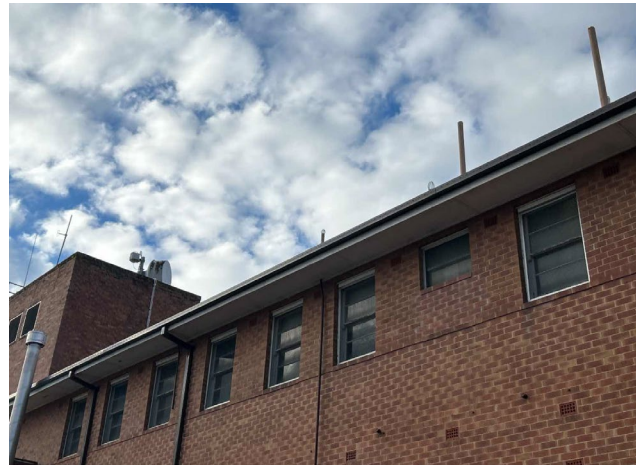
Line ID 27: External, L1, Southeast Wing, Throughout, Eaves, Fibre Cement Sheeting - Chrysotile Asbestos Detected

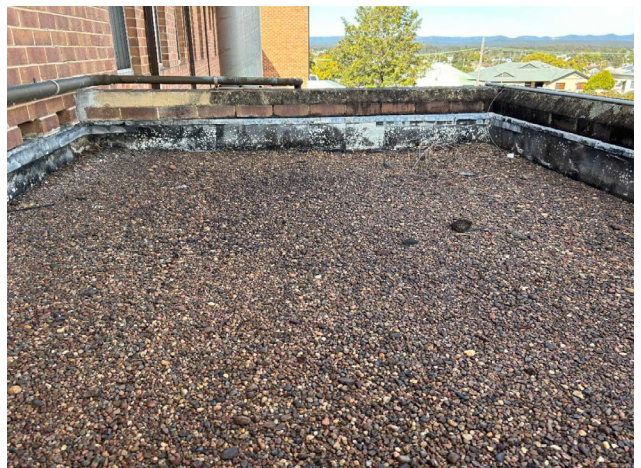
Line ID 35: External, Roof, Southeast Wing, Northwest Lower Roof Section, Waterproofing, Bituminous Membrane - Chrysotile Asbestos Detected

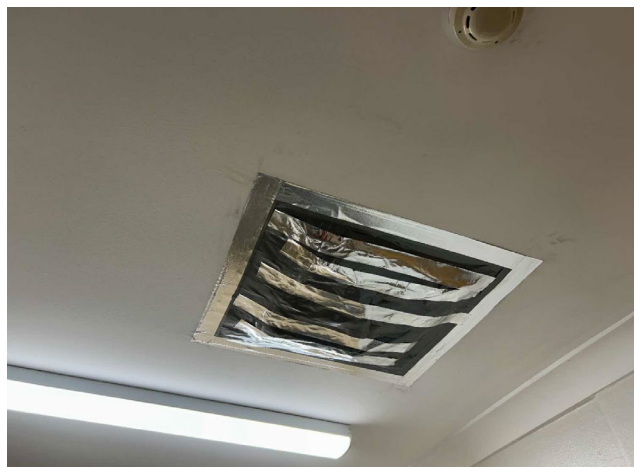
Line ID 48: Internal, GF, Central Wing, North Section, Pharmacy 1075 and 1076, Ceiling Space, Lagging - Amosite Asbestos Detected

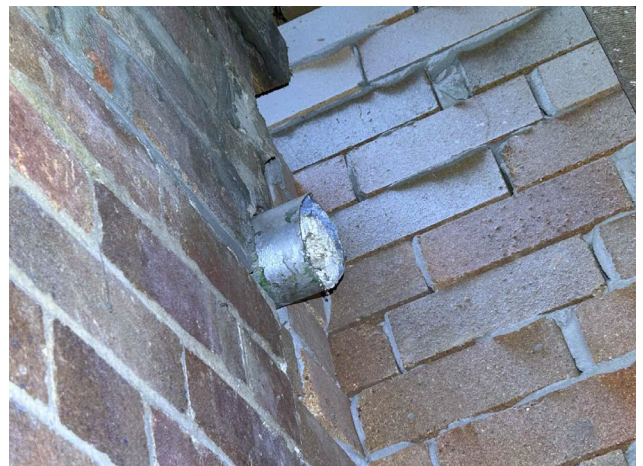
Line ID 57: Internal, GF, Central Wing, North Section, Plant Room 1073, Wall Cavity, Penetration, Lagging - Amosite Asbestos Detected

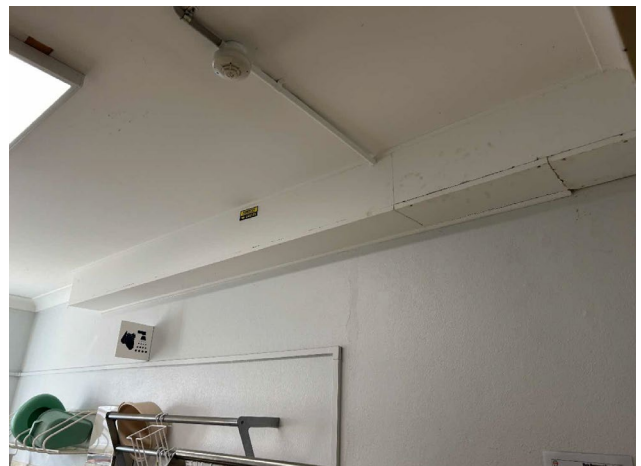
Line ID 67: Internal, GF, Central Wing, Ward A, Room 1097, Within Wall Cavity, Pipework, Lagging - Amosite Asbestos Detected

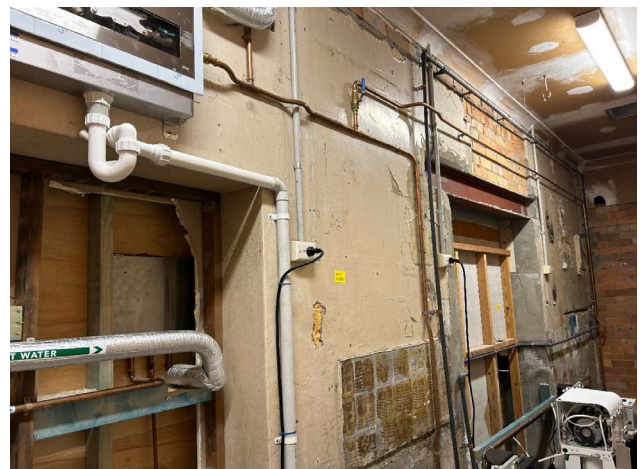
Line ID 116: Internal, GF, Central Wing, North Section, Plant Room 1060, Walls, Cream Paint - Lead Detected (8.7% w/w)

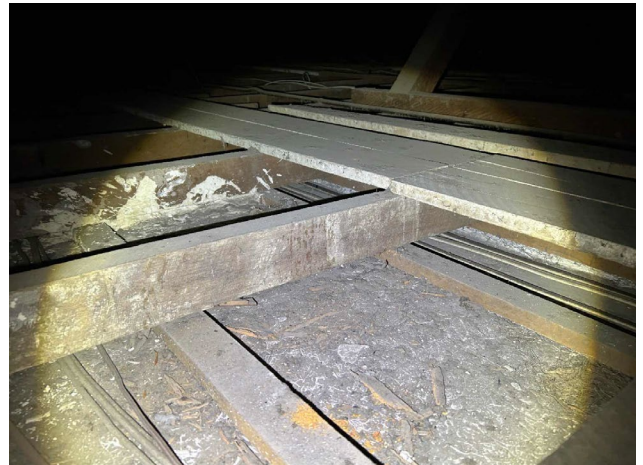
Line ID 129: Internal, GF and L1, Southeast Wing, Ceiling Space, All surfaces, Throughout, Dust - Lead Detected (1,800 mg/kg)
