ARBORICULTURAL IMPACT ASSESSMENT

TREE PROTECTION SPECIFICATION

REF: L&Co24003 | 04 March 2025 | v2.2 SITE ADDRESS | Upgrade to Dundas Public School PREPARED FOR | School Infrastructure NSW PREPARED BY |

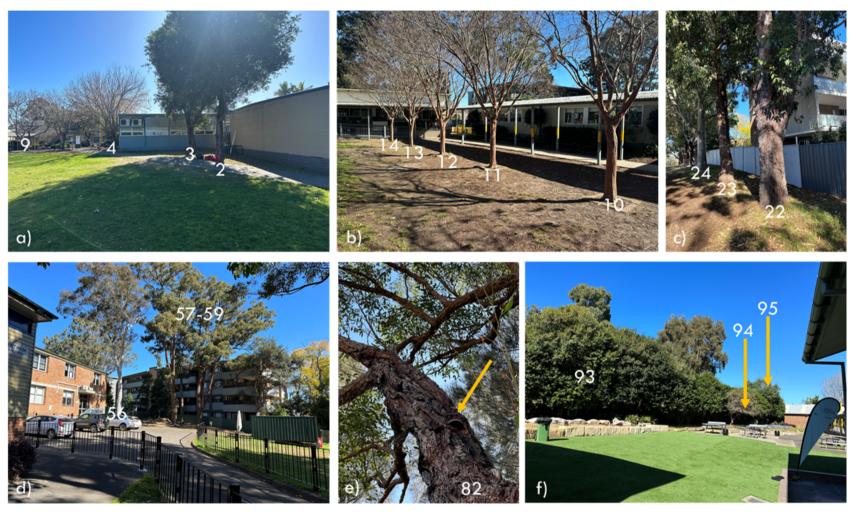
15.0 APPENDIX 10 | PLATES

a) Showing examples of Moderate Landscape Significance Trees (Trees 2-4 & 9) growing in proximity to existing built structures. b) Showing Trees 10-14. c) Showing examples of High Landscape Significance Trees (Trees 22-24) growing along western boundary. d) Showing examples of High Landscape Significance Trees (Tree 56-59) growing along western boundary e) Showing Tree 82 with *Phellinus* bracket on large lesion. f) Showing Tree Group 93 and Trees 94 & 95.
