## COMPLIANCE HAZARDOUS MATERIAL RE-INSPECTION AND RISK ASSESSMENT

AUGUST 2022

J049948

Milton Ulladulla Hospital -106 Princes Hwy  
Milton NSW  
2538

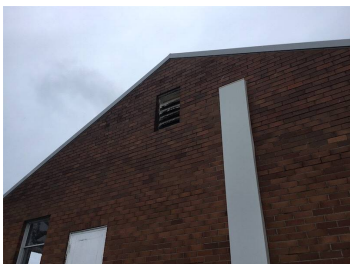
Location	MUH-A - Ground Level - Exterior - East and West - Ventilation Framework - Paint (White)

Hazard Type	Lead Paint	Material Assessment	Disturbance Assessment	
Friability	-	Product Type	Occupancy	
Sample No.	Visual	Extent of damage	Disturbance	
Result	Assumed Positive	Surface Treatment	Exposure	
		Asbestos Type	Maintenance	
Item Number	9	Material Score	Disturbance Score	
		Priority Score	-

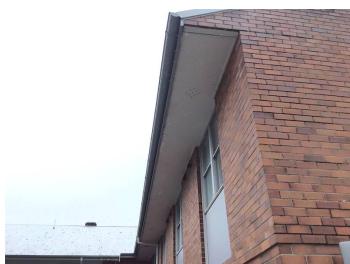
Location		MUH-A - Ground Level - Exterior - North - Eaves - Fibre Cement Sheetting					
Hazard Type		Asbestos		Material Assessment		Disturbance Assessment	
Friability		Non-friable		Product Type		Occupancy	
Sample No.		Visual		Extent of damage		Disturbance	
Result		Assumed Positive Unknown or Crocidolite		Surface Treatment		Exposure	
				Asbestos Type		Maintenance	
Item Number		10		Material Score		Disturbance Score	
				Priority Score		Very Low

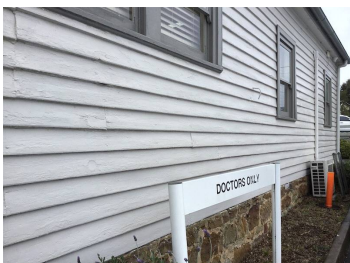
Location	MUH-A - Ground Level - Exterior - Original Section (South & West) - Cladding - Paint (White) - 1.1% w/w

Hazard Type	Lead Paint	Material Assessment	Disturbance Assessment	
Friability	-	Product Type	Occupancy	
Sample No.	J167110-ISLHD-MUH-A-LP-001 {CR000158}	Extent of damage	Disturbance	
Result	Positive	Surface Treatment	Exposure	
		Asbestos Type	Maintenance	
Item Number	16	Material Score	Disturbance Score	
		Priority Score	-

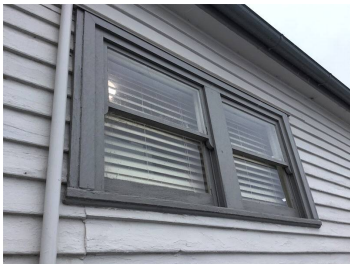
Location	MUH-A - Ground Level - Exterior - Original Section (South & West) - Various Throughout - Window Frames - Paint (Grey) - 0.33% w/w

Hazard Type	Lead Paint	Material Assessment	Disturbance Assessment	
Friability	-	Product Type	Occupancy	
Sample No.	J167110-ISLHD-MUH-A-LP-002 {CR000159}	Extent of damage	Disturbance	
Result	Positive	Surface Treatment	Exposure	
		Asbestos Type	Maintenance	
Item Number	17	Material Score	Disturbance Score	
		Priority Score	-

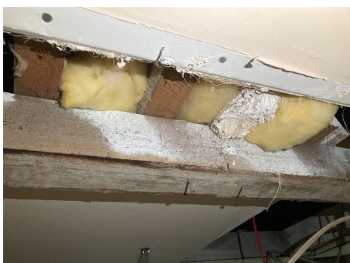
Location	MUH-A - Ground Level - Ceiling Space - Throughout - Above Original Ceiling - Insulation Batts

Hazard Type	SMF	Material Assessment	Disturbance Assessment	
Friability	Bonded	Product Type	Occupancy	
Sample No.	Visual	Extent of damage	Disturbance	
Result	Assumed Positive	Surface Treatment	Exposure	
		Asbestos Type	Maintenance	
Item Number	18	Material Score	Disturbance Score	
		Priority Score	-

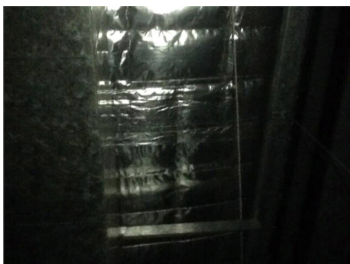
Location	MUH-A - Ground Level - Ceiling Space - Underside of Roof - Throughout - Sarking Insulation

Hazard Type	SMF	Material Assessment	Disturbance Assessment	
Friability	Bonded	Product Type	- Occupancy	
Sample No.	Visual	Extent of damage	- Disturbance	
Result	Assumed Positive	Surface Treatment	- Exposure	
		Asbestos Type	- Maintenance	
Item Number	19	Material Score	- Disturbance Score	
		Priority Score	-

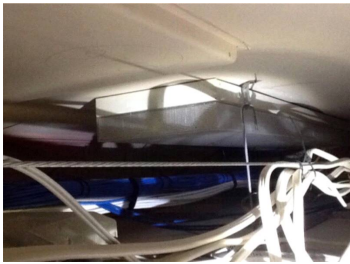
Location	MUH-A - Ground Level - Ceiling Space - Above Suspended Ceiling - Various Throughout - Fluorescent Light Fitting (Double Tube) - Capacitor

Hazard Type	PCB	Material Assessment	Disturbance Assessment	
Friability	Good Condition	Product Type	- Occupancy	
Sample No.	Visual	Extent of damage	- Disturbance	
Result	Assumed Positive	Surface Treatment	- Exposure	
		Asbestos Type	- Maintenance	
Item Number	20	Material Score	- Disturbance Score	
		Priority Score	-

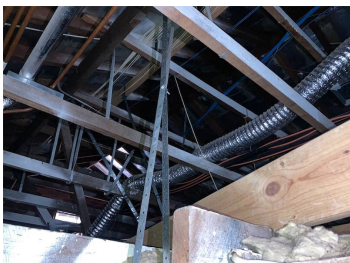
Location	MUH-A - Ground Level - Ceiling Space - Various Throughout - Flexible Ductwork Insulation

Hazard Type	SMF	Material Assessment	Disturbance Assessment	
Friability	Bonded	Product Type	- Occupancy	
Sample No.	Visual	Extent of damage	- Disturbance	
Result	Assumed Positive	Surface Treatment	- Exposure	
		Asbestos Type	- Maintenance	
Item Number	29	Material Score	- Disturbance Score	
		Priority Score	-

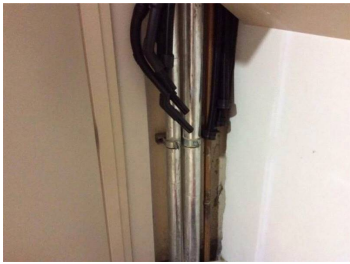
Location	MUH-A - Ground Level - Corridor MUHA00G60 - Within Cleaner's Cupboard - Pipework Insulation

Hazard Type	SMF	Material Assessment	Disturbance Assessment	
Friability	Bonded	Product Type	- Occupancy	
Sample No.	Visual	Extent of damage	- Disturbance	
Result	Assumed Positive	Surface Treatment	- Exposure	
		Asbestos Type	- Maintenance	
Item Number	21	Material Score	- Disturbance Score	
		Priority Score	-

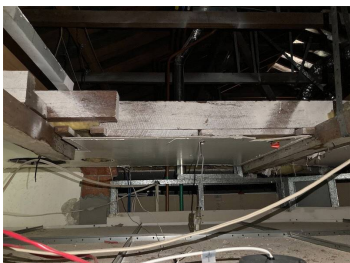
Location	MUH-A - Ground Level - Midwifery Room MUHA00G74 - Above Suspended Ceiling - Old Ceiling Lining - Fibre Cement Sheetting

Hazard Type	Asbestos	Material Assessment	Disturbance Assessment	
Friability	Non-friable	Product Type	1 Occupancy	
Sample No.	J149255-02-Block A-010 {CR000161}	Extent of damage	1 Disturbance	
Result	Positive Chrysotile + Amosite	Surface Treatment	0 Exposure	
		Asbestos Type	2 Maintenance	
Item Number	24	Material Score	4 Disturbance Score	
		Priority Score	7 Very Low

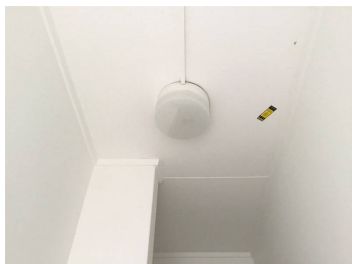
Location		MUH-A - Ground Level - Operating Suite Toilet MUHA00G33 - Throughout - Ceiling Lining - Fibre Cement Sheetting				
Hazard Type		Asbestos	Material Assessment		Disturbance Assessment	
Friability		Non-friable	Product Type	1	Occupancy	1
Sample No.		J149255-02-Block A-009 {CR000162}	Extent of damage	0	Disturbance	1
Result		Positive Amosite + Chrysotile + Crocidolite	Surface Treatment	0	Exposure	1
			Asbestos Type	3	Maintenance	0
Item Number	25	Material Score	4	Disturbance Score 3		
		Priority Score	7	Very Low

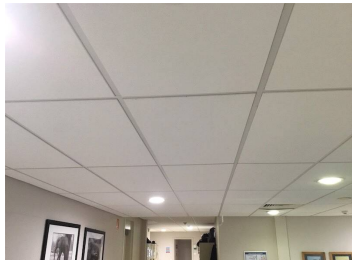
Location		MUH-A - Ground Level - All Areas - Various Throughout - Compressed Ceiling Tiles

Hazard Type		SMF	Material Assessment		Disturbance Assessment		
Friability		Bonded	Product Type	-	Occupancy		-
Sample No.		Visual	Extent of damage	-	Disturbance		-
Result		Assumed Positive	Surface Treatment	-	Exposure		-
			Asbestos Type	-	Maintenance		-
Item Number		22	Material Score	-	Disturbance Score		-
			Priority Score	-	-

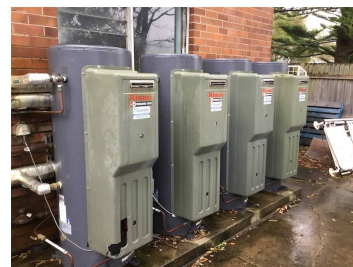
Location		MUH-B (formerly MUH-E) - Ground Level - Exterior - North - Hot Water Heater - Insulation Material	
Hazard Type	SMF	Material Assessment	Disturbance Assessment
Friability	Bonded	Product Type	Occupancy
Sample No.	Visual	Extent of damage	Disturbance
Result	Assumed Positive	Surface Treatment	Exposure
		Asbestos Type	Maintenance
Item Number	22	Material Score	Disturbance Score
		Priority Score	-

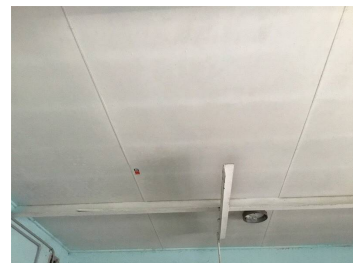
Location		MUH-B (formerly MUH-E) - Ground Level - Store MUHAB1-39 - Throughout - Ceiling Lining - Fibre Cement Sheeting	
Hazard Type	Asbestos	Material Assessment	Disturbance Assessment
Friability	Non-friable	Product Type	Occupancy
Sample No.	J155696-02-ISLHD-MUH-E-001 {CR000147}	Extent of damage	Disturbance
		Surface Treatment	Exposure
Result	Positive Chrysotile + Crocidolite	Asbestos Type	Maintenance
		Material Score	Disturbance Score
Item Number	18	Priority Score	Very Low

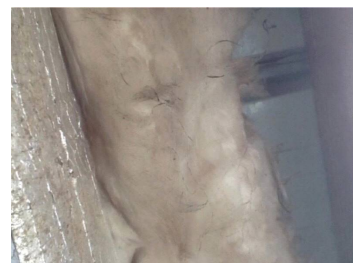
Location		MUH-B (formerly MUH-E) - Ground Level - Store MUHAB1-39 - Ceiling Space - Throughout - Insulation Batts	
Hazard Type	SMF	Material Assessment	Disturbance Assessment
Friability	Bonded	Product Type	Occupancy
Sample No.	Visual	Extent of damage	Disturbance
Result	Assumed Positive	Surface Treatment	Exposure
		Asbestos Type	Maintenance
Item Number	20	Material Score	Disturbance Score
		Priority Score	-

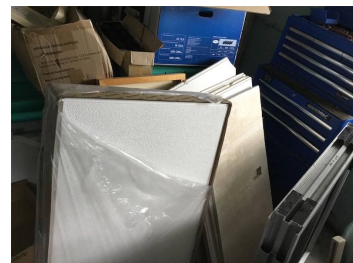
Location		MUH-B (formerly MUH-E) - Ground Level - Store MUHAB1-39 - Various Throughout - Stored Item - Compressed Ceiling Tiles	
Hazard Type	SMF	Material Assessment	Disturbance Assessment
Friability	Bonded	Product Type	Occupancy
Sample No.	Visual	Extent of damage	Disturbance
Result	Assumed Positive	Surface Treatment	Exposure
		Asbestos Type	Maintenance
Item Number	21	Material Score	Disturbance Score
		Priority Score	-

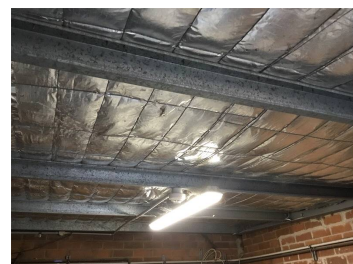
Location		MUH-B (formerly MUH-E) - Ground Level - Gas Store MUHAB1-40 - Ceiling - Throughout - Sarking Insulation	
Hazard Type	SMF	Material Assessment	Disturbance Assessment
Friability	Bonded	Product Type	Occupancy
Sample No.	Visual	Extent of damage	Disturbance
Result	Assumed Positive	Surface Treatment	Exposure
		Asbestos Type	Maintenance
Item Number	17	Material Score	Disturbance Score
		Priority Score	-

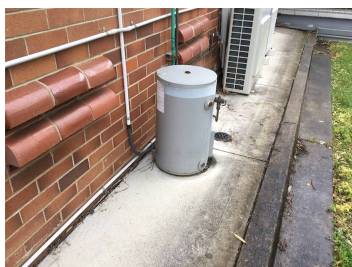
Location		MUH-C - Ground Level - Exterior - North - Hot Water Heater - Insulation

Hazard Type		SMF	Material Assessment		Disturbance Assessment		
Friability		Bonded	Product Type	-	Occupancy		-
Sample No.		Visual	Extent of damage	-	Disturbance		-
Result		Assumed Positive	Surface Treatment	-	Exposure		-
			Asbestos Type	-	Maintenance		-
Item Number	8	Material Score	-	Disturbance Score	-		
		Priority Score	-		-

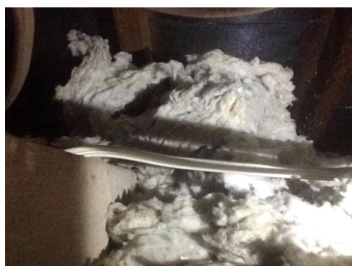
Location		MUH-C - Ground Level - Ceiling Space - Throughout - Insulation Batts				
Hazard Type		SMF	Material Assessment		Disturbance Assessment	
Friability		Bonded	Product Type	-	Occupancy	-
Sample No.		Visual	Extent of damage	-	Disturbance	-
Result		Assumed Positive	Surface Treatment	-	Exposure	-
			Asbestos Type	-	Maintenance	-
Item Number	13	Material Score	-	Disturbance Score	-	
		Priority Score	-		-

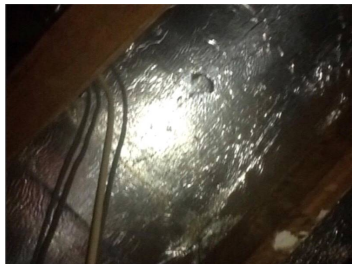
Location		MUH-C - Ground Level - Ceiling Space - Underside of Roof - Throughout - Sarking Insulation			
Hazard Type		SMF	Material Assessment		Disturbance Assessment
Friability	Bonded	Product Type	-	Occupancy	-
Sample No.	Visual	Extent of damage	-	Disturbance	-
Result	Assumed Positive	Surface Treatment	-	Exposure	-
		Asbestos Type	-	Maintenance	-
Item Number	14	Material Score	-	Disturbance Score	-
		Priority Score	-		-

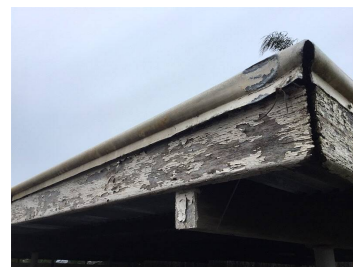
Location	MUH-D (formerly MUH-B) - Ground Level - Exterior - Surrounding - Fascia - Paint (Cream)		
Hazard Type	Lead Paint	Material Assessment	Disturbance Assessment
Friability	-	Product Type	Occupancy
Sample No.	J167110-ISLHD-MUH-B-LP-001 {CR000142}	Extent of damage	Disturbance
Result	Positive	Surface Treatment	Exposure
		Asbestos Type	Maintenance
Item Number	1	Material Score	Disturbance Score
		Priority Score	-

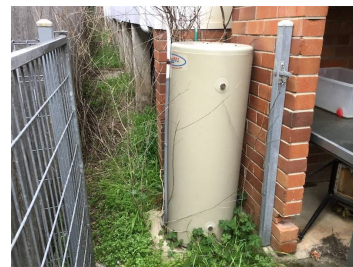
Location	MUH-F - Ground Level - Exterior - East - Hot Water Heater - Insulation Material		
Hazard Type	SMF	Material Assessment	Disturbance Assessment
Friability	Bonded	Product Type	Occupancy
Sample No.	Visual	Extent of damage	Disturbance
Result	Assumed Positive	Surface Treatment	Exposure
		Asbestos Type	Maintenance
Item Number	54	Material Score	Disturbance Score
		Priority Score	-

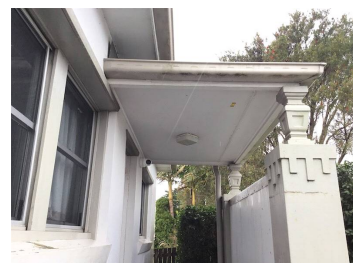
Location	MUH-F - Ground Level - Exterior - Southeastern Porch (flat) - Porch Ceiling Lining		
Hazard Type	Asbestos	Material Assessment	Disturbance Assessment
Friability	Non-friable	Product Type	Occupancy
Sample No.	J149255-02-Block F-003 {CR000167}	Extent of damage	Disturbance
Result	Positive Chrysotile + Amosite	Surface Treatment	Exposure
		Asbestos Type	Maintenance
Item Number	57	Material Score	Disturbance Score
		Priority Score	Very Low

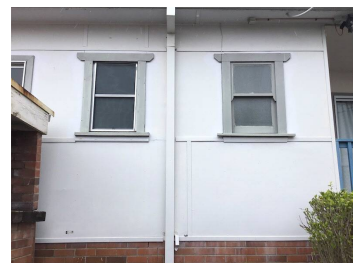
Location	MUH-F - Ground Level - Exterior - Original Building - North & East - Wall Cladding - Fibre Cement Sheetting		
Hazard Type	Asbestos	Material Assessment	Disturbance Assessment
Friability	Non-friable	Product Type	Occupancy
Sample No.	J155696-02-ISLHD-MUH-F-002 {CR000173}	Extent of damage	Disturbance
Result	Positive Chrysotile	Surface Treatment	Exposure
		Asbestos Type	Maintenance
Item Number	62	Material Score	Disturbance Score
		Priority Score	Very Low

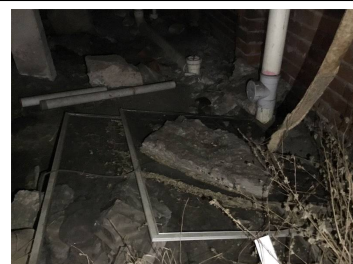
Location	MUH-F - Ground Level - Subfloor - Various Throughout - Debris - Insulation Material		
Hazard Type	SMF	Material Assessment	Disturbance Assessment
Friability	Bonded	Product Type	Occupancy
Sample No.	Visual	Extent of damage	Disturbance
Result	Assumed Positive	Surface Treatment	Exposure
		Asbestos Type	Maintenance
Item Number	64	Material Score	Disturbance Score
		Priority Score	-

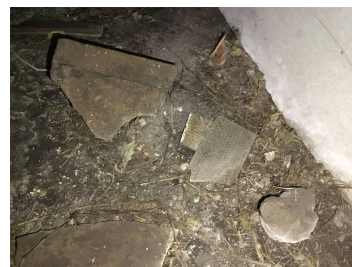
Location		MUH-F - Ground Level - Subfloor - Various Throughout - Debris - Fibre Cement Sheeting					
Hazard Type		Asbestos	Material Assessment		Disturbance Assessment		
Friability		Non-friable	Product Type	3	Occupancy	0	
Sample No.		J149255-02-Block F-006 {CR000174}	Extent of damage	3	Disturbance	0	
Result		Positive Chrysotile		Surface Treatment	0	Exposure	0
				Asbestos Type	1	Maintenance	2
Item Number		65		Material Score	7	Disturbance Score	2
				Priority Score	9	Low

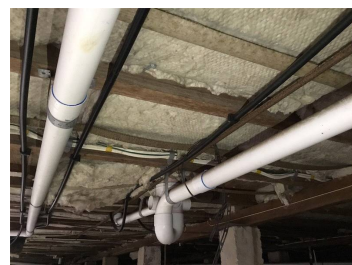
Location		MUH-F - Ground Level - Subfloor - Underside of Floor - Throughout - Insulation Batts				
Hazard Type		SMF	Material Assessment		Disturbance Assessment	
Friability		Bonded	Product Type	-	Occupancy	-
Sample No.		Visual	Extent of damage	-	Disturbance	-
Result		Assumed Positive	Surface Treatment	-	Exposure	-
			Asbestos Type	-	Maintenance	-
Item Number	66	Material Score	-	Disturbance Score	-	
		Priority Score	-	-

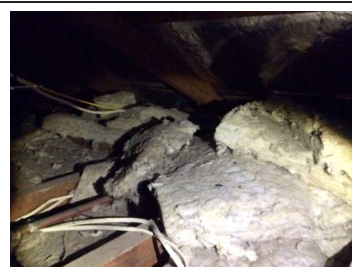
Location		MUH-F - Ground Level - Ceiling Space - Throughout - Insulation Batts				
Hazard Type		SMF	Material Assessment		Disturbance Assessment	
Friability		Bonded	Product Type	-	Occupancy	-
Sample No.		Visual	Extent of damage	-	Disturbance	-
Result		Assumed Positive	Surface Treatment	-	Exposure	-
			Asbestos Type	-	Maintenance	-
Item Number	67	Material Score	-	Disturbance Score	-	
		Priority Score	-	-

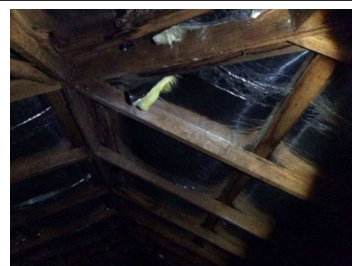
Location		MUH-F - Ground Level - Ceiling Space - Underside of Roof - Throughout - Sarking Insulation						
Hazard Type		SMF	Material Assessment		Disturbance Assessment			
Friability		Bonded	Product Type		-	Occupancy	-	
Sample No.		Visual	Extent of damage		-	Disturbance	-	
Result		Assumed Positive		Surface Treatment		-	Exposure	-
				Asbestos Type		-	Maintenance	-
Item Number		68		Material Score		-	Disturbance Score	-
				Priority Score		-	-

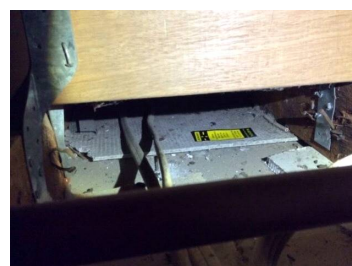
Location		MUH-F - Ground Level - Ceiling Space - Above Bathroom & Adjacent Areas - Above Plasterboard Ceiling - Original Ceiling Lining - Fibre Cement Sheeting									
Hazard Type		Asbestos		Material Assessment		Disturbance Assessment					
Friability		Non-friable		Product Type		1 Occupancy		0			
Sample No.		J155696-02-ISLHD-MUH-F-001 {CR000176}		Extent of damage		1 Disturbance		1			
Result		Positive Chrysotile		Surface Treatment		0		Exposure		0	
				Asbestos Type		1		Maintenance		0	
Item Number		70		Material Score		3		Disturbance Score		1	
				Priority Score		4		Very Low

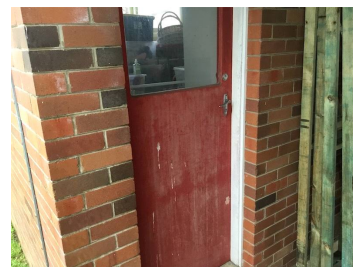
Location		MUH-F - Ground Level - External Storage Room - South - Door - Paint (Red)	
Hazard Type	Lead Paint	Material Assessment	Disturbance Assessment
Friability	-	Product Type	Occupancy
Sample No.	J167110-ISLHD-MUH-F-LP-002 {CR000171}	Extent of damage	Disturbance
Result	Positive	Surface Treatment	Exposure
		Asbestos Type	Maintenance
Item Number	59	Material Score	Disturbance Score
		Priority Score	-

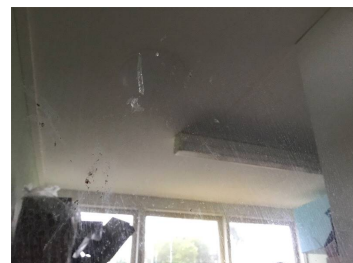
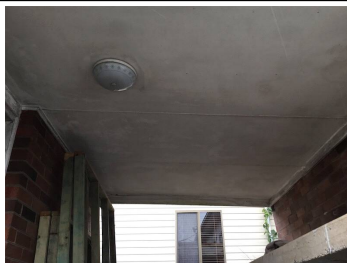
Location		MUH-F - Ground Level - External Storage Room - Throughout - Ceiling Lining - Fibre Cement Sheeting	
Hazard Type	Asbestos	Material Assessment	Disturbance Assessment
Friability	Non-friable	Product Type	Occupancy
Sample No.	J167110-ISLHD-MUH-F-002 {CR000172}	Extent of damage	Disturbance
Result	Positive Chrysotile	Surface Treatment	Exposure
		Asbestos Type	Maintenance
Item Number	61	Material Score	Disturbance Score
		Priority Score	Very Low

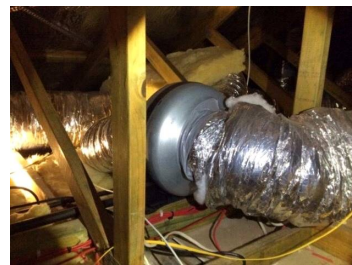
Location	MUH-I - Ground Level - Ceiling Space - Various Throughout - Flexible Ductwork Insulation		
Hazard Type	SMF	Material Assessment	Disturbance Assessment
Friability	Bonded	Product Type	Occupancy
Sample No.	Visual	Extent of damage	Disturbance
Result	Assumed Positive	Surface Treatment	Exposure
		Asbestos Type	Maintenance
Item Number	5	Material Score	Disturbance Score
		Priority Score	-

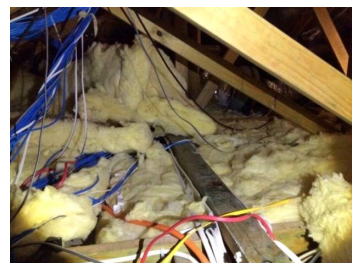
Location	MUH-I - Ground Level - Ceiling Space - Throughout - Insulation Batts		
Hazard Type	SMF	Material Assessment	Disturbance Assessment
Friability	Bonded	Product Type	Occupancy
Sample No.	Visual	Extent of damage	Disturbance
Result	Assumed Positive	Surface Treatment	Exposure
		Asbestos Type	Maintenance
Item Number	6	Material Score	Disturbance Score
		Priority Score	-

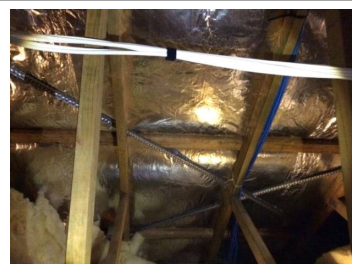
Location	MUH-I - Ground Level - Ceiling Space - Throughout - Underside of Roof - Sarking Insulation		
Hazard Type	SMF	Material Assessment	Disturbance Assessment
Friability	Bonded	Product Type	Occupancy
Sample No.	Visual	Extent of damage	Disturbance
Result	Assumed Positive	Surface Treatment	Exposure
		Asbestos Type	Maintenance
Item Number	7	Material Score	Disturbance Score
		Priority Score	-
