Northern Rivers Flood Recovery – Richmond River High Campus Redevelopment

Hazardous Building Materials Assessment

NSW Department of Education

27 June 2025

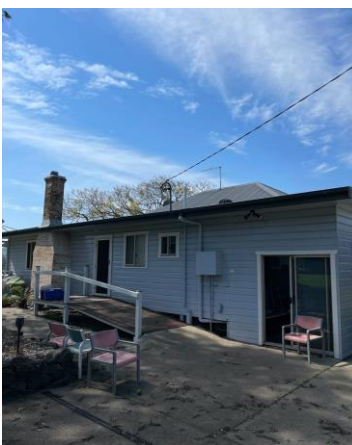
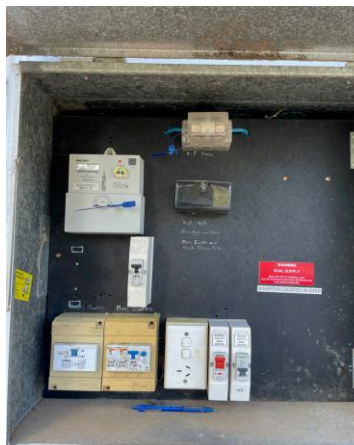
Asbestos detected or assumed																							
27-Aug-24		GHD	FH1	GF	External	Resin-based materials	Electrical box	Fixed to side of house	Backing board	Sealed	Not sampled	Presumed to contain asbestos until proven otherwise	Non-friable	Good	Low	Low	Defer. Monitor and maintain current condition	Labels required (not affixed or not sufficient)	<1	m2

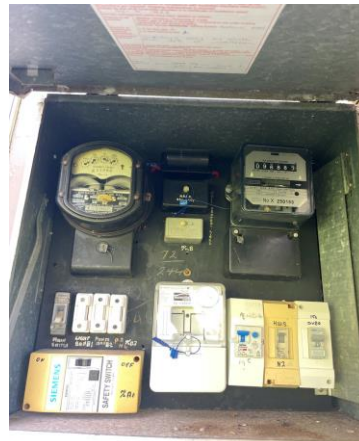
</div>																						
Asbestos detected or assumed																									
27-Aug-24		GHD	FH2	GF	External	Resin-based materials	Electrical board	Electrical box	Backing board	Sealed	Not sampled	Presumed to contain asbestos until proven otherwise	Non-friable	Good	Low	Low	Defer. Monitor and maintain current condition	Labels required (not affixed or not sufficient)	<1	m2

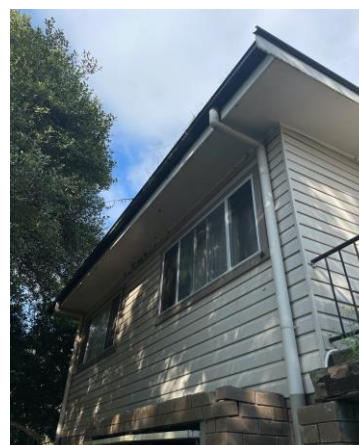
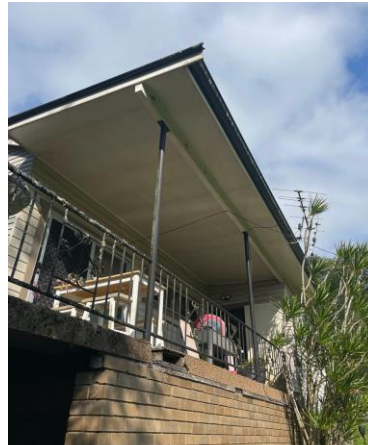
27-Aug-24		GHD	FH2	01	External	Flat cement product	Eaves / porch	Ceiling	Linings	Sealed	FH2-A01	Chrysotile Detected	Non-friable	Good	Low	Low	Defer. Monitor and maintain current condition	Labels required (not affixed or not sufficient)	45	m2

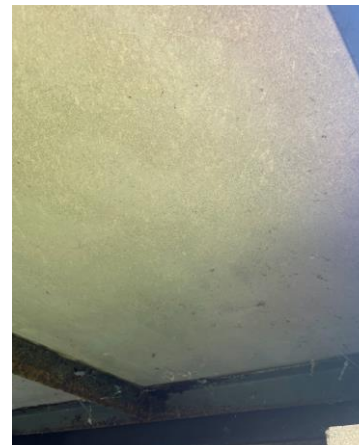
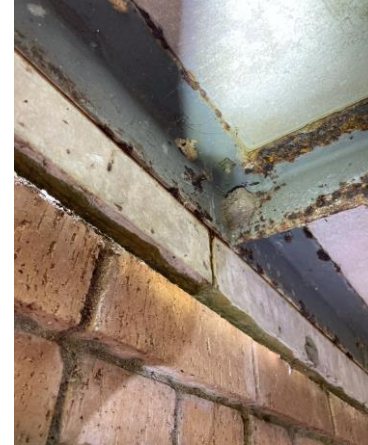
27-Aug-24		GHD	FH2	01	External	Flat cement product	Porch	Flooring	Compressed cement sheet flooring	Sealed	FH2-A02	Chrysotile Detected	Non-friable	Poor	Low	Low	Defer. Monitor and maintain current condition	Labels required (not affixed or not sufficient)	35	m2	Beneath pebble crete

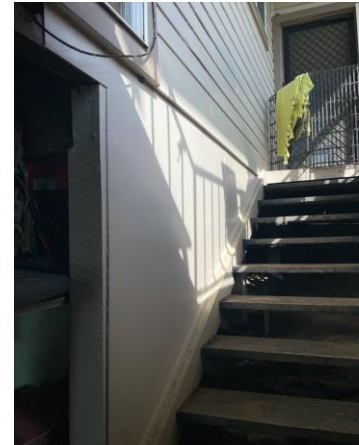
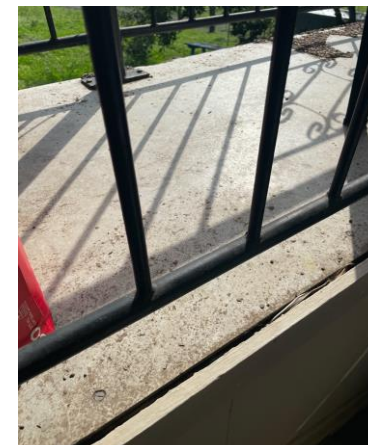
27-Aug-24		GHD	FH2	GF	External	Flat cement product	Garage stairs	Leading to porch	Sides of stairs	Sealed	FH2-A03	Chrysotile Detected	Non-friable	Good	Low	Low	Defer. Monitor and maintain current condition	Labels required (not affixed or not sufficient)	15	m2

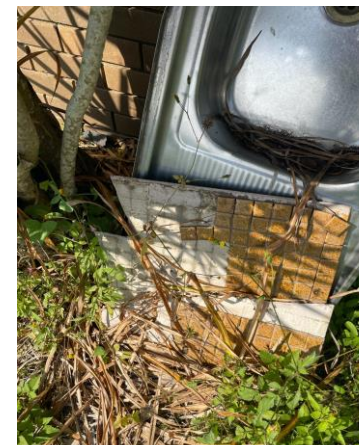
27-Aug-24		GHD	FH2	GF	External	Debris	North external stairs	Ground surface	Debris	Unsealed	FH2-A04	Chrysotile Detected	Non-friable	Poor	Medium	Medium	Removal	Labels required (not affixed or not sufficient)	<1	m2

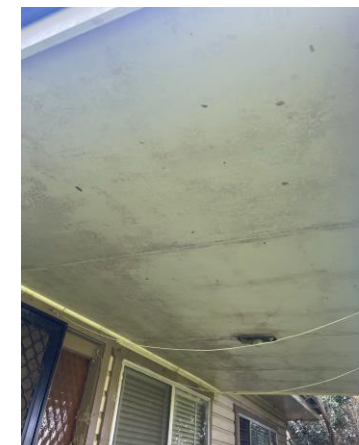
27-Aug-24		GHD	FH2	01	External	Flat cement product	South porch	Ceiling	Linings	Sealed	Refer FH2-A01	Chrysotile Detected	Non-friable	Good	Low	Low	Defer. Monitor and maintain current condition	Labels required (not affixed or not sufficient)	8	m2

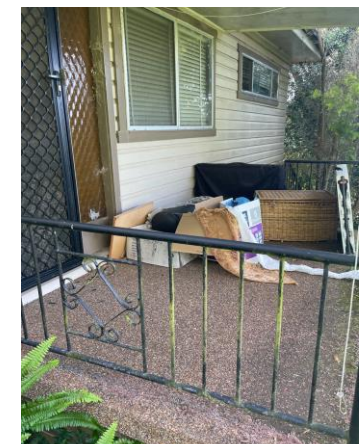
27-Aug-24		GHD	FH2	01	External	Flat cement product	South porch	Flooring	Compressed cement sheet flooring	Sealed	Refer FH2-A02	Chrysotile Detected	Non-friable	Fair	Medium	Medium	Encapsulate (seal)	Labels required (not affixed or not sufficient)	8	m2	Compressed cement sheet located beneath pebblecrete finish

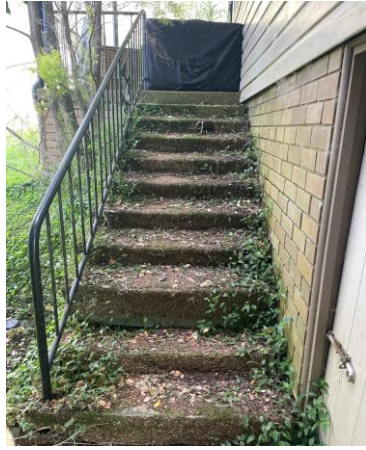
27-Aug-24		GHD	FH2		External	Flat cement product	South stairs to porch	Flooring / stair treads	Compressed cement sheet	Unsealed	FH2-A06	Chrysotile Detected	Non-friable	Poor	Medium	Medium	Encapsulate (seal)	Labels required (not affixed or not sufficient)	10	m2	Compressed cement sheet located beneath pebblecrete finish

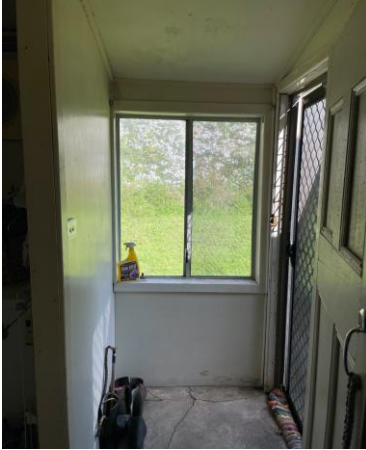
27-Aug-24		GHD	FH2	01	Internal	Flat cement product	Rear entryway	Walls and ceiling	Linings	Sealed	FH2-A07	Chrysotile Detected	Non-friable	Good	Low	Low	Defer. Monitor and maintain current condition	Labels required (not affixed or not sufficient)	15	m2

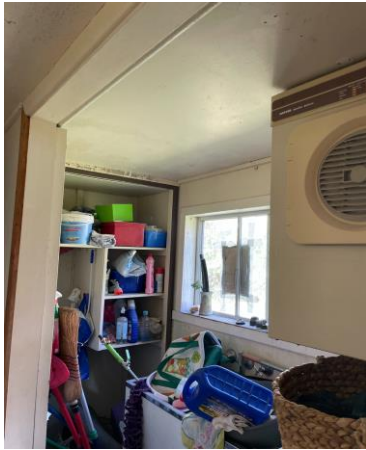
27-Aug-24		GHD	FH2	01	Internal	Flat cement product	Laundry	Walls and ceiling	Linings	Sealed	Refer to FH2-A07	Chrysotile Detected	Non-friable	Good	Low	Low	Defer. Monitor and maintain current condition	Labels required (not affixed or not sufficient)	20	m2

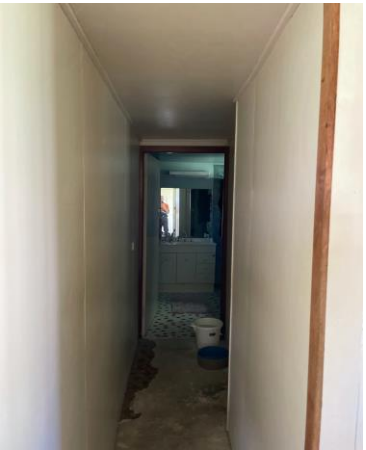
27-Aug-24		GHD	FH2	01	Internal	Flat cement product	Hallway to bathroom	Walls and ceiling	Linings	Sealed	Refer to FH2-A07	Chrysotile Detected	Non-friable	Good	Low	Low	Defer. Monitor and maintain current condition	Labels required (not affixed or not sufficient)	32	m2

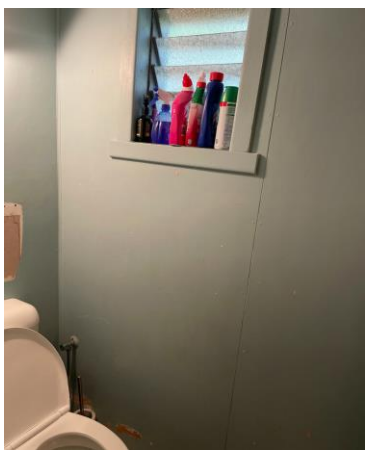
27-Aug-24		GHD	FH2	01	Internal	Flat cement product	Toilet	Walls and ceiling	Linings	Sealed	Refer to FH2-A07	Chrysotile Detected	Non-friable	Good	Low	Low	Defer. Monitor and maintain current condition	Labels required (not affixed or not sufficient)	12	m2

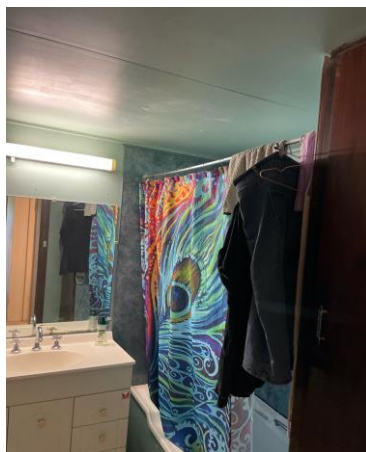
27-Aug-24		GHD	FH2	01	Internal	Flat cement product	Bathroom	Walls and ceiling	Linings	Sealed	Refer to FH2-A07	Chrysotile Detected	Non-friable	Good	Low	Low	Defer. Monitor and maintain current condition	Labels required (not affixed or not sufficient)	22	m2

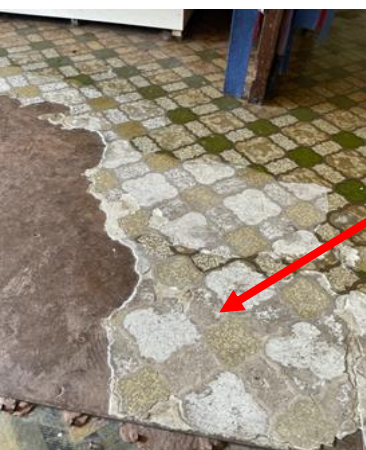
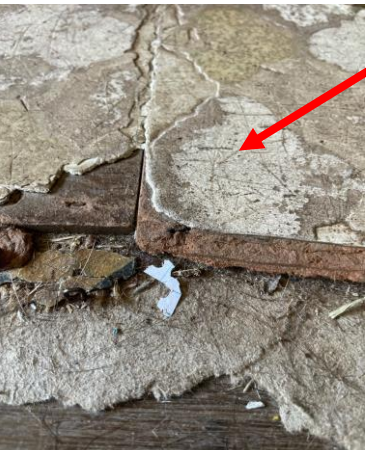
27-Aug-24		GHD	FH2	01	Internal	Floor sheeting	Kitchen/dining	Vinyl sheet - cream/brown/green (top layer)	Floor covering and backing	Sealed	FH2-A10	Chrysotile Detected	Friable	Poor	High	Very high	Removal	Labels required (not affixed or not sufficient)	12	m2

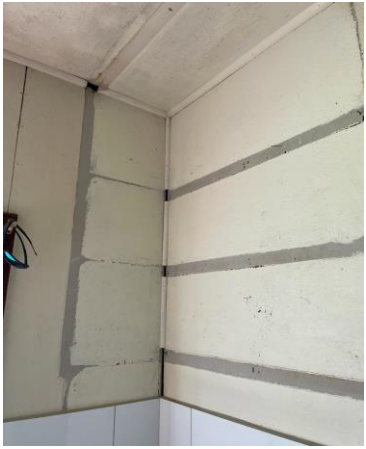
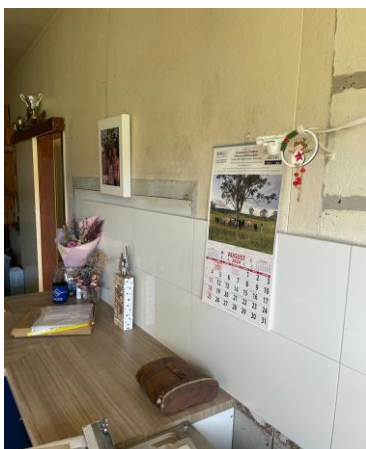
27-Aug-24		GHD	FH2	01	Internal	Flat cement product	Kitchen/dining	Tilux style wall linings	Linings	Sealed	Visual inspection	Presumed to contain asbestos until proven otherwise	Non-friable	Good	Low	Low	Defer. Monitor and maintain current condition	Labels required (not affixed or not sufficient)	45	m2

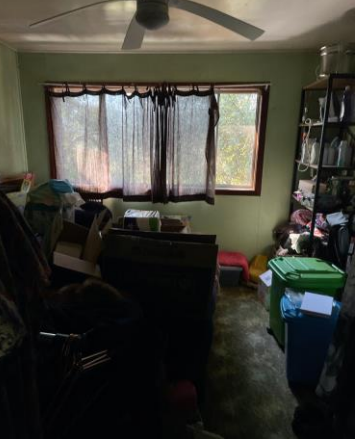
27-Aug-24		GHD	FH2	01	Internal	Flat cement product	Bedroom	Walls and ceiling	Linings	Sealed	FH2-A13	Chrysotile Detected	Non-friable	Good	Low	Low	Defer. Monitor and maintain current condition	Labels required (not affixed or not sufficient)	65	m2

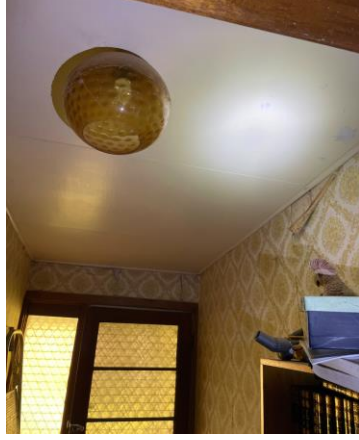
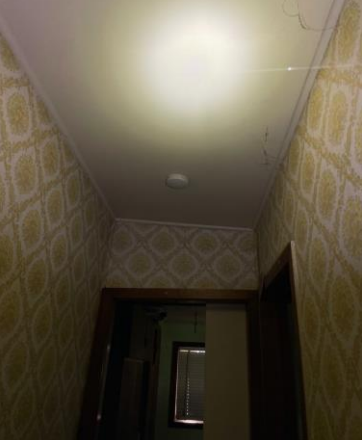
27-Aug-24		GHD	FH2	01	Internal	Flat cement product	Southern entry way	Ceiling	Linings	Sealed	FH2-A14	Chrysotile Detected	Non-friable	Good	Low	Low	Defer. Monitor and maintain current condition	Labels required (not affixed or not sufficient)	10	m2

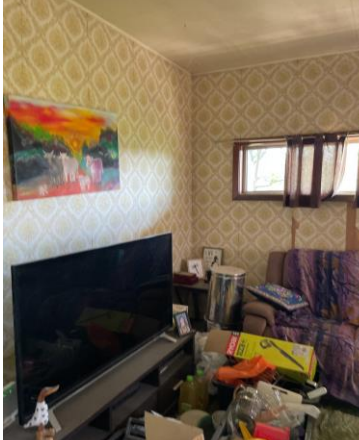
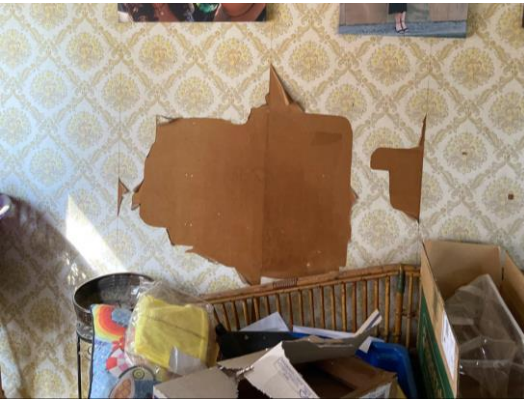
27-Aug-24		GHD	FH2	01	Internal	Flat cement product	Lounge/bedroom	Walls	Linings	Sealed	FH2-A15	Chrysotile Detected	Non-friable	Good	Low	Low	Defer. Monitor and maintain current condition	Labels required (not affixed or not sufficient)	95	m2

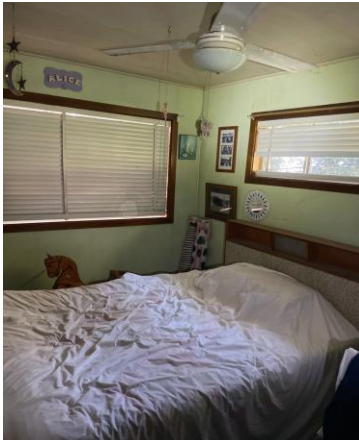
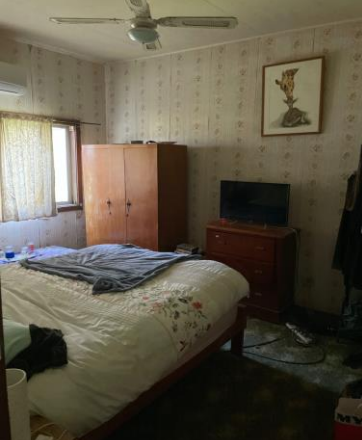
27-Aug-24		GHD	FH2	01	Internal	Flat cement product	Front bedroom - south east	Ceiling	Linings	Sealed	FH2-A16	Chrysotile Detected	Non-friable	Good	Low	Low	Defer. Monitor and maintain current condition	Labels required (not affixed or not sufficient)	65	m2

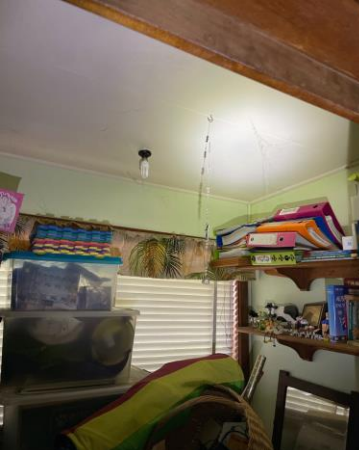
27-Aug-24		GHD	FH2	01	Internal	Flat cement product	Office	Ceiling	Linings	Sealed	Refer to FH2-A16	Chrysotile Detected	Non-friable	Good	Low	Low	Defer. Monitor and maintain current condition	Labels required (not affixed or not sufficient)	11	m2

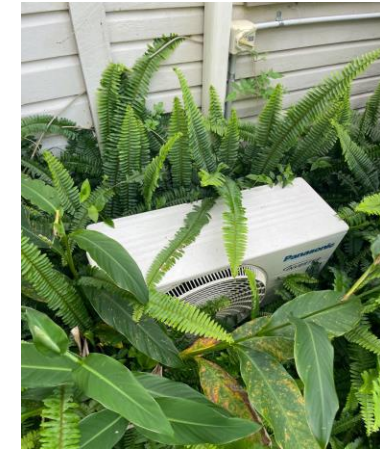
27-Aug-24		GHD	FH2		Internal	Thermal insulation	Air conditioning unit	-	Insulation	Sealed	Not sampled	Assumed positive	N/A	Good	Low	Low	Defer. Monitor and maintain current condition	Labels required (not affixed or not sufficient)	1	Item

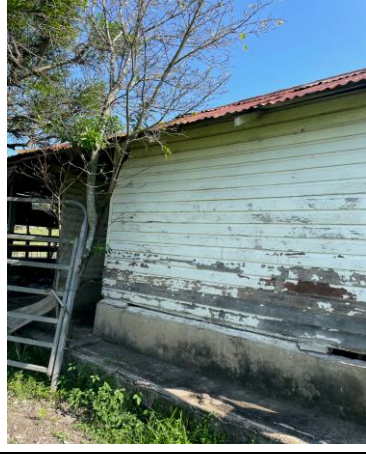
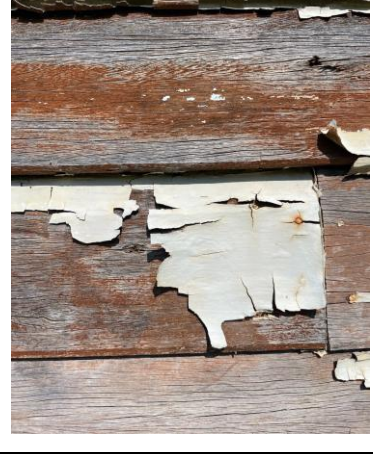
No potential asbestos materials detected or assumed																									
Lead paint																									
27-Aug-24		GHD	Dairy	GF	External	Paint	Wall paint	Cream paint	Paint	Sealed	FH2-P04	Lead paint detected >0.1% w/w (8.6% w/w)	N/A	Poor	Low	Low	Removal	N/A	25	m2

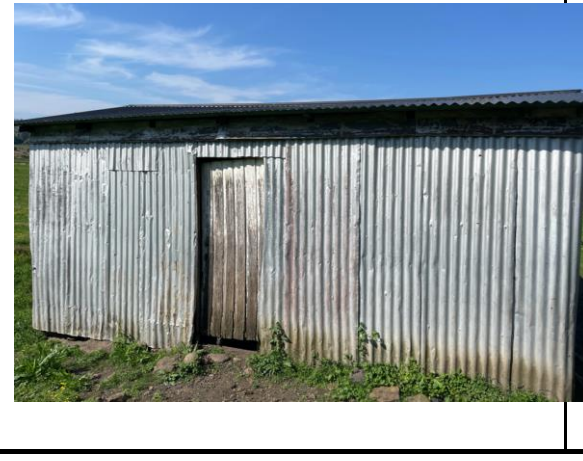
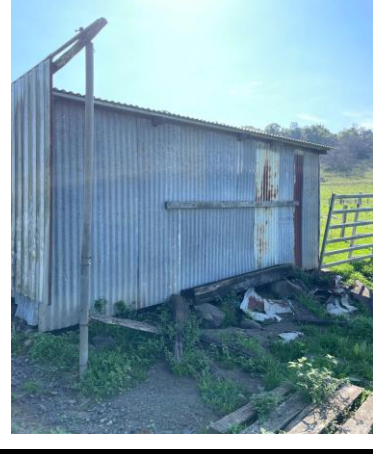
No potential asbestos materials detected or assumed																									
Lead paint																									
27-Aug-24		GHD	Shed	GF	External	Paint	Door and external weatherboards	Cream paint	Paint	Sealed	FH2-P05	Lead paint detected >0.1% w/w (20% w/w)	N/A	Poor	Medium	Medium	Removal	N/A	35	m2
