Geotechnical site investigation report

World Class End of Life Care

Tamworth Hospital, 31 to 35 Dean Street, Tamworth NSW

Ref: R44178g

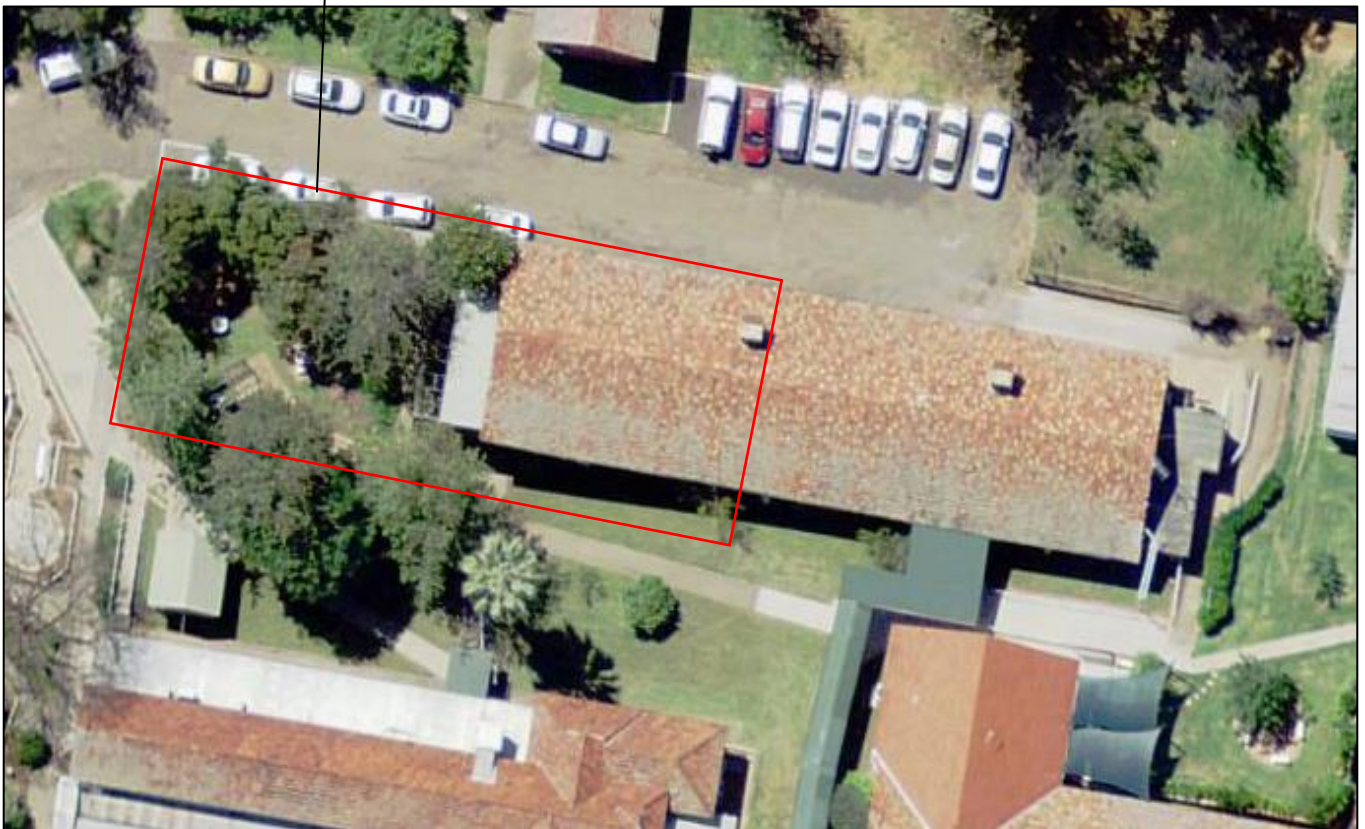
Figure 1. Aerial image (SIXmaps 2011), Removed structure and tree location
