**RE: INTERIM AUDIT ADVICE LETTER NO. 1 - GILLIESTON PUBLIC SCHOOL REDEVELOPMENT AND NEW PUBLIC PRESCHOOL SITE AUDIT - REVIEW OF RAP**

Ref: 318002140

Audit Number: TO-139

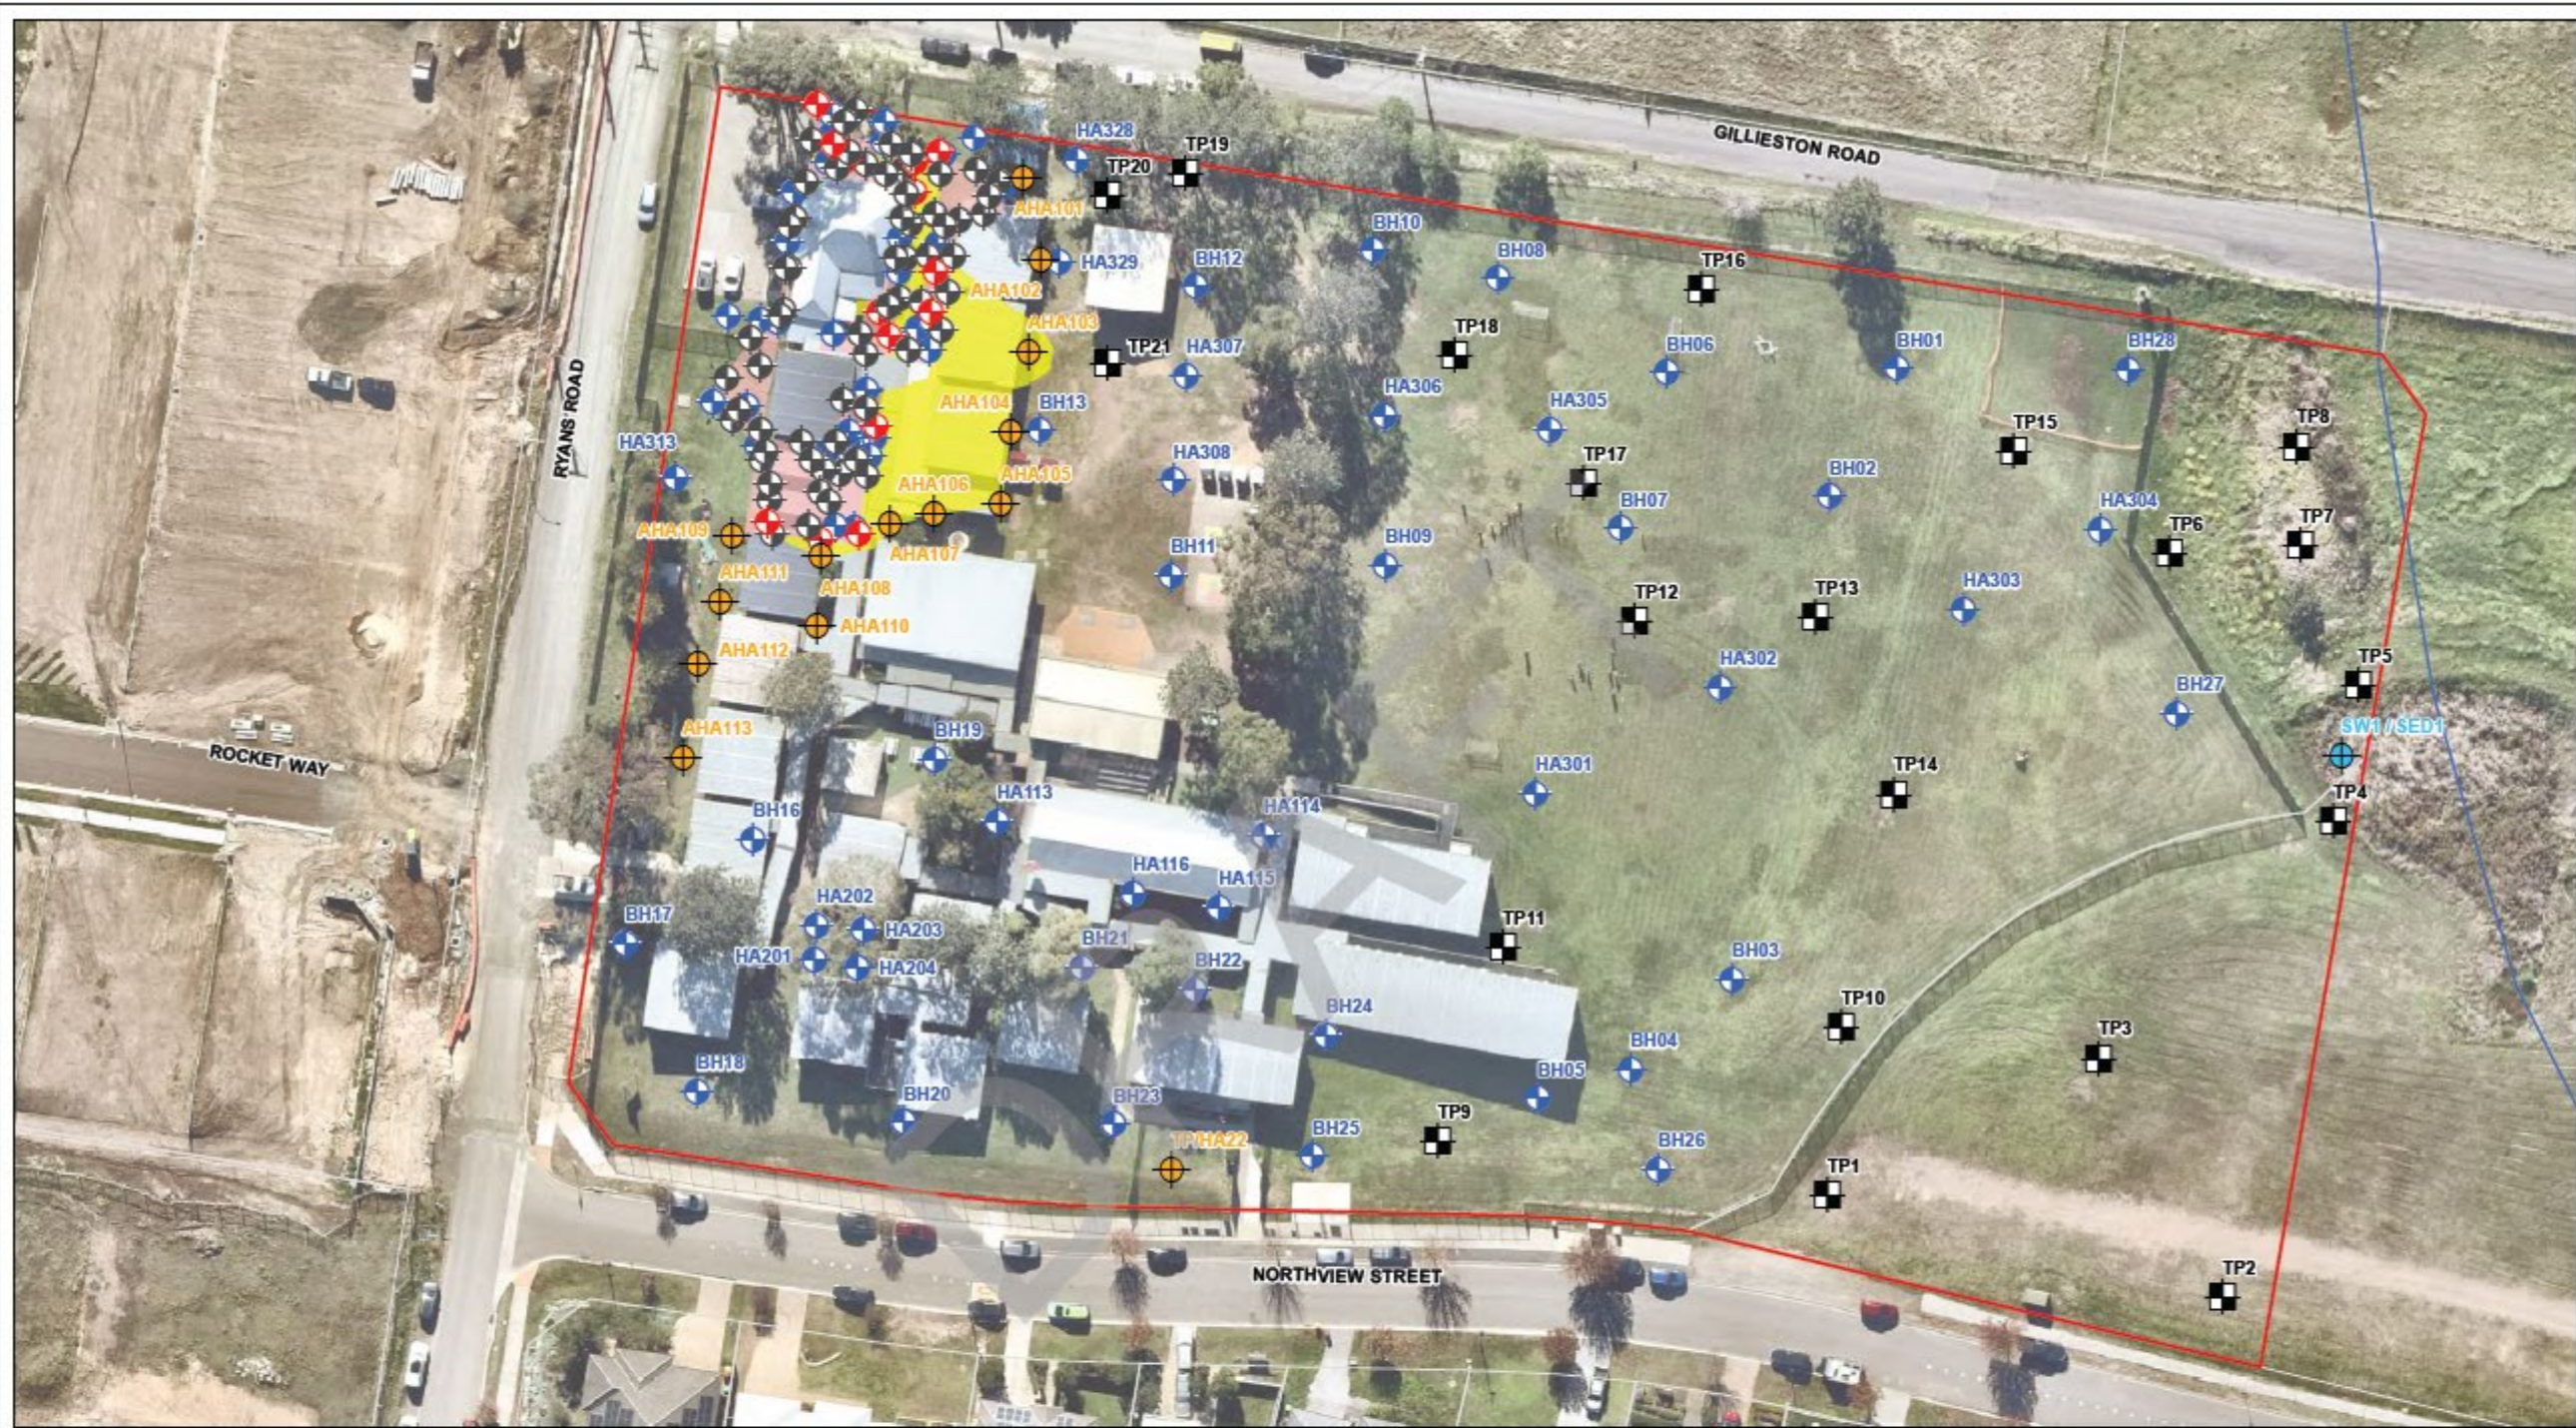
Previous Sampling Plan - Overview

Soil samples reported concentrations exceeding the adopted human health criteria for lead at 12 locations and friable asbestos at one location, all within the north-western portion of the site, and largely adjacent to the existing heritage building (Building D, on **Attachment 1**). The sample containing friable asbestos was coincident with a fragment of bonded asbestos containing material (ACM). Concentrations of zinc (15 locations), lead (two locations) and nickel (one location) also exceeded the adopted urban residential and open space ecological criteria, also generally located within the north-western and western portion of the site.

Soil analytical results identified one sample location with lead concentrations at greater than 2.5 times the adopted criterion, adjoining demountable buildings in the western portion of the site. Sediment analytical results were below the adopted sediment quality criteria. Surface water reported concentrations of copper, lead, nickel and zinc above the ANZG (2018) default guideline value for 95% protection of freshwater species, and PFOS above the NEMP (2020) criterion for 99% protection of freshwater species.

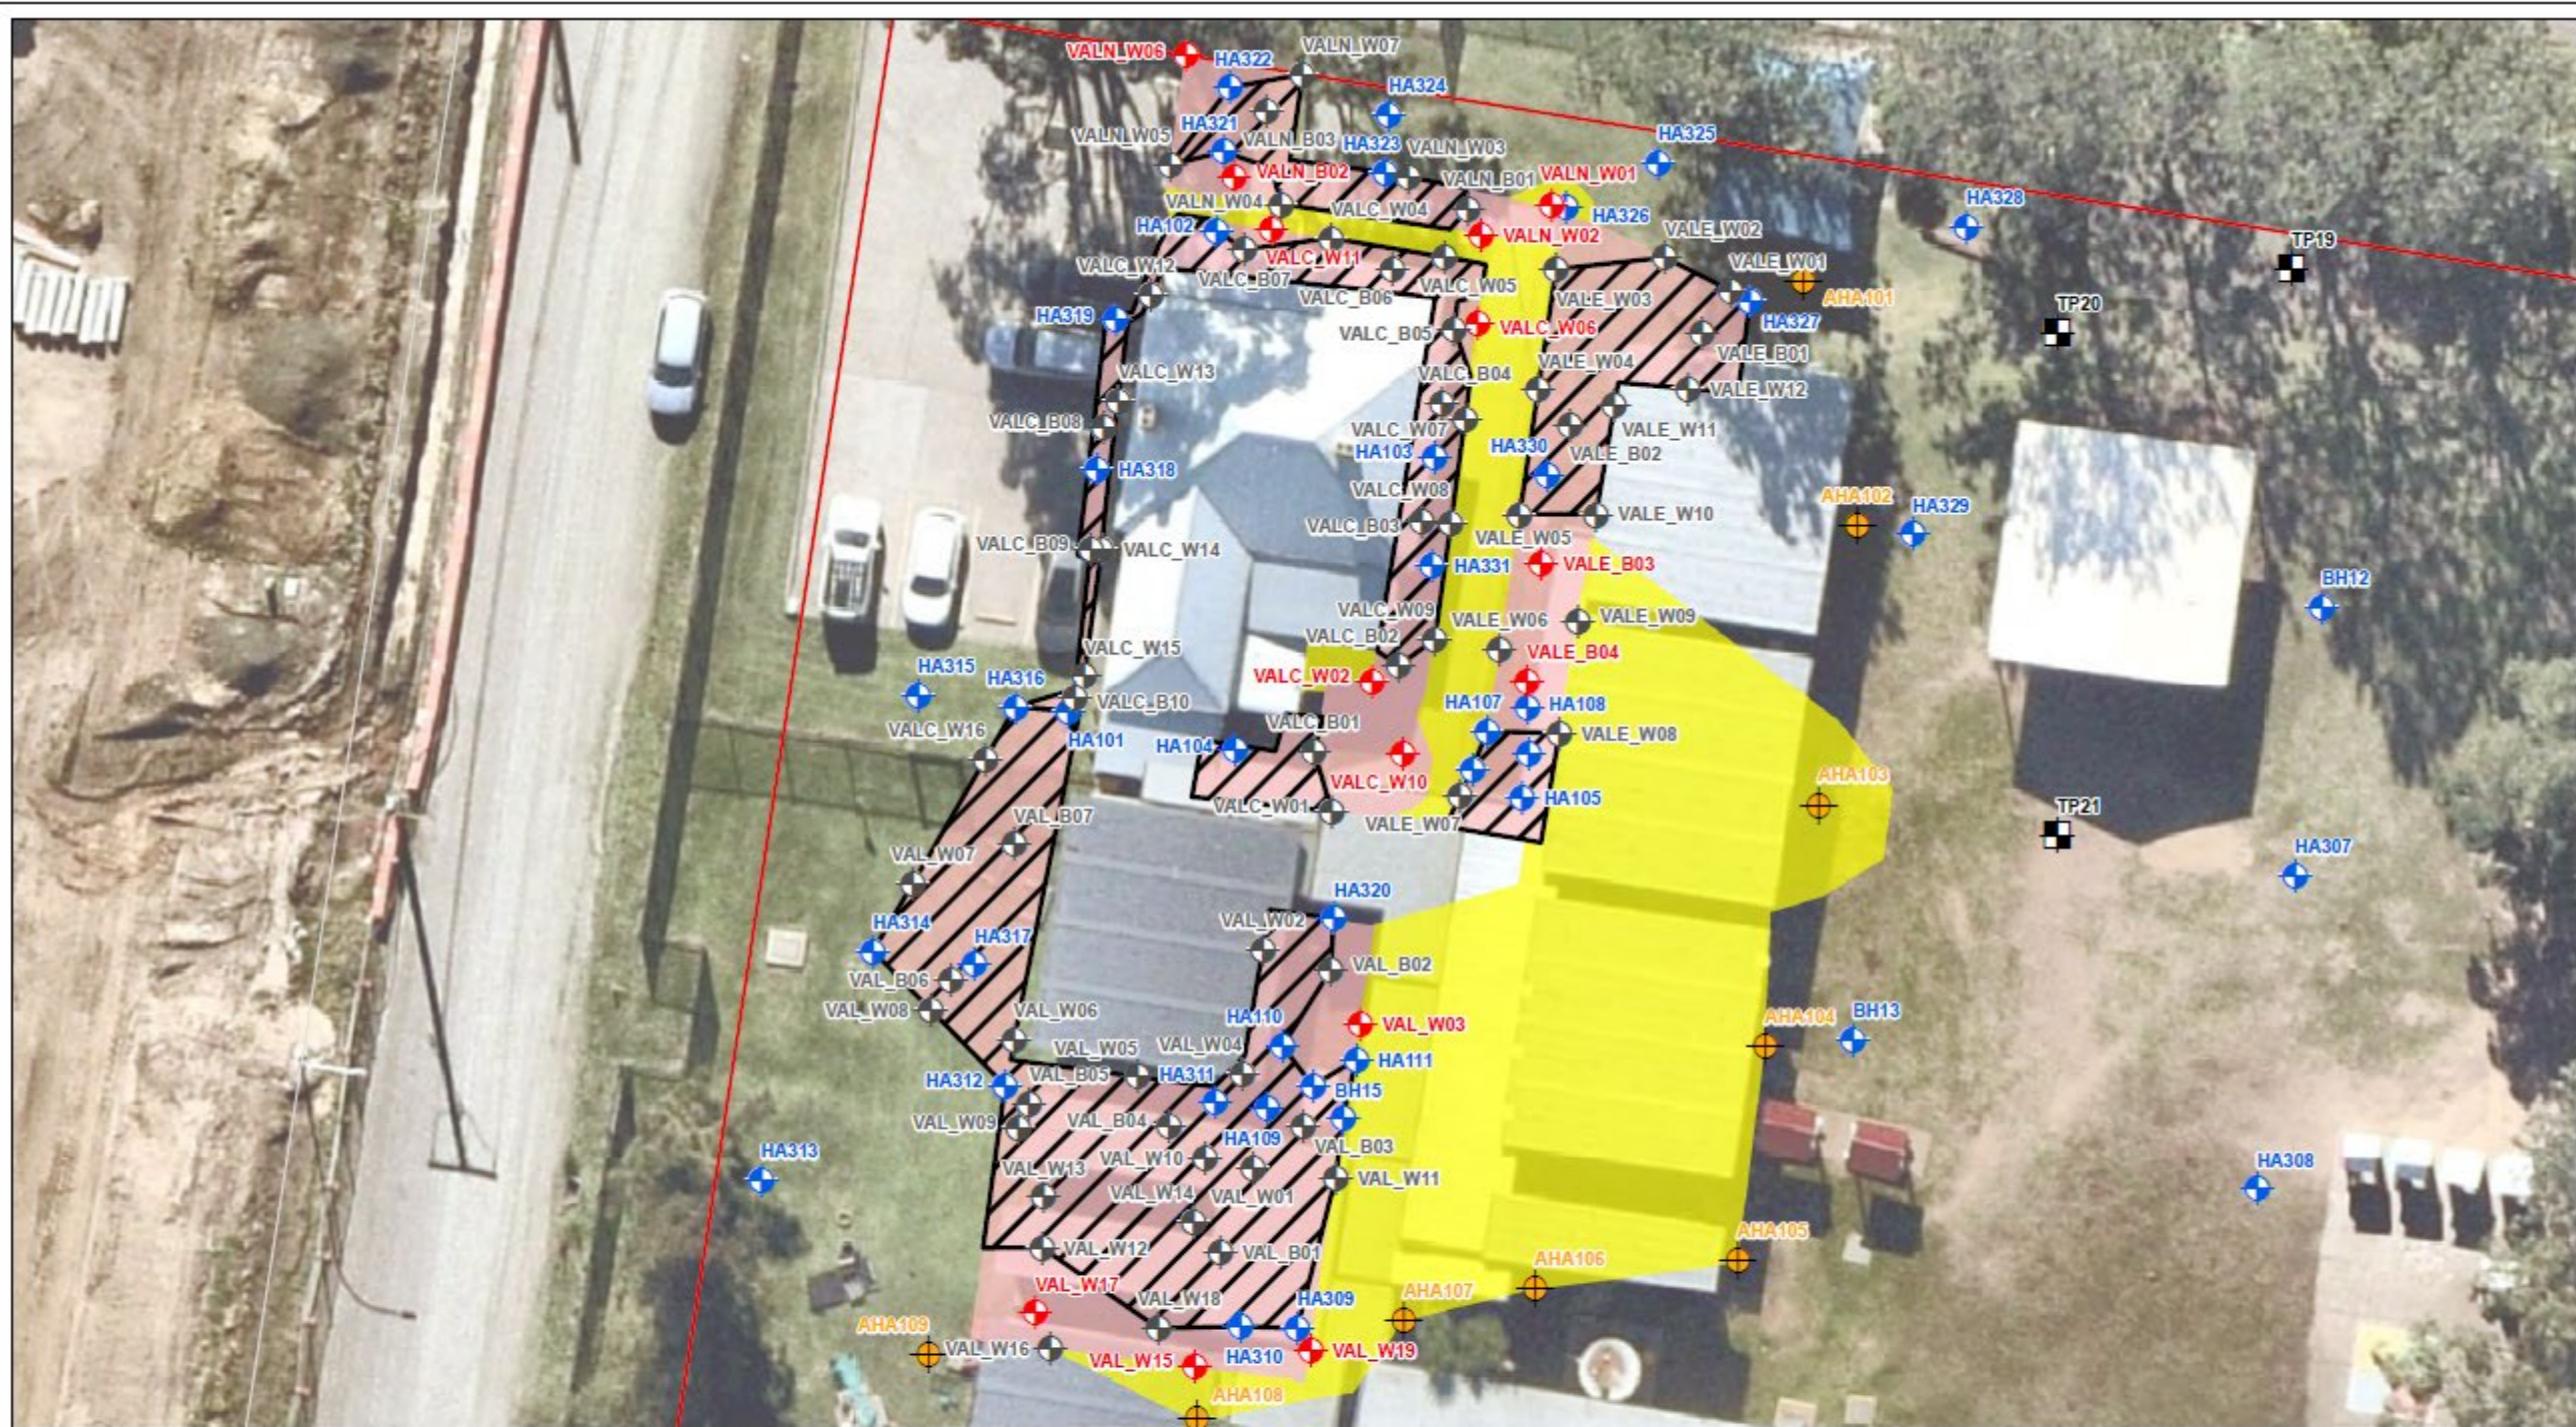
# Validation Sampling and Remediation Extents

Eighty-two validation samples were collected from the excavations, 14 of which did not meet the adopted remediation criterion for lead in soil, including samples collected in close proximity to building footprints. It was deemed impracticable to undertake further excavation to achieve validation until demolition of buildings occurs. Validation sample locations and the extent of the interim remediation excavations are shown on **Attachment 3**.

Due to the failed validation samples, the validation reporting was not completed and DoE elected to temporarily backfill the excavations with imported soil. It is understood that the imported soil was sourced from Australian Native Landscapes and sampling and inspection of the material was carried out prior to import. The results of imported material validation were not provided.
