# New High School for Leppington and Denham Court – Hazardous Building Materials Survey

NSW Department of Education

JBS&G 67606 | 163,954 Rev 1

13 January 2025

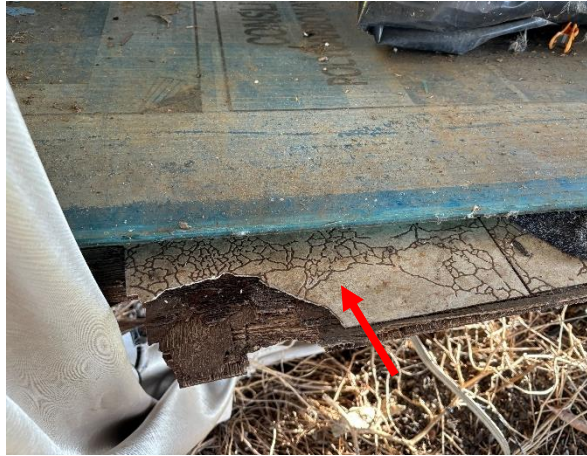
Photo 2: Caravan – asbestos containing vinyl floor tiles to the floor

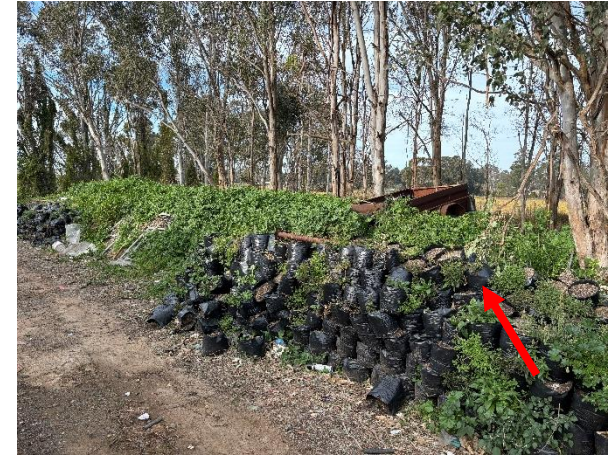
Photo 3: Large stockpile adjacent driveway (south) – asbestos containing fibre cement debris identified within stockpiled material

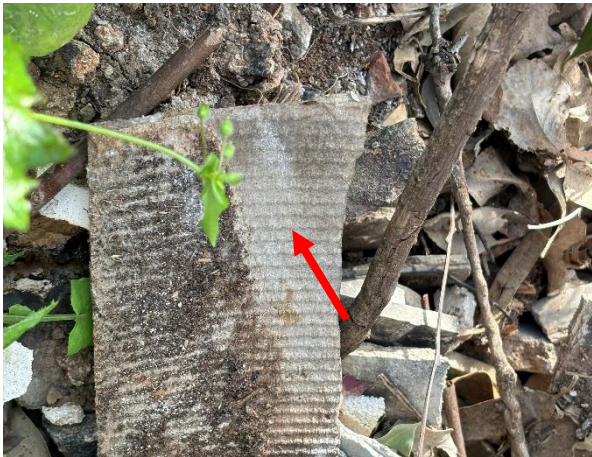
Photo 4: Large stockpile (south) – asbestos containing fibre cement sheeting debris within stockpiled material

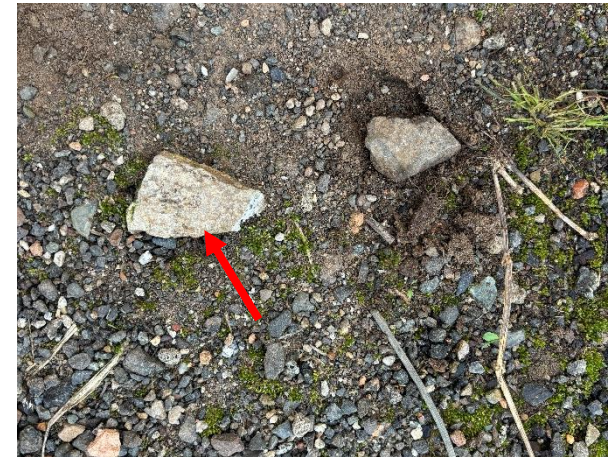
Photo 6: Chicken coops (central) – asbestos containing fragment identified to the ground surface

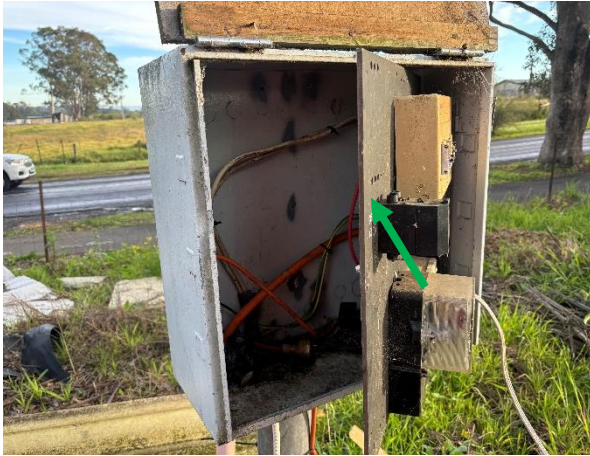
Photo 7: Non-asbestos containing compressed fibre cement backing board

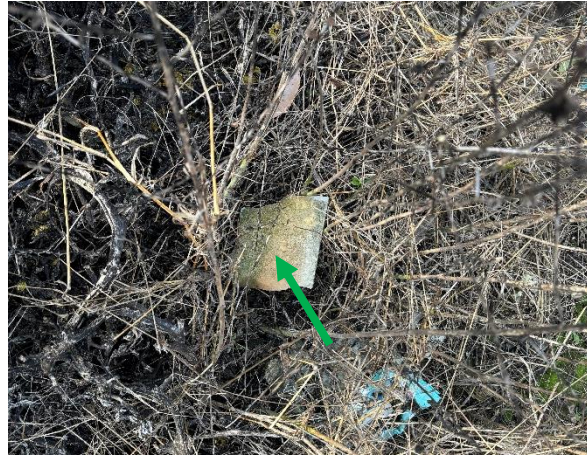
Photo 8: Non-asbestos containing fibre cement sheeting debris to ground surface adjacent south fence line

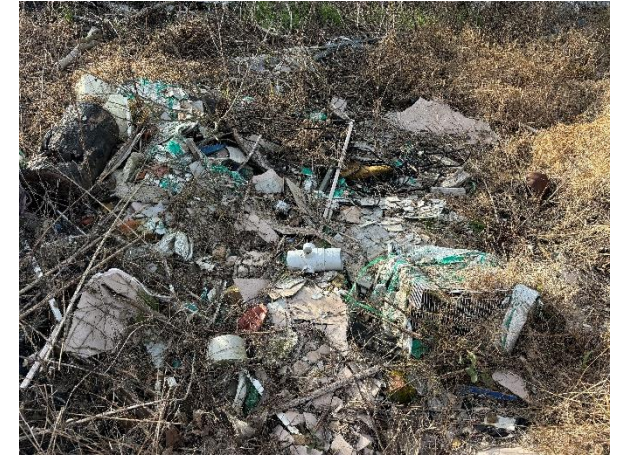
Photo 9: Ground surface adjacent the large shed (south) – non-asbestos containing fibre cement sheeting

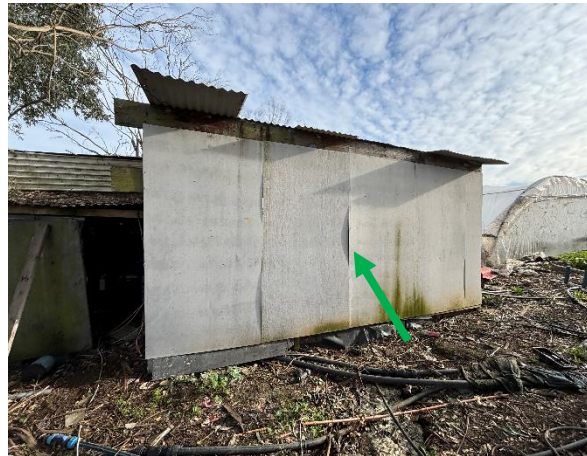
Photo 11: Large Shed Area – Non-asbestos containing fibre cement sheeting to the wall panels

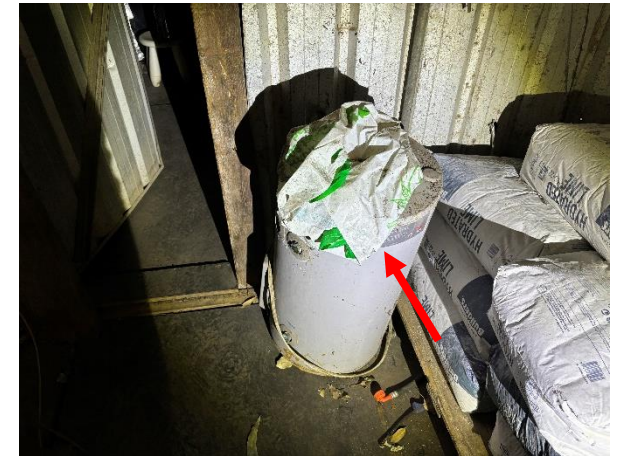
Photo 12: Assumed SMF internal insulation to HWU

All synthetic mineral fibres encountered during this inspection were generally contained and deemed to be low risk. These SMF materials can be removed with the building and demolition waste with care taken not to generate fibres. Appropriate PPE is to be worn including the use of P2 respirator as minimum and appropriate removal methodology as outlined in [NOHSC: 1004(1990)] and [NOHSC: 2006(1990)].

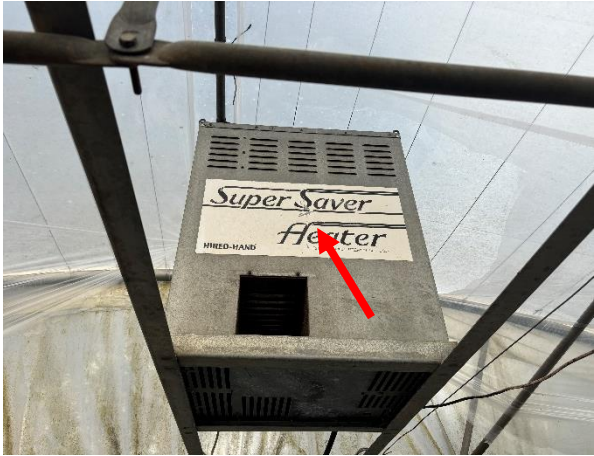
Photo 13: Enclosed Green Houses – Assumed SMF internal insulation to the heaters

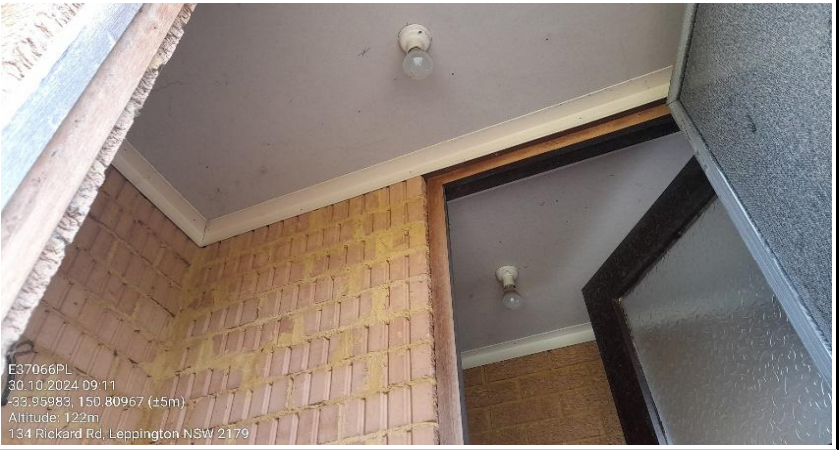
Building interior, Southern toilet, All internal walls	Fibre Cement Sheeting	ASB5	No asbestos detected: Organic fibres detected	-	-	-	-	-	
Building interior, Southern bathroom, All internal walls and Bath	Fibre Cement Sheeting	Same as ASB5	Assumed to not contain Asbestos	-	-	-	-	-	-
Building interior, South-eastern Laundry, Eastern, western and southern internal walls	Fibre Cement Sheeting	Same as ASB5	No asbestos detected: Organic fibres detected	-	-	-	-	-	-

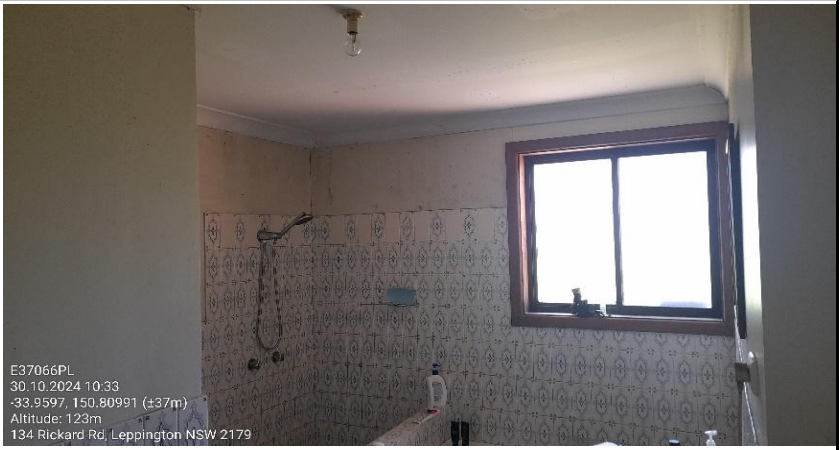
Building interior, Main bedroom ensuite, All internal walls	Fibre Cement Sheeting	Same as ASB7	Chrysotile asbestos detected: Organic fibres detected	Generally Intact	Non-Friable	10m <sup>2</sup>	Remove prior to refurbishment / demolition by appropriately licensed asbestos removal contractor in accordance with the relevant standard/code of practice/guidelines.	Yes
