Hazardous Building Materials (HAZMAT) Survey

Parramatta East Public School Upgrade  
30-32 Brabyn Street, Parramatta NSW

Prepared for  
NSW Department of Education  
School Infrastructure

Project 214531.01  
4 March 2025

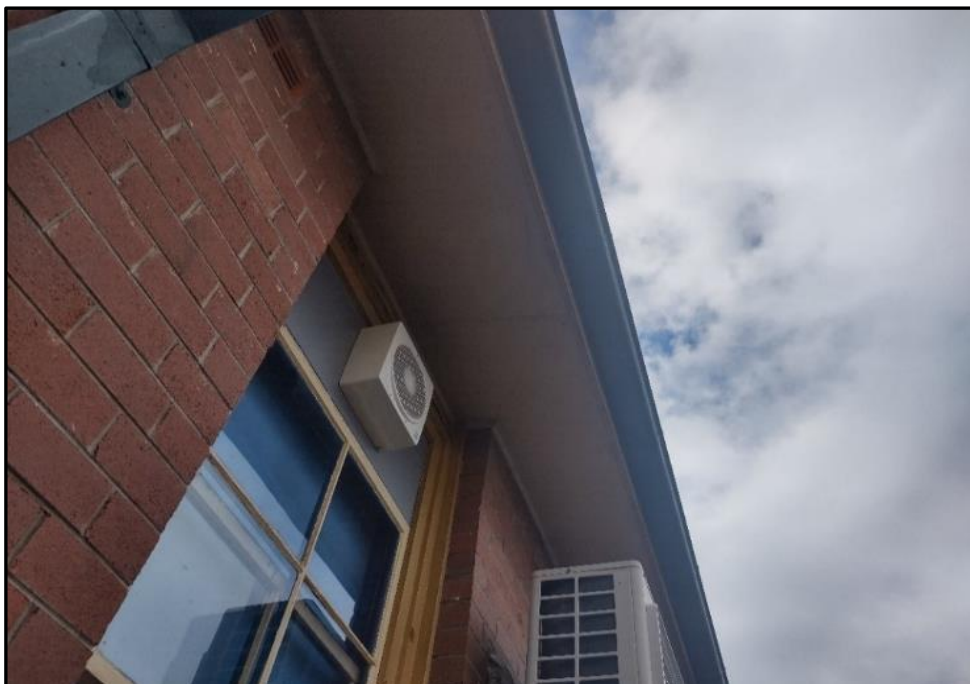
Photograph 1: B00B, exterior, eave linings, fibre cement sheeting, asbestos detected by analysis.

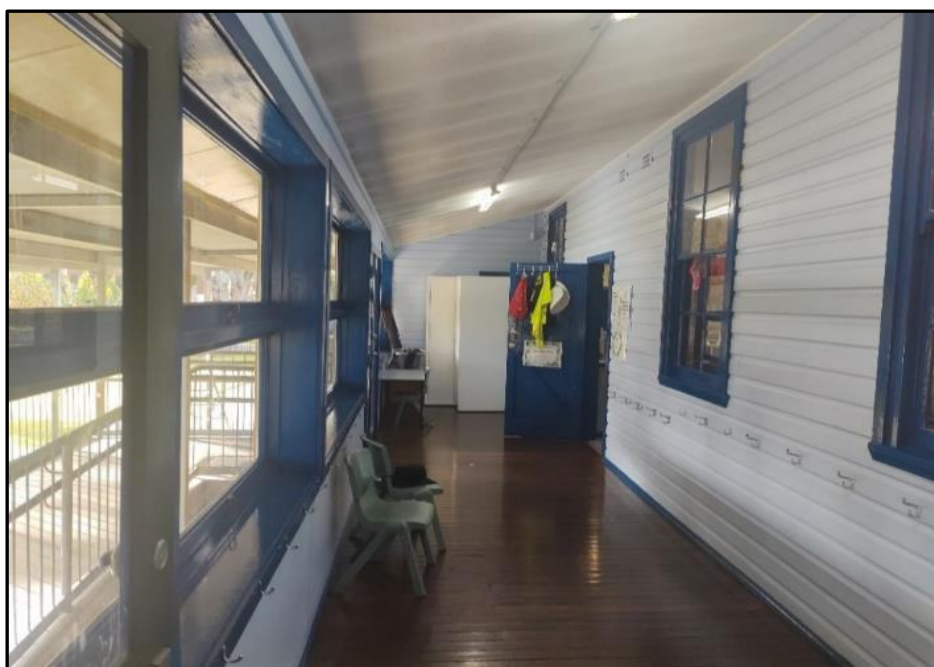
Photograph 2: B00B, BR0004, ceiling, fibre cement sheeting, asbestos detected by analysis.

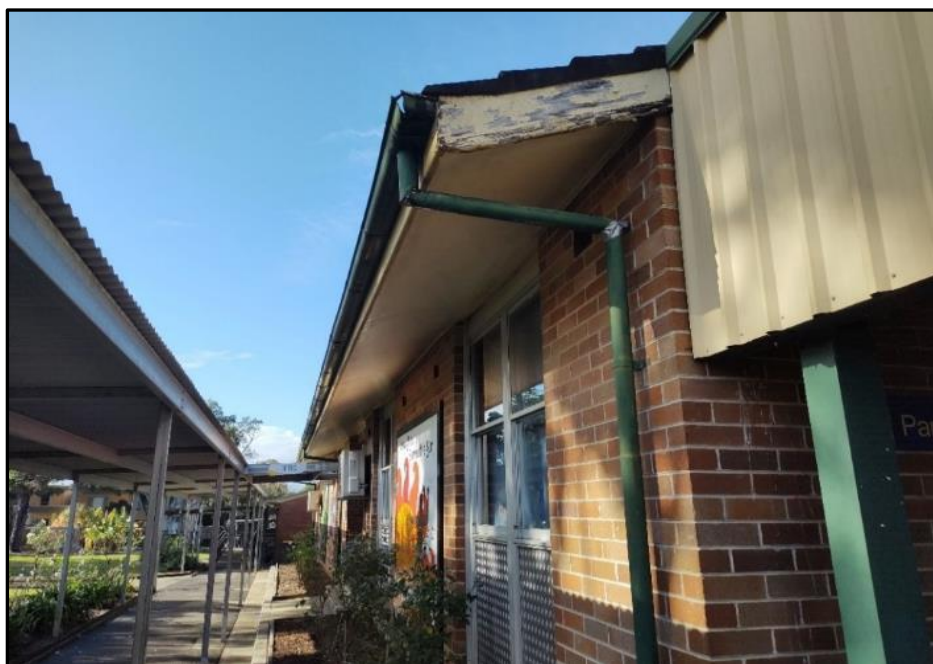
Photograph 3: B00C, exterior, eave linings, fibre cement sheeting, asbestos detected by analysis.

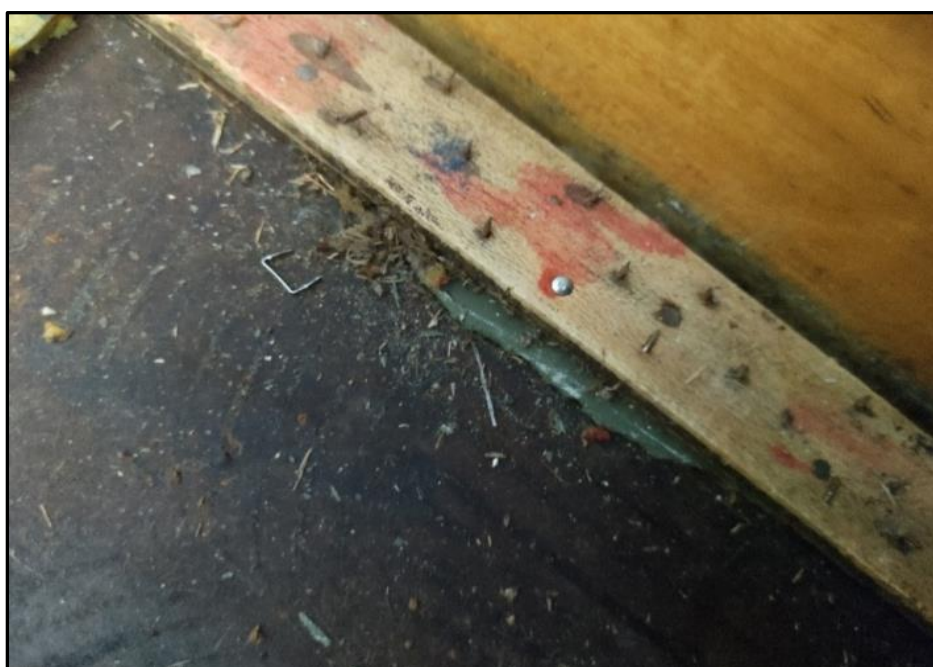
Photograph 4: B00C, CR0001, floor, green vinyl sheeting pieces along the edges, asbestos detected by analysis.

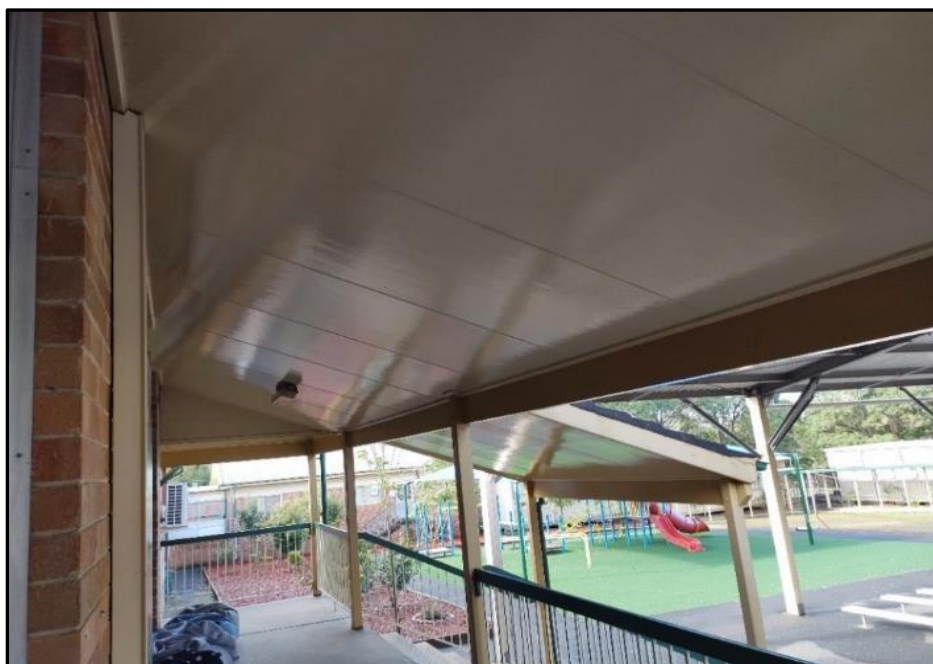
Photograph 5: B00C, CR0002, ceiling, fibre cement sheeting, asbestos detected by analysis.

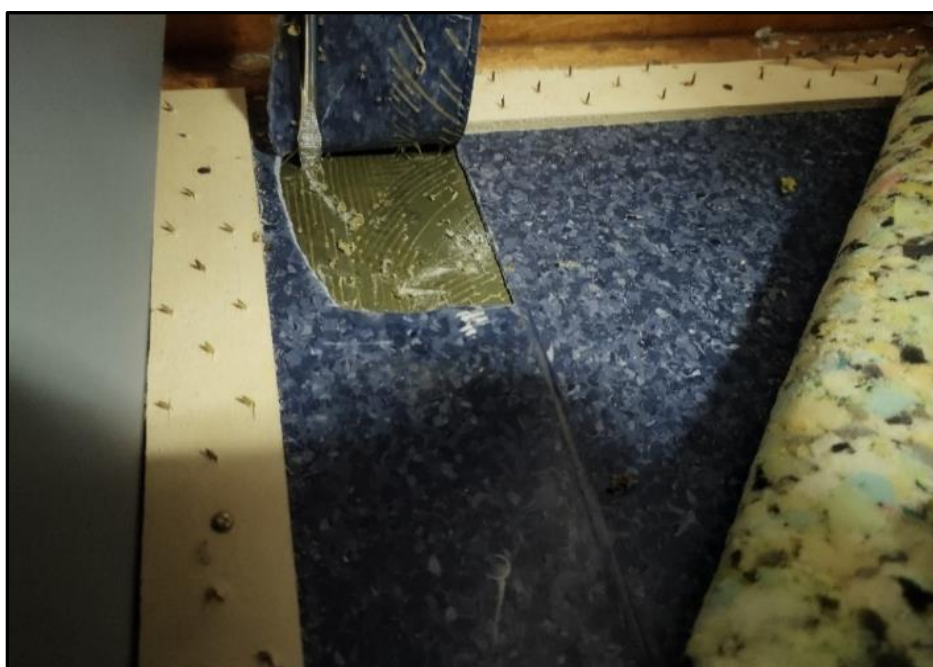
Photograph 6: B00C, CR0003, floor, green vinyl sheeting, asbestos detected by analysis.

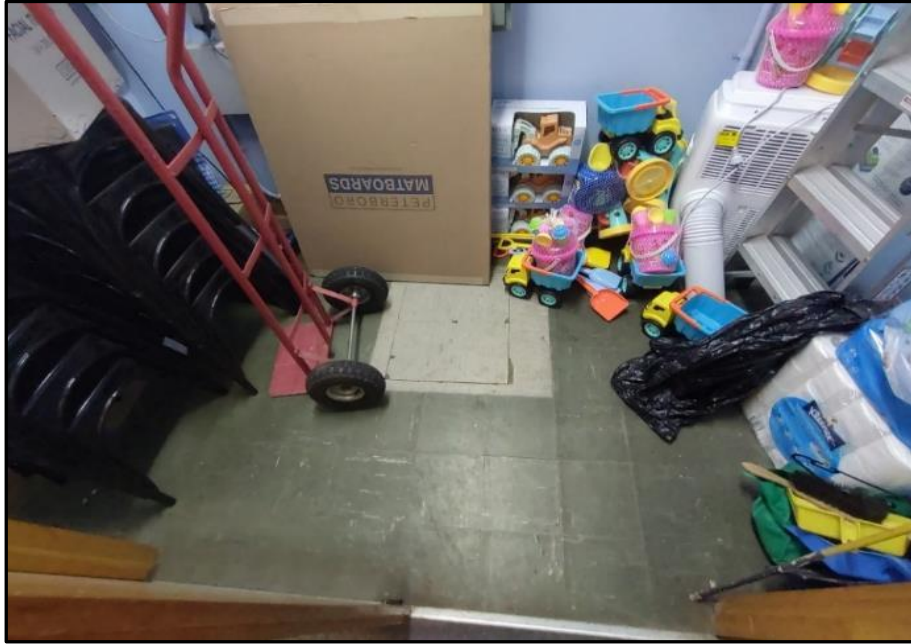
Photograph 7: B00C, CR0006, floor, green vinyl sheeting, asbestos detected by analysis.

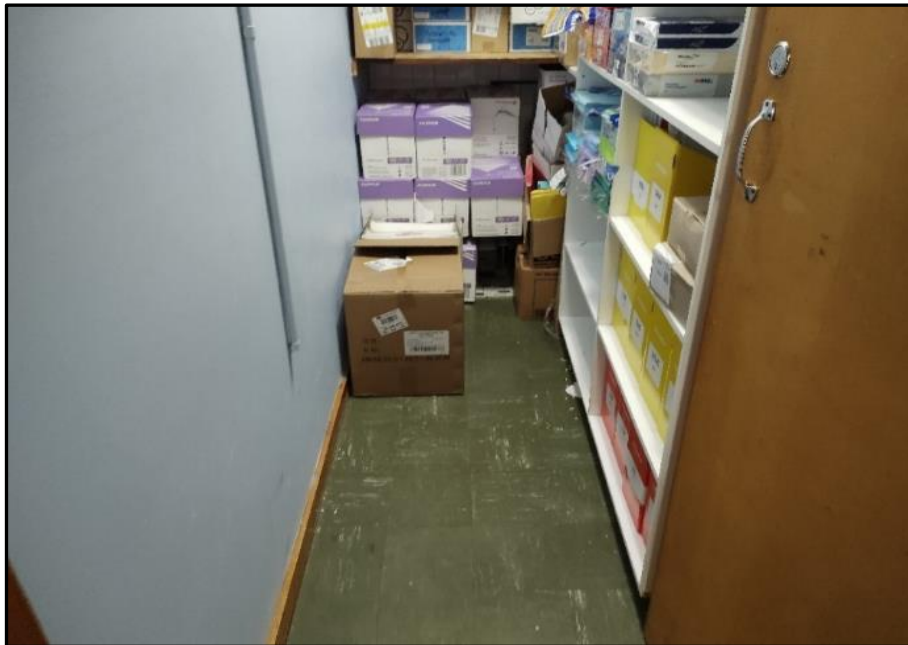
Photograph 8: B00C, CR0010, floor, vinyl sheeting, asbestos detected by analysis.

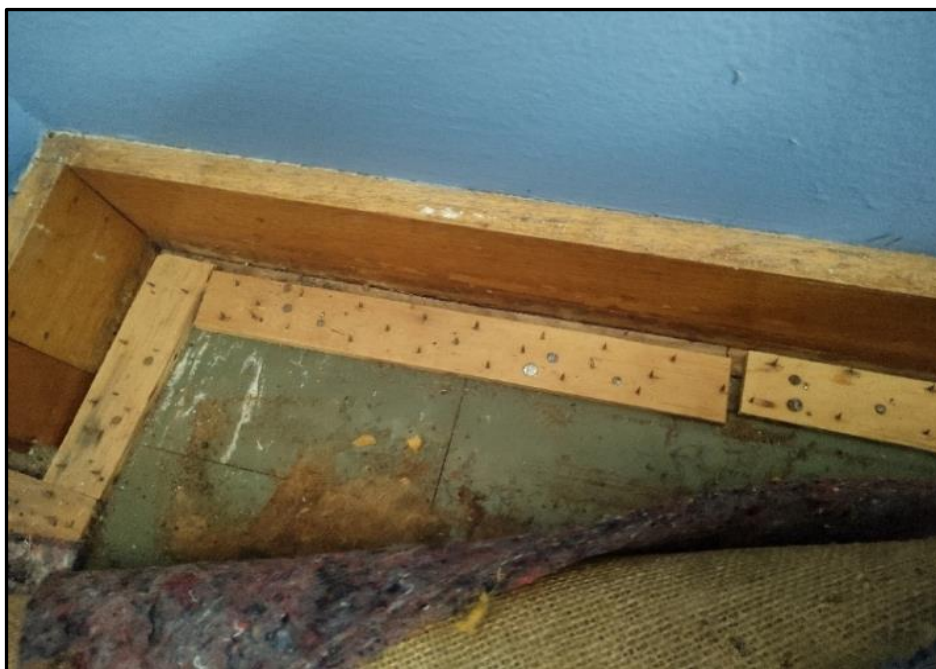
Photograph 9: B00C, CR0014, floor, vinyl sheeting, asbestos detected by analysis.

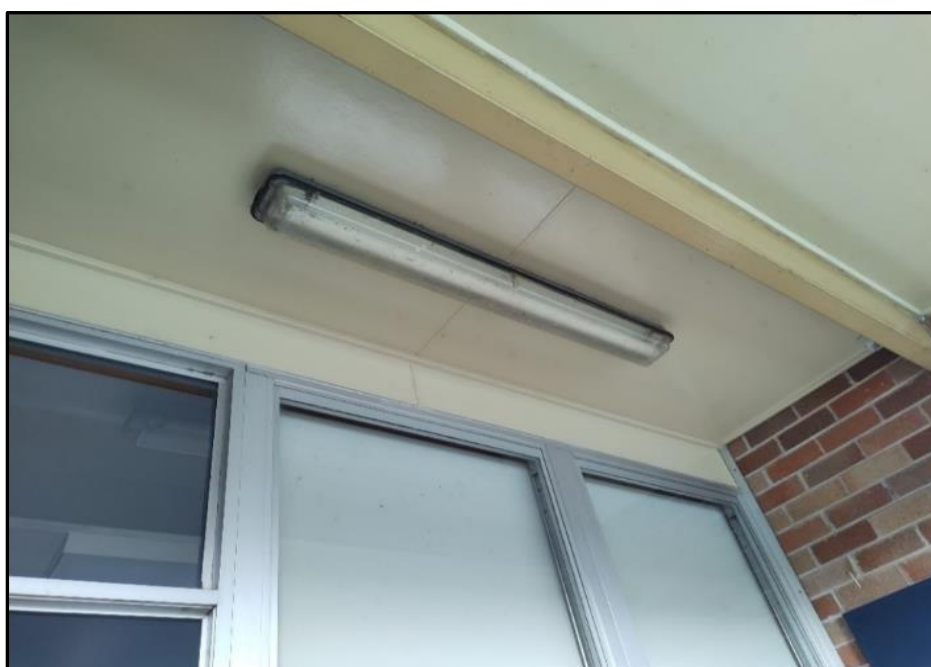
Photograph 10: B00C, CR0016, ceiling and wall, fibre cement sheeting, asbestos detected by analysis.

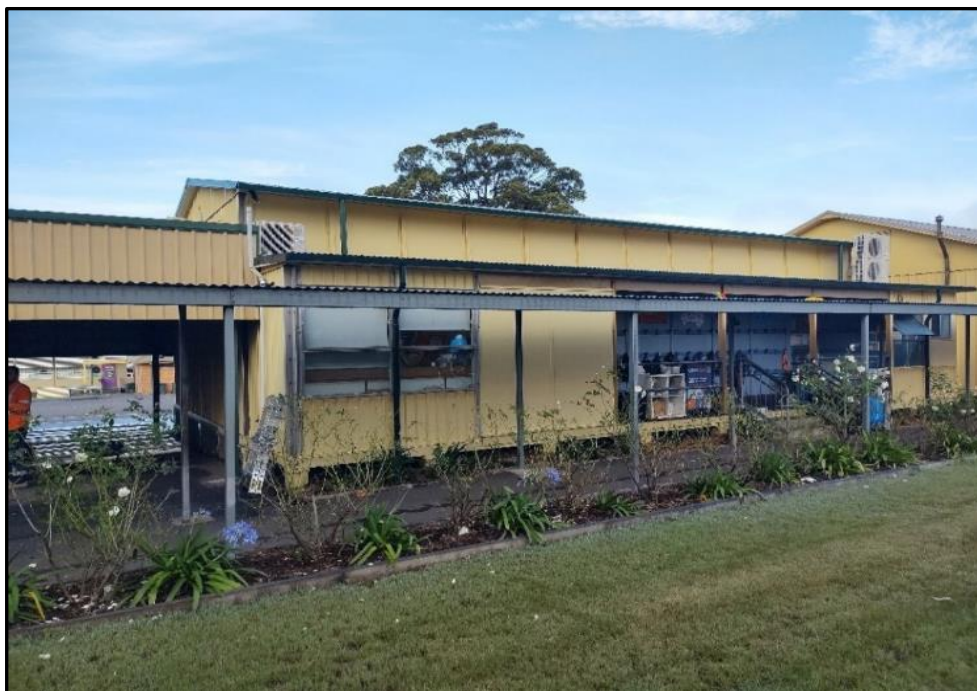
Photograph 11: B00D, exterior, wall cladding, fibre cement sheeting, asbestos reported in DoE Register. Cream paint to wall, and green paint to gutter / downpipe, found to contain lead.

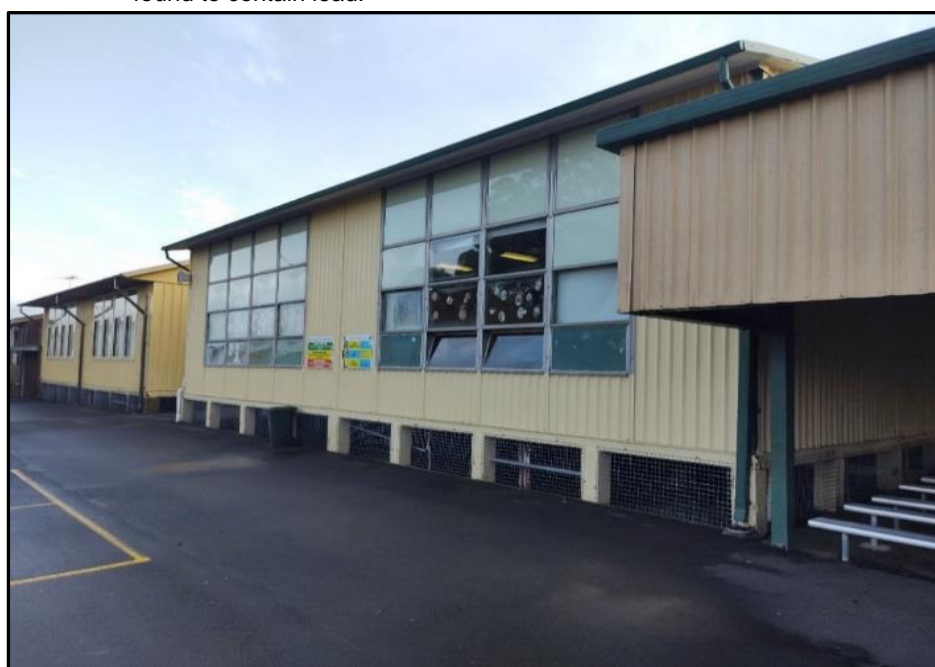
Photograph 12: B00D, exterior, eave linings, fibre cement sheeting, asbestos detected by analysis.

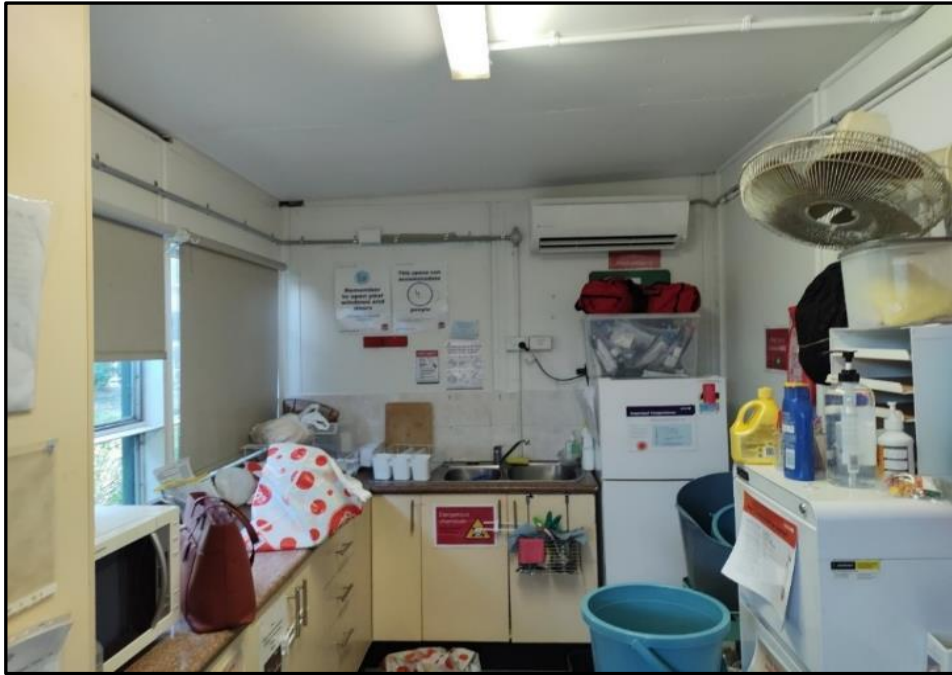
Photograph 13: B00D, DR0001, walls and ceiling, fibre cement sheeting, asbestos detected by analysis.

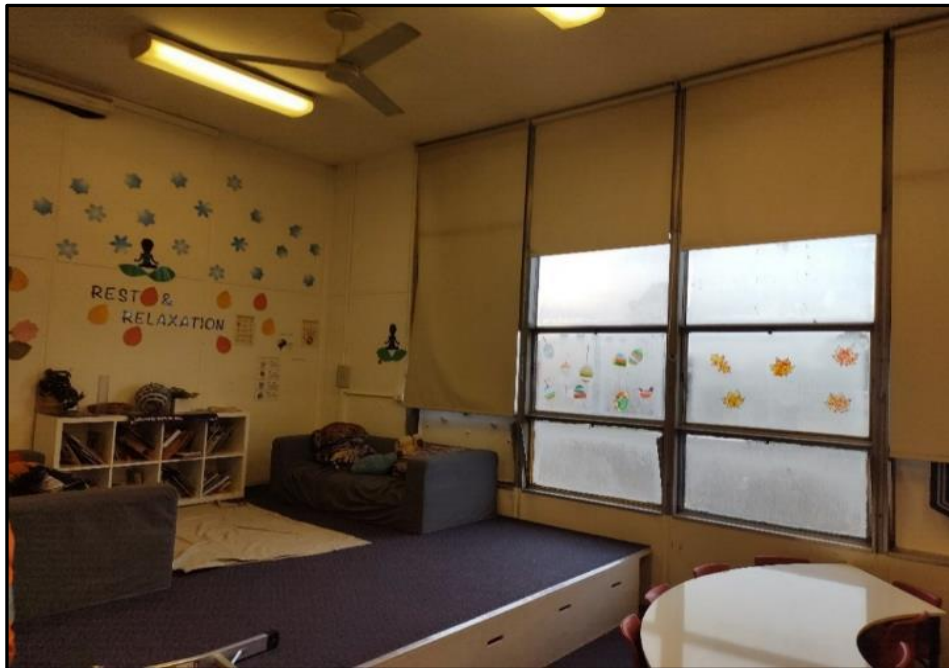
Photograph 14: B00D, DR0002, windows, mastic, asbestos detected by analysis.

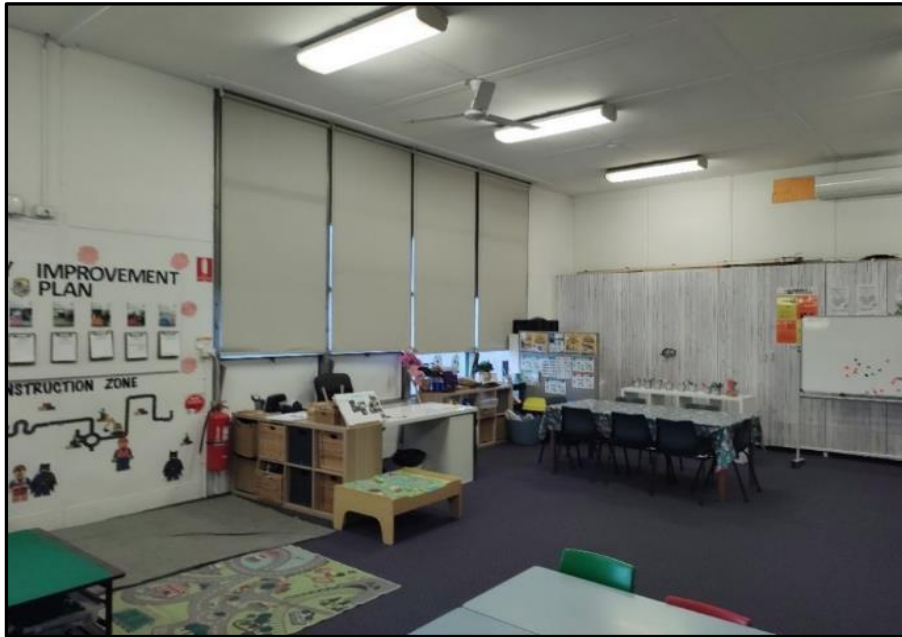
Photograph 15: B00D, DR0003, ceiling, fibre cement sheeting, asbestos detected by analysis.

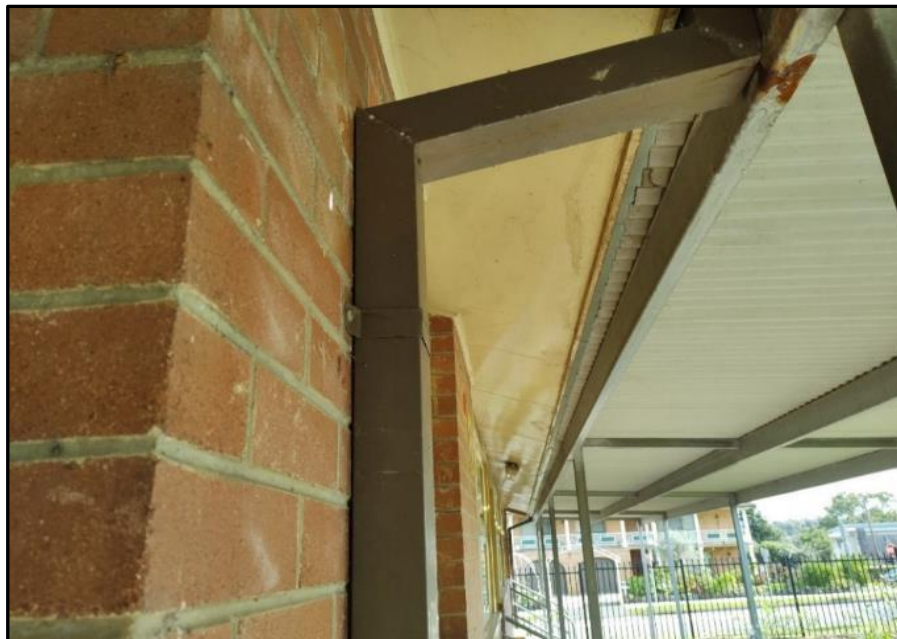
Photograph 16: B00F, exterior, eave linings, fibre cement sheeting, asbestos detected by analysis.

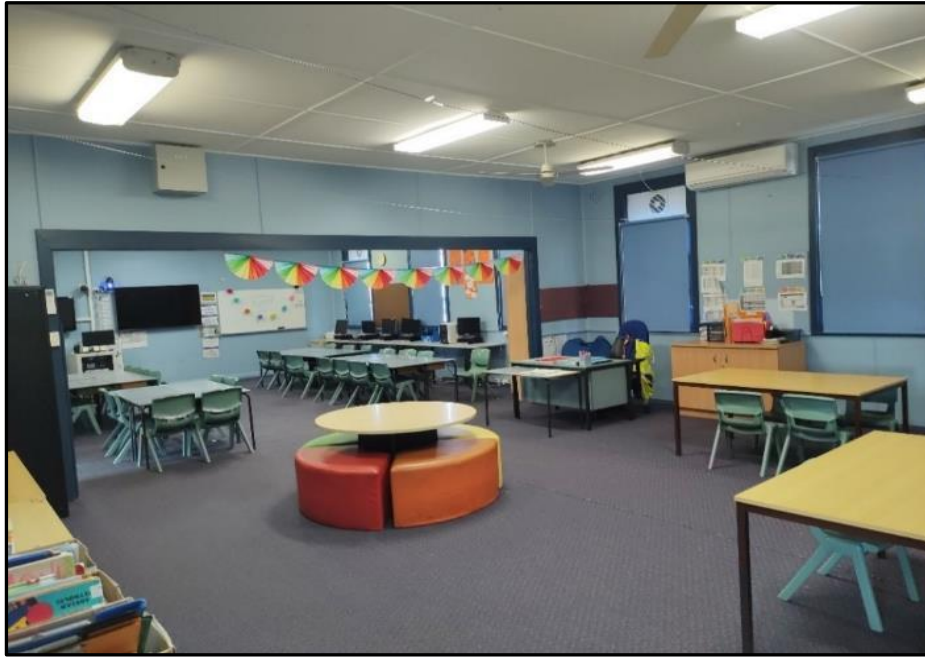
Photograph 17: B00F, FR0002, ceiling and wall(s), fibre cement sheeting, asbestos detected by analysis.

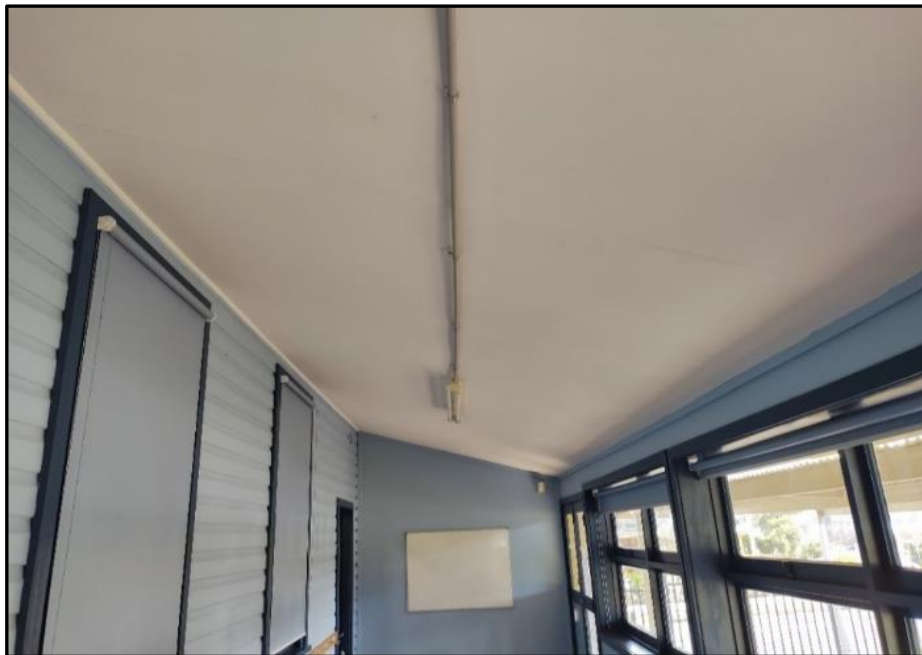
Photograph 18: B00F, FR0004, ceiling, fibre cement sheeting, asbestos detected by analysis.

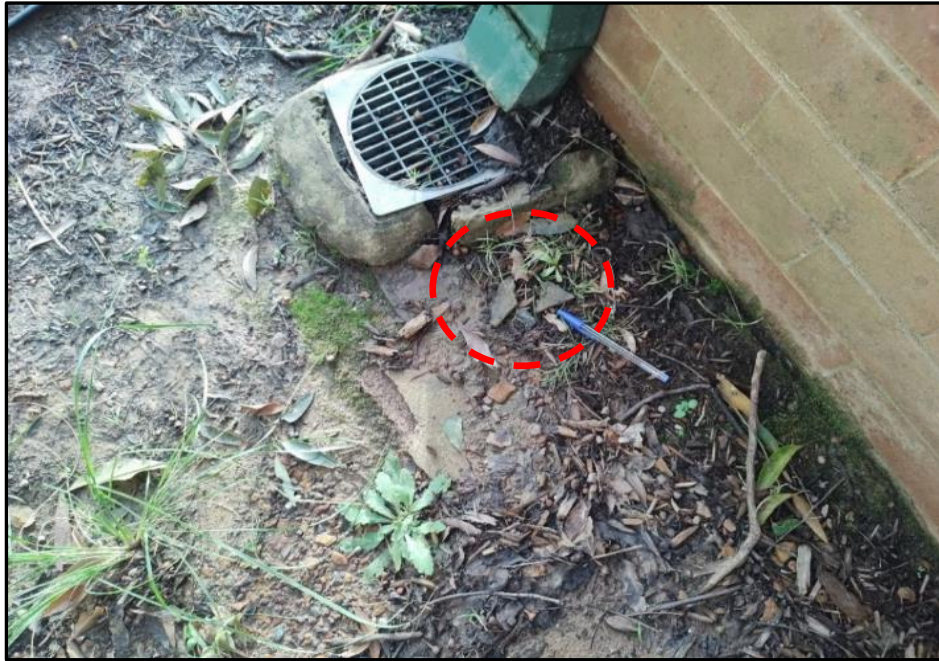
Photograph 19: B00G, exterior, south-west corner, ground surface, fibre cement fragment(s), asbestos detected by analysis.

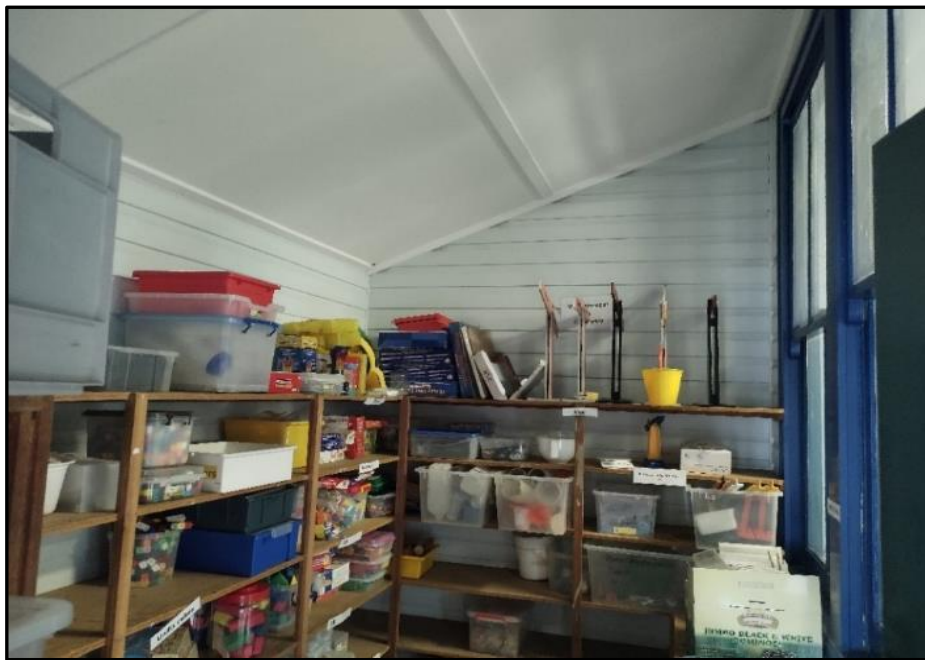
Photograph 20: B00G, GR0001, ceiling, fibre cement sheeting, asbestos detected by analysis.

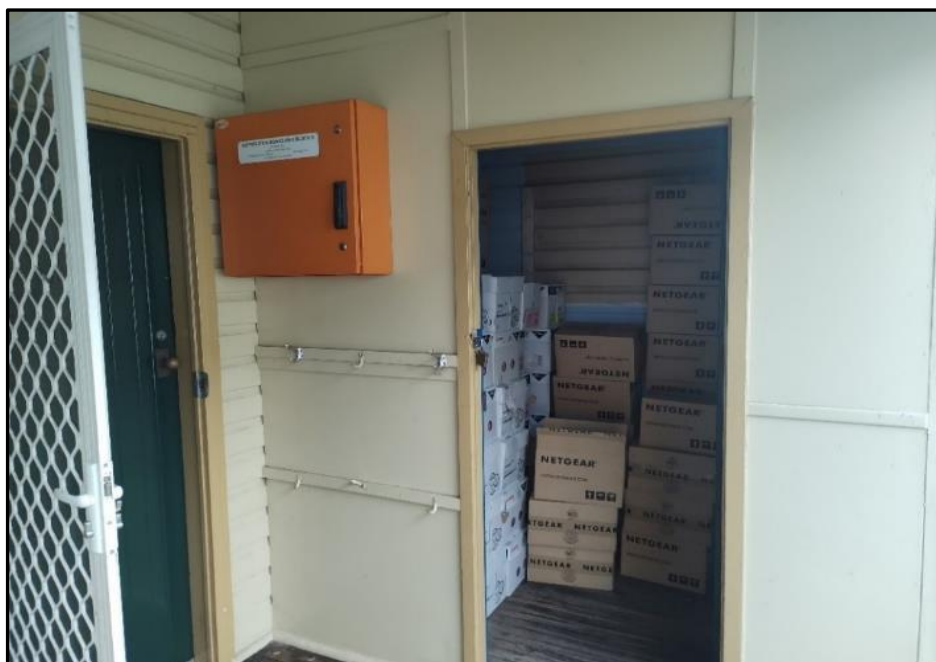
Photograph 21: B00G, GR0007, ceiling, fibre cement sheeting, asbestos detected by analysis.

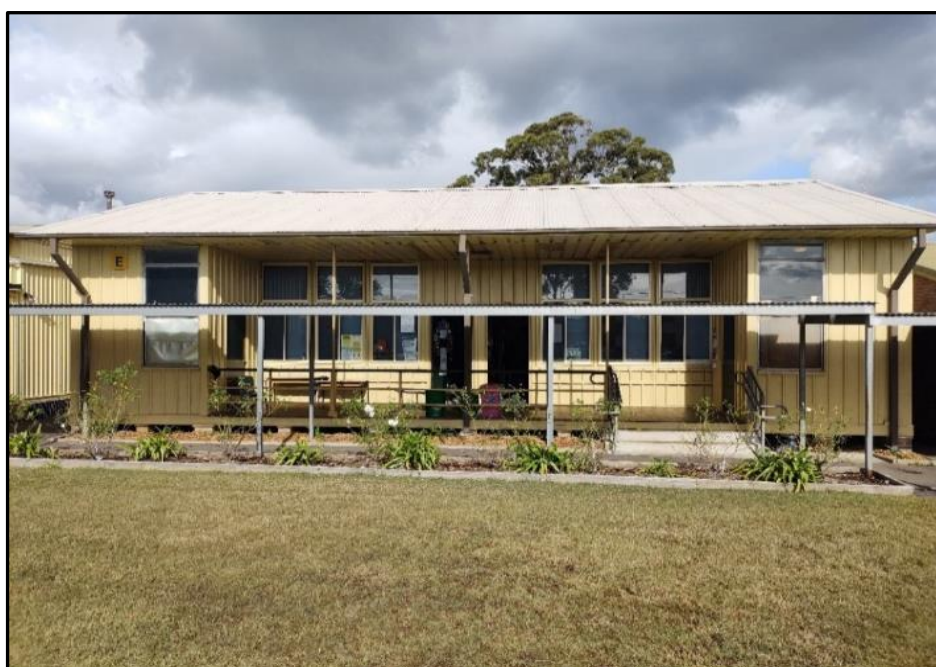
Photograph 22: B00E, exterior, walls, cream paint, lead paint identified.

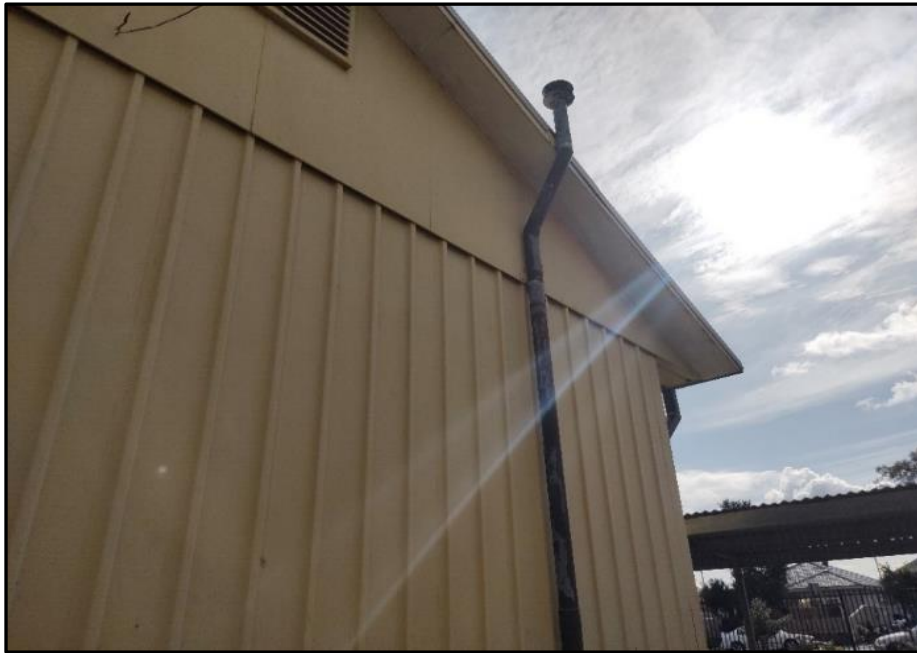
Photograph 23: B00E, exterior, east side, pipe, brown paint, lead paint identified.

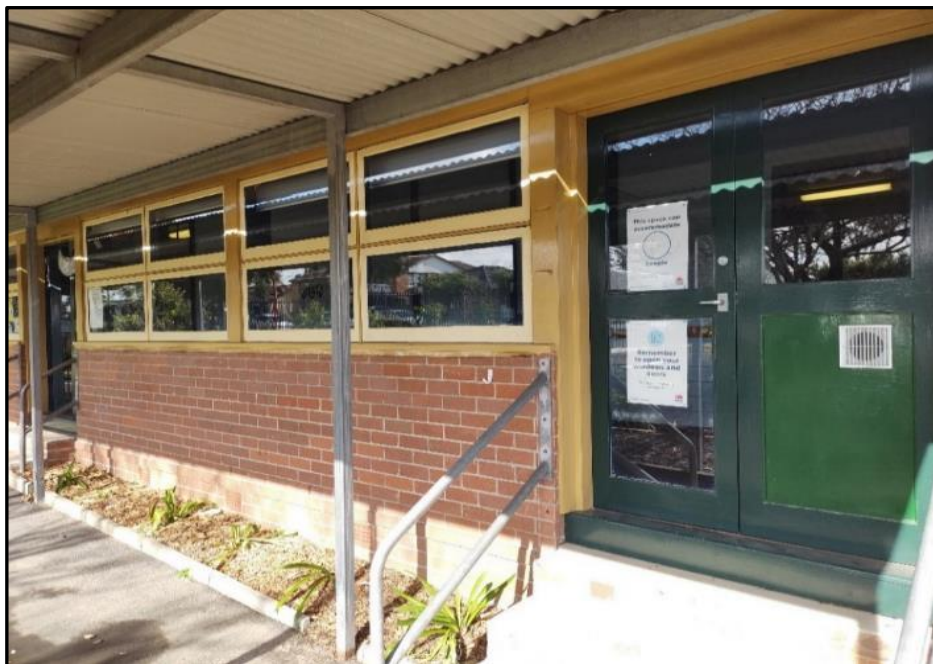
Photograph 24: B00F, exterior, window / door frame, cream paint, lead paint identified.

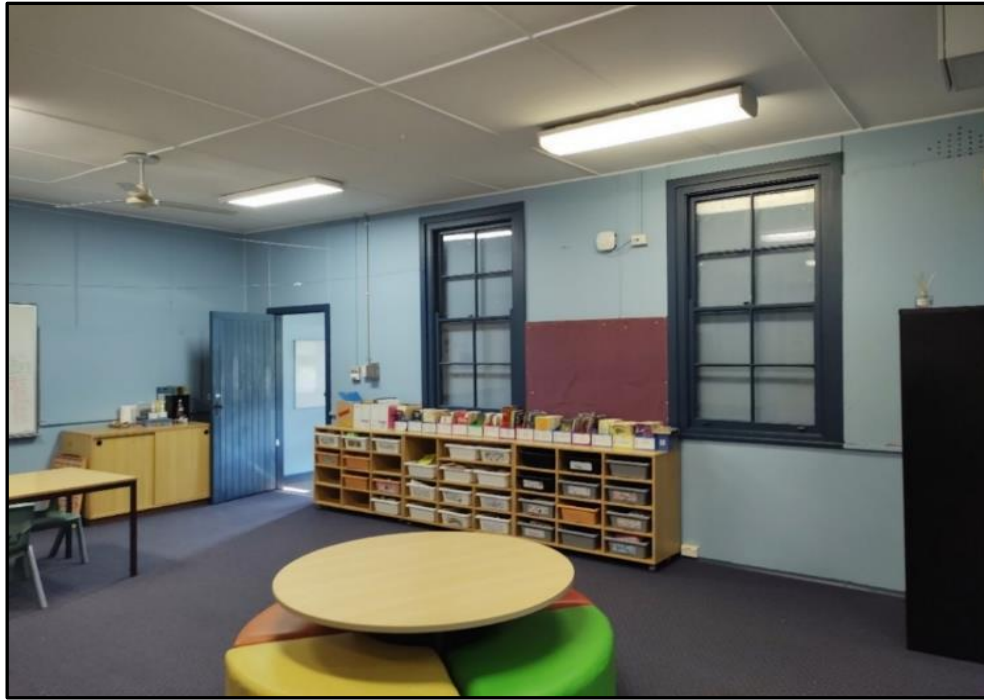
Photograph 25: B00F, FR0003, door / window frame, dark blue paint, lead paint identified.

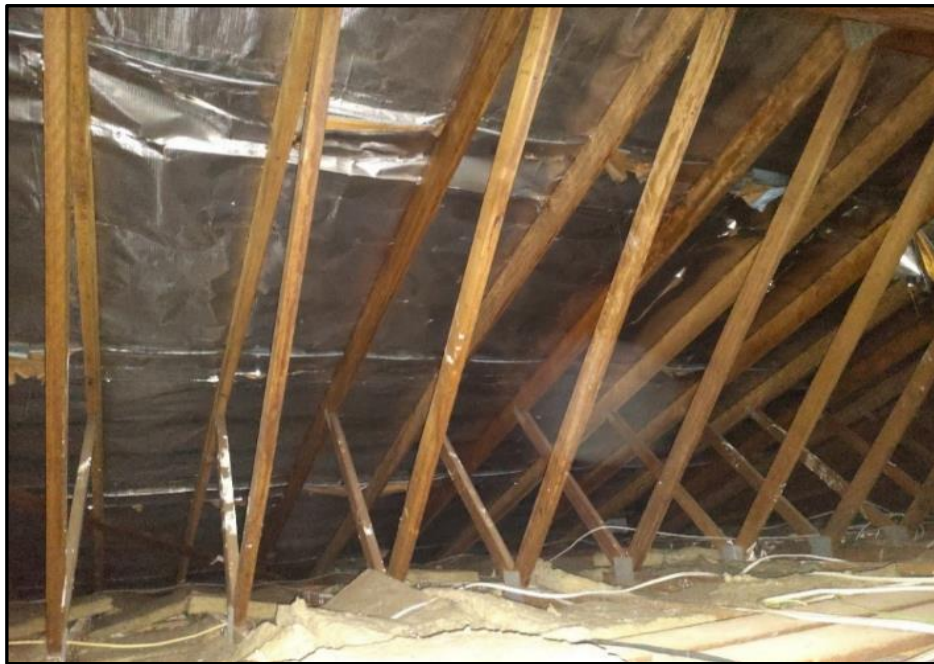
Photograph 26: B00C, ceiling cavity generally, sarking to underside of roof and insulation to top of ceiling, suspected SMF.

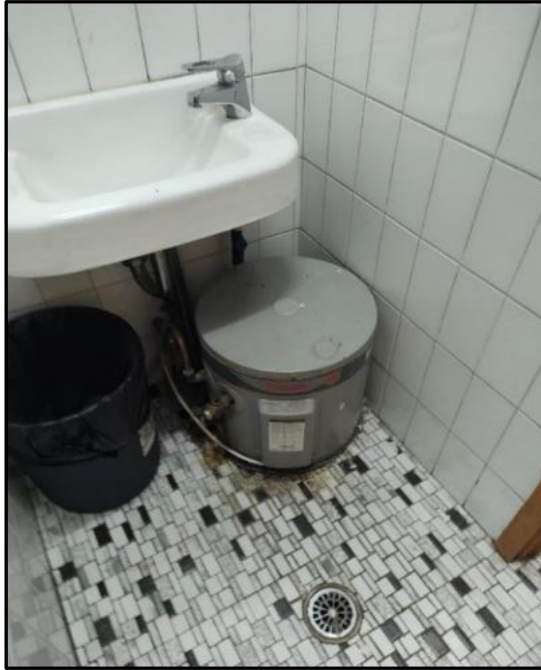
Photograph 27: B00C, CR0007, hot water unit, internal insulation, suspected SMF.

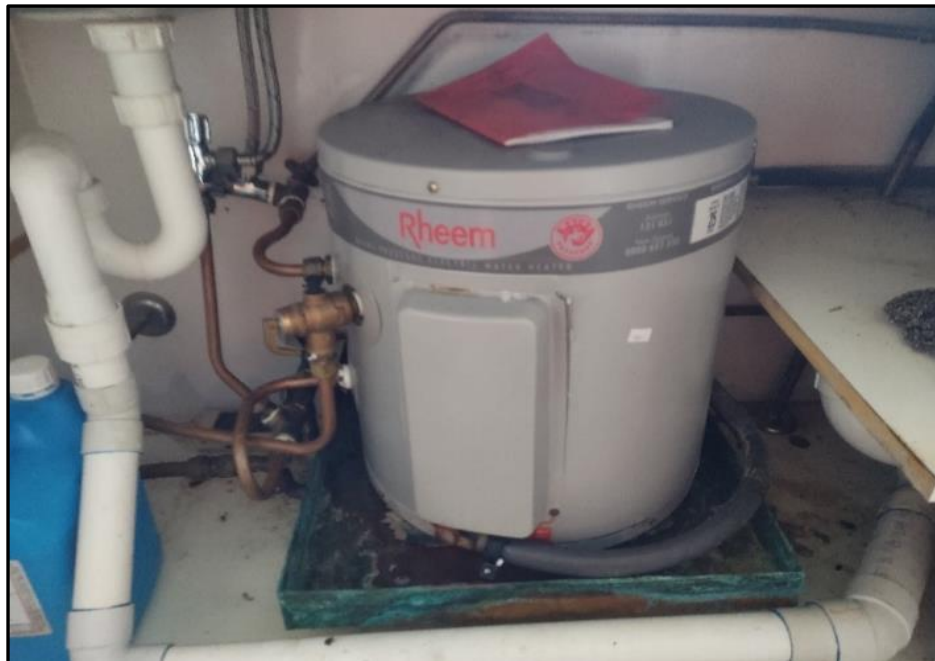
Photograph 28: B00D, DR0001, hot water unit, internal insulation, suspected SMF.

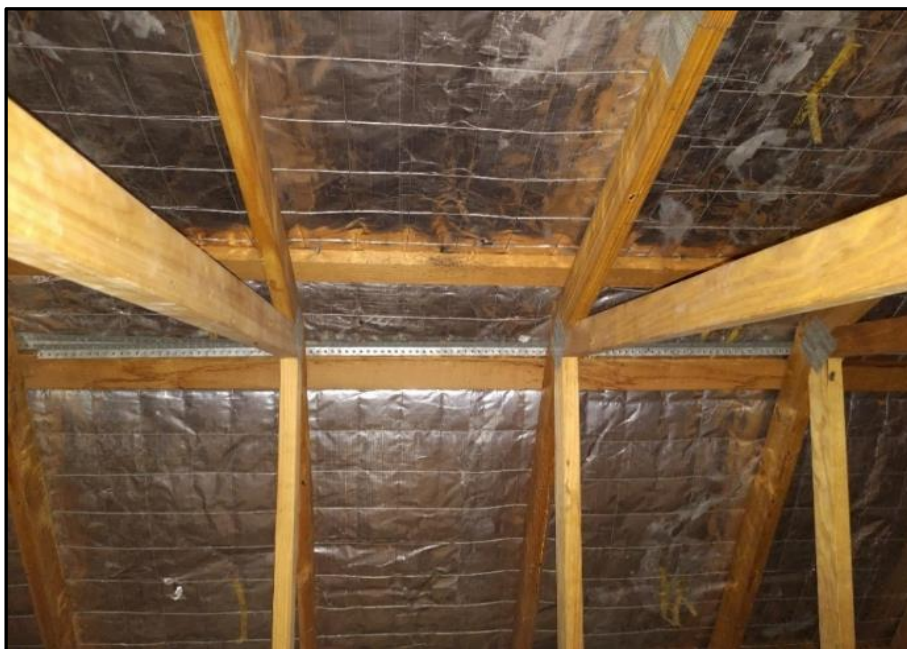
Photograph 29: B00H, roof, ceiling cavity, sarking, suspected SMF.

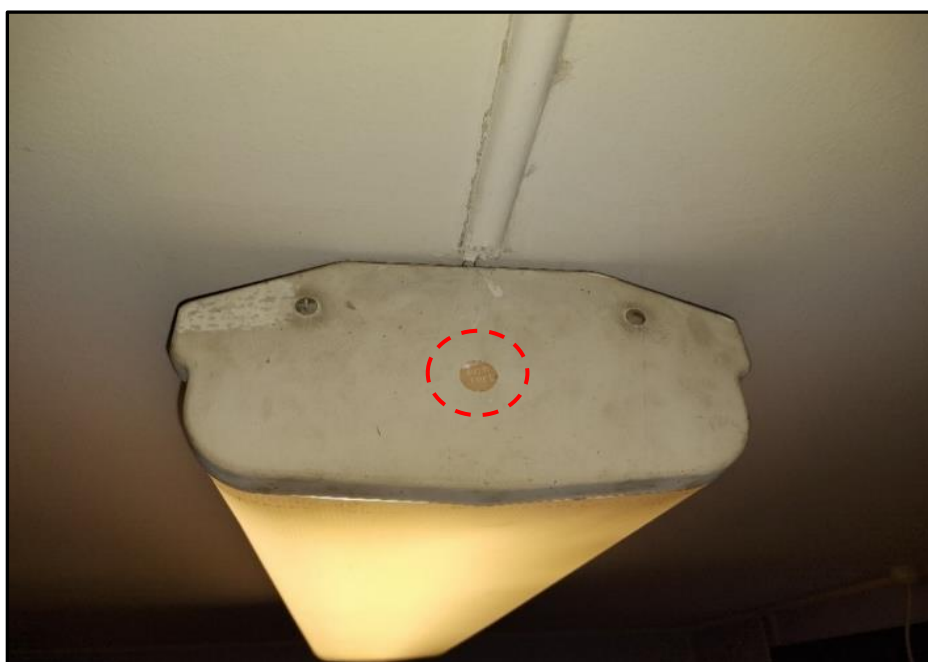
Photograph 30: Buildings in general, fluorescent light fittings, internal components, insulating oil, nil PCB (suspected).

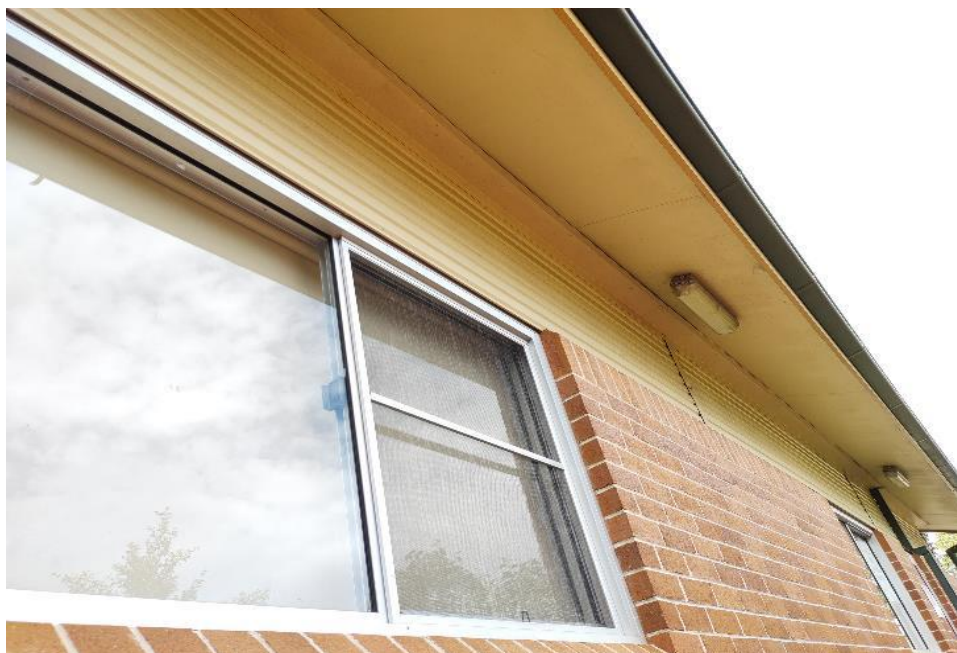
Photograph 31: B00A, exterior, eaves, fibre cement, asbestos detected by analysis.

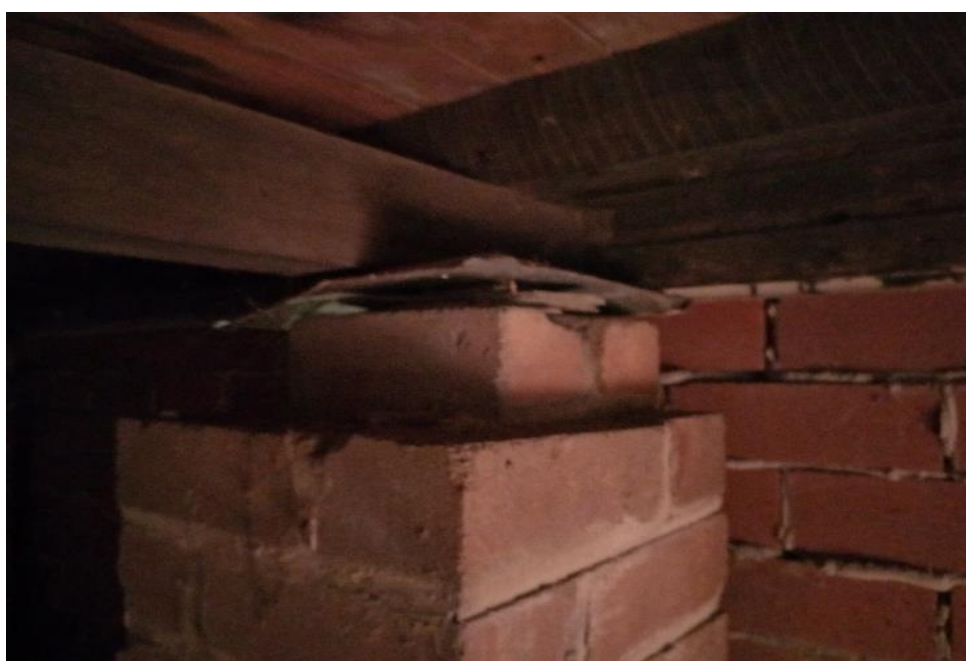
Photograph 32: B00A, floor void, packing materials, fibre cement, asbestos detected by analysis.

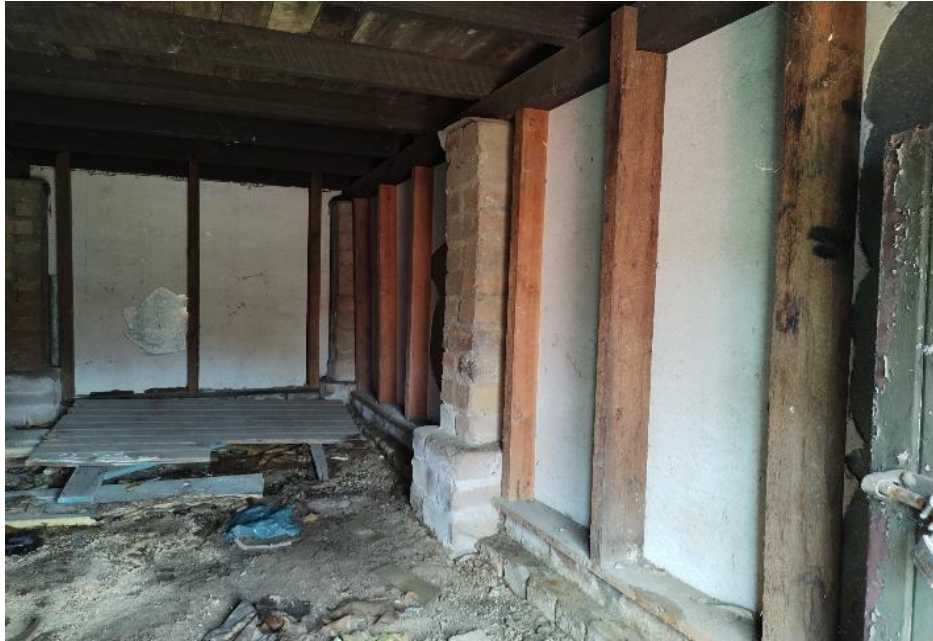
Photograph 33: B00A, floor void storage, walls, fibre cement, asbestos detected by analysis.

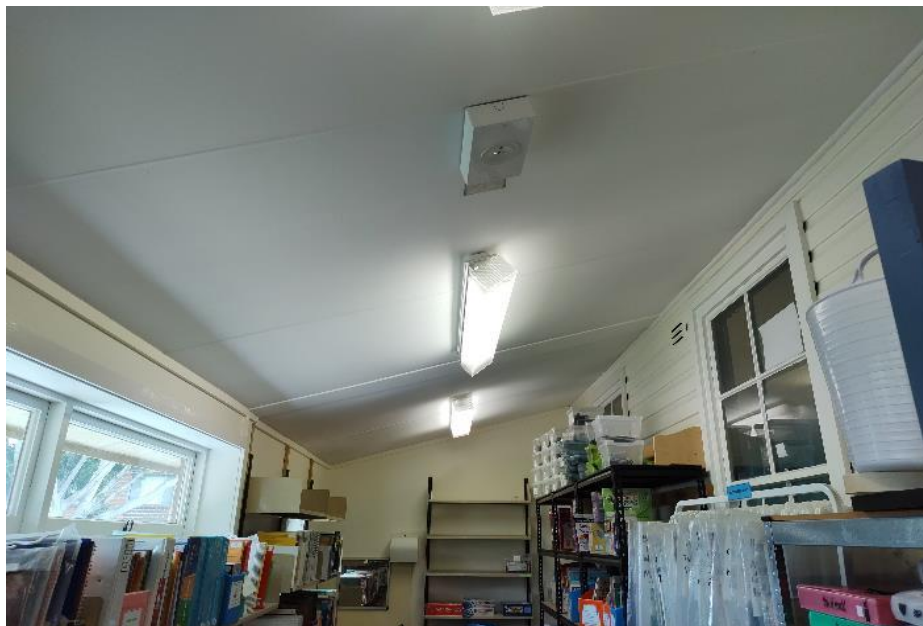
Photograph 34: B00A, AR0009, ceiling, fibre cement, asbestos detected by analysis.

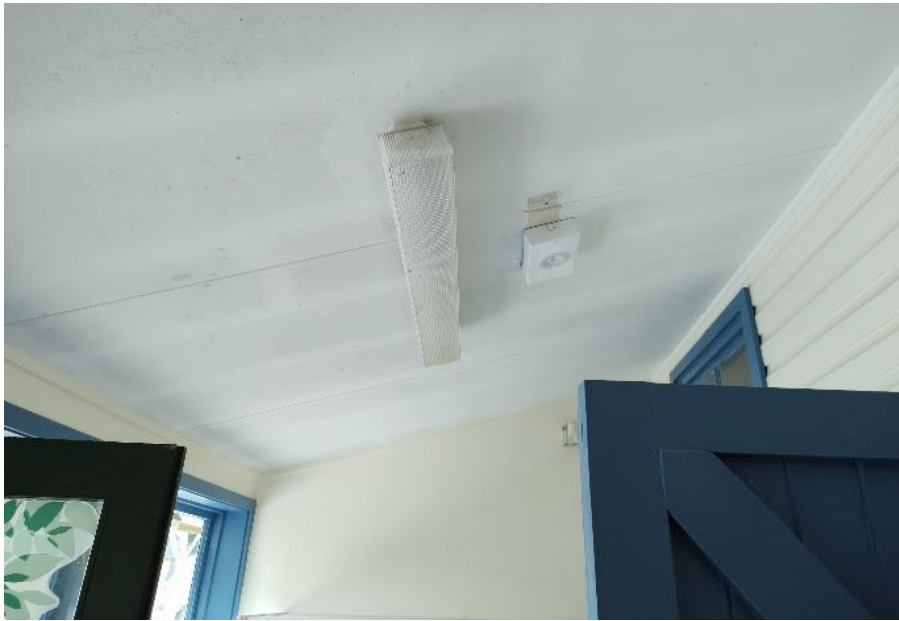
Photograph 35: B00A, AR0008, ceiling, fibre cement, asbestos detected by analysis.

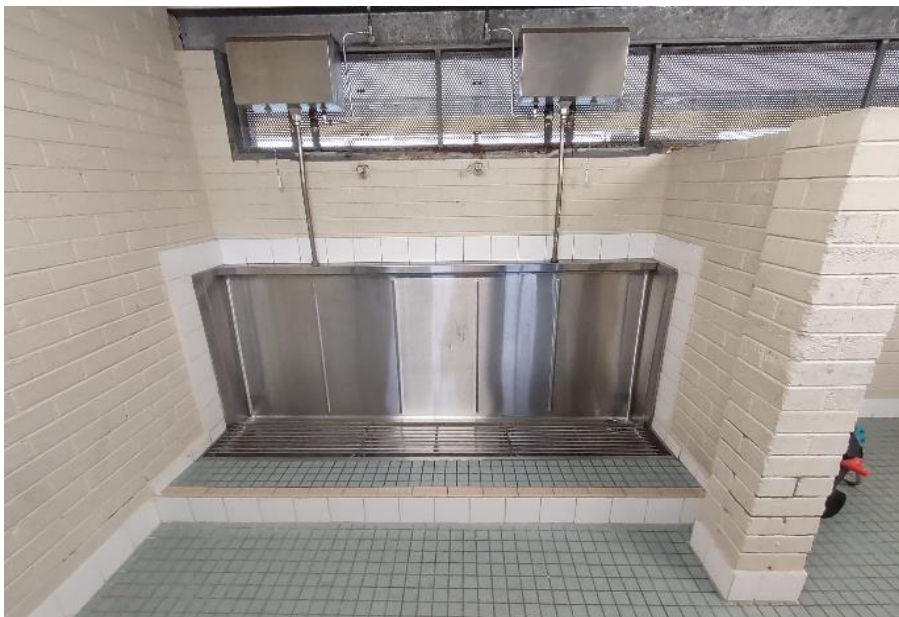
Photograph 36: B00J, JR0002, underneath urinals, bituminous lining (if present), inaccessible.
